RDTR NO. 160 3 DECEMBER 1969

SAFETY TEST OF FLARE EXTRUSION FACILITY

NAVAL AMMUNITION DEPOT, CRANE, INDIANA

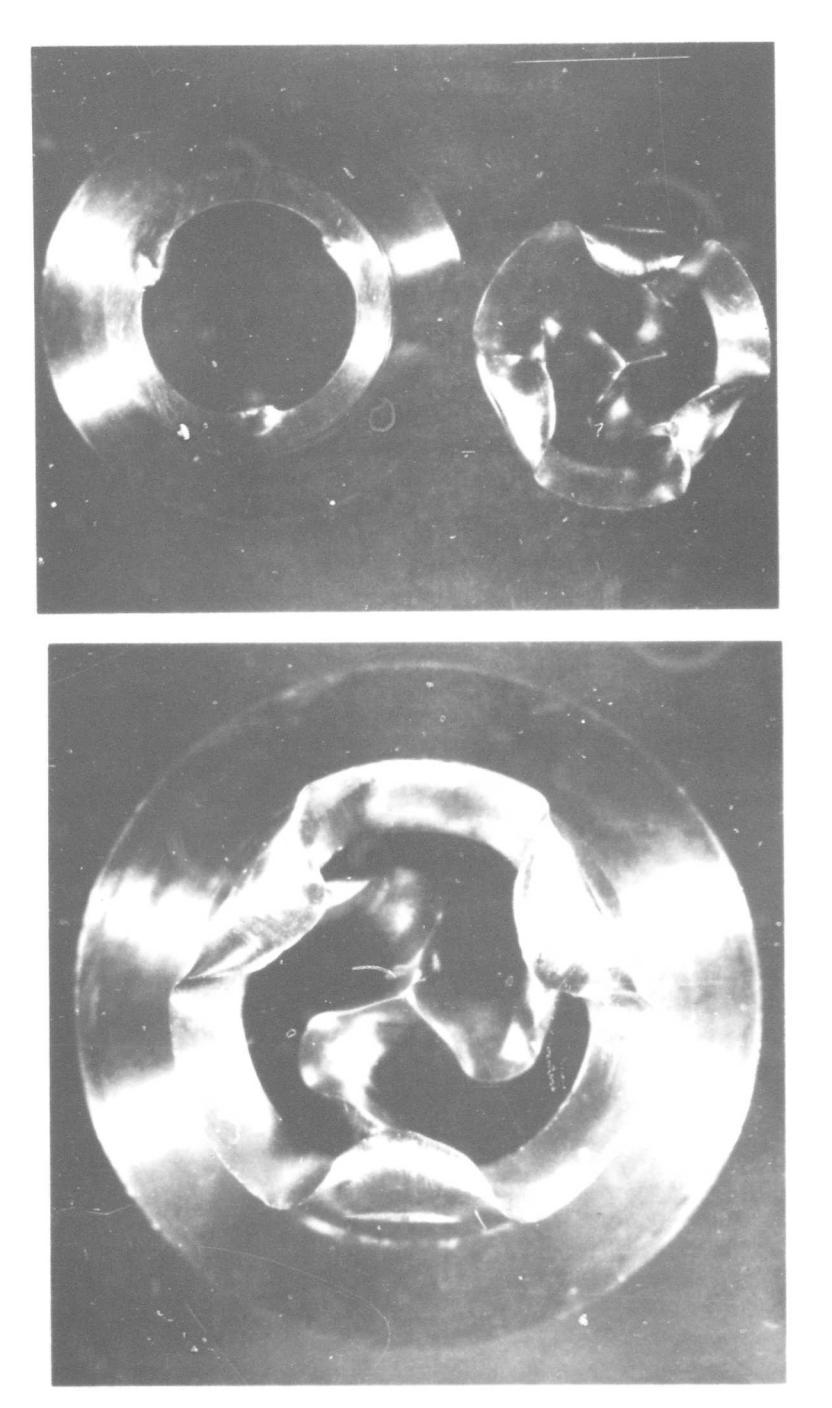
FIGURE 1 COLLAPSED DIE CROWN

compression of air not evacuated from the charge cylinder, broken extrusion die, or static electricity. The exact cause was not established; however, several opinions strongly favored a broken extrusion die. After the extrusion facility was restored, an extrusion die for the MK 46 flare grain with a crown made of material that had twice the tensile strength of the crown being used in December was installed in the press. Several inert extrusions were made at a line pressure of 1000 psi and at 130°F charge cylinder temperature. In order to increase the stress on the die, additional inert extrusions were made at a line pressure of 1500 psi and with the charge cylinder at ambient temperature. During the second run, the die crown collapsed as can be seen in Figure 1. Die collapse with only 50% over stress adds strength to the opinions that the die crown broke and caused ignition in the press on December 18.

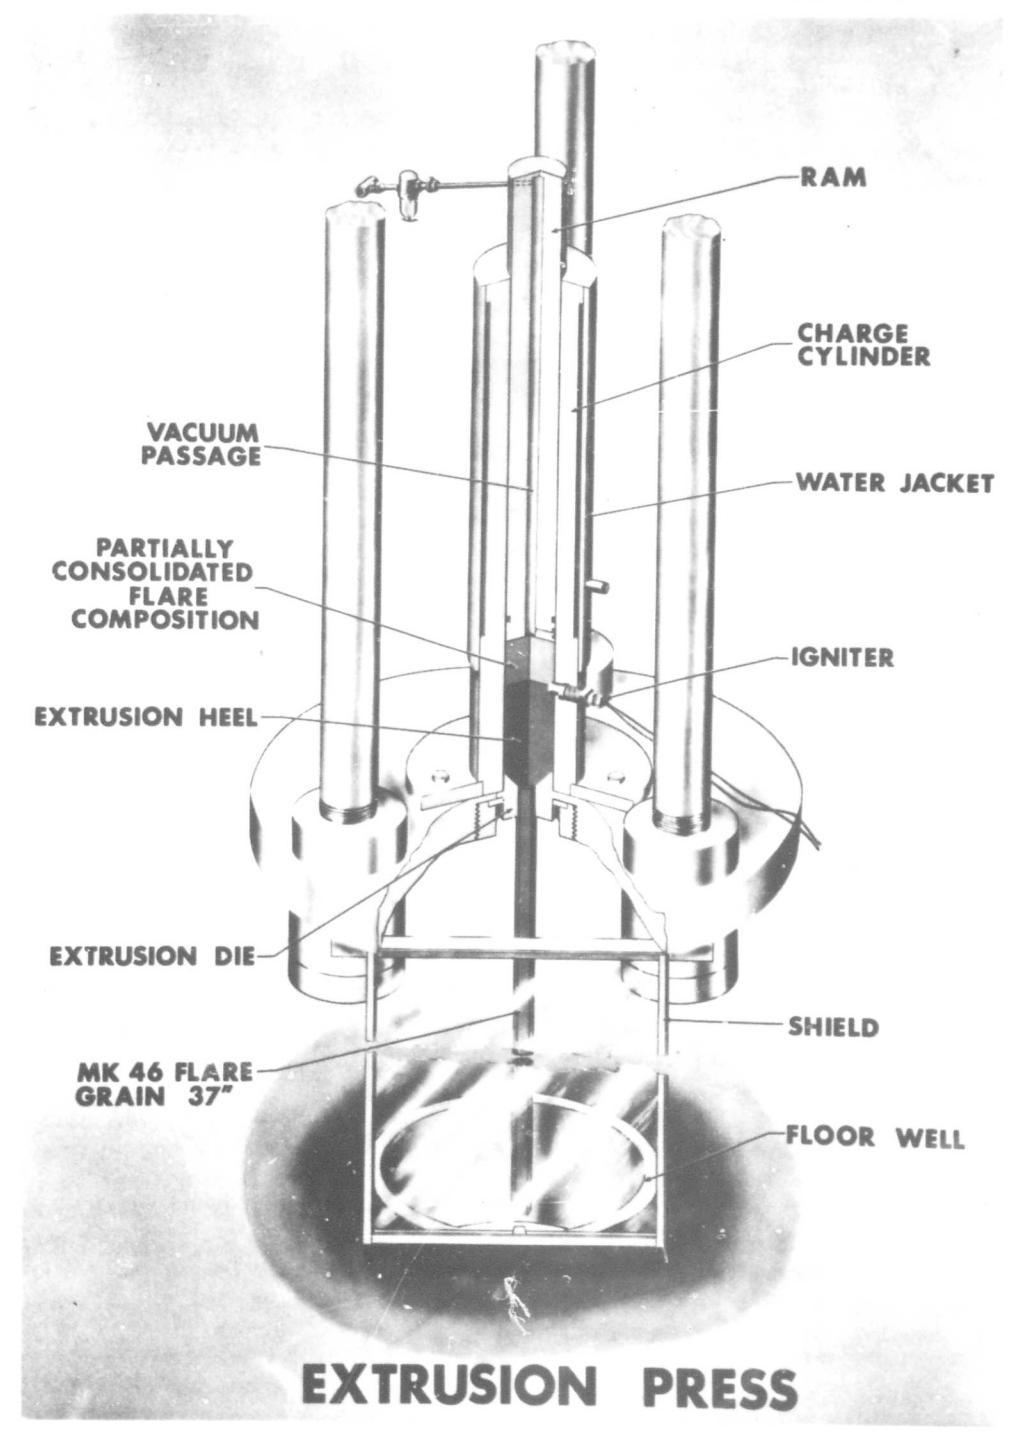
Figure 2 13

grain. The press was loaded with seven pounds of MK 46 flare composition, so as to simulate a point in the extrusion cycle at which an accidental ignition might occur. Figure 2 is an illustration of the press as loaded for the test.

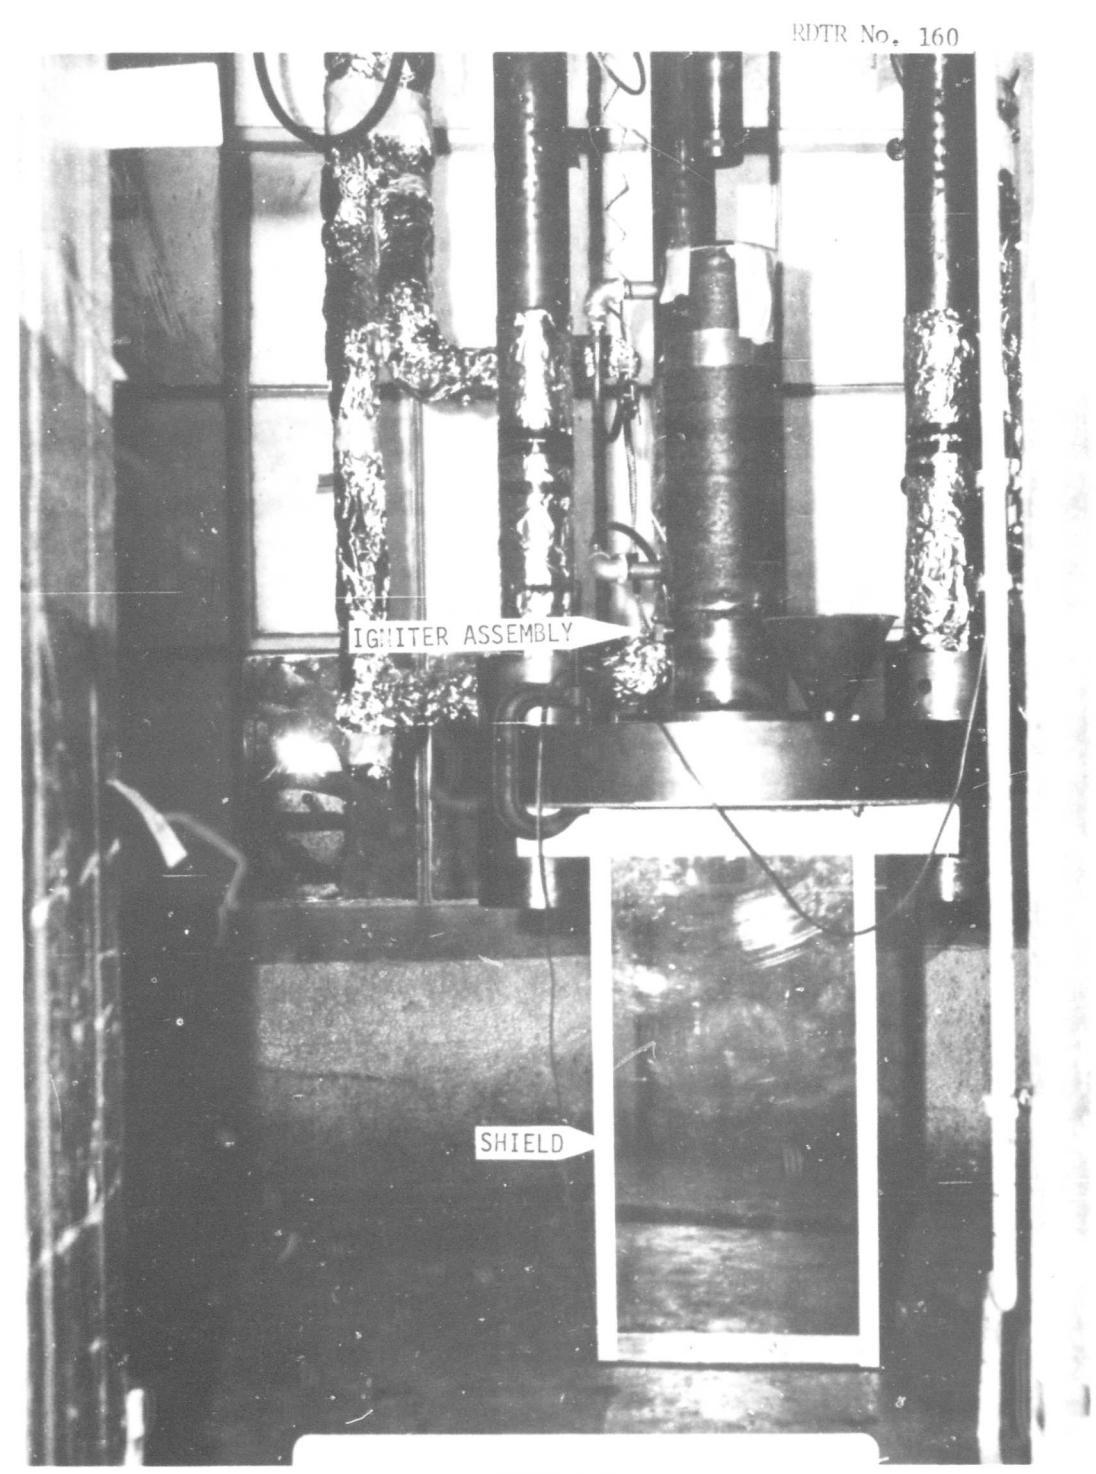
FIGURE 3 PRESS CELL BEFORE TEST

3. Figure 3 shows the press before the test and the shield which was installed to help deflect flame away from the loose-fitting cell door and to provide more protection for personnel entering the cell to remove extrusions.

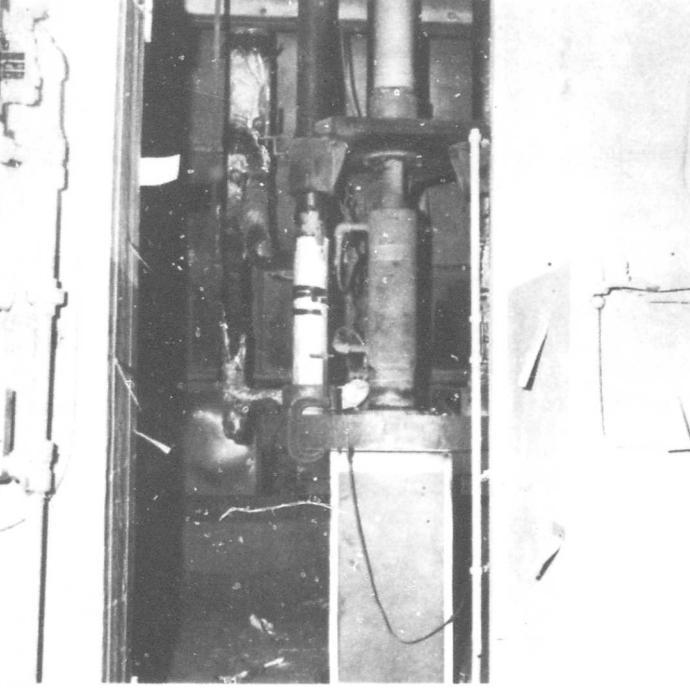
FIGURE 8a PRESS CELL AFTER TEST

2. Figure 8a shows the cell after the test. The shield deflected much of the heat away from the front of the cell. None of the newspaper in the doorway burned. Figure 8b shows the blowout window from the outside. The lower two rows of window sections were badly distorted. One section fell to the inside of the cell after the composition had burned out. The temperature under the press rose high enough to melt aluminum, as can be seen by figures 9a and 9b, but was insufficient at the front of the cell to burn all the newspaper on the inside of the cell door, figure 10a. Figure 10b shows the top part of the door where two pieces of newspaper scorched and the third piece mostly burned.

a. The extrusion facility has been restored so as to afford adequate safety protection to the press operating personnel. None of the newspaper in the doorway to the press cell burned, indicating that the press operators would not have received serious burns.

b. The polycarbonate shield between the press and floor deflected heat from the cell door much better than anticipated. We now have greater confidence in polycarbonate shielding used in other operations.

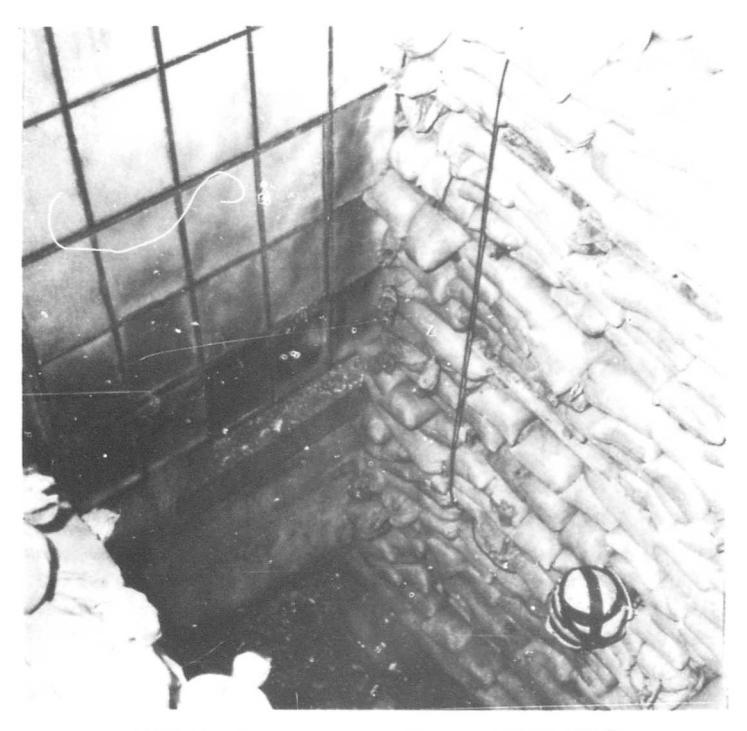
FIGURE 85 BLOWOUT WINDOW AFTER TEST

7. P3 indicated a maximum overpressure in the cell of 3.2, however, the blowout windows did not blow. If the window had blown as it should have, most of the smoke and heat that went around the cell door into the building would have exhausted to the outside.

The pressure rise in the cell of approximately three psi was not great enough to blow the windows. The window should be replaced with one that blows at a lower pressure.

c. Blowout window improvement is needed. If the window had blown, as it should have, much less smoke and heat would have been forced past the door.

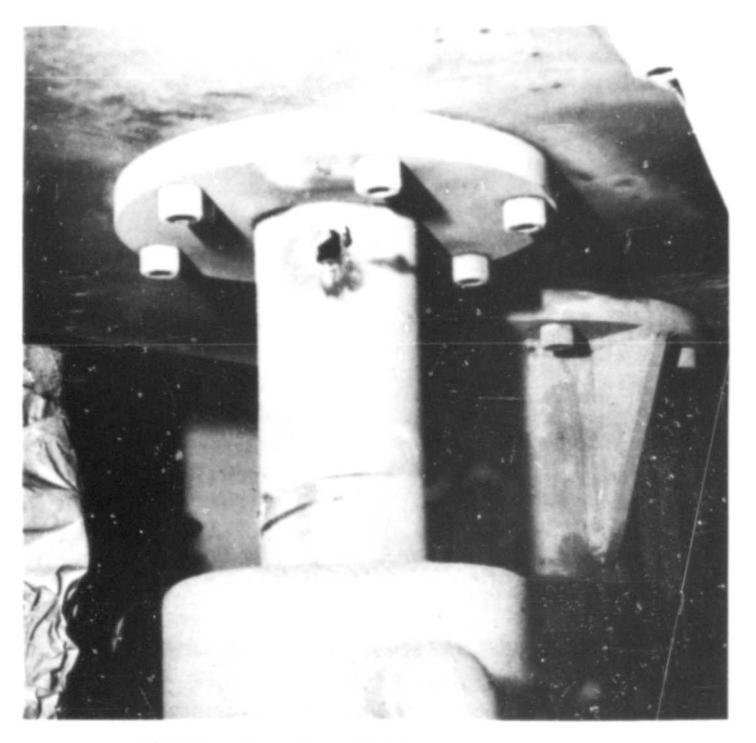
FIGURE 11b TOP OF RAM

3. Burning inside the press was very vigorous and hot, as was expected. A total time of nine seconds of audible burning was indicated by the audio tape. The combustion pressure in the charge cylinder vented in two directions, up through the vacuum passage in the ram and down through the die. Flame venting through the ram melted steel pipe fittings as shown in Figure 11a. These fittings were originally located at the top of the ram-figure 11b. The beryllium copper ram was eroded as shown in figure 12a.

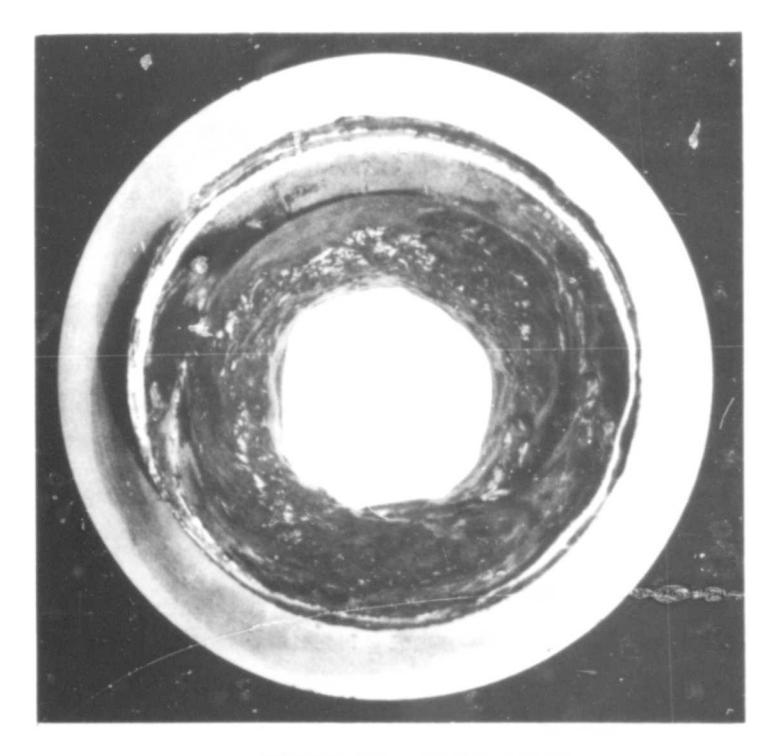
FIGURE 12b DIE EROSION

The 0 ring on the ram (not shown) was not damaged significantly. The stainless steel die, figure 12b, was eroded in a spiraling pattern. The vacuum pump was pumping during the test which definitely promoted venting through the ram. Venting through the ram began at approximately 0.15 seconds from test initiation.
