FAA-AM-71-3

GENERAL AVIATION STRUCTURES DIRECTLY RESPONSIBLE FOR TRAUMA IN CRASH DECELERATIONS

SPECIAL REPORT

January 1971

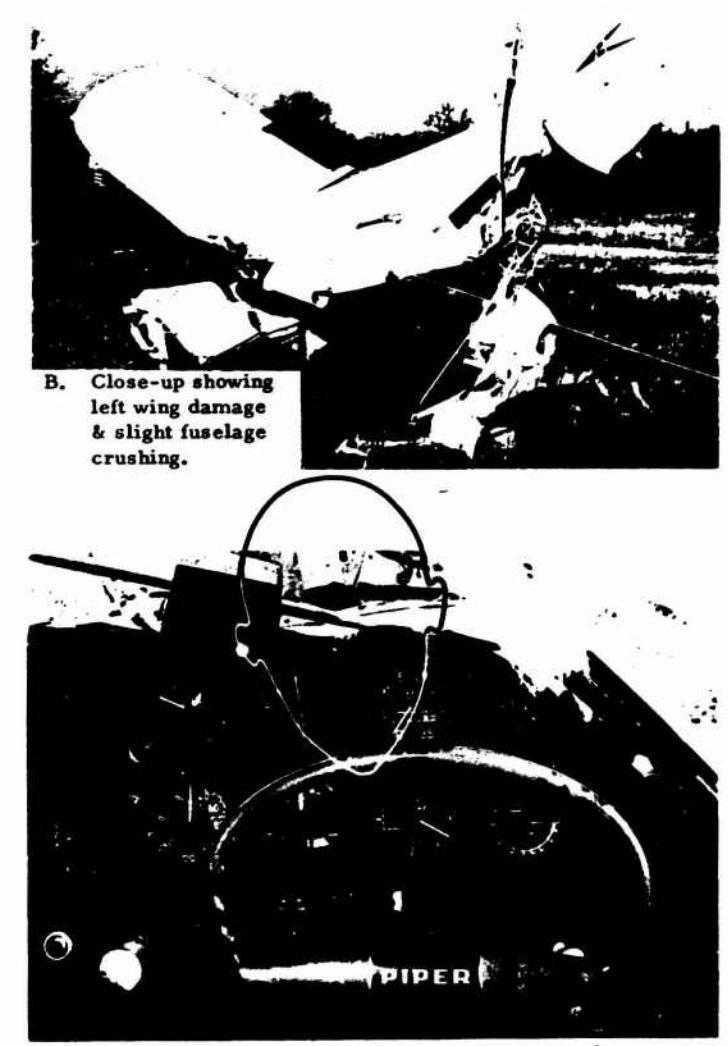
D. Dent at the top edge of instrument panel caused by copilot's head impact.

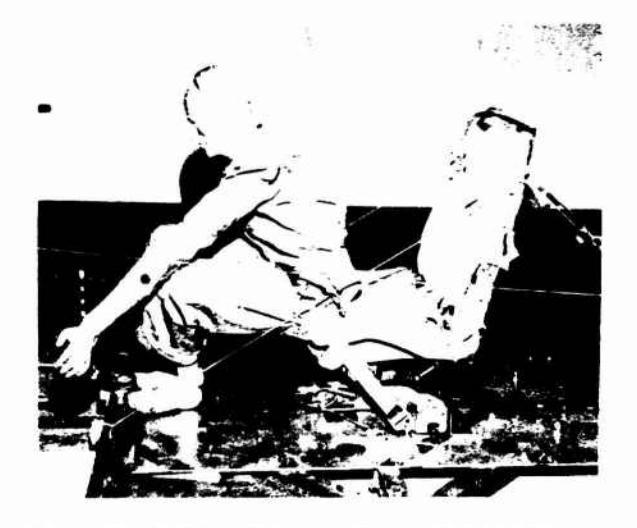
FIGURE 5. Position of dummy after crash test. Extreme forward motion is allowed by improper seat belt installation.

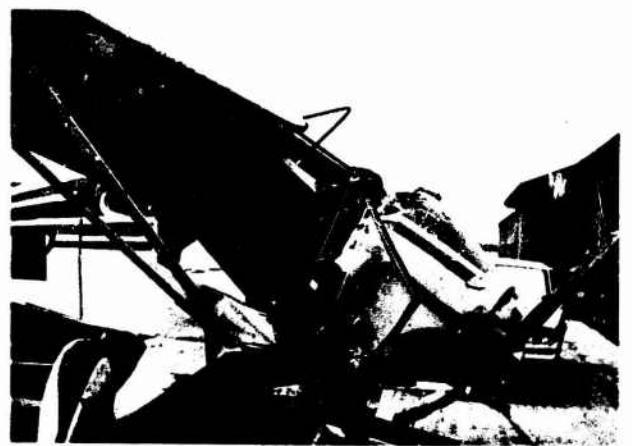
C. Close-up of right side of aircraft shows complete failure of right "A" post. (Only structure resisting backward displacement of motor & instrument fanel on that side).

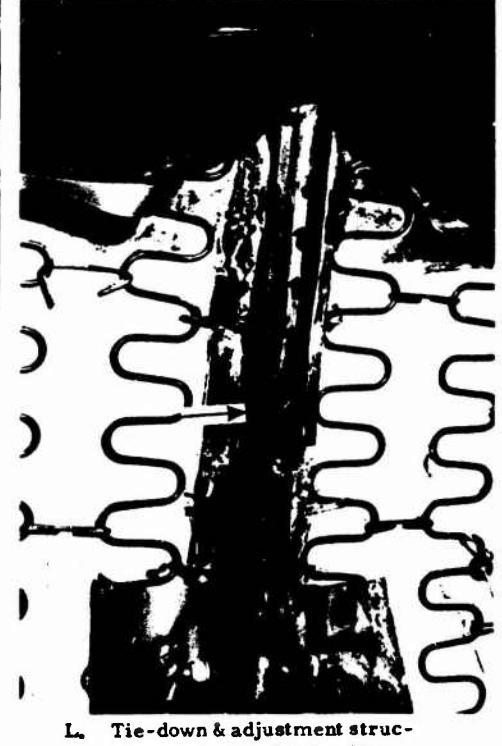
Tie-down & adjustment structure on bottom of seat. The thin metal on either side of the adjustment holes bent & allowed seat to tear loose.

CASE 12-5
of two occupants and the weight of the seat could fail with only one occupant in such a minor deceleration. It is possible, since this aircraft was nearly 15 years old, that deterioration of the seat attachments may have been a factor. However, since general aviation aircraft keep on flying until they disintegrate in a crash, seat tiedown attachments should be designed for long usage. If the restraint system fails under these minor conditions, certainly it is of little or no benefit in even a hard landing, let alone a minor crash.

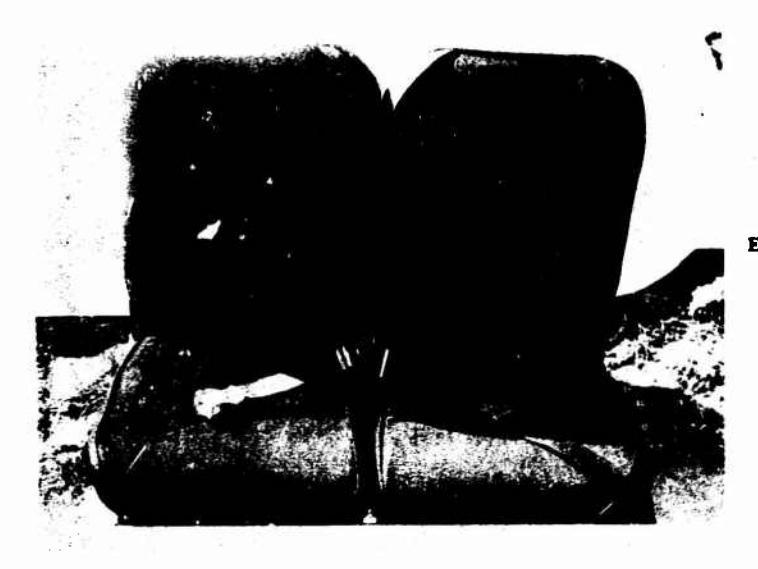
E. Seats failed in this minor incident (1) because seat belts were attached to the seat.

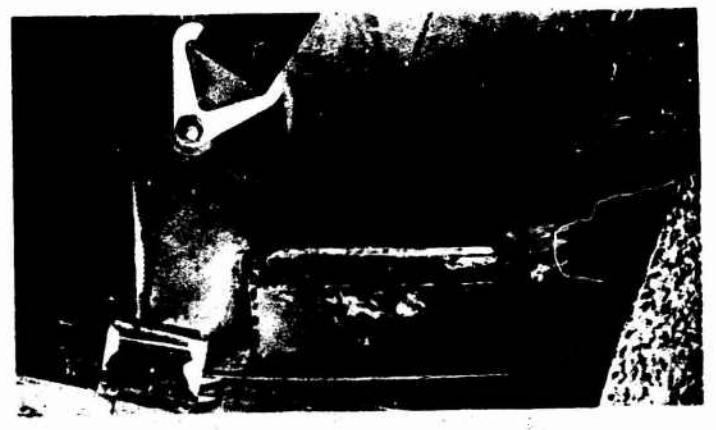
F. (2) wall track for end of seat allows seat to slip out.

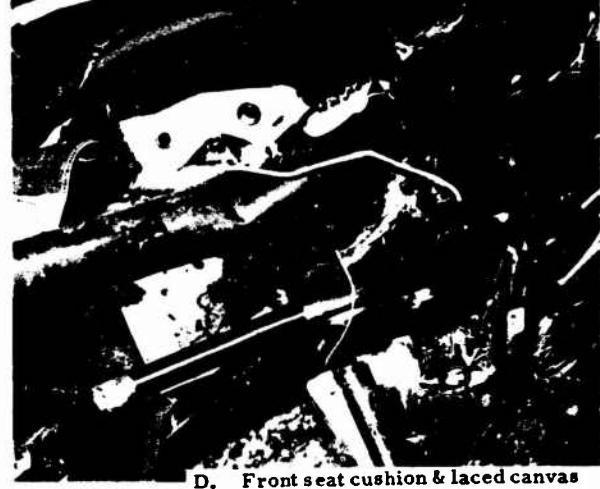
Front seat cushion & laced canvas removed to show tubular structure under seat that was responsible for vertebral fractures.

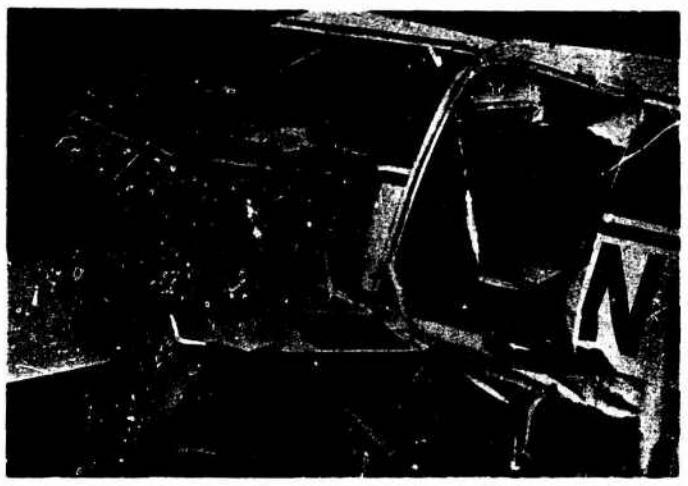
B. Motor is bent downward, landing gear pushed up into wings, instrument panel completely undamaged & rear passenger appears to be sitting flat on the ground.
