**MISCELLANEOUS PAPER S-69-29**

# EVALUATION OF HARVEY NONWELDED ALUMINUM LANDING MAT

July 1969

U. S. Army Engineer Waterways Experiment Station CORPS OF ENGINEERS Vicksburg, Mississippi

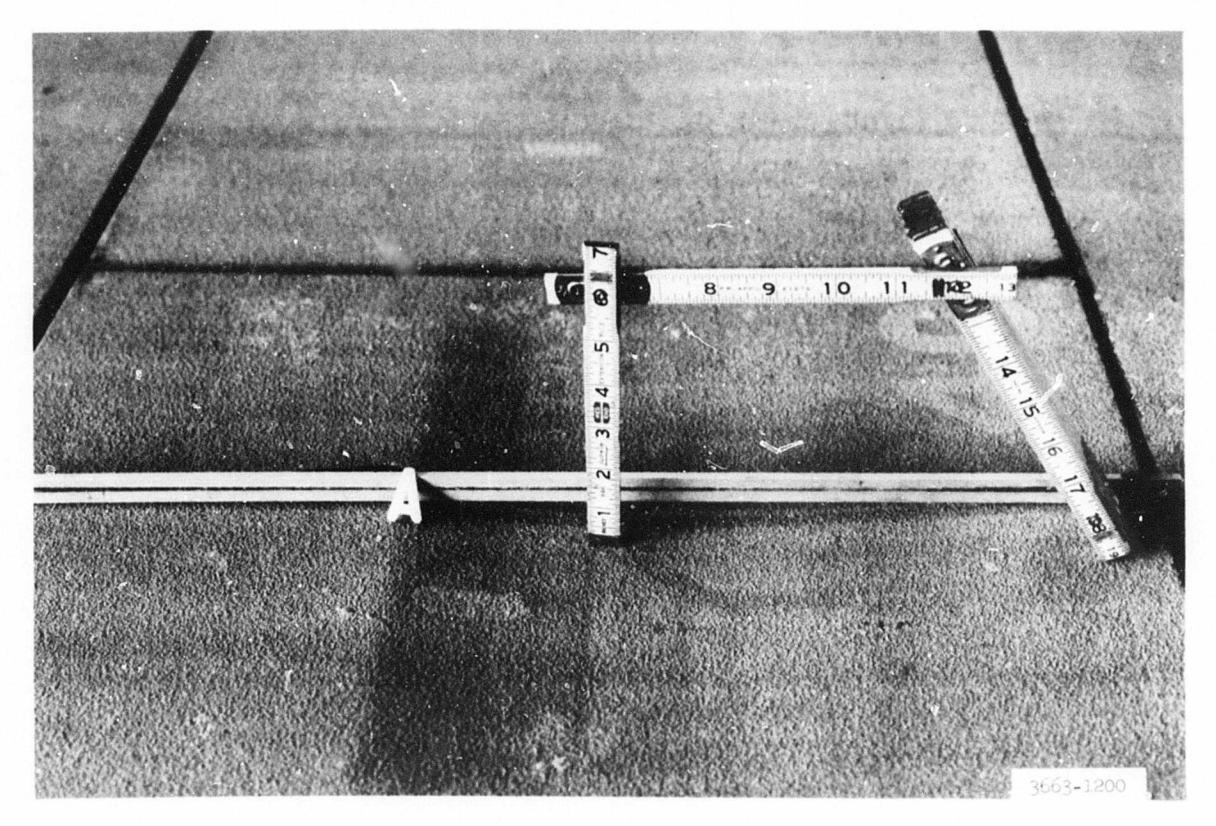
31. No external damage was noticed in item 1 from 0 coverages to the time the test was stopped at 26 coverages. After 8 coverages of traffic, plank 40 in item 2 showed signs of severe internal damage, i.e. rib damage, and at 12 coverages, plank 38 showed signs of slight internal damage. Both planks 38 and 40 were replaced after 16 coverages because of internal damage, as shown in figs. 5 and 6. Internal failure in plank 40a, the replacement for plank 40, was noticed after two coverages of traffic. These failures were also caused by extrusion defects instead of the nonwelded joint configuration. Since this test program was mainly concerned with evaluating the performance of the nonwelded end connectors of the mat and not the

Fig. 5. Indicated internal damage in plank 40 after 16 coverages

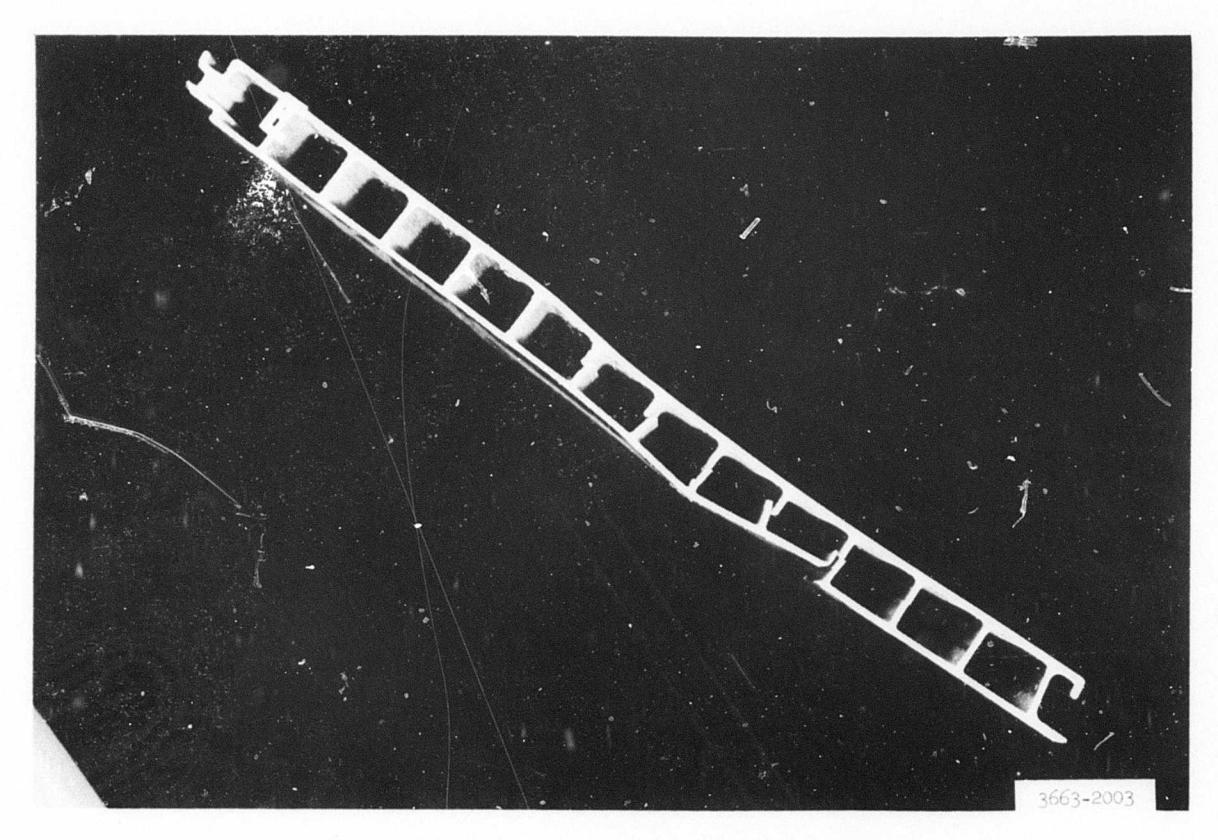
Fig. 6. Rib damage in plank 40 after 16 coverages

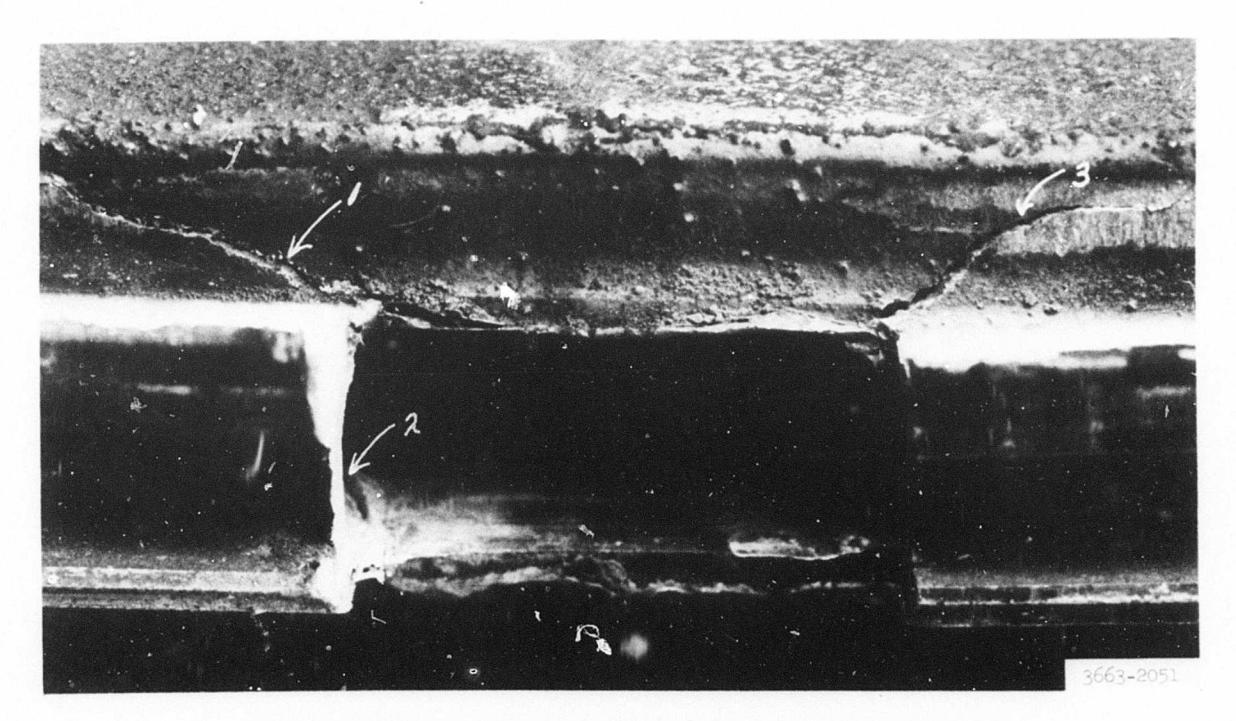
bar (fig. 4) fitting into the notch cut in the male side connector of the plank in the adjacent run. Fig. 7 shows a close-up of the mat damage at a notch after 187 coverages of traffic. At the end of traffic, there were only five planks with breaks such as those labeled 1 and 3 in fig. 7, and one plank with a break such as that labeled 2 in fig. 7. These breaks were approximately 1 in. in length. Other damage that was observed when the mat was taken up was 18 C-rail splits that averaged 7-3/4 in., the longest being 13-1/2 in., and 1 to 12 ribs broken in 19 planks. The maximum deformation measured in item 2 after traffic was 0.5 in. A plot of deformation along the center line of the traffic lane is shown in plate 7.

Fig. 7. Damage at notch in the modified mat at 187 coverages

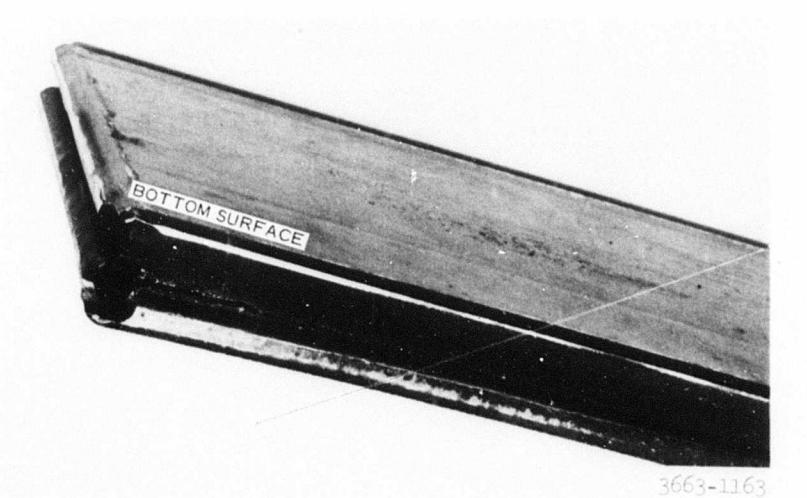
Photograph 2. C-rail split

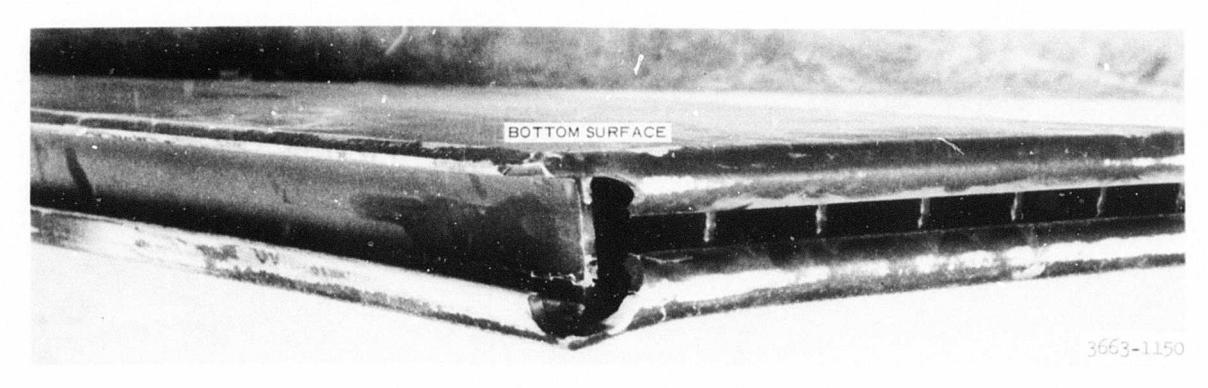
Photograph 3. End-curl split

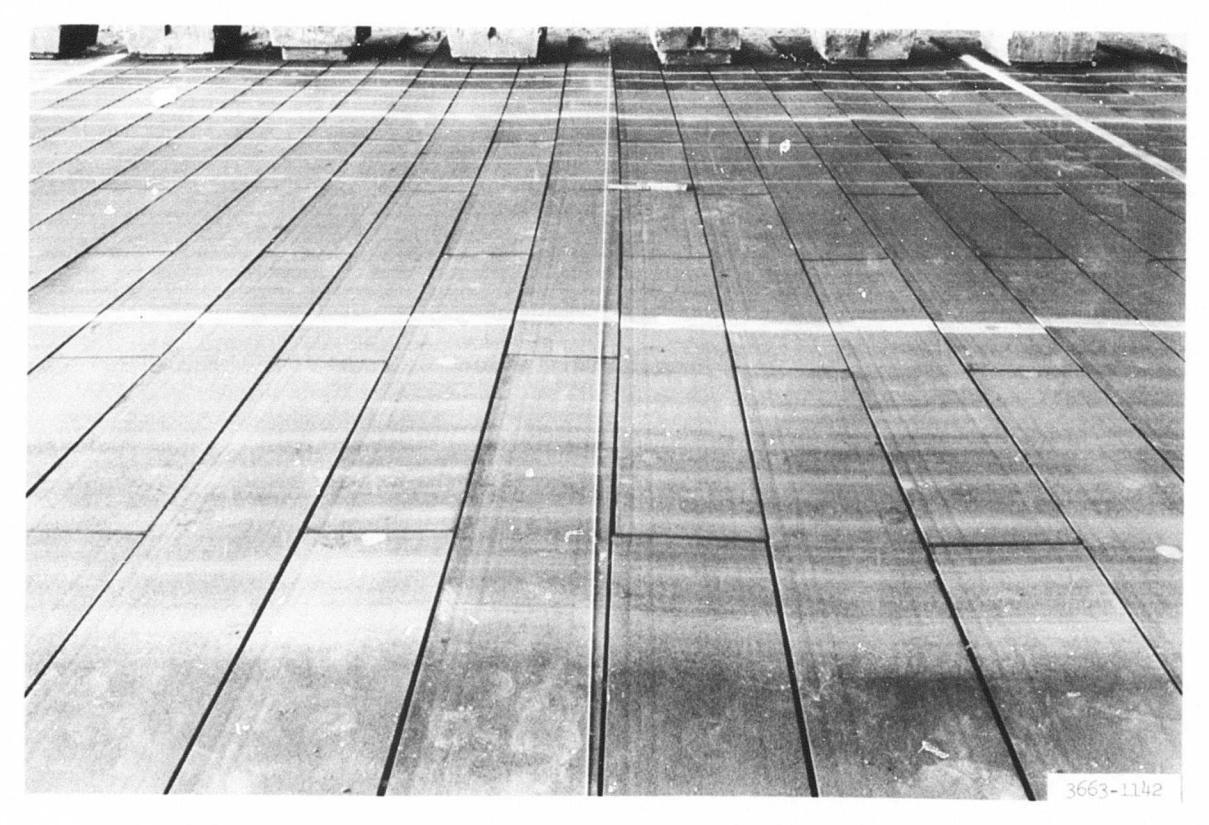
Photograph 8. Bow (2-1/2-in.) in mat after 100 coverages on items 1 and 2

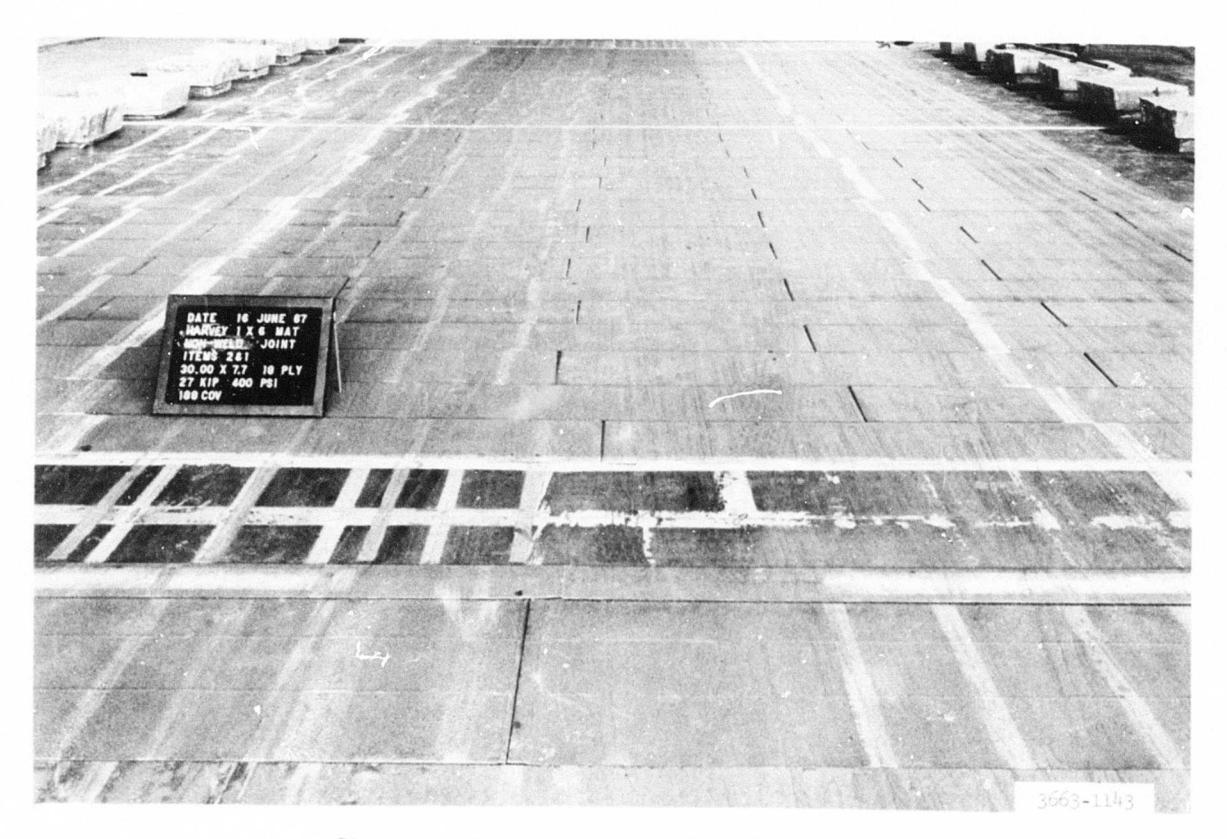
25. Item 1 was in fair condition and item 2 was in good condition at 188 coverages. The only apparent damage observed at this time was the curl of the end connectors on 11 planks in item 1 and 4 planks in item 2. Photograph 9 shows the test section after 188 coverages of traffic. Twenty-seven planks were taken up in item 1 after 188 coverages in order that the CBR could be checked and a partial break count could be taken. There were 31 C-rail splits out of 32 possibilities in the 27 planks inspected. These splits varied in length from 3/4 to 4 in. with an average of about 2-1/4 in. These small breaks could not be detected until the mat was taken up and would not have caused any operational problems.

Photograph 9. Test section 1 after 188 coverages

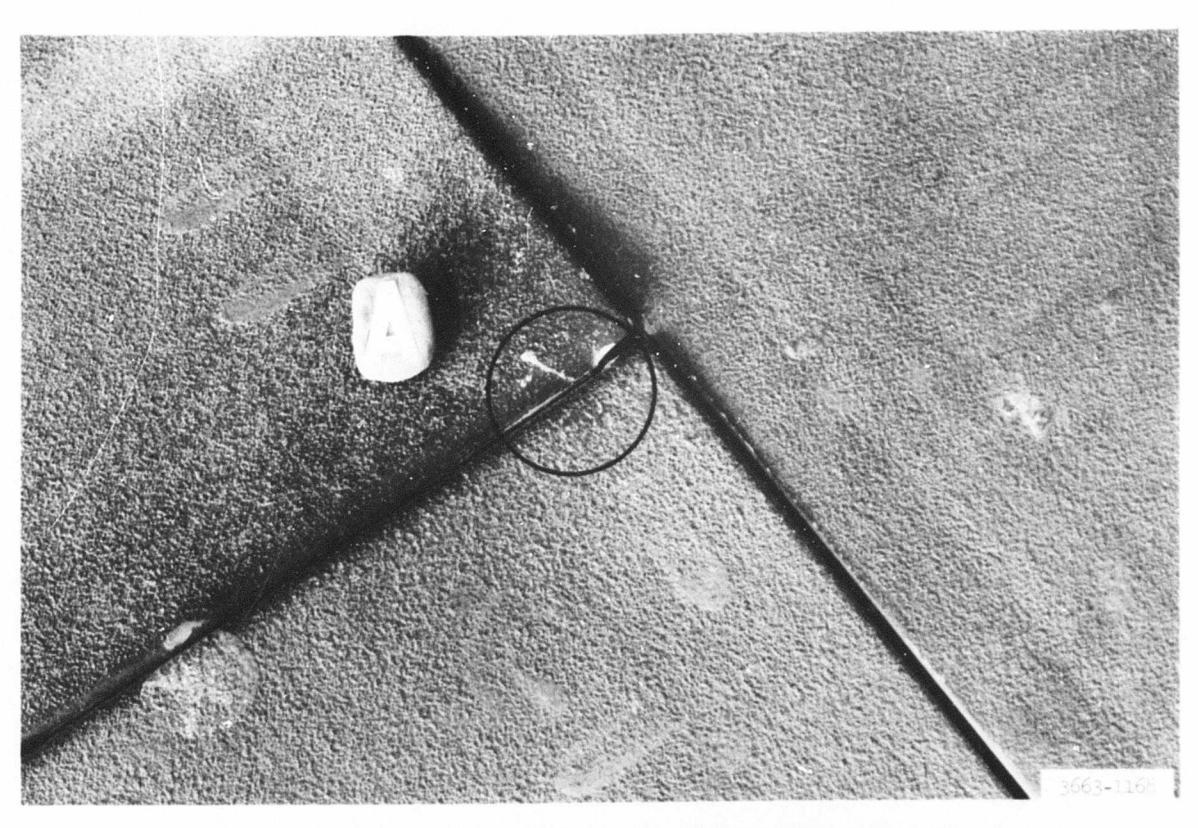
26. Traffic was continued on the test section to 296 coverages, at which time item 1 was considered failed. Although the top surface of the mat was in fair condition at 296 coverages, interior breakage of the mat was evidenced by skin tears and loud crackling noises as the load cart passed over the broken planks. The only visible damage in item 1 after 298 coverages was small top skin tears, as shown in photograph 10, which appeared on nine planks, and two planks showed end-curl splits. All the end connectors in both items had a small amount of curl but not enough to cause a traffic hazard. A general view of the test section at failure is shown in photograph 11.

Photograph 10. Skin tear in plank 11 after 298 coverages; item 1, lane 1

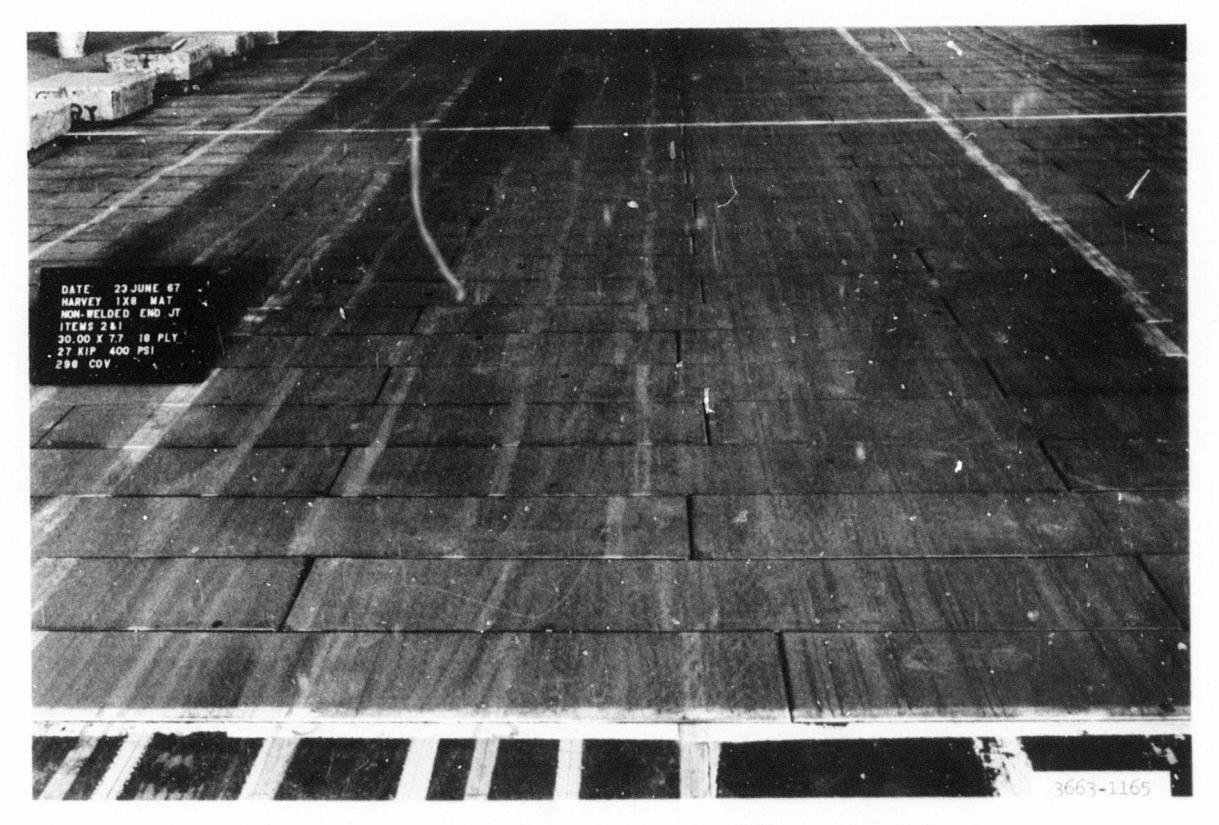
Photograph 11. Test section 1, lane 1, after 298 coverages (failure)

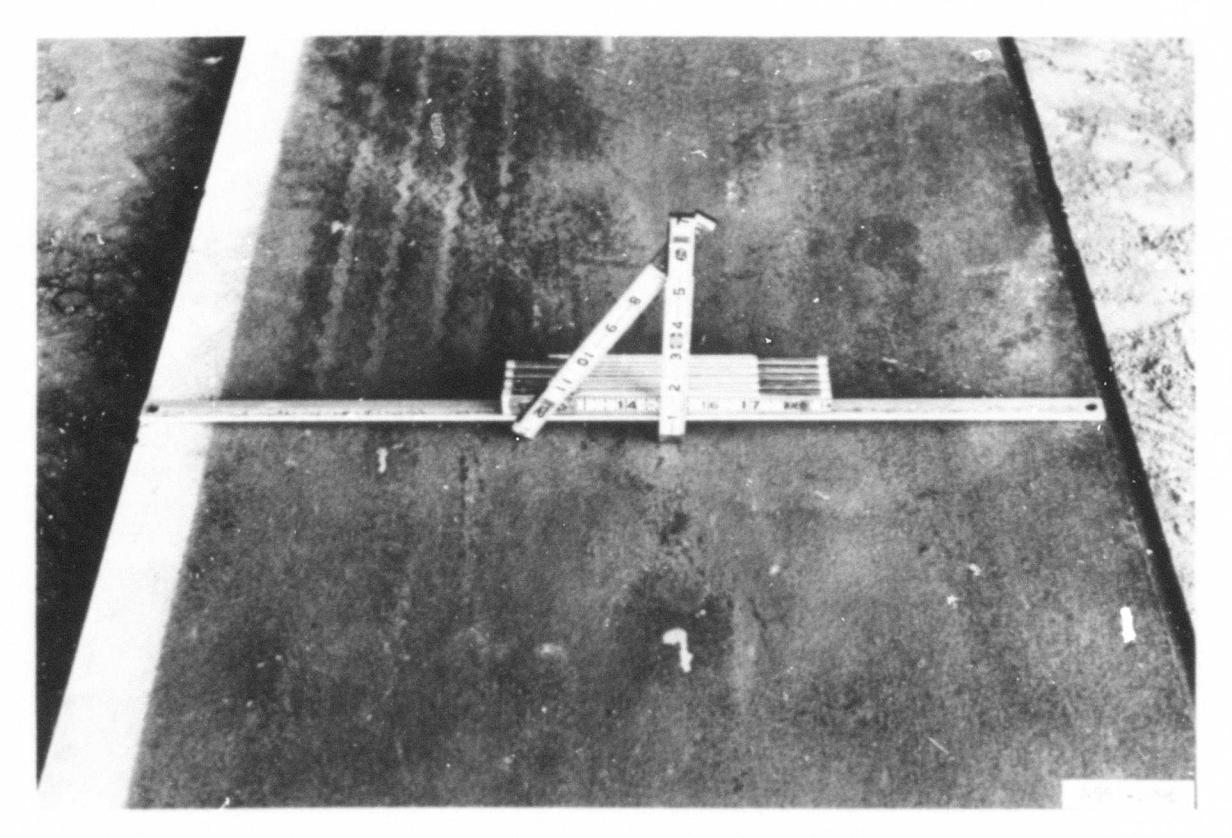
30. After 12 coverages of traffic, the mat planks in item 1 were dished from 3/8 to 1/2 in. The dish in the mat planks in item 2 ranged from 1/8 to 1/4 in. Photograph 14 shows the dish in plank 2 after 16 coverages. This dishing was caused by defects in the internal ribs, not by the nonwelded joint configuration. Therefore, traffic was stopped after 16 coverages of traffic upon the request of a Harvey representative with the concurrence of WES and NAEC. The mat was then taken up and shipped back to the factory for inspection by the fabricator. Harvey replaced this mat with new 2- by 6-ft nonwelded mat for further tests.

Photograph 14. Dish in plank 2 after 16 coverages; test section 2, item 1, lane 1

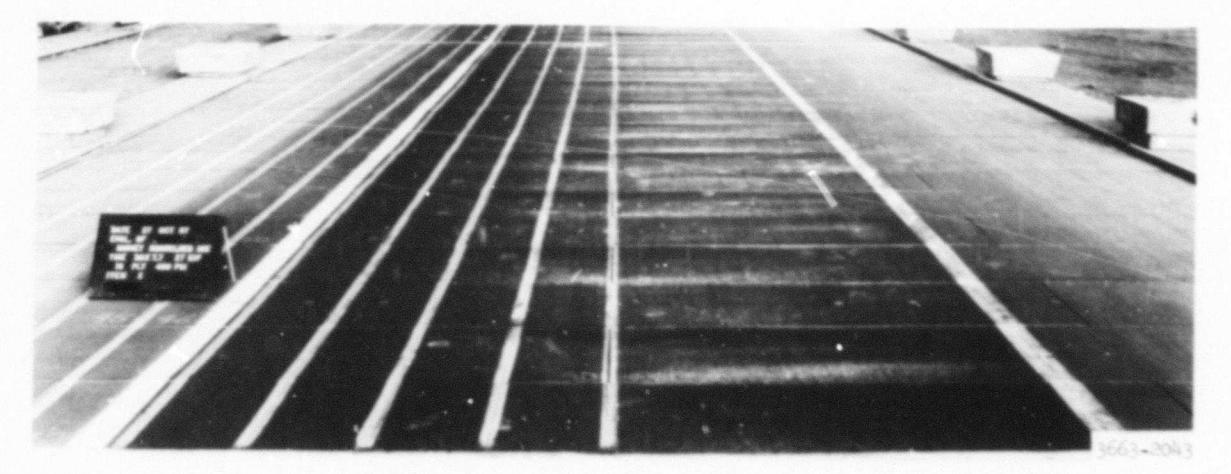
Photograph 16. General view of item 2, section 3, after 187 coverages

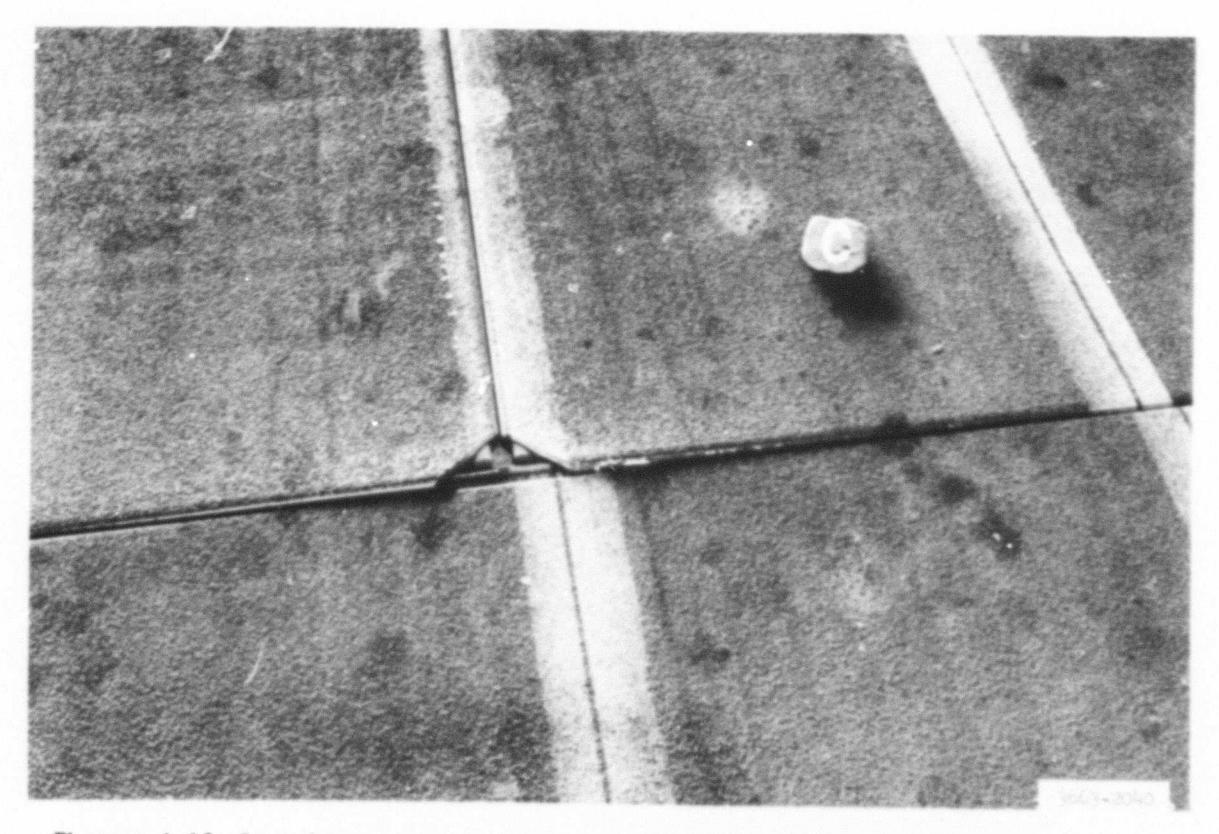
Photograph 18. Lateral movement of the mat planks after 68 coverages of traffic; item 3, section 3

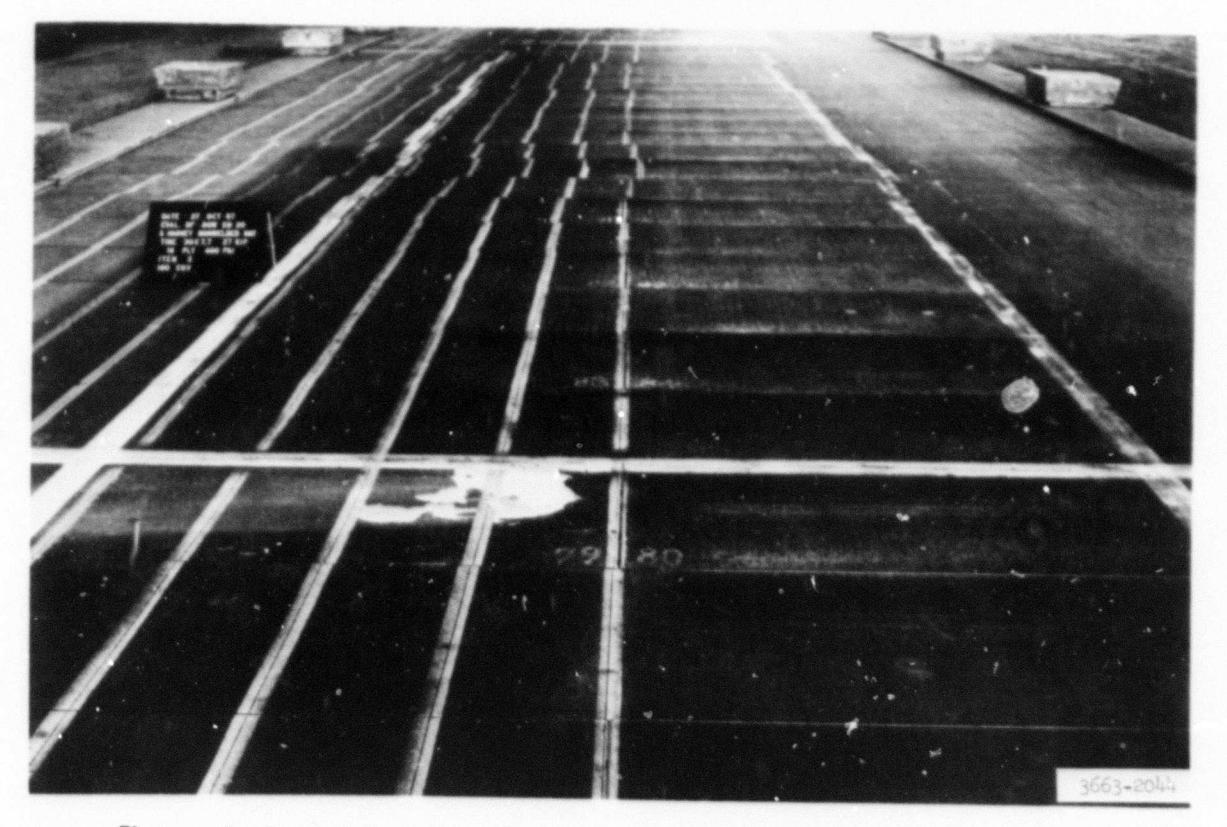
34. A general view of item 3 prior to traffic is shown in photograph 17. After 10 coverages, a maximum dish of 3/16 in. was measured in this item on several mat planks with end joints in the traffic lane. At 14 coverages, the top lip of the C-rail at the end joints had begun to curl up on the mat planks. The largest curl measured was 7/32 in. The first mat breakage occurred at 58 coverages when a small crack appeared in the C-rails of planks 83 and 84. After 68 coverages, photograph 18 was taken showing the lateral movement of the mat planks in this item as opposed to very little movement in item 2. A popping noise, which usually indicates internal damage, was heard at 100 coverages of traffic as the test cart rolled up and down the item across the end joints. Fifteen of the twenty end joints in the traffic lane, with a maximum dish of 3/8 in. measured in three planks. The only other damage observed after 100 coverages was a small skin tear on plank 84. After 120 coverages, seven planks were in poor condition due to dishing, skin tears, and the curling of the upper lip of the C-rail. The dish in these planks ranged from 3/8 to 1/2 in., the average length of the skin tears was 1/2 in., and the height of curl was approximately 1/2 in. At 160 coverages, this item was considered failed. A general view of item 3 at failure is shown in photograph 19.

Photograph 19. Item 3, section 3 in background, after 160 coverages of traffic (failure)

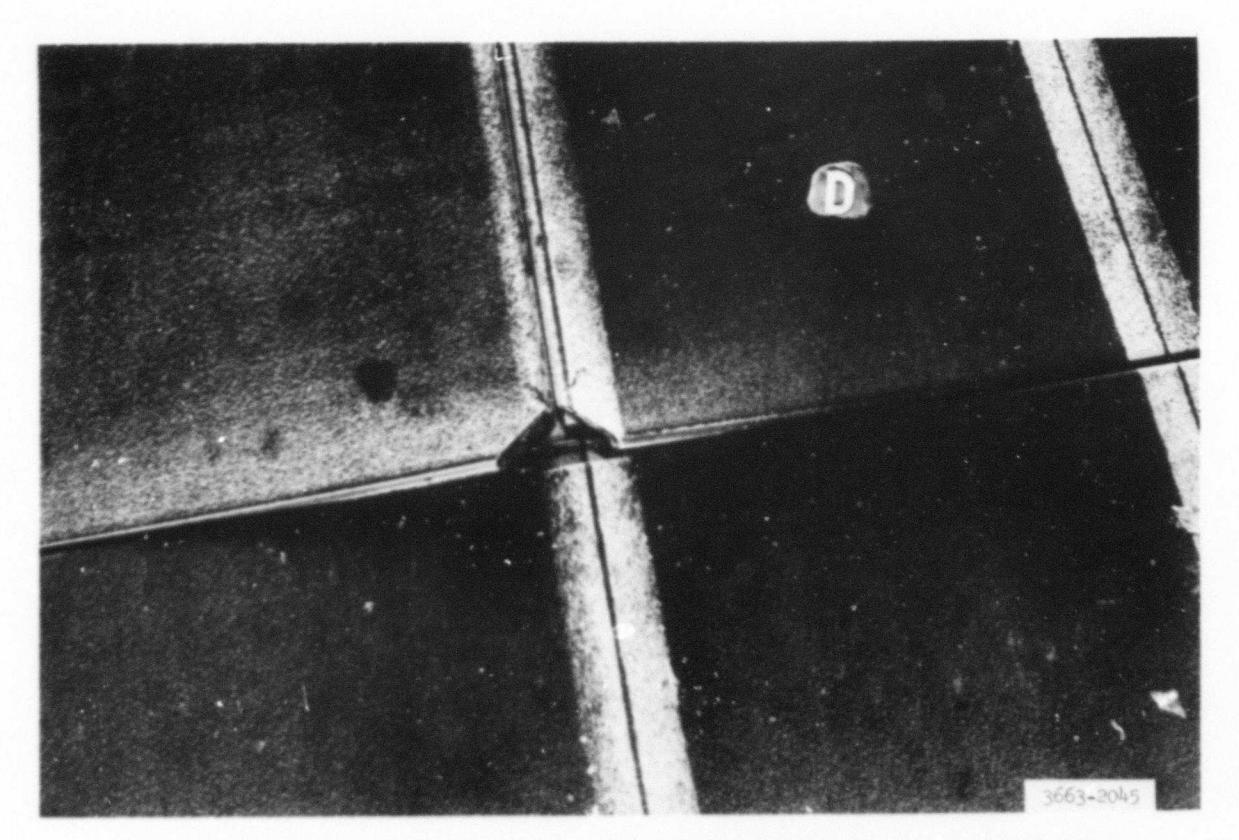
35. When traffic was stopped, the top skins of 16 planks were slightly torn, all 20 of the end joints in the traffic lane had curled top lips of the C-rail such as that shown in photograph 20, and there were 19 C-rail splits averaging approximately 7-1/4 in. in length. Ten planks were failed due to a dish of 1/2 in. or more. The dish in plank 103 after 160 coverages, which indicated rib failure, is shown in photograph 21. During the inspection after traffic, 18 planks (all in the even-numbered runs) were found to have 4 to 12 broken ribs at the end joints. The maximum mat deformation measured in item 3 after traffic was 0.4 in. A plot of deformation along the center line of the traffic lane is shown in plate 7.

Photograph 20. Curl of top lip of C-rail (due to break in C-rail) and break in top skin of the end connector after 160 coverages; item 3, section 3

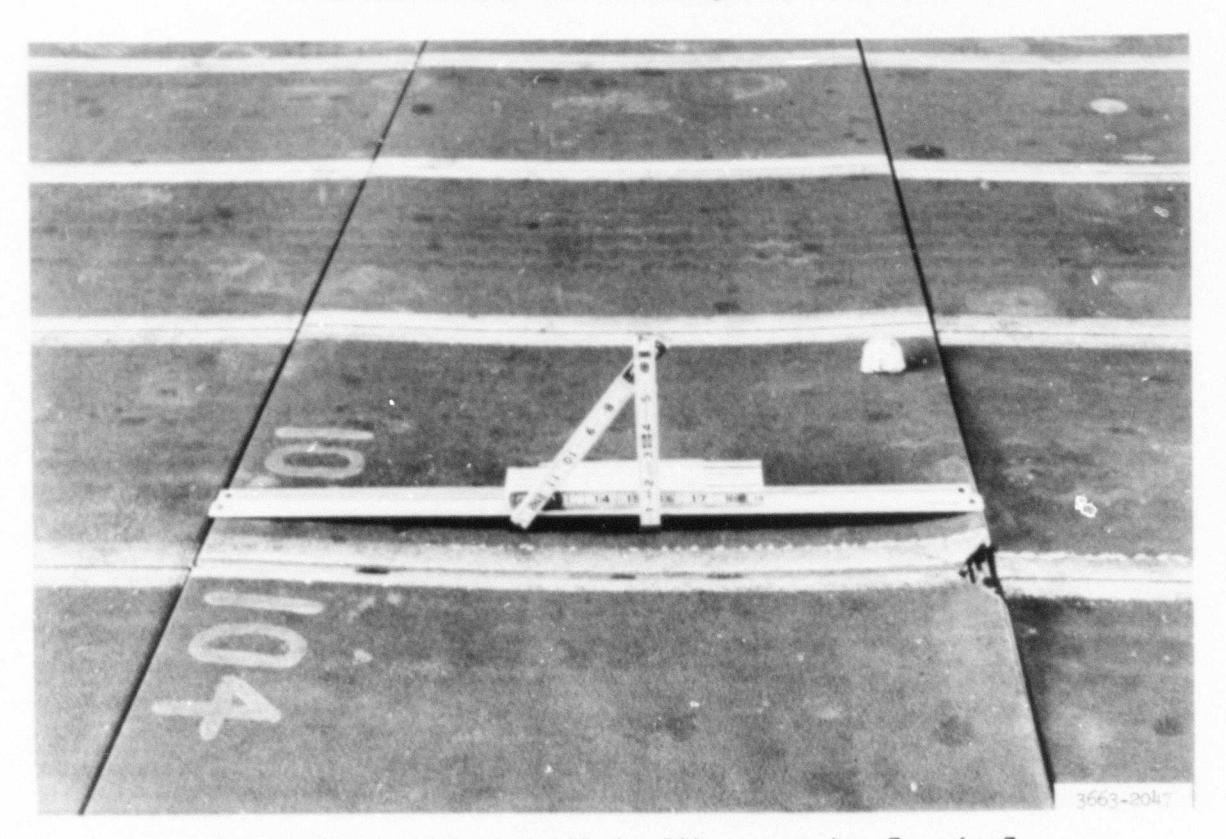
Photograph 21. Dish in plank 103 after 160 coverages; item 3, section 3
