IMPROVEMENT OF
TITANIUM ALLOY INGOT CONSOLIDATION

F.W. Wood
and
R.L. Carpenter
U.S. Bureau of Mines
Albany Metallurgy Research Center

Technical Report AFML-TR-72-46

May 1972

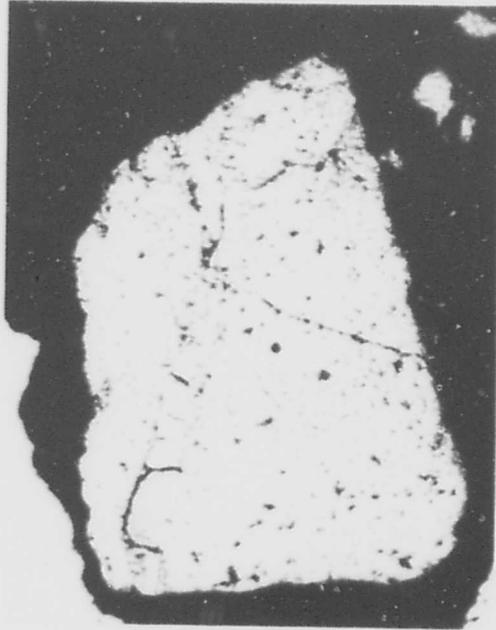
Figure 12 shows a large inclusion with a seam or vein of contrasting material running through it. The specimen is from a location that should have been about 1 to 1.5 inches from the top of an as-cast ingot that was not cropped to eliminate the shrinkage region. In other words, the defect is from the shrinkage region of the ingot. The material in the seam contained about 12% N and 1.8% V, and the material outside contained about 16% N and 0.5% V. The difference in vanadium content is probably more significant than the difference of nitrogen content. Another inclusion with a contrasting seam through it is shown in Figure 13. Apparently, this structural feature is not uncommon. Neither is the occurrence restricted to a particular part of an ingot. This example was formed about 4 to 4.5 inches from the ingot bottom. Figure 14 illustrates an acicular structure sometimes exhibited by inclusions instead of the spongier structure

FIGURE 12. - Micrograph (originally 50X) of specimen R4,
mount F763, from plate SA 26,869-TT

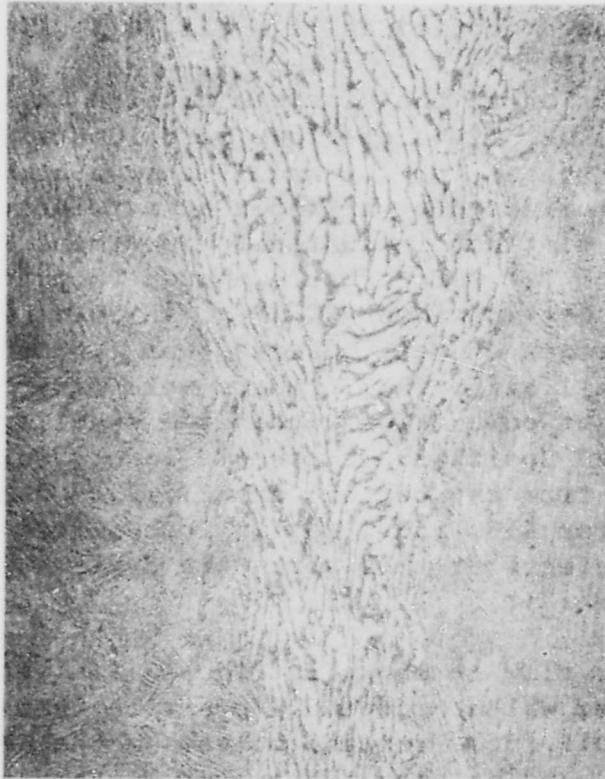
In addition to the discrete nitride inclusions, at least four other types of flaws were identified by metallography. Figures 15, 16, and 17 show α -stabilized regions contaminated by nitrogen at a relatively low level, but without distinct inclusions. Specimens R15 and R37 (Figs. 16 and 17) were brittle enough to crack during conversion, but specimen R27 (Fig. 15) did not. The maximum nitrogen content observed was 1.3% for R27, 1.2% for R15, and 1.5% for R37. There were minor deficiencies of Al and V at some sites within the stabilized regions. The estimated positions in as-cast ingots were about 6.5 to 7 inches from the bottom for R27, 2 to 2.5 inches from the bottom for R15, and 1 to 1.5 inches from the bottom for R37. Defects of this sort were designated Type II in reference (7).

FIGURE 15. - Micrograph (originally 100X) of specimen R27,
mount F1094, from plate SA 26,956-B-TB

FIGURE 16. - Micrograph (originally 50X) of specimen R15,
mount F995, from plate SA 26,975-BB

FIGURE 17. - Micrograph (originally 50X) of specimen R37,
mount F1288, from plate SA 26,917-TB

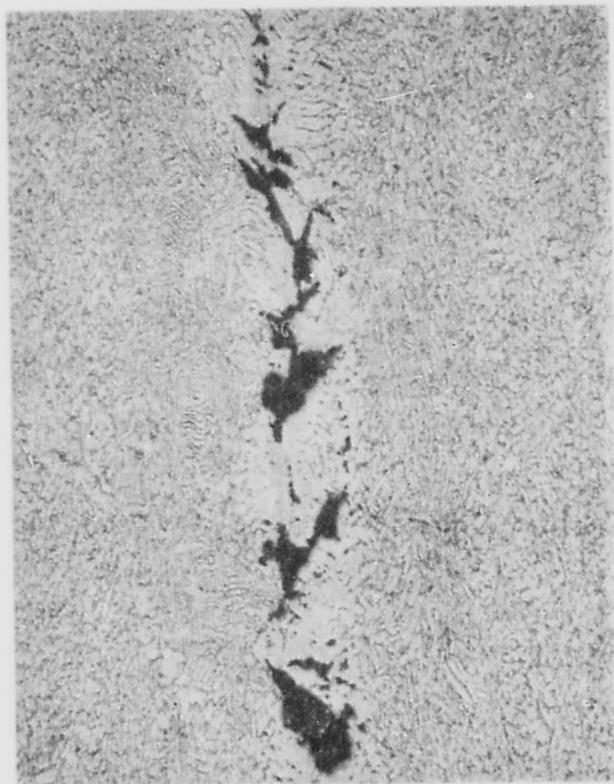
Another flaw is shown in Figure 18. This is an Al-rich stringer which occupied a position that would have been about 0.5 inch from the bottom of the as-cast ingot. Analysis of a point near the center of the stringer indicated 12.2% Al, 1.2% V, and <0.5% N. Similar defects containing 8 to 9% Al in Ti-6Al-4V matrices have been reported previously (2,6), so the occurrence is not unique.

FIGURE 18. - Micrograph (originally 100X) of specimen R2,
mount F761, from plate SA 26,869-BB

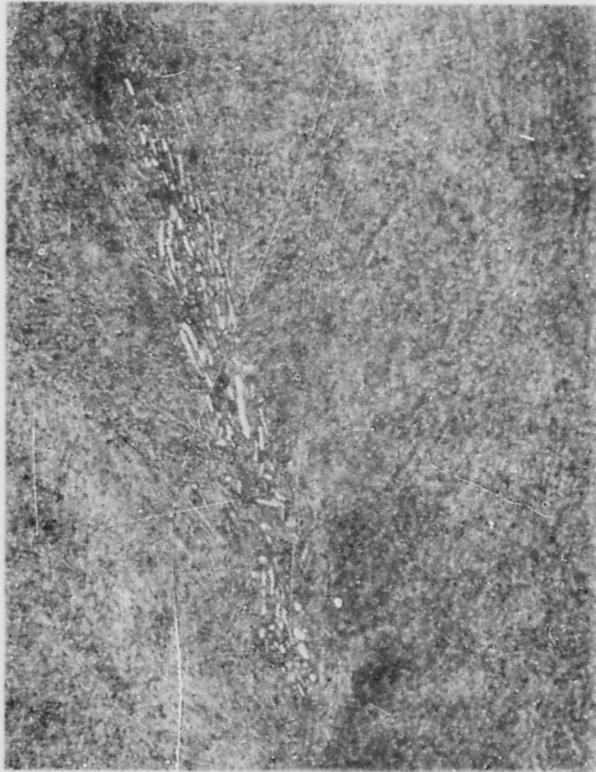
Figure 19 shows an α -stabilized stringer for which no compositional irregularities were detectable. Of course, with regard to nitrogen, this means only that any

FIGURE 19. - Micrograph (originally 100X) of specimen R16,
mount F996, from plate SA 26,975-BB

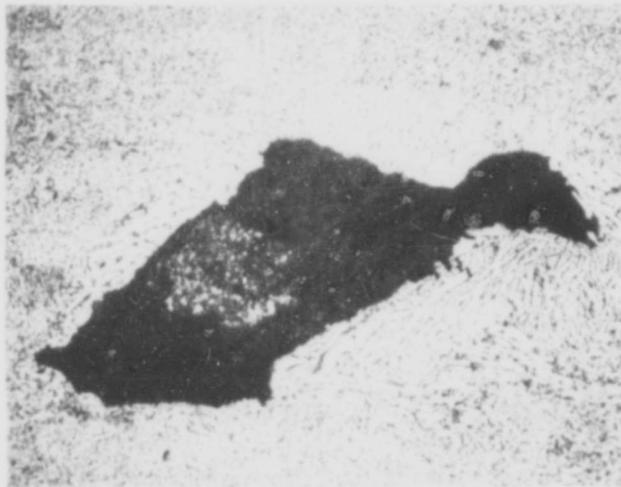
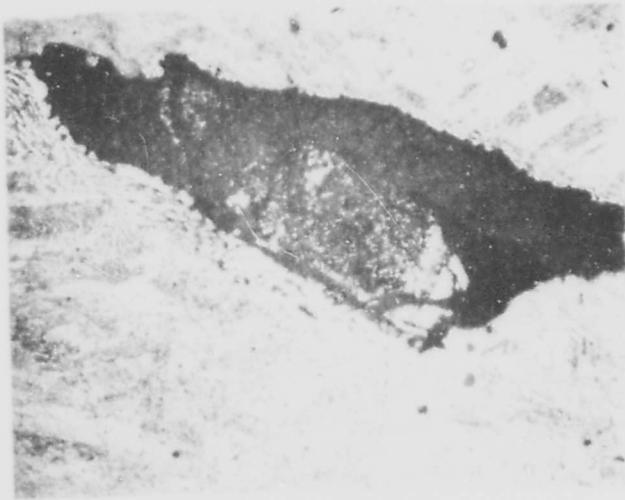
The primary defects found were of the nitride-inclusion type. These generally consisted of a void with some fragments of the inclusion material still present. The area around the void contained zones of stabilized alpha phase. Typical examples of this type of defect are shown in Figures 29 and 30. The matrix in Figure 29 is normal alpha-beta structure and that of Figure 30 has a worked beta structure. Some slight modifications of this structure were found. Figure 31 shows a nitride inclusion with a solid band of reacted material along one side. The electron probe analyses of this band showed that the fragments of the inclusion contain 10 to 12% nitrogen and less than 0.2% Al and 0.3% V. The equiaxed structure at the edge of the hole is similar to the fragments. The acicular structure is no doubt a mixture of phases but

FIGURE 29. - Nitride-type inclusion with stabilized α zone. Normal α - β matrix structure. (Originally 50X) Specimen R-67, Mount G 410, from plate SA 27,171-BB.

FIGURE 30. - Nitride-type inclusion with stabilized a zone. Worked B matrix structure. (Originally 50X) Specimen R-59, Mount G 347, from plate SA 27,109-TB.

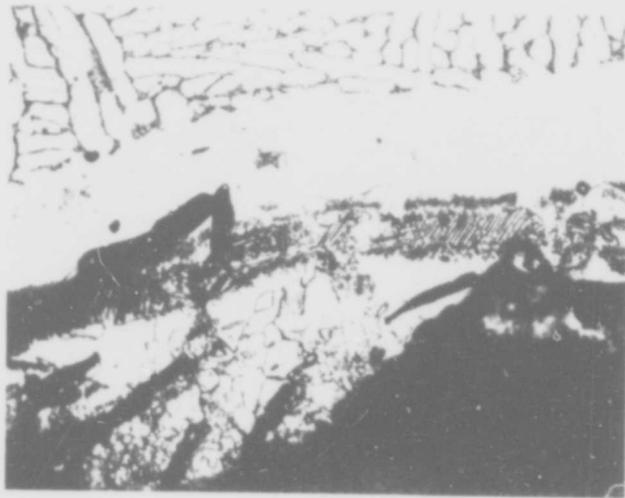
FIGURE 31. - Reaction zone associated with nitride inclusion
(Originally 200X) Specimen R-70, Mount G 413
from plate SA 27,171-BB.

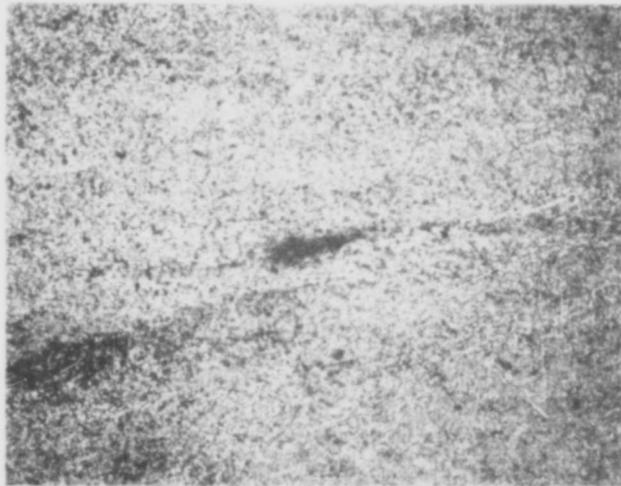
FIGURE 32. - Small void with α -stabilized zone.
(Originally 50X) Specimen R-68, Mount G 411,
from plate SA 27,171-BB.

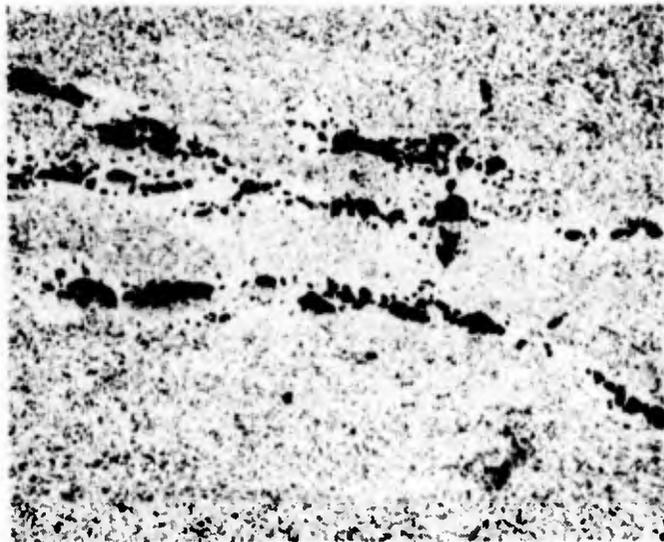
The structure shown in Figure 33, although it has the alpha-stabilized zone around a void area, does not appear to be of the same type as the defects described above. It is possible that this defect was due to nitrogen contamination from some source other than seeding, or the different appearance may be related to the relatively low temperature maintained during break-down forging of this particular metal (SA 26,869). The defect is more elongated and broken up than those normally seen.

FIGURE 33. - Elongated nitride inclusion.
(Originally 50X) Specimen R-9, Mount F 933,
from plate SA 26,869-BB.

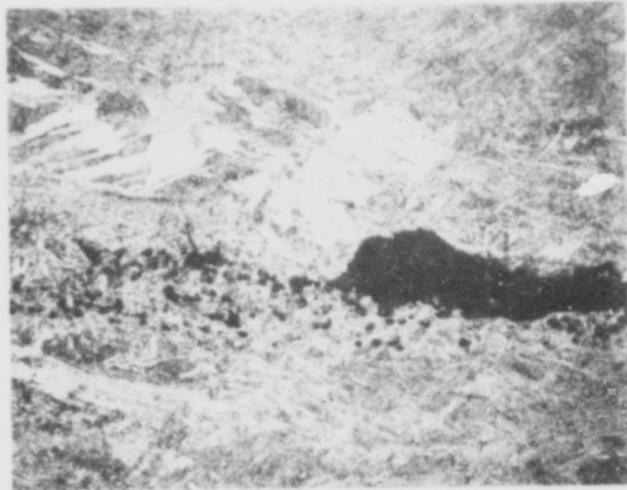
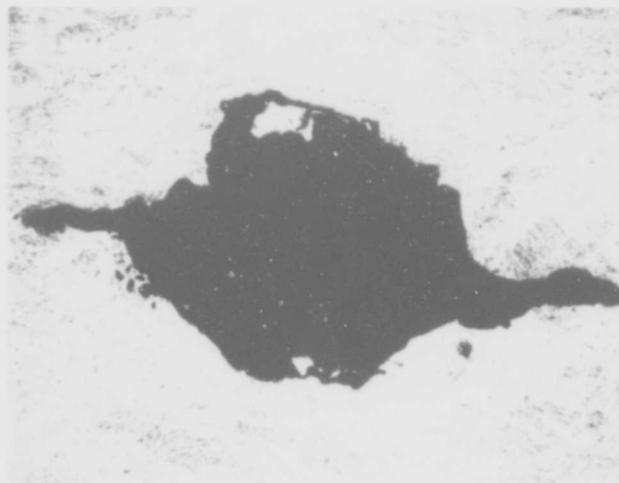
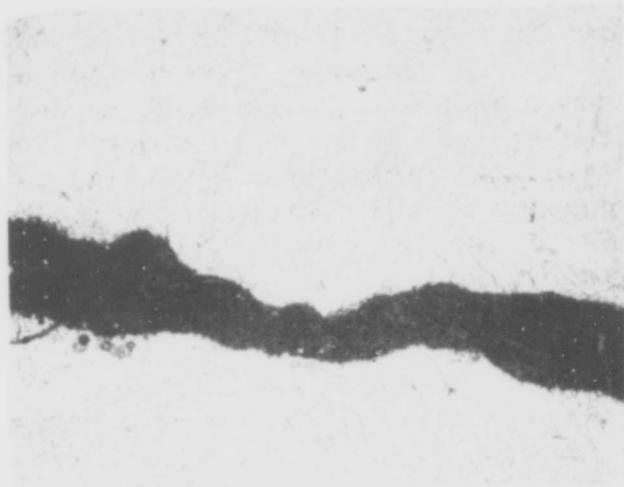
Three examples of carbide-type inclusions were found in the same ingot, SA 27,162. These are characterized by the absence of a reaction zone of stabilized alpha around the defect. The structure of the surrounding material was that of a worked-beta structure around the two defects found in section TB and a partially broken-up Widmanstätten structure around the one in section BB. Microprobe analyses were made on the inclusion and on the edge of the defect. These data are shown in Table XVII. The carbon content of the inclusions found in section TB is stoichiometric

Figures 34, 35, and 36 are photomicrographs of the carbide inclusions. All show the absence of an alpha-stabilized zone, but some differences are apparent. Figure 34 has one large defect with many small carbide particles in the surrounding area. These small carbides are not found in the other two. The defect area shown in Fig. 35 does not appear to be deformed as much as the other two. This could be due to the higher carbon content, 0.7%, which hardened the surrounding material so that it deformed less during conversion.

FIGURE 34. - Carbide inclusion with small carbide particle
in matrix. (Originally 50X)
Specimen R-62, Mount G 355,
from plate SA 27,162-TB.

FIGURE 35. - Carbide inclusion with high carbon content
in surrounding material. (Originally 50X)
Specimen R-63, Mount G 356,
from plate SA 27,162-TB.

FIGURE 36. - Carbide inclusion without α -stabilized zone.
(Originally 50X) Specimen R-64, Mount G 367,
from plate SA 27,162-BB.

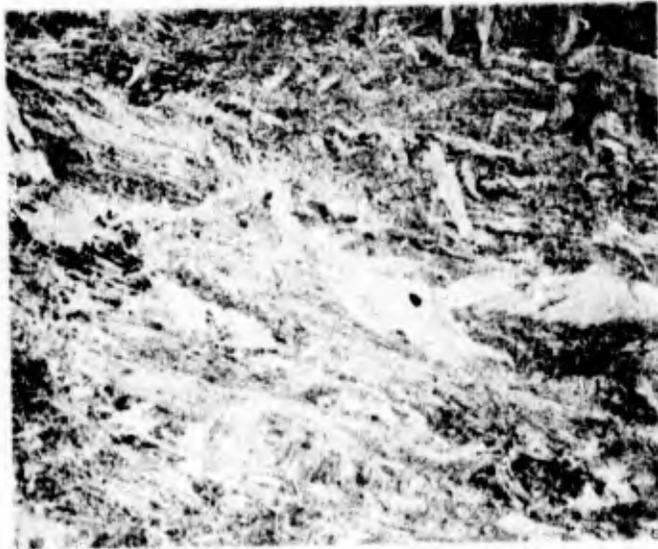
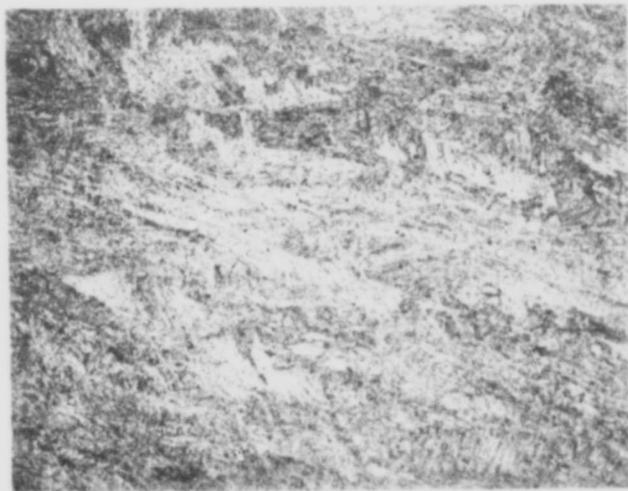
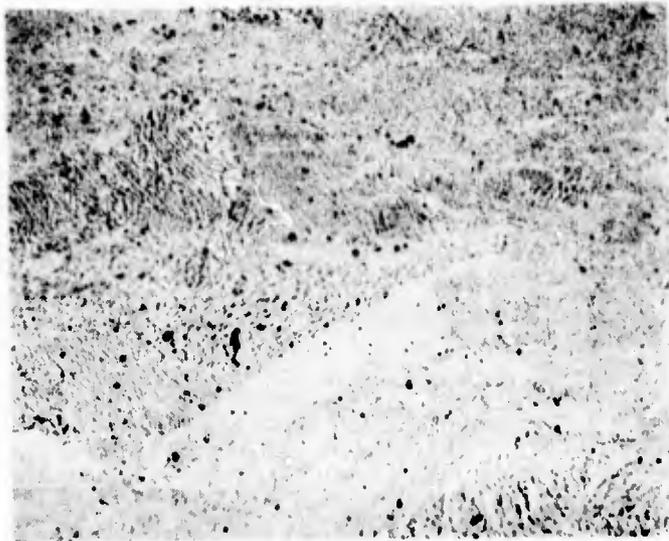
In seven cases where the ultrasonic inspection indicated a large defect, no definite inclusion was located. Instead, the material had a worked-beta structure consisting of partially deformed acicular alpha plus beta, with distorted prior beta grain boundaries. Figure 37 is typical of the microstructure found in most of the cases. This structure was found in section BT of ingot SA 27,171 and in the section TT of ingot SA 27,172, the unseeded ingot. It was also found in section BT of SA 27,030, the ingot that had numerous indications of defects in sections BT and TB that could not be confirmed by repeated sawing through suspect areas. The microstructure for SA 27,030 (BT) is shown in Figure 38, and for SA 27,030 (TB) in Figure 21. The "defect area" from section BB of ingot SA 27,167 had a similar structure but appears to be worked less than the others, as shown in Figure 39. The microstructure itself did not appear always to cause the indication of defects on the ultrasonic charts since other material, SA 27,030 (BB), which had this structure showed no indication of defects other than in areas with inclusions.

FIGURE 37. - Worked β structure. (Originally 50X)
Specimen R-74, Mount G 430,
from plate SA 27,171-BT.

FIGURE 38. - Worked B structure. (Originally 50X)
Specimen R91, Mount H433 from plate
SA 27,030-BT.

FIGURE 39. - Worked β structure. (Originally 50X)
Specimen R-49, Mount G 275,
from plate SA 27,167-BB.

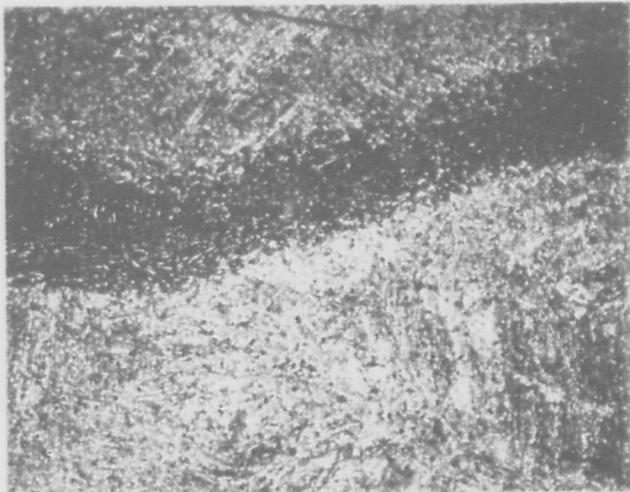
One example of a beta-rich stringer or band was found. This was located in section BB of ingot SA 27,175. It appears in the photomicrograph, Figure 42, as a dark etched band with light etched grains dispersed in the dark etched area. Microprobe analyses were made of the area and the results are shown in Table XVIII. The dark, beta grains

FIGURE 42. - Beta-rich stringer (Originally 50X)
Specimen R-52, Mount G 308,
from plate SA 27,175-BB.

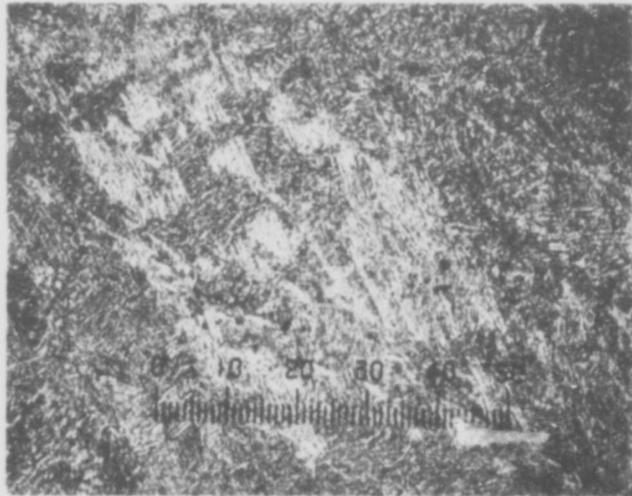
One major defect was indicated on the ultrasonic chart for the triple-melt ingot SA 26,917, in the top (TT) section. But metallographic examination did not reveal any defect. The microstructure is shown in Figure 43 and appears to be a normal alpha-beta structure with some areas that have more than the normal amounts of alpha.

FIGURE 43. - Excess α in α - β structure (Originally 50X)
Specimen R-45, Mount G 23,
from plate SA 26,917-TT.

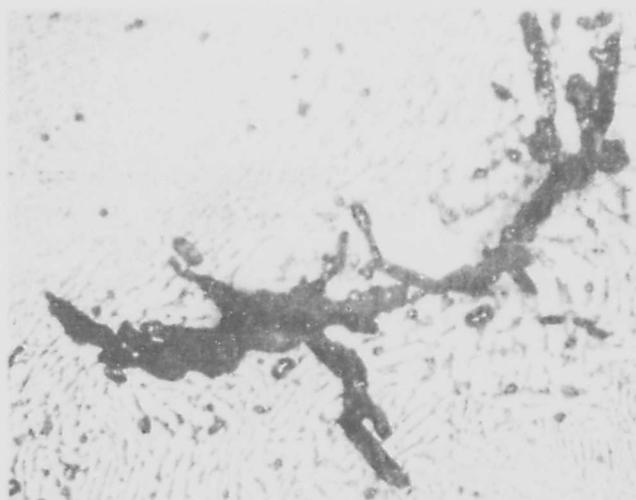
Figure 44 (also see Fig. 17) is a photomicrograph of a defect area found in section TB of ingot SA 26,917, the triple-melt ingot. This flaw was slightly less than one-half inch long, and therefore it was not included in Tables XV and XVI. It is a nitride-type defect which

FIGURE 44. - Nitride-type defect in triple-melt ingot.
(Originally 200X) Specimen R-37, Mount F 1288,
from plate SA 26,917-TB.

probably resulted from seeding of the sponge bars used for first-melt electrodes with Ti_xN . It differs in structure from nitride inclusions found in double-melt ingots in three ways. First, the nitrogen content is lower than usual; second, there appears to be branching of the defect area; third, the small voids around the main defect have the smooth, shiny appearance of gas holes. Microprobe analyses showed the flaw contained up to about 1.5% N. The alloy content was lower than in the matrix. The aluminum content was 5.4% and the vanadium, 2.1 to 2.5%. In the normal matrix material the aluminum was 6.3 and the vanadium 4.3%.
