LARGE NAVIGATIONAL BUOY ENGINE-GENERATOR TEST PROGRAM. PART I. TECHNICAL DISCUS-SION AND CONCLUSIONS

R-72-019 July 1972

FINAL REPORT

Contract DOT-CG-91,904A

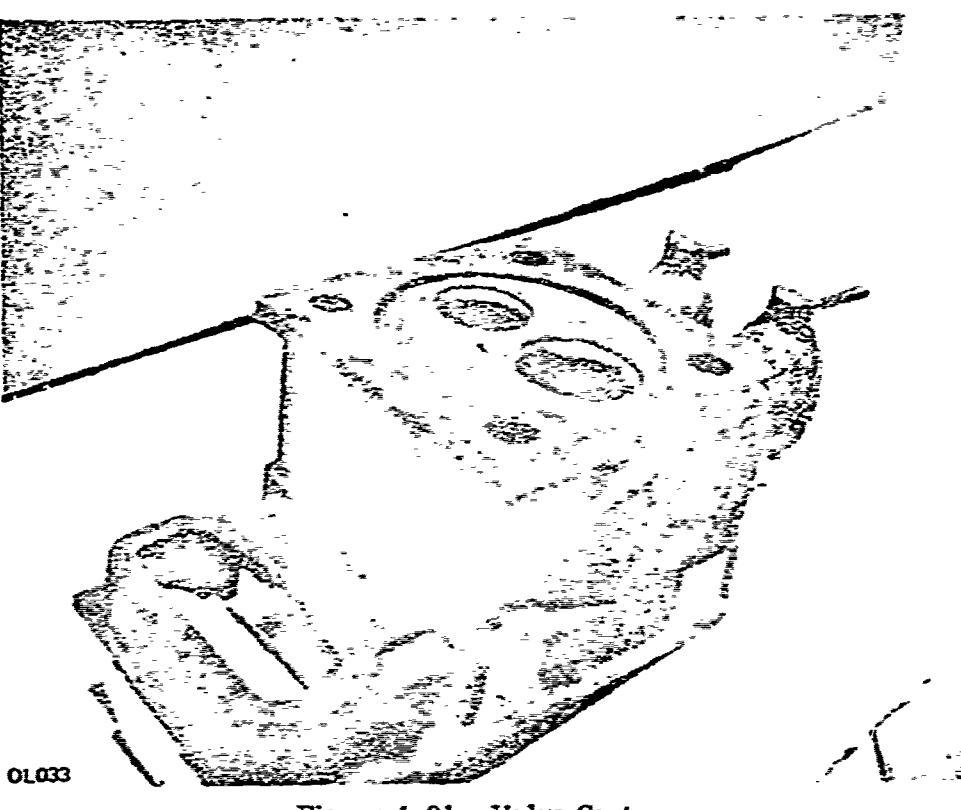
Figure 4-21. Valve Seats

Initial examination of the visible surface of the valves disclosed no evidence of burning. Upon valve removal, considerable erosion of valve faces and seats was noted (see Figures 4-21, 4-22, and 4-23). Valve clearances were not examined during disassembly. However, the absence of burning and the fact that although eroded the valve and respective seat surfaces interfaced well, suggested that pounding as opposed to insufficient clearance was the likely cause. Valve stem, guide, and port deposits of carbon were light. Considering the period of operation, stem and guide wear were minimal, resulting in clearances not exceeding 0.006 inch.
