# USAAMRDL TECHNICAL REPORT 73-20

## MANUFACTURING METHODS TECHNOLOGY (MM&T) FOR BALLISTIC-TOLERANT FLIGHT CONTROL COMPONENTS

R. L. Van Auken

May 1973

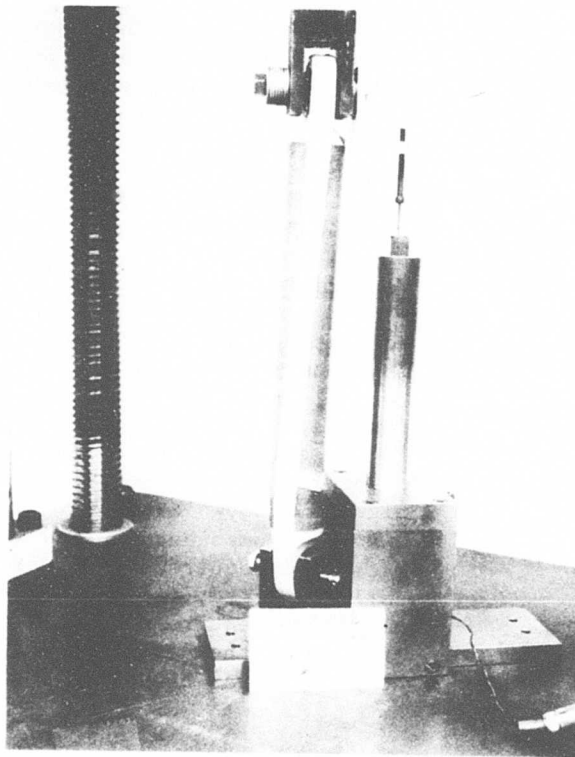
Figure 40. Failed Connecting Link.

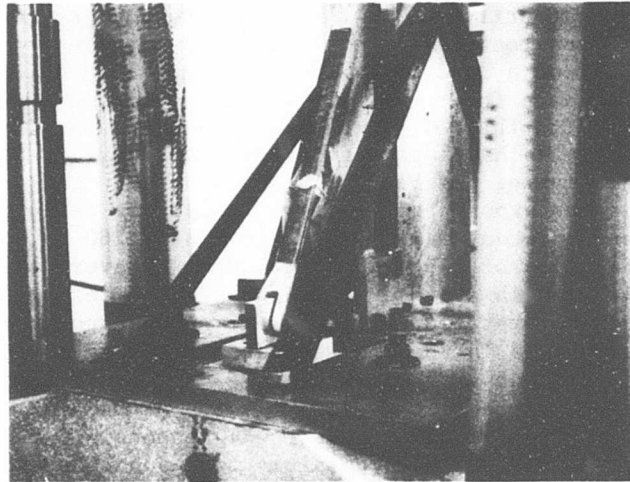
The base line requirement for the forward bell crank assembly is a compressive load of -2,070 lb. Figure 41 shows the typical installation of the forward bell crank in the test fixture. In the front left portion of the picture is the extensometer which is mounted directly at the pivot fitting for measuring load/deflection during the test. Figure 42 shows a typical failure of the connecting link assembly. All components tested met or exceeded the base line ultimate load requirements. Set no. 2, which had been ballistically impacted, failed at 2,080 lb, just slightly above the base line requirement. All other components failed in excess of 200% of the base line load. The spread for the remaining components was between 4,000 and 4,900 lb.

Figure 42. Failed Forward Bell Crank.

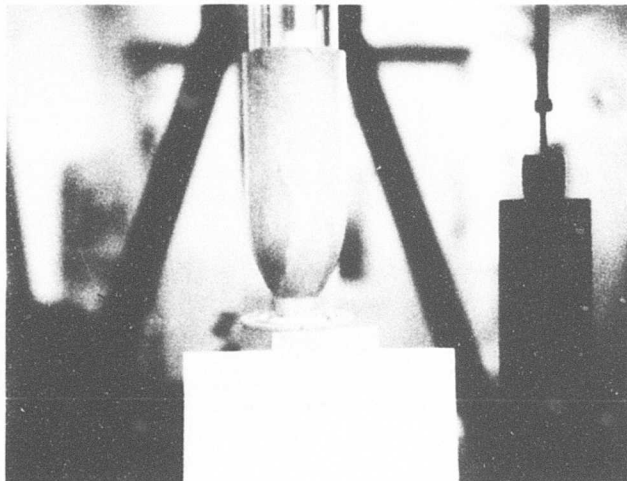
All of the four components withstood the static load condition. The only evidence of degradation during the static loading test was on the idler arm assembly, when a crack developed in an adhesive bond line between the two reinforcing straps around the ball and socket

joints. It was not determined whether this was the result of a poorly bonded interface or the result of the test load. However, the component continued to take load up to the 4,013-lb requirement without any change in deflection. A second run on the same component produced the same deflections, indicating the crack did not significantly affect the test results.

Figure 44. Typical Failure of Idler Assembly.

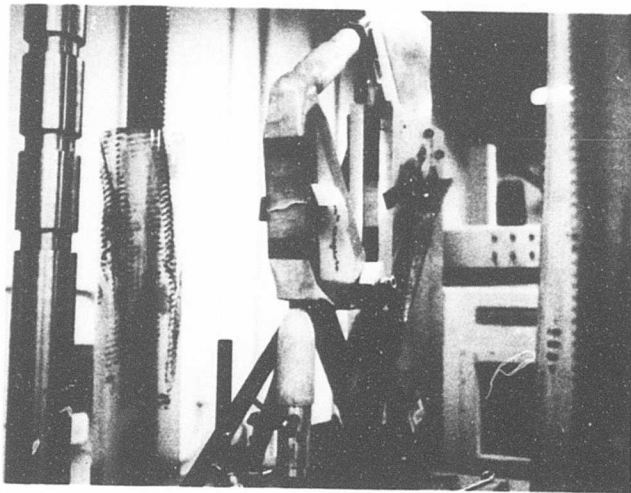
Some components failed to meet the static base line requirement. Two of these, the component that had been through ballistic impact test and that which had been exposed to the fire resistance tests, were not expected to perform satisfactorily due to the excessive damage incurred by the previous tests. The ballistically impacted component withstood a load of -1060 lb and had high deflections. The reason for this was the removal of approximately three-fourths of the socket portion of the input fitting; there also had been considerable fracture of the face sheet bonds during the ballistic impact test. The component which had been exposed to the fire resistance test performed better than expected, failing at a load of 3,280 lb, with a total deflection of 136 mil. There was, however, an unexpectedly low failure with set no. 5, which had been through the humidity, sand and dust, fungus, and salt spray exposures. This component failed in the rod end fitting at the pilot input end. Its failure mode is shown in Figure 46. The deflections were in line with the best performing components, and it is suspected that a manufacturing defect was responsible for this low failure load (2,290 lb), possibly poor adhesion between the BMC and the unidirectional insert. Failures in this same area occurred in the rod ends of the idler arm but at much higher loads.

The other three components failed at loads between 4,720 lb and 4,820 lb, or at approximately 125% of the base line requirement. It is apparent from these results that the aft bell crank as designed has the least margin of safety.

Figure 45. Test Setup and Type Failure of Aft Bell Crank.

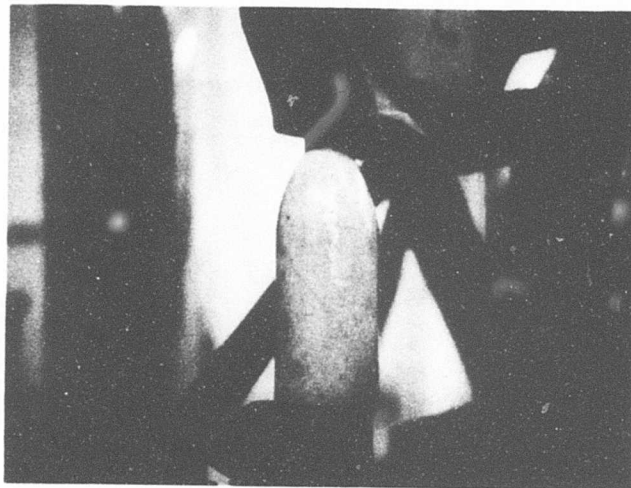
Figure 46. Failure in Rod End of Aft Bell Crank.

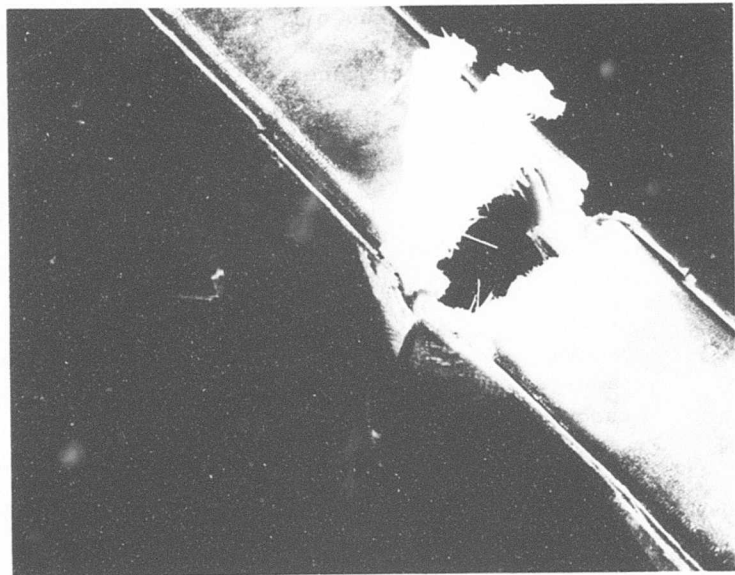
Figure 48. Impacted  
Forward  
Bell Crank.

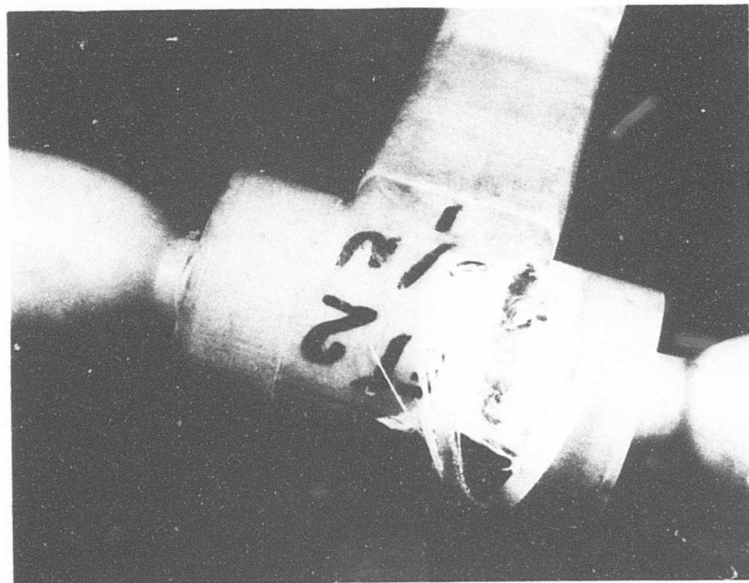
Figure 50. Rod End  
Idler  
Arm After  
Impact.

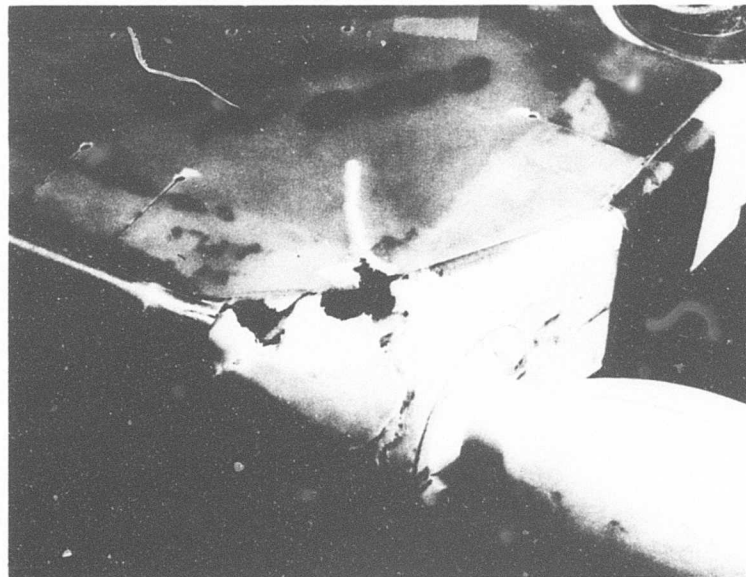
The aft bell crank assembly was positioned in the fixture and loaded as shown in Figure 51. The target for the ballistic impact was the center of the ball and socket joint at the input fitting. In the first test, the projectile hit approximately 0.4 inch below in a tumbled fashion. In this area it impacted the retainer ring and completely severed it from the rest of the assembly. No further damage was incurred; however, the ball was completely loose from the socket and would not permit further testing. Observation of the failure indicated that the projectile, when penetrating the retainer ring, had made contact with the unidirectional glass wrapped reinforcement around the retainer and appeared to have unwrapped this reinforcement on its path through the part. A second test was performed

Figure 52. Aft Bell  
Crank  
After  
Impact.

in an attempt to achieve a hit more centered on the ball and socket joint. The component for this test was the aft bellcrank assembly that had been exposed to the ultraviolet radiation condition. During the second test, the tumbled projectile hit directly on the center of the ball and socket joint and ricocheted inward. While there was minimal damage to the ball itself, it did stop the projectile, leaving the jacket and lead fragments inside the bell crank cavity. While absorbing this impact, considerable damage was incurred in the molded fitting. However, the bell crank was still operational. Figure 52 is a picture of the damage incurred on the second ballistic test.

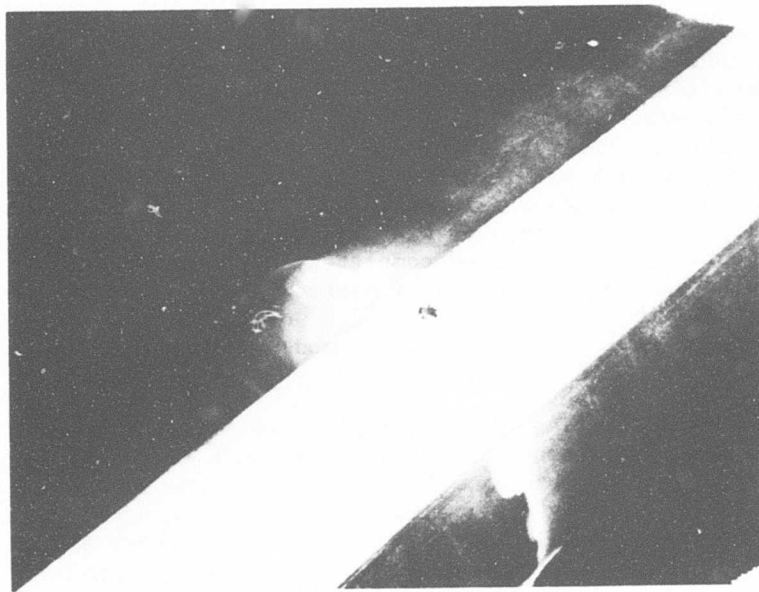
Figure 53. Connecting Link After Ballistic Impact and Static Failure Test.
