LONG RANGE ACOUSTIC PROPAGATION PROJECT.  
BLAKE TEST SYNOPSIS REPORT

**Long Range Acoustic Propagation Project**

**BLAKE TEST Synopsis Report**

**TECHNICAL REPORT**

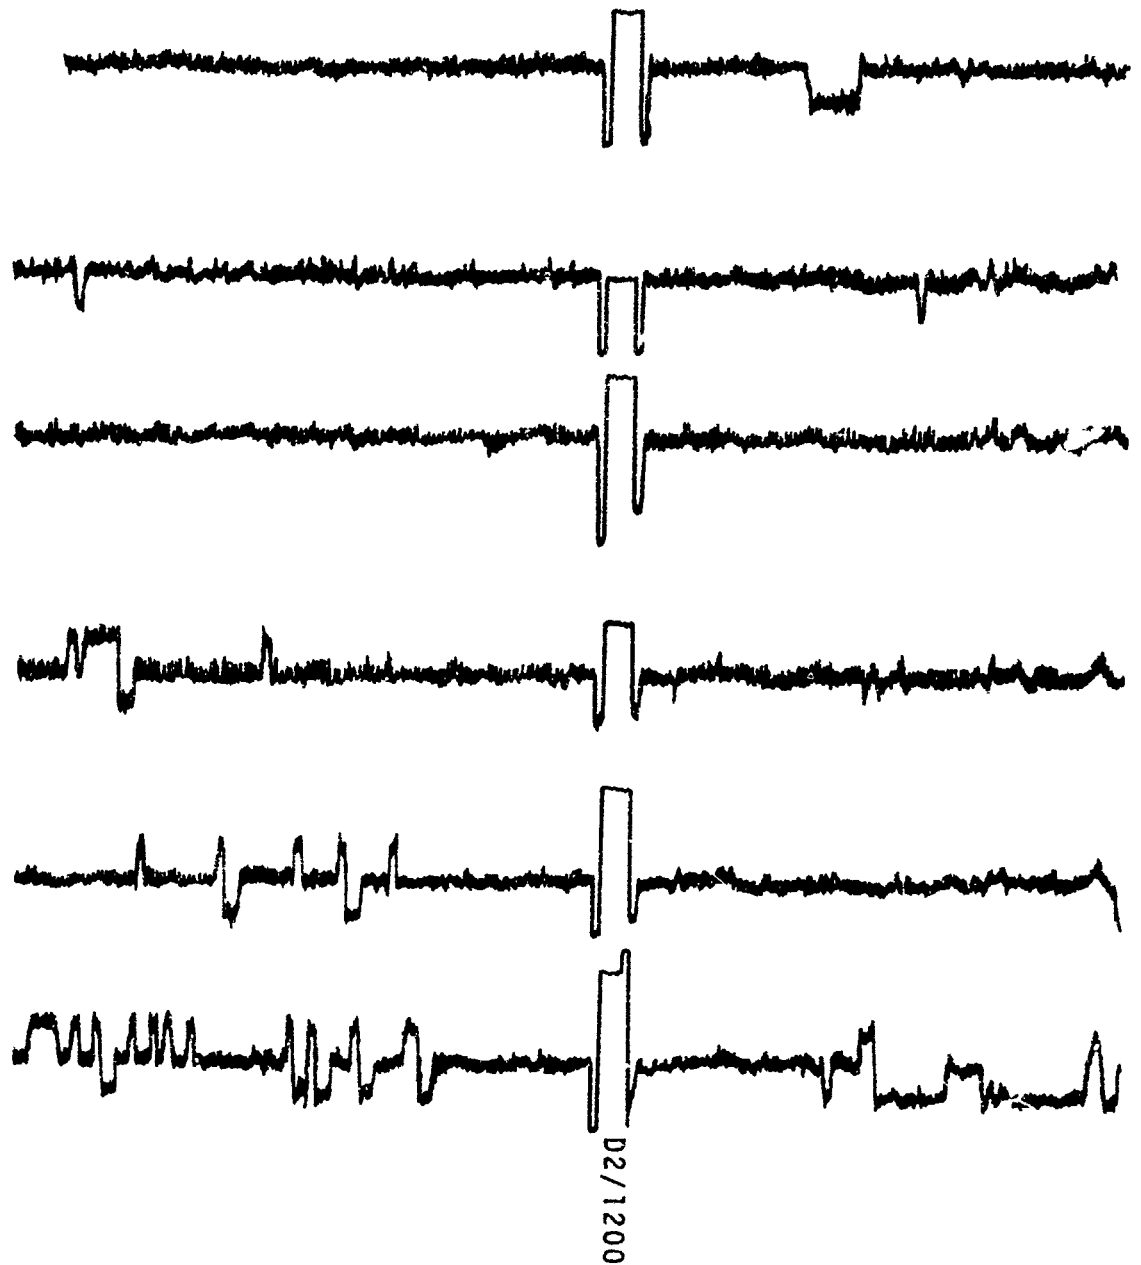
Figure 6. Broadband Time Record Calibration Error

After the first calibration sequence a problem developed in the calibration system of hydrophone number six of the WHOI/TI mooring. There seemed to be a loss of synchronization between the level of the calibration signal and the gain state of the amplifier system. This was evidenced by a "finger" appearing in the last quarter of the calibration signature, see Figure 6. This "finger" protruded above the level of the calibration signal which is designed to be level throughout.

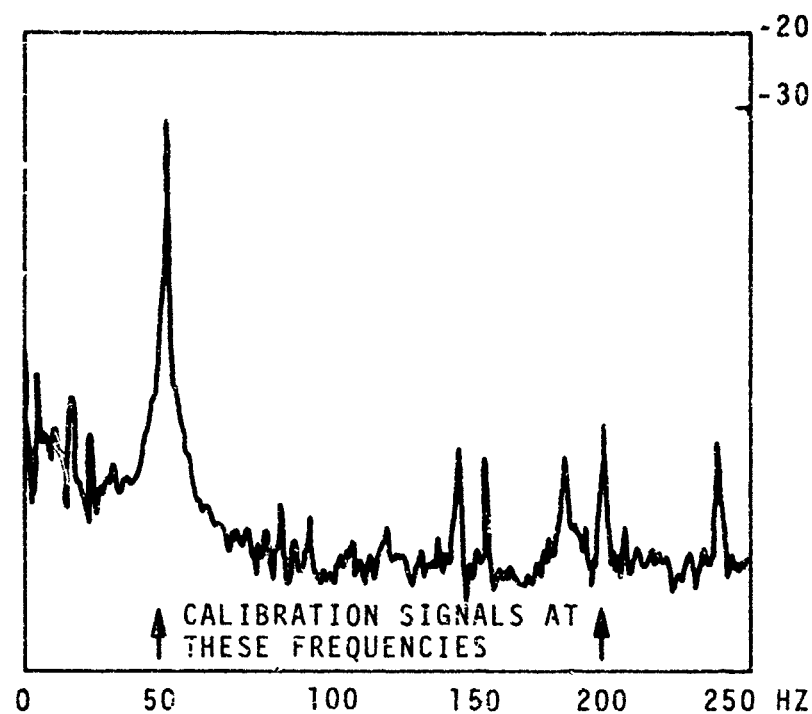
Figure 8. Calibration Sequence Power Spectrum  
BLAKE TEST, RPM 004, 0000Z 13 June

Evidence exists of a non-linearity somewhere in the data recording or playback systems. This is manifest in plots of the spectra of calibration signals; Figures 7 and 8, which show not only the 50 Hz and 200 Hz lines, but also the harmonics of 50 Hz (which unfortunately for analytical purposes are also located at difference frequencies). LOFARgrams also always show harmonics of lines; see for example Figure 9. Some harmonic distortion is inevitable and acceptable. As long as the energy in the harmonic stays well below that of the signal, e.g., 30 dB, there is no problem; see Figure 7.

But when the energy in the harmonics approaches that of the signal, Figure 8, an unacceptable data processing situation results.

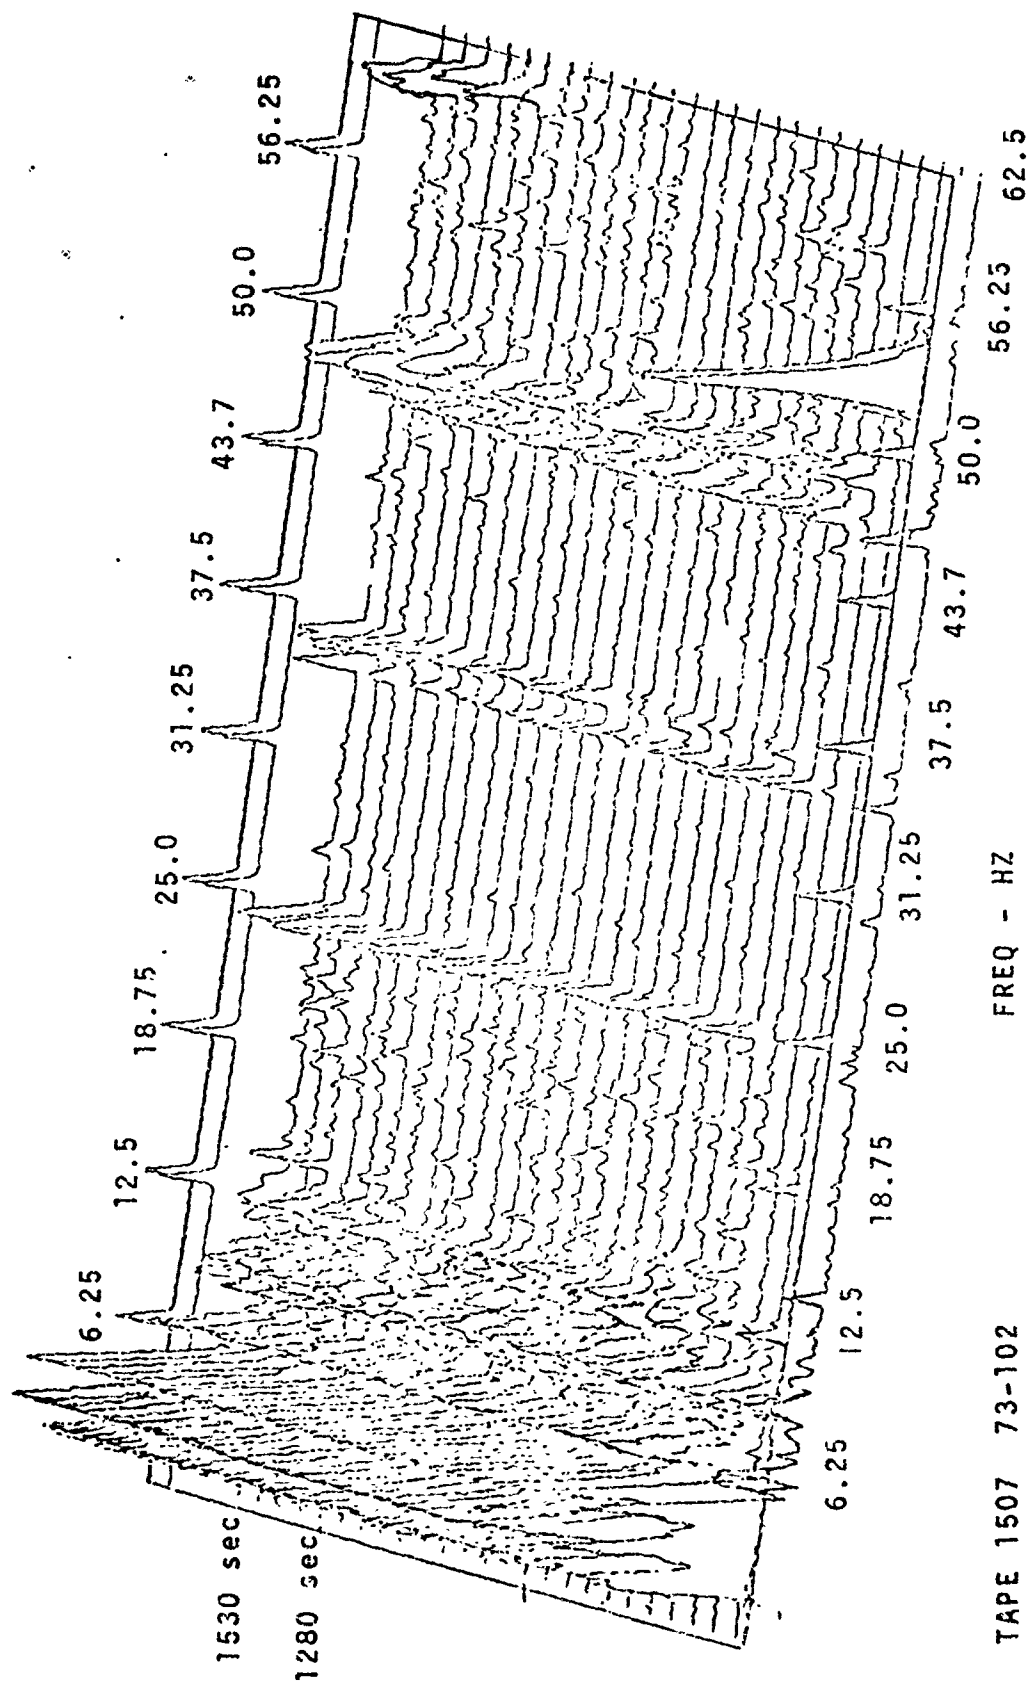
Data were reduced by three organizations, the Woods Hole Oceanographic Institution, the Applied Research Laboratory of the University of Texas and Texas Instruments, Inc; See G. E. Ellis et al, "ARL Preliminary Data Analysis from ACODAC System" ARL-TM-73-11 of 14 June 1973 and "Blake Test Quick Look Report" July 1973, Texas Instrument, Inc. Woods Hole data were reduced and presented in the ACODAC 1/3 octave format. Each one minute average in selected 1/3 octave bands was plotted. The resultant time series were displayed with distribution histograms on the left ordinate. These are shown in Figures 10 and 11. Another form of data was the narrowband power spectrum, produced by FFT. Power spectra of approximately 1/4 Hz and 1/10 Hz resolution were calculated which permitted diagnosis of the sources of certain strumming lines. See Figures 12 and 13. Sequential narrowband spectra constituted the most useful data from ARL/UT and LOFARgrams produced by TI were useful in identifying strumming occurrences and frequencies. See Figures 14 and 15.
