INVESTIGATION OF THE HOOD EFFECT
OF THE 6" COMM. MK. 27-7 PROJECTILE
AT VARIOUS OBLIQUITIES

EXPERIMENTAL DEPARTMENT MEMORANDUM

No. 1238-47

21 April 1947.

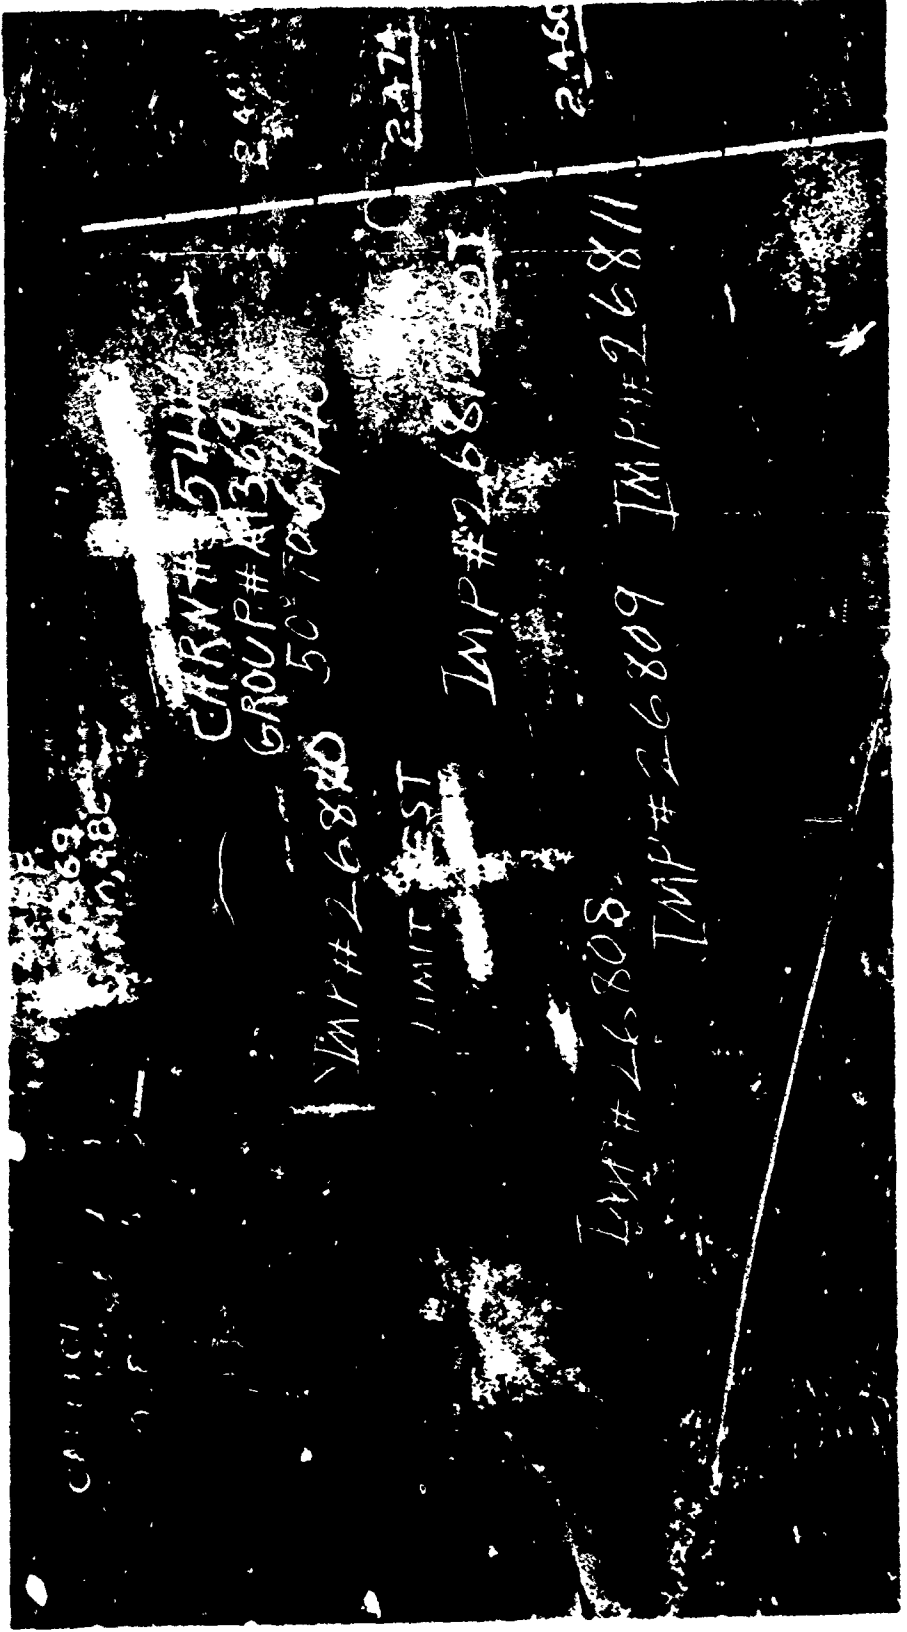
Imp 34254 - Imp. Limit Test of 2.45" 270 Plate No. 75446 Imp. by Carnerie
 Wichita Steel Co. vs. Imp. Corp. No. 27-7 Proj. IMP with and without
 windshield and hood. View: front of Plate.

Impact Cbl.	J.V.	Sk. 74241	Fene.	Thru Open	Projectile
26202	50°30'	1339	103.7	None	with windshield and hood "
26209	49°20'	1442	107.9	9" x 9"	" " " "
26210	50°10'	1405	105.3	9" x 1 1/2"	" " " "
26211	48°40'	1339	95.3	6" x 3/8"	Without windshield and hood "
26212	49°30'	1325	95.1	6" x 9"	" " " "

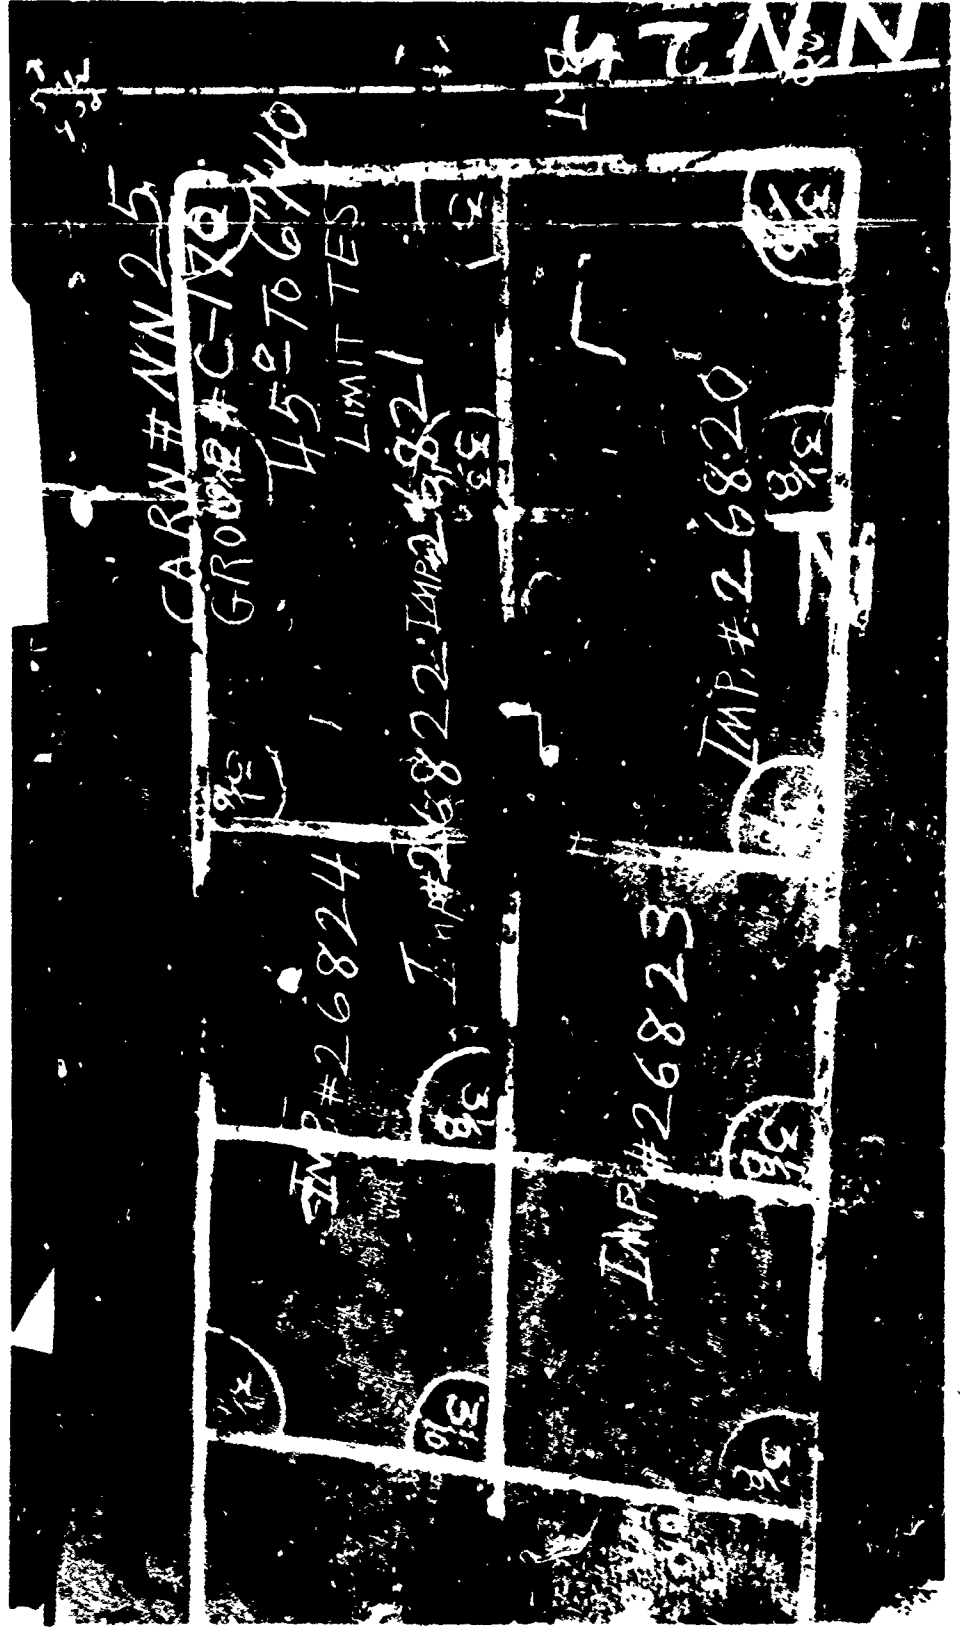
NY 34055 - Bal. Limit Test of 3" x 13 STS Plate No. NN-25 Mfd. by Carnegie
 Illinois Steel Co. vs. 6" Corron Pk. 27-7 Proj. I&P with and without
 windshield and hood. View: Front of Plate.

Impact	Cbl.	S.V.	K. K. 78841	None.	Thru Open	Projectile
25220	45°00'	1438	97.6	2-3/4"	None	with windshield and hood "
25221	45°40'	1507	100.9	2-1/4"	None	" " "
25222	45°30'	1543	105.7	3" P.	6" x 7"	" " "
25223	44°20'	1413	92.3	2-1/2"	None	without windshield and hood "
25224	45°00'	1421	97.4	Comp.	6" x 7"	" " "

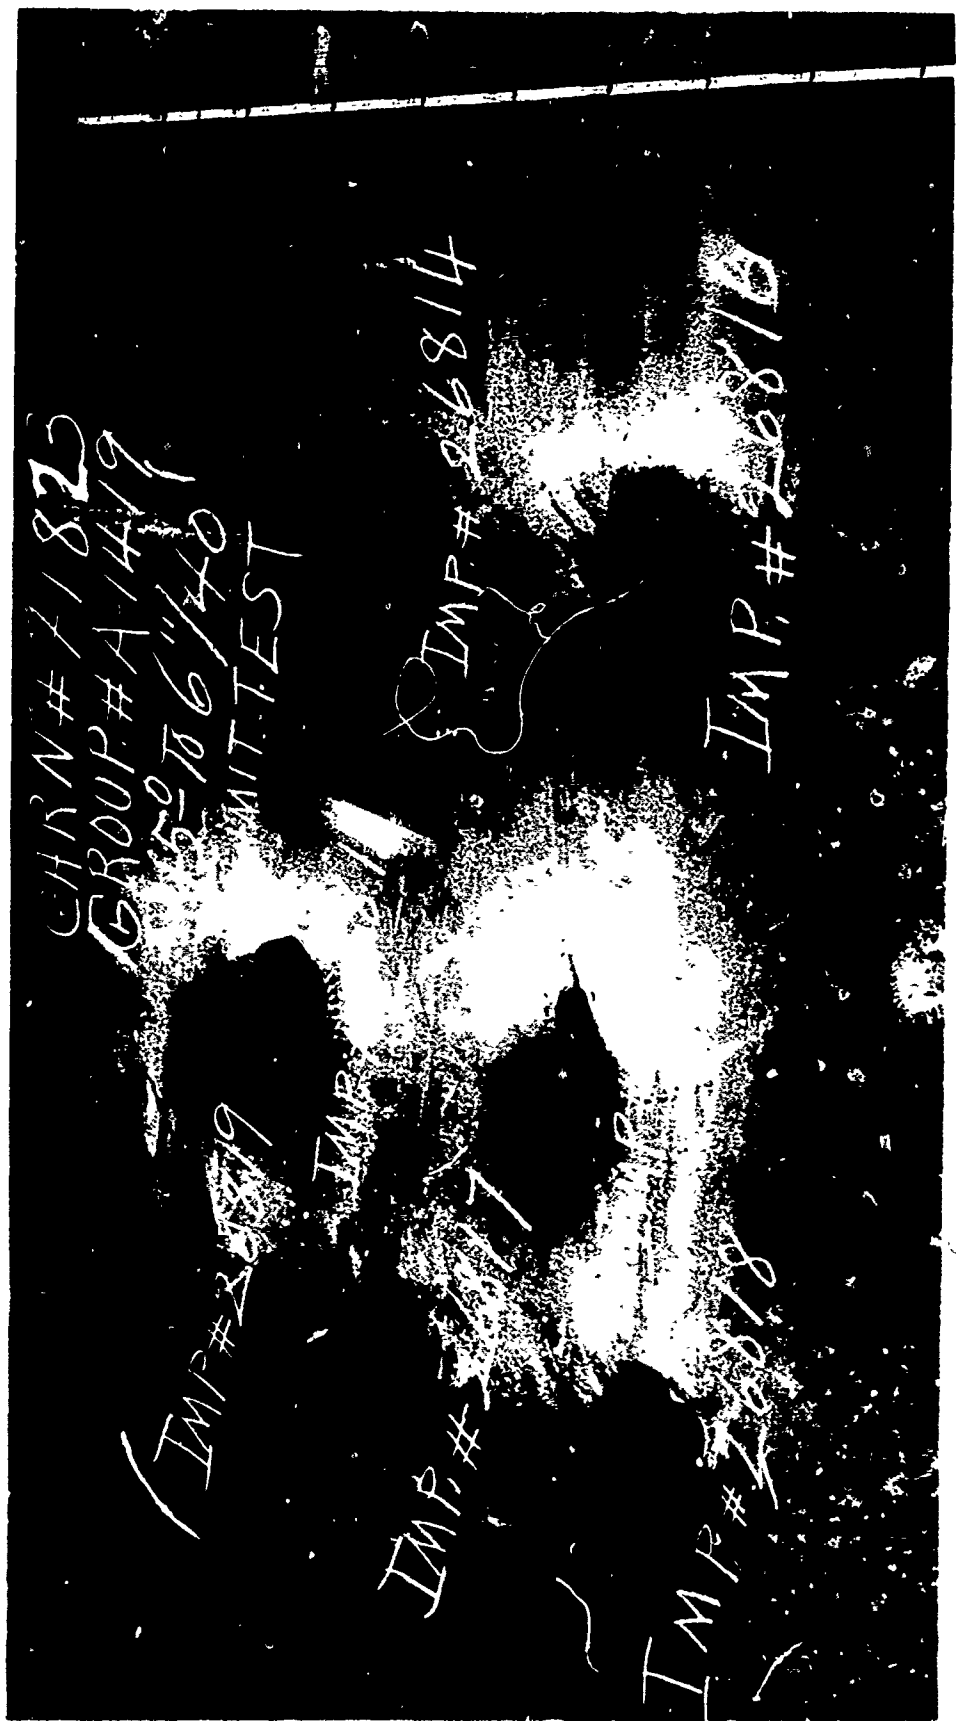
329 3560 - 601. 1/16" dia. of 1875 W.P. Plate No. F-1242 Mfd. by Carnegie Illinois
 Steel Co. W.P. 3" Corron No. 27-7 Projectiles IMP with and without windshield
 and hood. View: Front of Plate.

Impact	Cbl.	J.V.	% Sk.	78441	Pene.	Thru Open	Projectile
26813	45000	256		95.3	Comp.	6" x 7"	without windshield and hood
26814	45000	733		87.4	Comp.	6" x 6-1/4"	" " "
26815	45000	716		78.7	1-1/2"	1/2" x 5-1/2"	" " "
26816	45000	746		82.9	3"	6-1/2" x 4-1/2"	With windshield and hood
26817	44000	297		109.0	Comp.	6" x 7"	" " "
26818	44000	254		103.8	Comp.	6" x 7"	" " "
26819	44000	795		96.6	3"	3-1/2" x 8"	" " "

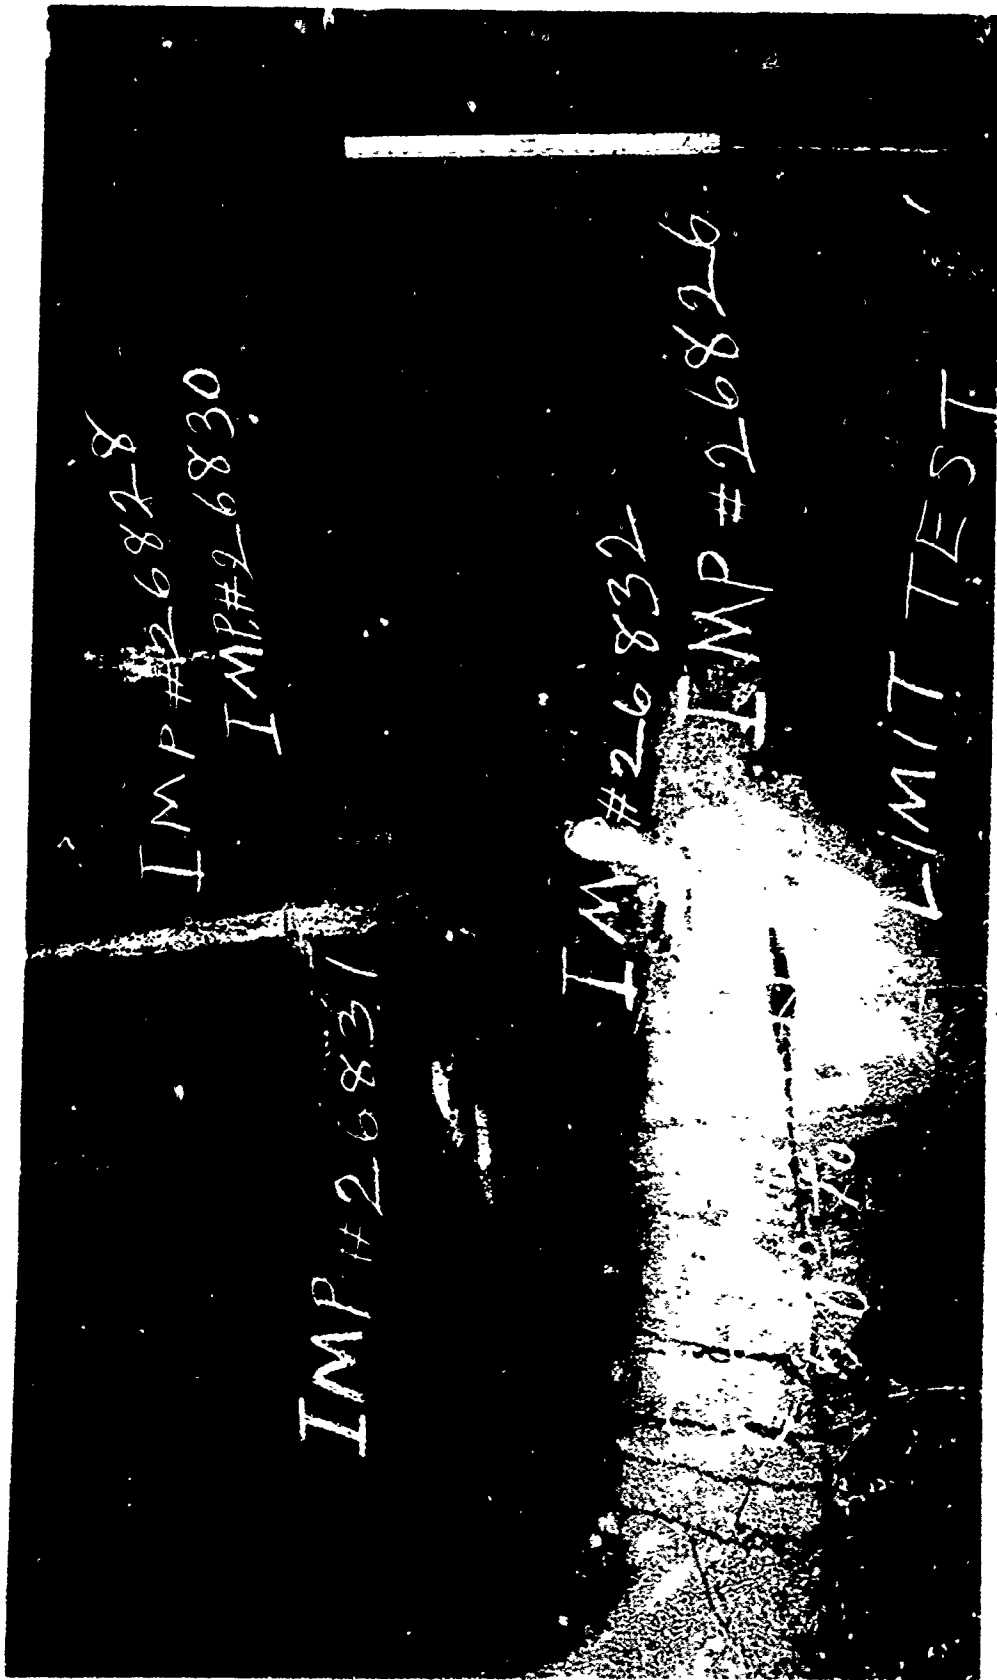
ST9 35062 - Bal. Limit Test of C-97 ST3 Plate No. 634580 Mfd. by Carnegie Illinois Steel Co. vs. 6" Corron Pk. 27-7 Proj. IL&P with and without windshield and hood. View: Front of plate.

Impact	Obl.	S.V.	% Sk. 78841	Pene.	Thru Open	Projectile
20820	50°50'	724	101.7	Comp.	6" x 17"	With windshield and hood "
20828	51°00'	695	96.8	5/8"	None	" "
26830	50°00'	662	89.3	Corp.	6" x 8"	Without windshield and hood "
26831	50°00'	597	80.7	1-1/4"	3/4" x 10"	" "
20832	51°00'	628	84.0	Corp.	6" x 11"	" "

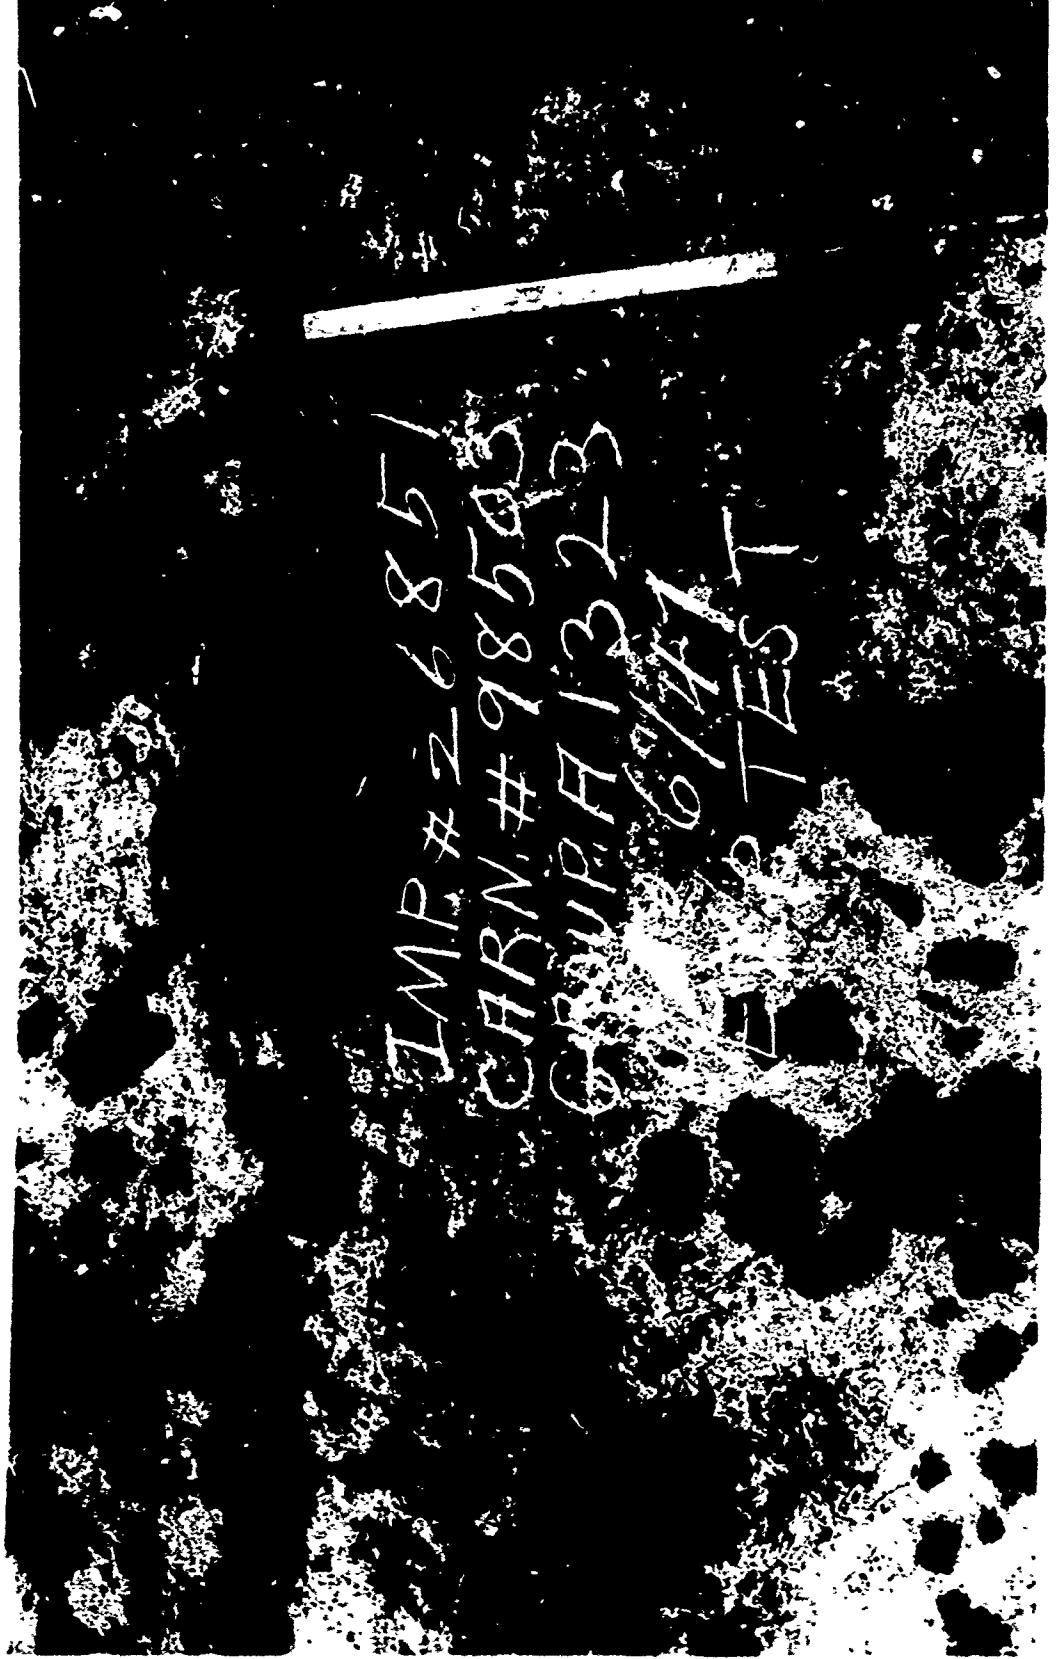
NP9 34056 - Bal. Exp. Test of 18908 STS Plate No. 98503 Mfd. by Carnegie
Illinois Steel Corp. vs. 6" Common Mk. 27-7 Proj. IL&P fired for recovery of
fragments of the windshield and hood. View: Front of Plate.

Impact Obl. S.V. $\frac{1}{2}$ Sk. 78841 Pene. Thru Open

26851 0° 957 127.9 Comp. 6-3/4" x 7"

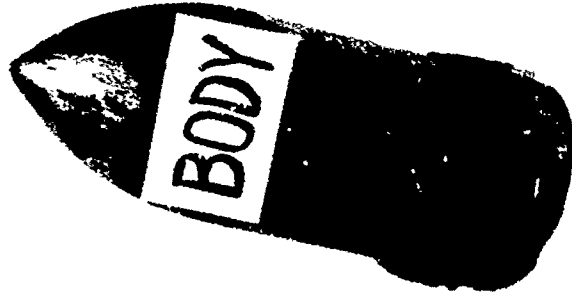
The fragments were recovered without evidence of any secondary damage. The windshield and the crown of the hood were splintered into many small pieces, but the skirt of the hood was recovered in three equal pieces. The crown of the hood appeared to have fractured by shear after severe plastic deformation, as illustrated by lamellar blocks of the metal which have slipped over each other without becoming separated. The skirt of the hood experienced several brittle fractures on planes normal to the prevailing axis of tension in the region free from severe cold work, but each normal fracture shifted to the shear type of fracture when it ran into the severely worked region. Three of these brittle fractures were initiated by three minute punched indentations on the shoulder of the

hood, but a fourth crack was also observed which did not originate from any obvious imperfection. The fourth crack did not pass into the plastically deformed region, as revealed by microsections of the recovered fragment. The fourth crack probably failed to reach completion because of a release of stress by the prior completion of the other three fractures. Measurements of the fragments show that the reduction of area at the brittle fractures was not more than 2%, whereas the material of the hood would undergo a reduction of area of more than 65% in a standard tensile test. The full elongation was, in fact, obtained in the region of severe plastic deformation.

679 34290 - Ballistic X-ray of 1.90 gm fragment of the
by ballistic-tilted steel ball, vs. a portion of the
shield and hood - view of recovered fragments.
