STRUCTURAL EVALUATION OF UH-1D TUBULAR ROTOR BLADE

Don Cook

Fiber Science, Incorporated

August 1974

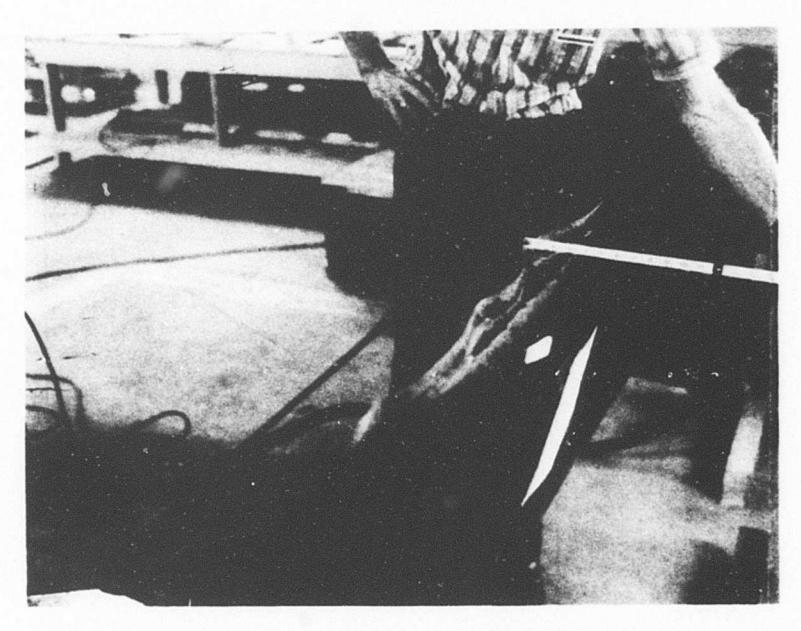
Figure 27. Chordwise Proof Test Failure - S/N 001.

The blades were subjected to 150% of limit flapwise and chordwise bending and torsional loads except for the chordwise loading portion on Blade S/N 001. During the chordwise portion of the test on S/N 001, the blade failed at a loading of 1650 pounds. When the 1650-pound load was reached, audible cracking noises were heard coming from the general area toward the root end third of the blade. Application of the loading was stopped and the blade was observed. More cracking was heard and the trailing edge around Station 50 became unstable and took a serpentine shape. This condition progressed for about 5 seconds and then the trailing edge separated suddenly with a loud bang. Separation occurred in the material near the bond line and also in the foam beginning at 27.5 inches from the root end and extending to 84.5 inches from the root end. The total length of the split was 57 inches. The foam separation depth varied from very little at both ends of the split to a maximum of 15 inches at a point approximately 55 inches from the root end (midway between split ends).

Figure 27 is a photograph of the damage as seen during post failure flapwise static deflection tests.

The blade $v_{n,k}$ svery simply repaired by pouring a mixture of resin into the separation arca and then clamping the area closed using a vacuum bag around the blade. Resin was also injected into the fringes of the damaged area where the poured resin could not reach.

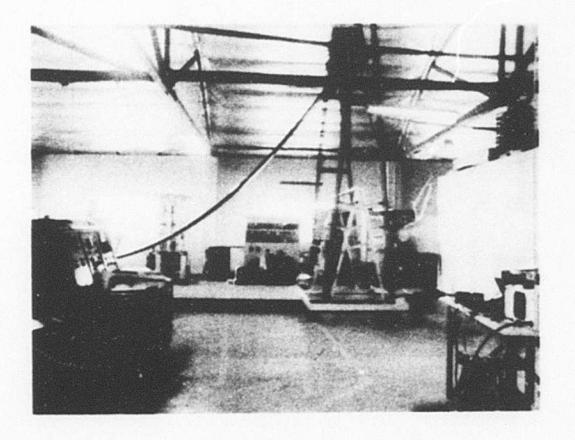
Figure 35. Ultimate Test -Maximum Loading at Break - S/N 002.

S/N 002 ultimate testing was terminated at a tip leading edge height of 144 inches above zero and a loading of 915 pounds. The test was terminated at this point because the blade was hinging at the damaged section of the root end sustained during fatigue testing (see Figures 35 and 37).

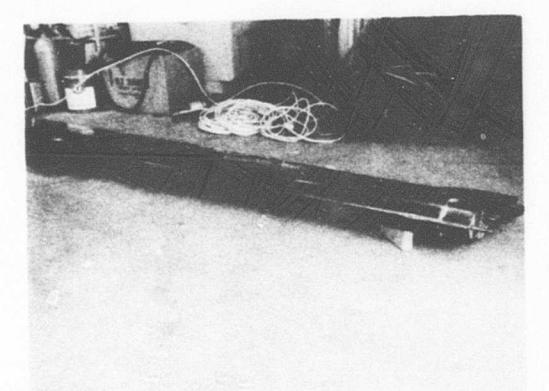
Figure 36. Ultimate Test Failure -S/N 001.

S/N 001 failed at a tip height (leading edge) of 10 feet above the zero position with a loading of 750 pounds. Failure occurred in the root end beginning at the damaged area incurred during fatigue testing. The failure line began at the center of the 2-1/2-inch-diameter hole, progressed straight to the leading edge, made an abrupt right angle turn at the seam in the leading edge, and progressed toward the tip for about 2-1/2 feet. The load after breakage dropped to 600 pounds (see Figures 33 and 36).

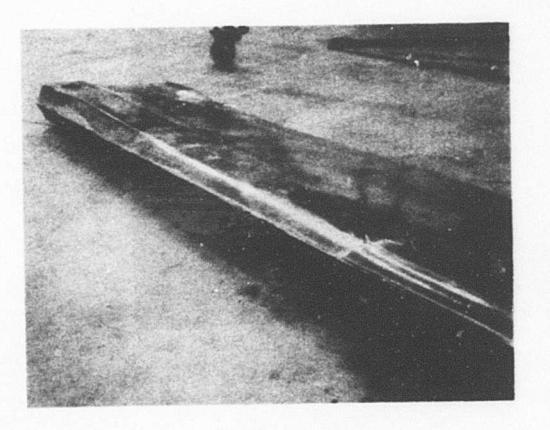
Figure 38. Ultimate Test Failure -S/N 003.

S/N 003's first major break occurred at a tip height of 120 inches and a loading of 975 pounds. The break consisted of skin compression failure at Station 84 and leading edge split from Station 35 to Station 76. When the break occurred, the load dropped immediately back to 850 pounds. Testing was continued to a height of 132 inches and 1100 pounds. At this time, the trailing edge split open from Station 48 to 96 and the load dropped to 950 pounds (see Figures 34 and 38).

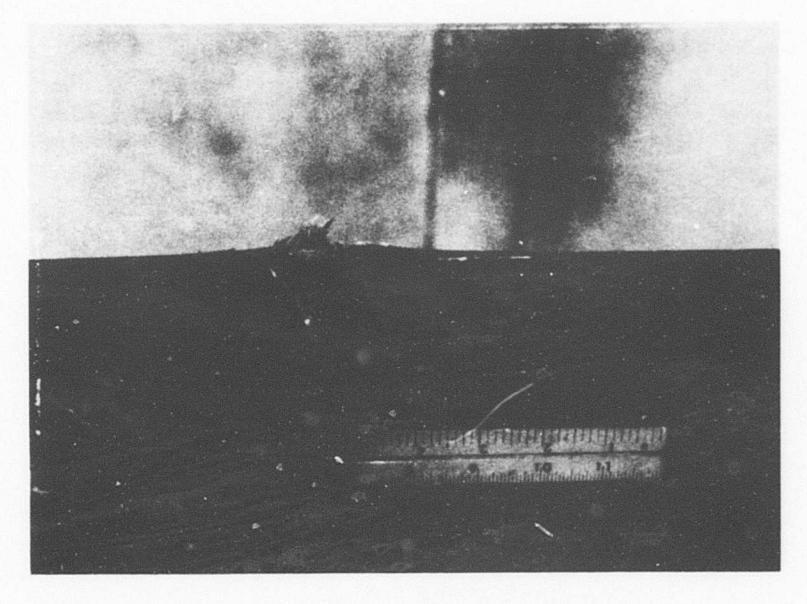
Figure 40. Bullet Impact, Trailing Edge - S/N 002.

The bullet penetrated the trailing edge of the blade and exited on the opposite side, leaving a groove running chordwise for about 1-1/2 inches long at the entrance and about 3 inches long on the exit side. The trailing edge split at the bond line approximately 4 inches on both sides of the bullet entrance. The bullet severed the trailing-edge longo material, and the damage extended forward into the foam area.

- The skin was stripped away on both sides of the blade until the trailing edge longo material and foam were exposed for 7-1/2 inches on both sides of the damaged area and 1 inch in front. The resulting exposed areas were rectangular in shape. Using an air-operated disc sander with No. 60 grit paper, the skin was tapered back 1-1/2 inches on each side of the rectangles.
- 2. Again, using the sander, the damaged longo material was removed and the two severed ends were sanded to a knife edge taper or the ends with the taper extended back 2 inches on the bullet entrance side and 4 inches on the bullet exit side.
- 3. Voids in the damaged foam area were filled using a thick mixture of micro-balloons in a resin system composed of DOW DER 332 resin and APCO 320 hardener mixed to a ratio of 17.4 parts by weight per hundred.

- 11. The entire area was then covered with a plastic coating to restore the natural surface appearance of a glass-reinforced plastic structure.
- 12. Repair required 4 hours plus another 4 hours for cure.
