11. Mail11 MISSILE 1F INVESTIGATION REPORT This document is subject Run S1-613-14-01 . 1 Controls and to 📬 🖉 🖉 _ .: ioreign ea 🗈 v a station -BOWLFILL --na. i.i. . . be made only Run Date: 13 May 1962 with pror approval of: GENERAL DYNAMICS ASTRONAUTICS Issue Date: 17 July 1962 JUL 20 1962 Attn: SMSD Report No. AC-62-0031 LIBRARY Copy No. 4 WS 107A (ATLAS) CLASSIFICATION CHANGED TO: э UNCLASSIFIED AUTHORIZED BY: AIR FORCE LETTER SAN BERNARDINO AIR MATERIEL AREA (SBAMA) s) J DATED 17 NOVEMBER 1965 э**r** ĴØĹ RECLASSIFIED BY: REE DEPT. 190-1 DATE 12-13 gèr Ass General Dynamics/Astronautics General Dynamics/Astronautics Durgede pluid on dr. by Security Dept., 112/66. An. D. M. McCray A. C. Chase Manager - STL Responsible Representative Sycamore Field Office Rocketdyne Field Office - Sycamore S. R. Simpson Acting Site Manager - Acoustica Associates Acoustica Field Office .. Sycamore meaning of the Esplorage La Marined person is prohibited rs, Title by law. This document centeles informati 18, U.S.C., Soction 793 and 794.

This report presents the findings of the Accident Investigation Board investigating the explosion of Missile IF during static firing S1-613-14-01 at-Sycamore--Canyon

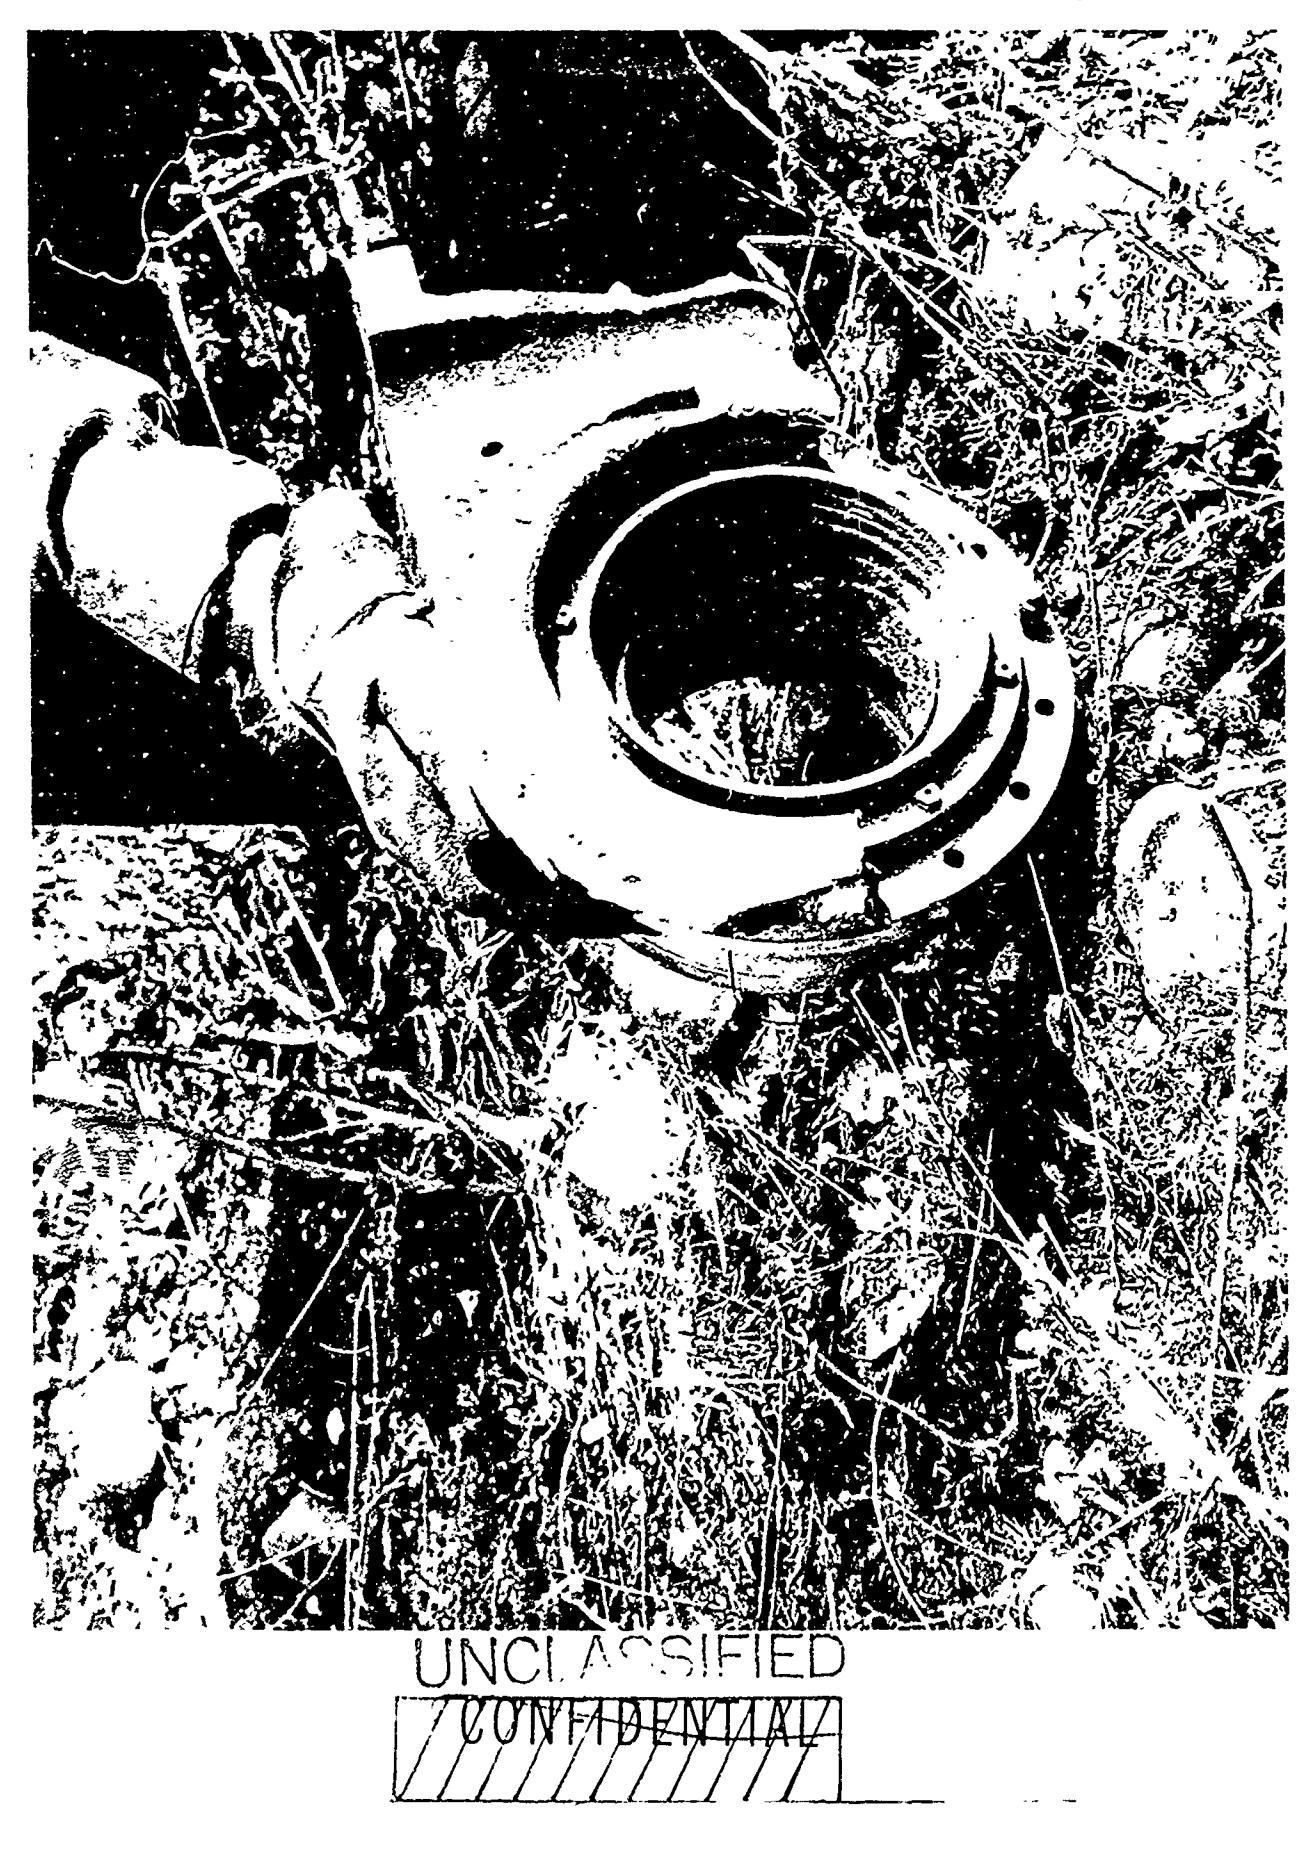
- 7. Fower Fackage The lox rump, fuel pump, and rearcase were found as a unit. The lox rump case was split at its maximum periphery over the entire circumference. The inlet side of the pump case was found separate from the power package east of the flame deflector spillway approximately 300 feet from the test stand with the inlet reapter, "Y" duct attaching flange, Bayco seal, and internal spring intact. The lox pump impeller and inducer remained attached to the pump but showed considerable evidence of heat. The impeller was burned and eroded both internally and externally with an erosion pattern indicating the heating occurred while the impeller was rotating. Both the lox pump wear ring and diverter lip were also extremely eroded. The hydraulic pump was broken from the georease at its weakest section.

SUSTAINER LOX DUCT ADAPTER AND PART OF BROKEN LOX PUMP VOLUTE (Neg. No. 87912A)
