SUBJECT: Operational Report - Lessons Learned, Headquarters, 589th Engineer Battalion (Const), Period Ending 30 April 1968 (U)

SUBJECT: Operational Report of 589th Engineer Battalion (Construction),
For Period Ending 30 April 1968 (RCS CSFOR-65(R1))

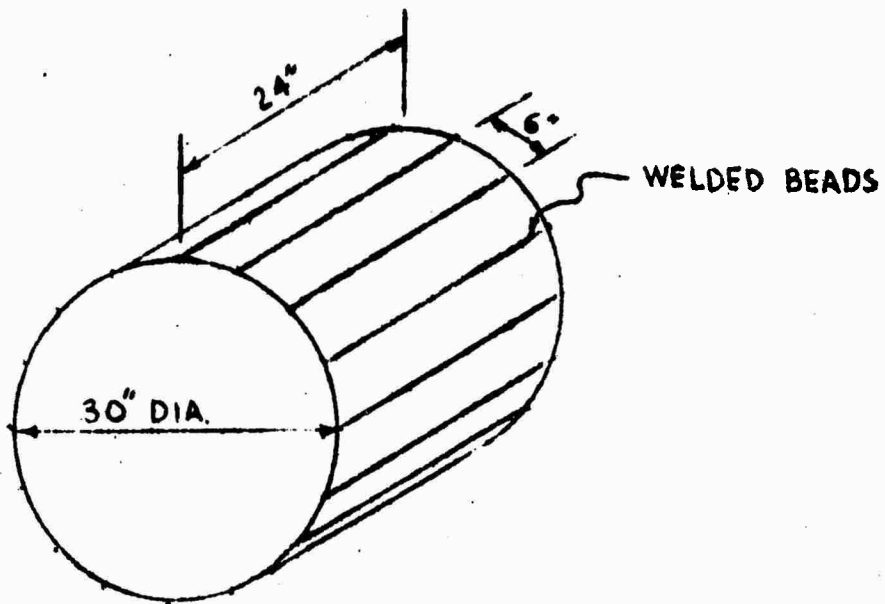
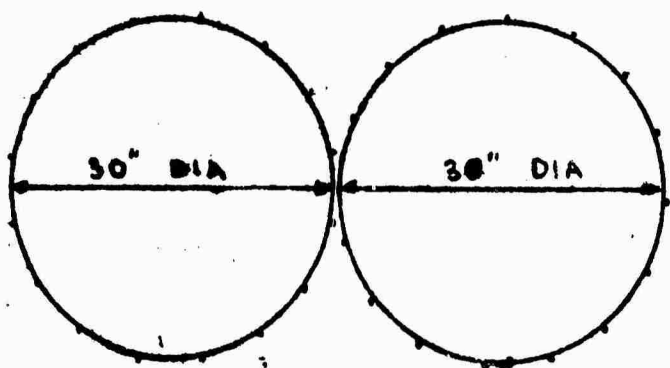
Incl 2

(b) EVALUATION. Fine aggregate, $\frac{1}{2}$ "(-), is needed to constantly supply the asphalt plant operation. The crusher was not producing $\frac{1}{2}$ "(-) material because the corrugations were of such a size as to allow minimum contact between the aggregate and the companion roll. The rolls were set as close together as possible but to no avail. It was found that by welding beads parallel to the axis of rotation on the smooth roll, gradation was improved and production increased.

CRUSHER ROLLS
(FOR 1/4 (-) AGGREGATE)

(c) RECOMMENDATION. That hard surface beads be welded onto the smooth rolls of rock crushers when greater productivity and quality gradation are required.
