SUBJECT: Operational Report - Lessons Learned, Headquarters, 577th Engineer Battalion (Construction), Period Ending 31 Oct 1968

SUBJECT: Operational Report of 577th Engineer Battalion (Construction),
for Period Ending 31 October 1968, RCS CSFOR-65 (R1)

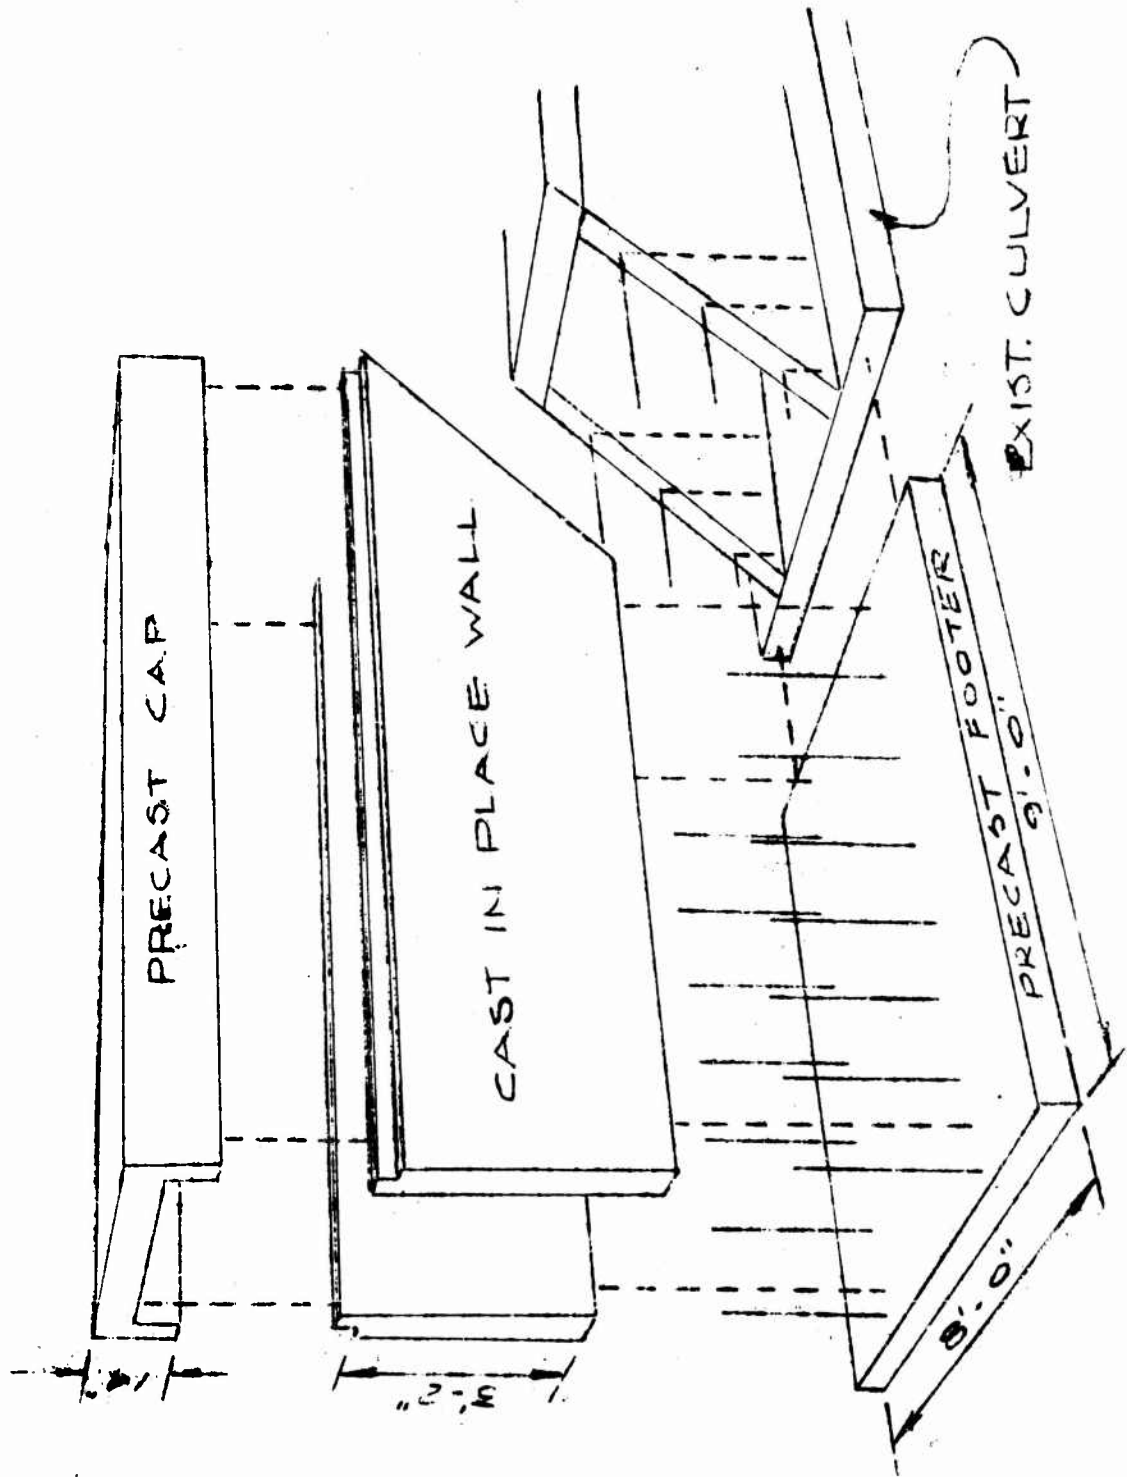
PRECAST CONCRETE CULVERT EXTENSION

shallow to accommodate corrugated metal pipe.

(b) EVALUATION: On highway QL-1 north of Vung Ro Bay there are many old box culverts that are only 20 feet wide, and must be either widened or replaced by CMP culverts or lengthed. In areas where water stands above rice paddy level, great difficulty has been experienced in placing concrete footers for the culvert headwalls. By precasting concrete culvert floors, with vertical reinforcement extending, and placing these floors as an extension to existing box culverts, pouring in-place vertical walls and placing pre-cast caps on top, these box culverts can be extended without digging up the existing road or disrupting traffic to any extent. See sketch.

(c) RECOMMENDATION: Precast concrete culvert extensions should be used in situations where a large number of culverts need to be extended and developing a precast yard is deemed feasible.

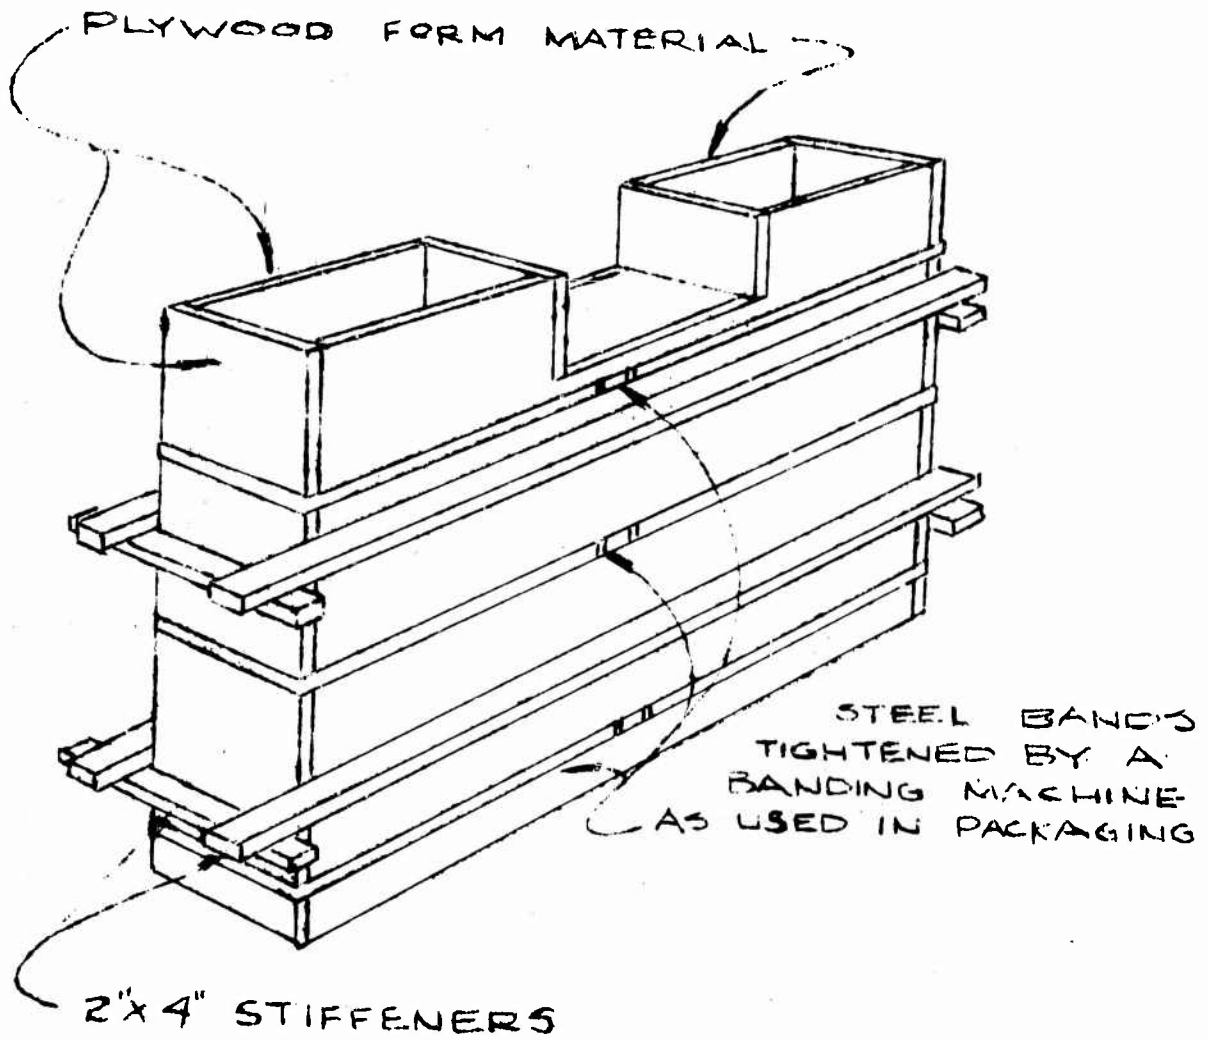
CHECKDAM FORM

(a) OBSERVATION: Highway QL-1 through the Vung Ro Pass has grades and rainfall runoff which require installation of over 100 checkdams and ten drop inlet culverts.

(b) EVALUATION: In the precast operation which was initiated, a steel banding machine was used to hold together the plywood forms. The banding permitted quick assembly and disassembly and considerable re-use of the forms. See sketch.

(c) RECOMMENDATION: In the precasting of simple forms, a banding machine be used to hold together the forms.
