USAAVLABS TECHNICAL REPORT 69-42

**FLAW POINT AND DYNAMIC
MICROPHOTOELASTICITY INVESTIGATION**

A. A. Caputo

June 1969

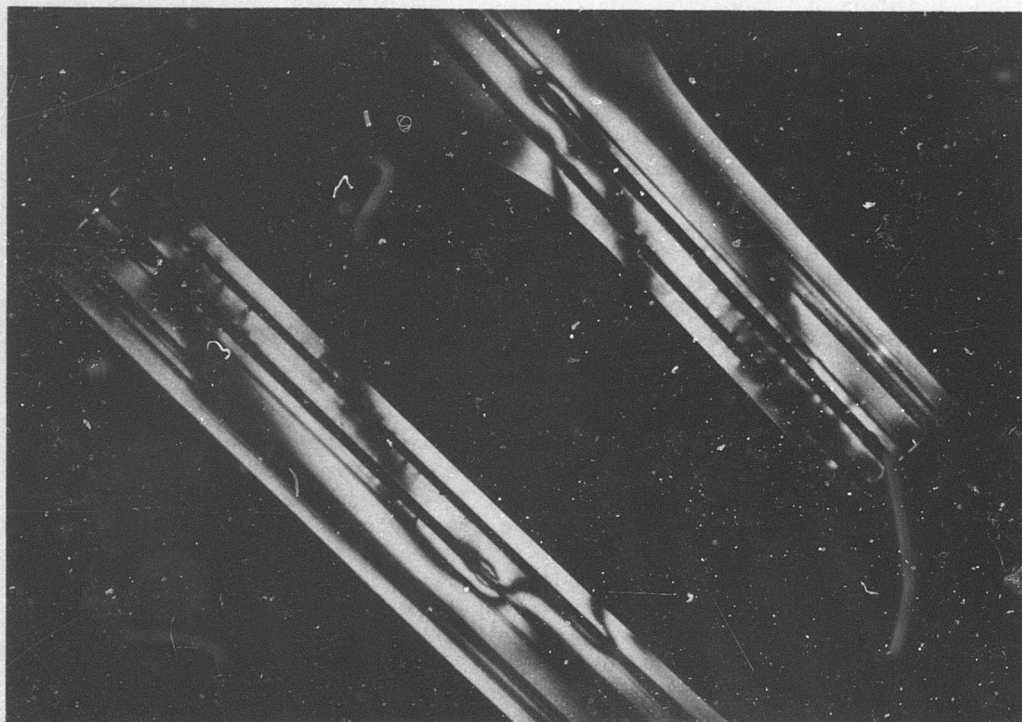
Six 0° fiberglass-reinforced specimens were subjected to axial tension. Fracture occurred very rapidly, and the action was not stopped by a Milliken camera operating at 400 frames per second. The average ultimate stress for five specimens (one specimen failing in the grips) was 18,700 psi. In each case a brittle-type failure occurred. A few small secondary cracks developed at the fibers near the main crack. Fracture was accompanied by unbonding of fiber bundles away from the fracture surface. Distinct residual stress patterns associated with the unbonded fibers were observed. A typical residual stress pattern is shown in Figure 2.

Figure 2. Residual Stresses in Unidirectional Fiberglass-Reinforced Tensile Specimen Showing Unbonding of Fiber Bundles (1.8X) .

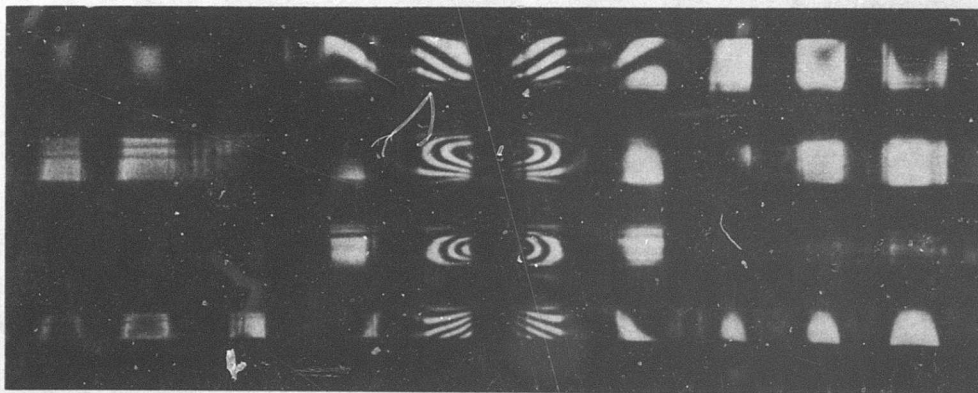
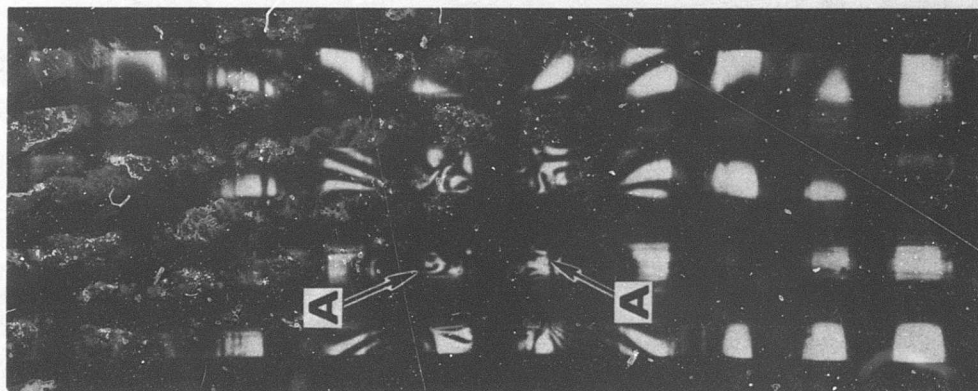
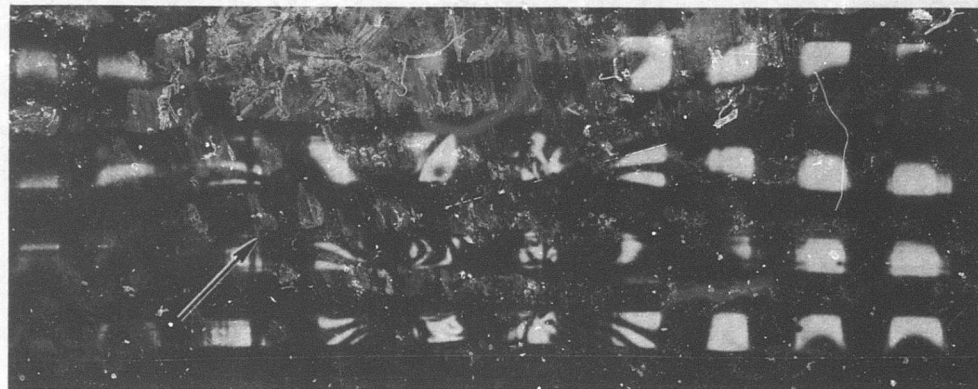
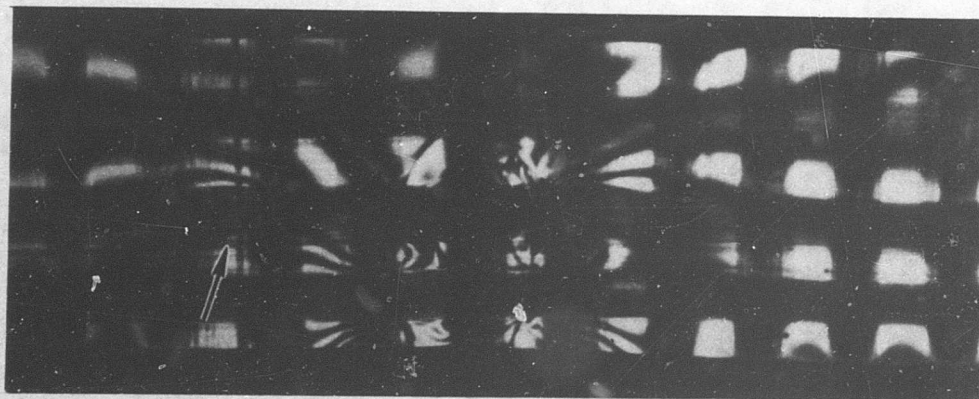
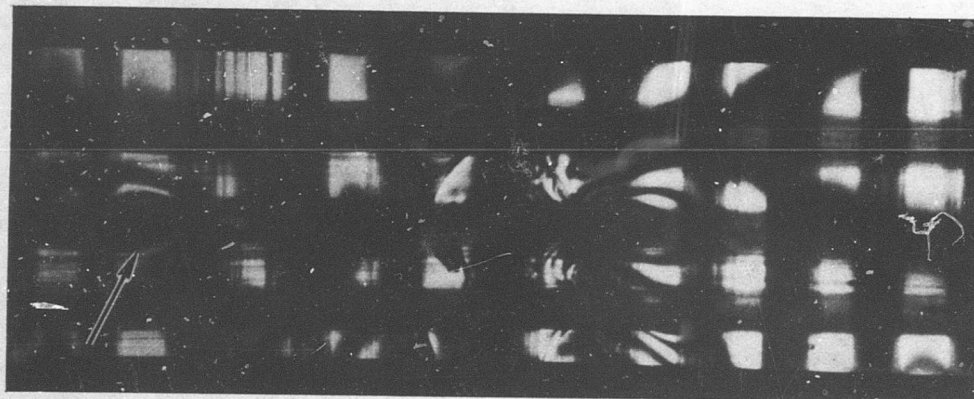
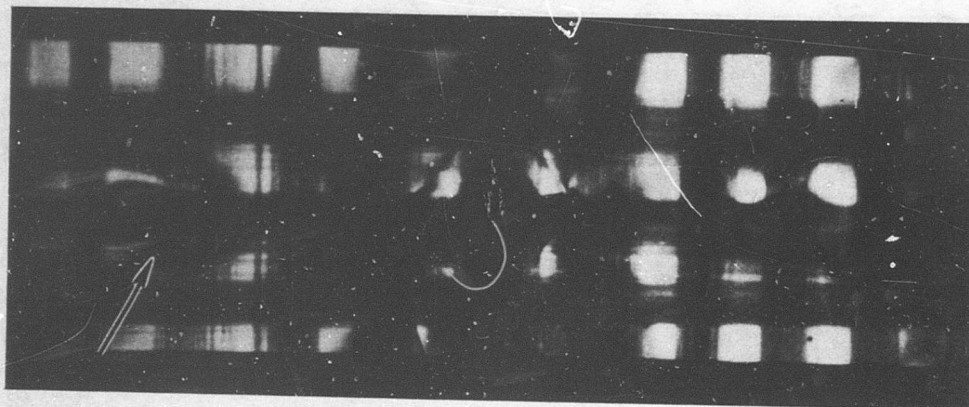
Five 0° - 90° cross-ply fiberglass-reinforced specimens were subjected to axial tension to failure. Fracture generally took place more slowly than in the 0° specimens. Selected frames from a 70-mm film strip (taken with a Holcher camera operating at 20 frames per second) are shown in Figure 3. The series of pictures shows a sequence of failure propagation over a 0.5-second time interval. Two curved cracks (A), located on each side of the eventual failure surface, can be seen together with a small number of stacked, dish-shaped cracks. Note that the stacked cracks are in regions between transverse fiber bundles and are confined by these transverse fibers. A progressive unbonding emanating from the eventual failure surface and propagating away from this surface can be observed. Arrows in these pictures point to the fringe pattern caused by the unbonding.

Figure 3. Tensile Failure Sequence of 0° - 90° Fiberglass-Reinforced Specimen (3.8X).

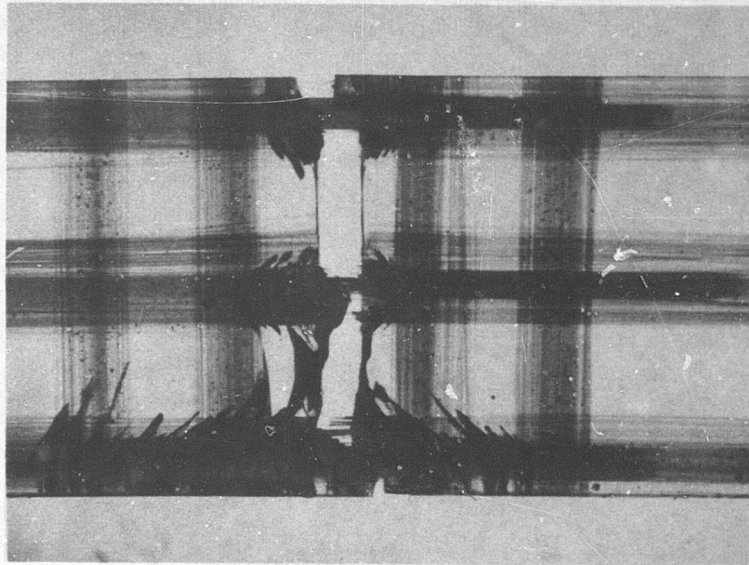
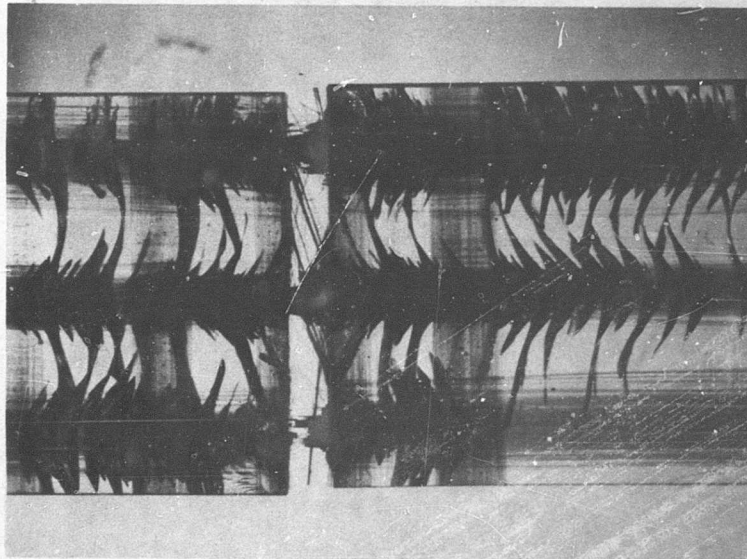
Dish-shaped crack formations were present, to a greater or lesser extent, in all of the 0° - 90° cross-ply specimens tested. Two cases of extensive stacked crack formations are presented in the posttest photographs of Figure 4. Several pertinent observations can be made from these photographs. Here, as in all other stacked crack formations, the dish-shaped cracks are concave toward the main fracture. Also, transverse fibers tend to inhibit the formation of these cracks.

Figure 4. Posttest Details of Stacked Crack Formations in a 0° - 90° Fiberglass-Reinforced Specimen (5.1X).

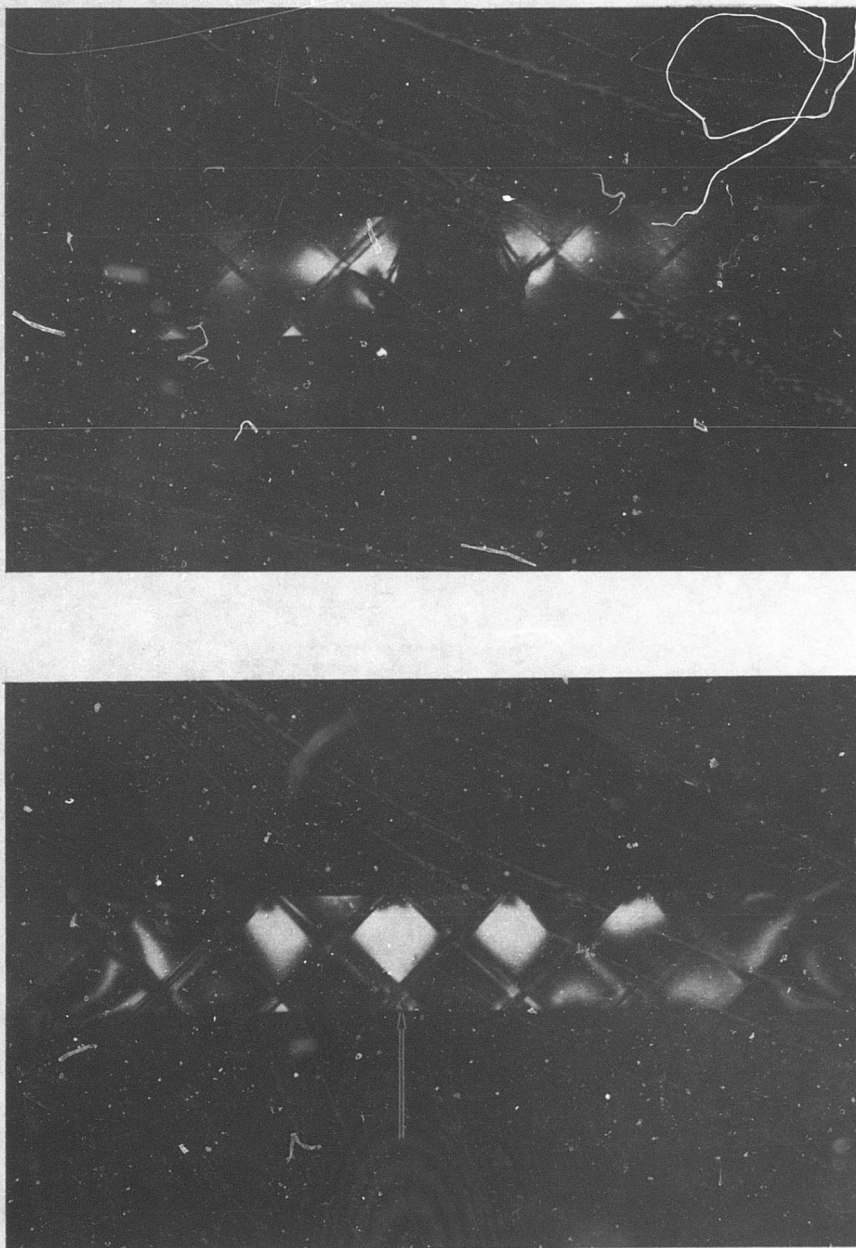
Tensile specimens having glass fiber orientation of $\pm 45^{\circ}$ demonstrated some basically different failure characteristics. Failure always initiated at locations where fiber bundle crossover points were at or near the edge of the specimen (arrow in Figure 5). The basic mechanism of failure was shear along the fibers. This was accompanied by local stacked cracks at the crossover point and some unbonding along the fiber bundles intersecting at the crossover point.

Figure 5. Failure of $\pm 45^\circ$ Cross-Ply, Fiberglass-Reinforced Tensile Specimen Initiated at Fiber Bundle Crossover (1.4X).

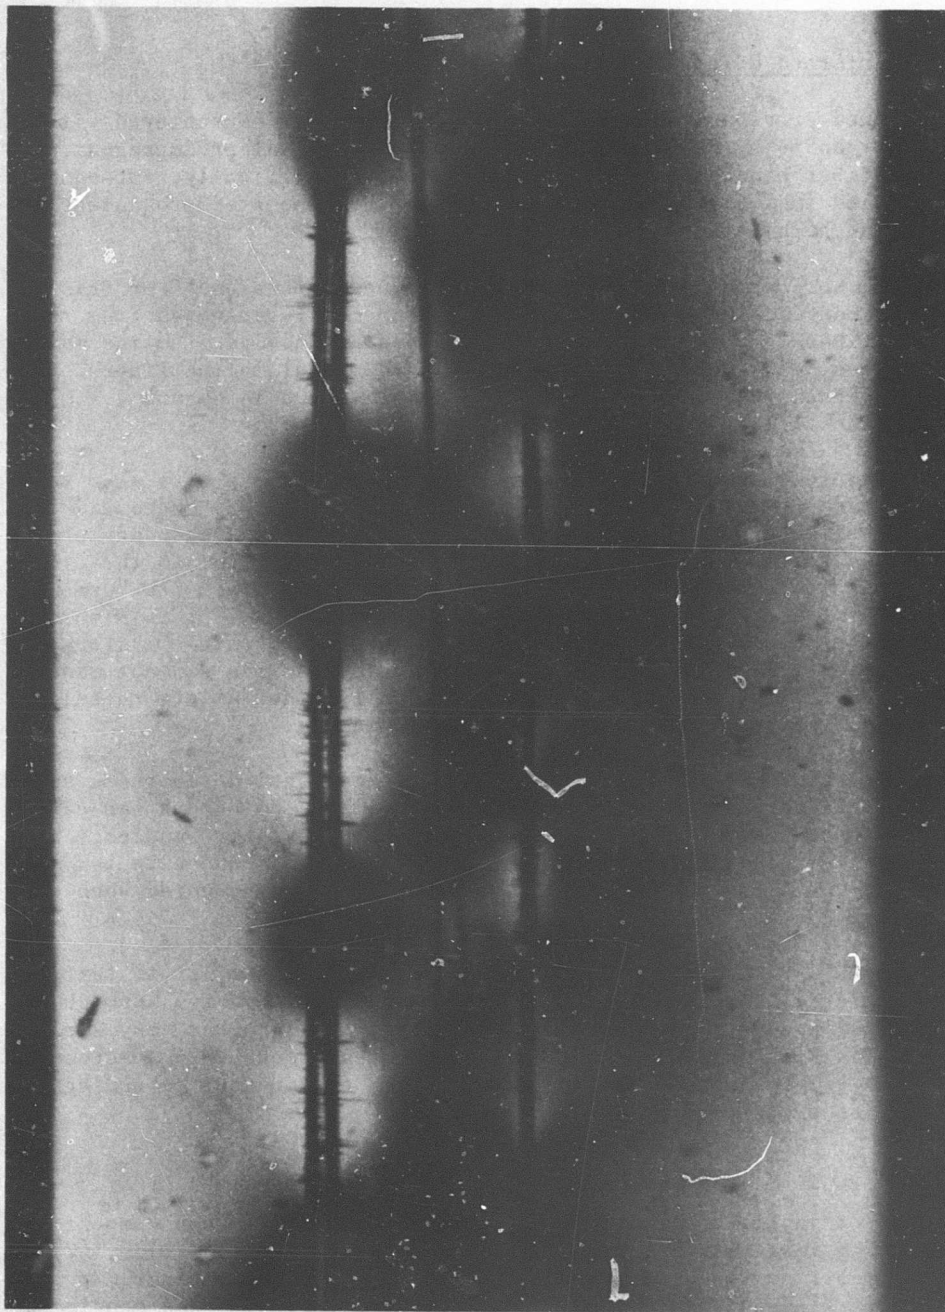
In Figure 6, a Morganite-reinforced specimen is under tension. For this specimen, several individual Morganite fibers were carefully separated from the large tow of fibers. Portions of the fibers became unbonded from the matrix. In these regions, many very fine cracks developed normal to the fibers. A detail of the cracked and uncracked regions is presented in Figure 7. Ultimate failure took place within the grips.

Figure 6. Matrix Cracks in 0° Morganite Tensile Specimen (20X).

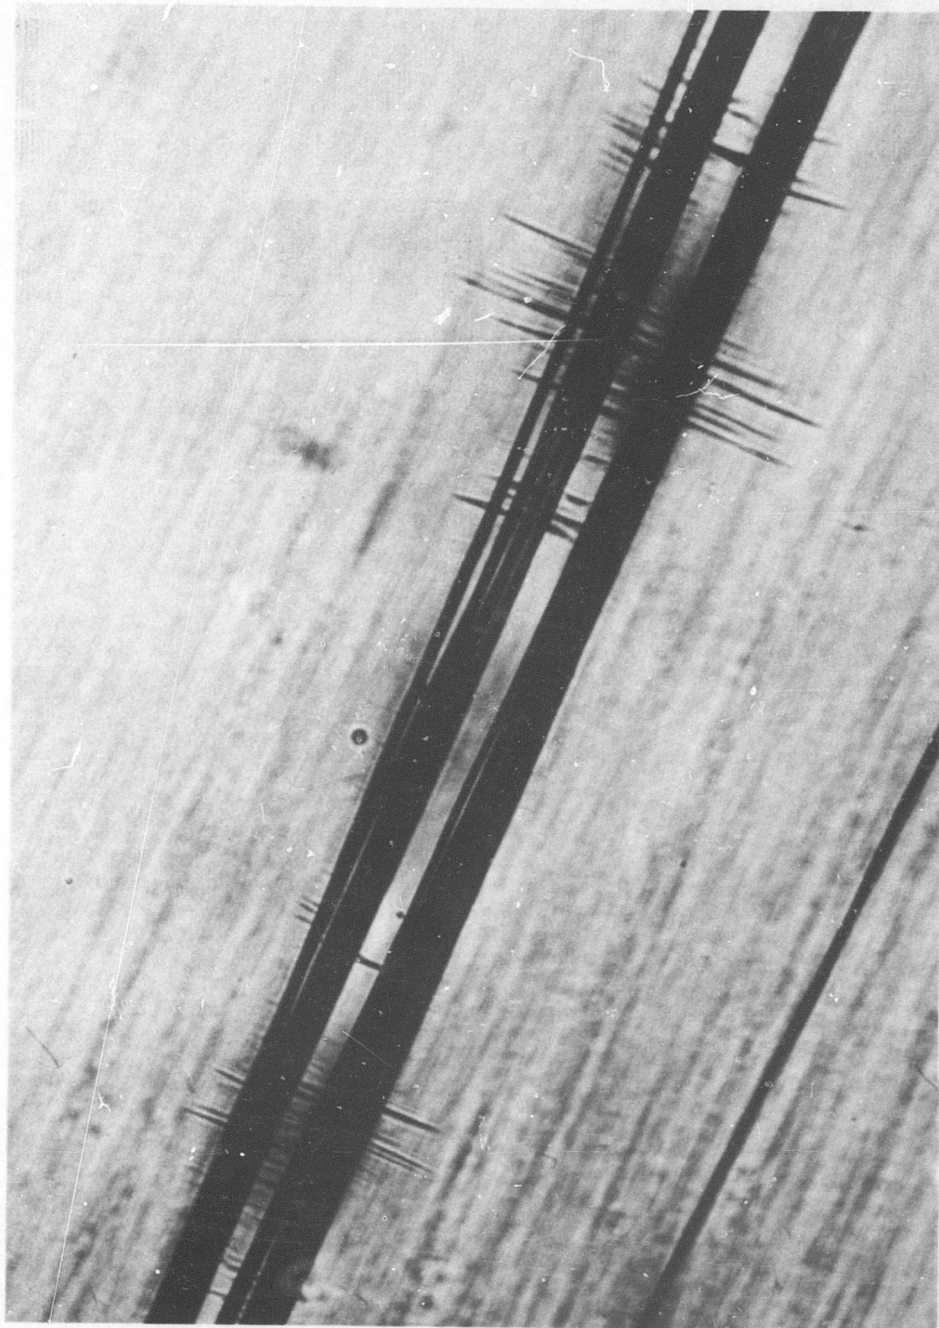
Figure 7. Detail of Matrix Cracks Shown in Figure 6 (100X).

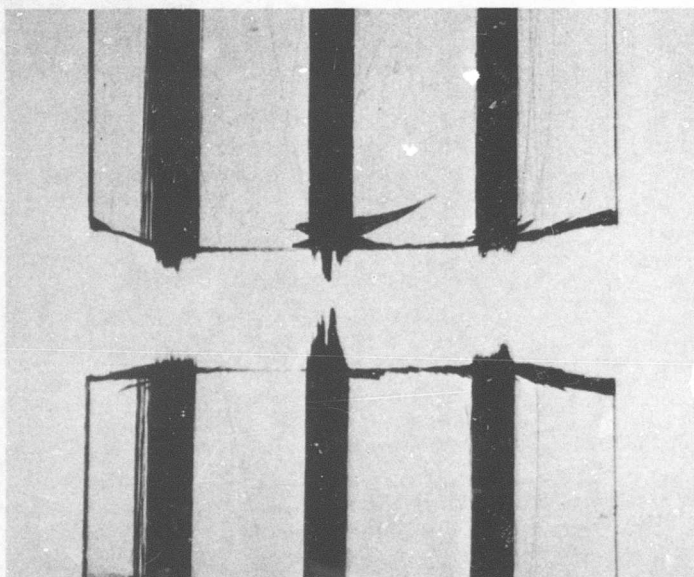
Morganite-reinforced specimens with larger fiber bundle size were also tested. Failures of these specimens were of a brittle fracture type. There was little tendency to form arrays of secondary cracks. Some isolated secondary cracks developed close to the main crack surface. Some were parallel to the fiber and some normal to the fiber. An example is shown in Figure 8 (the crack parallel to the fiber is obscured by the fiber). Fiber pullout is also evident. Posttest examination revealed only a low-order, rather uniform residual stress field. It is to be noted that this specimen was not made with preimpregnated fiber bundles, and examination of the failure revealed that the interior of the bundle had little or no matrix.

Figure 8. Posttest Detail of Morganite-Reinforced Tensile Specimen (6.4X).

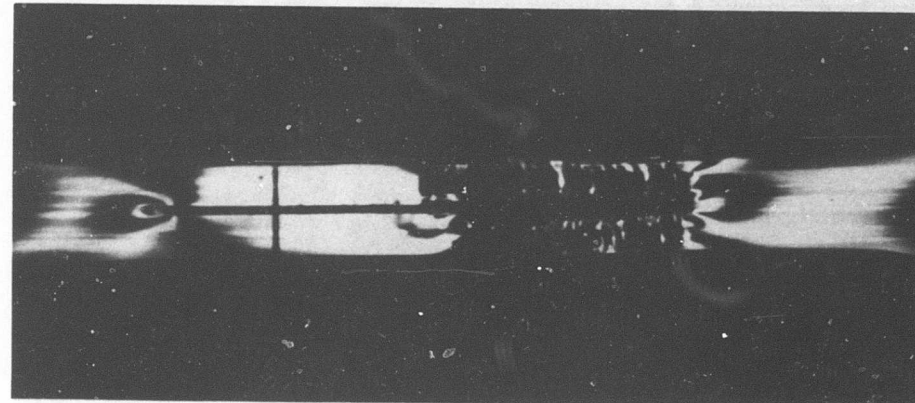
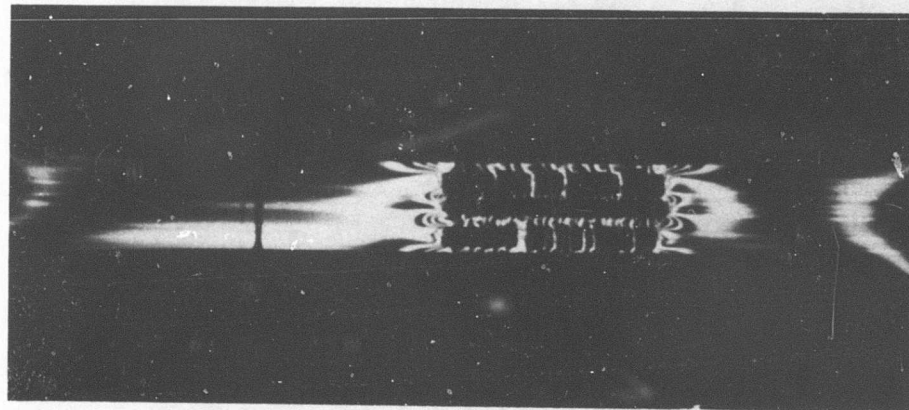
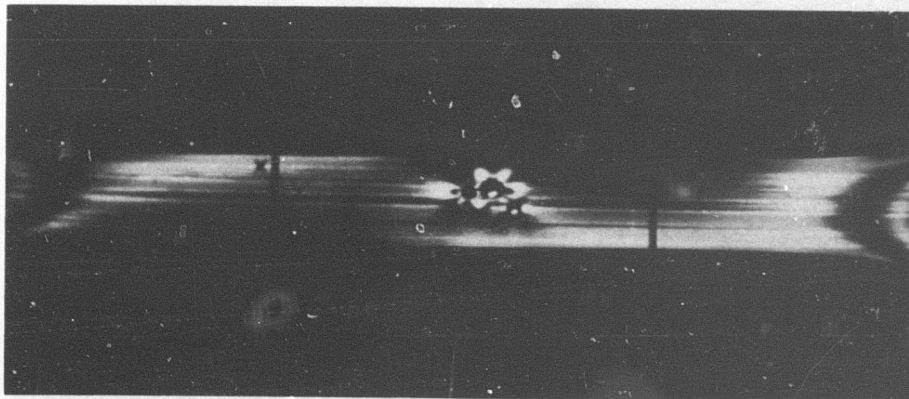
An example of the effects of a cluster of macroscopic bubbles in the vicinity of fiber bundles is presented in Figure 10. A remarkable alteration of the behavioral pattern of 0° fiberglass-reinforced specimens can be observed here. Whereas all previously tested 0° specimens exhibited no stacked crack formations, the specimen presented in Figure 10 developed a very intricate array of stacked cracks. Unbonding of the central fiber bundle occurred after formation of the stacked crack array. An average ultimate stress for three specimens with large voids was 13,360 psi, compared with 18,700 psi for five unfaulted specimens.

Figure 10. Influence of Large Bubbles on Failure of Fiberglass-Reinforced Tensile Specimen (1.1X).

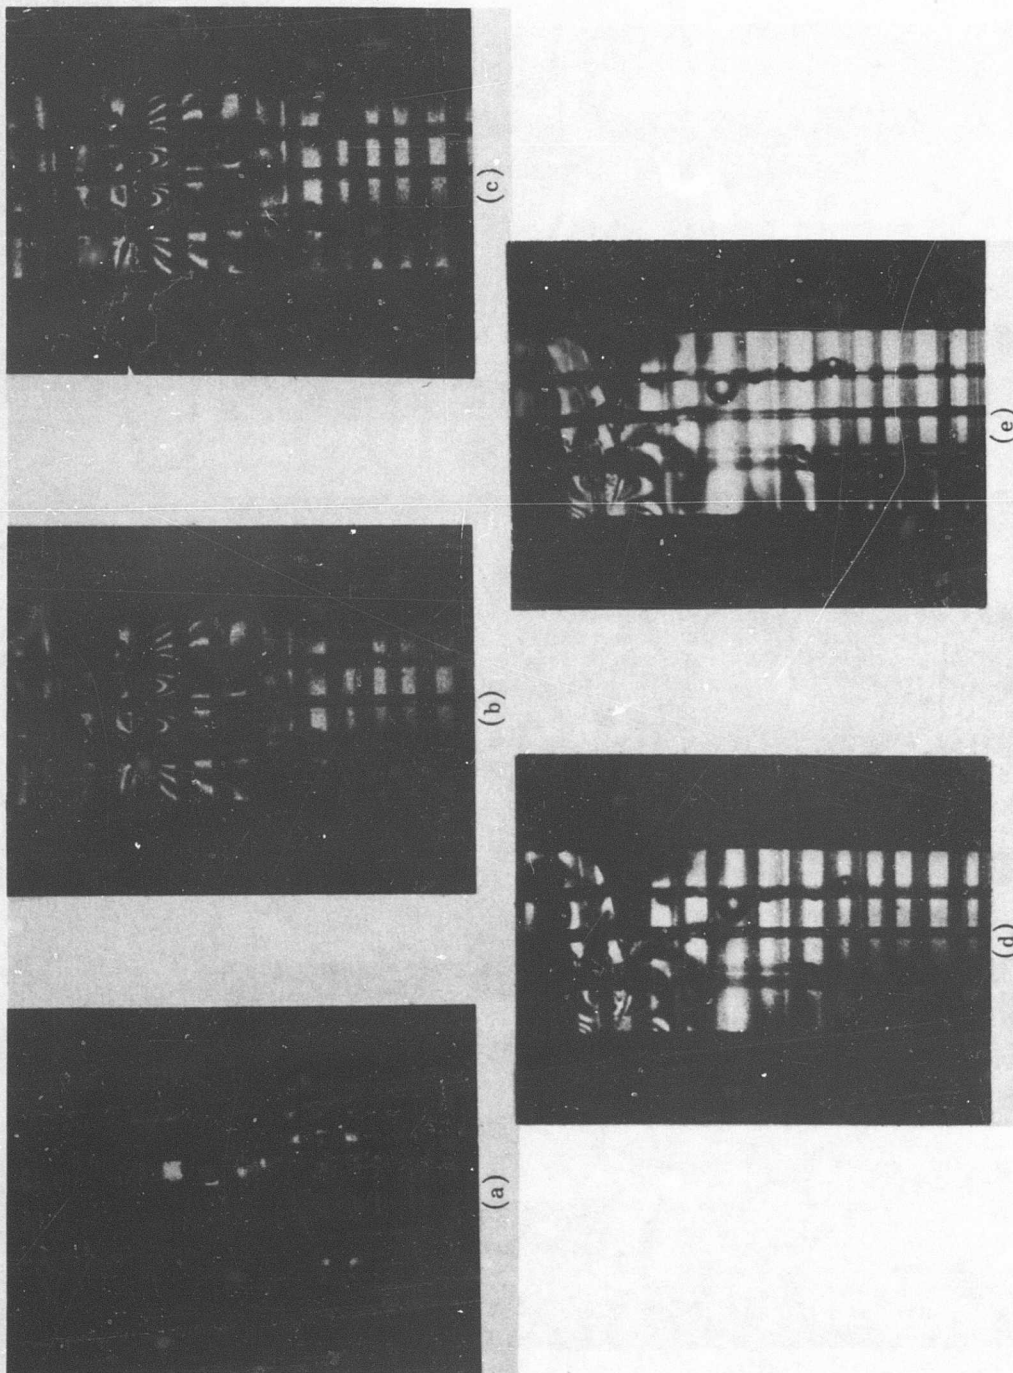
Initial flaws did not appear to alter the behavior of the 0° - 90° glass-reinforced specimens. An example of this is presented in Figures 11 and 12. This specimen contained clusters of bubbles, some of which were quite large. Failure initiated at the edge of the specimen at a transverse fiber bundle. Little difference could be seen between the ultimate stresses in 0° - 90° specimens with flaws (voids, cut and contaminated fibers) and those without flaws. In every case, failure initiated at transverse fiber bundles.

Figure 11. Cross-Ply Fiberglass Uniaxial Tensile Test
(2.2X).

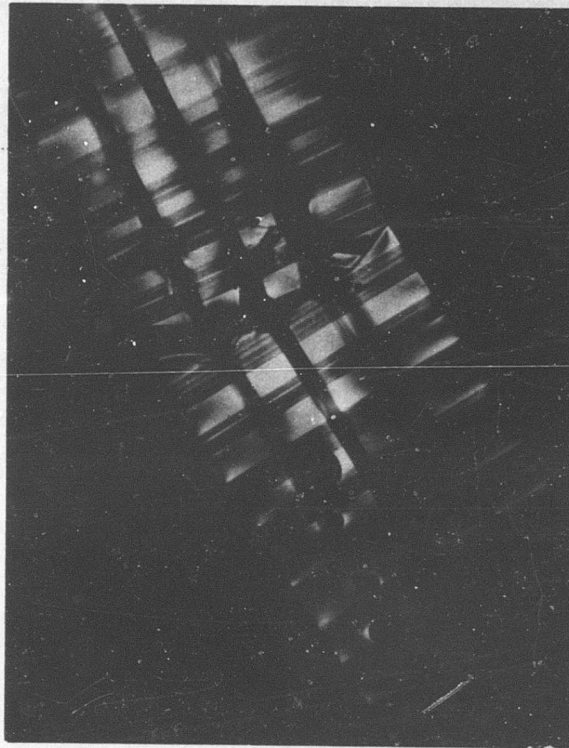
Figure 12. Posttest Closeup of Fiberglass Specimen Shown in Figure 11 (3.4X).

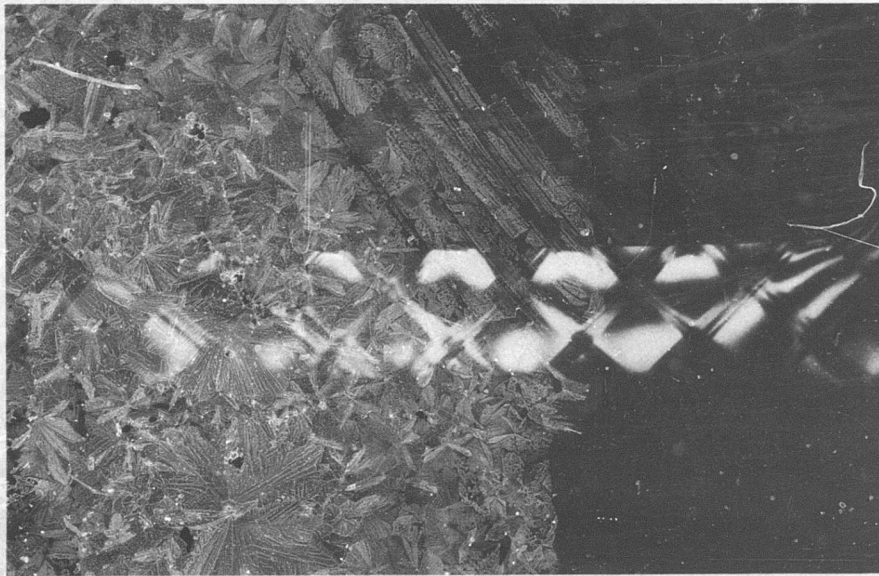
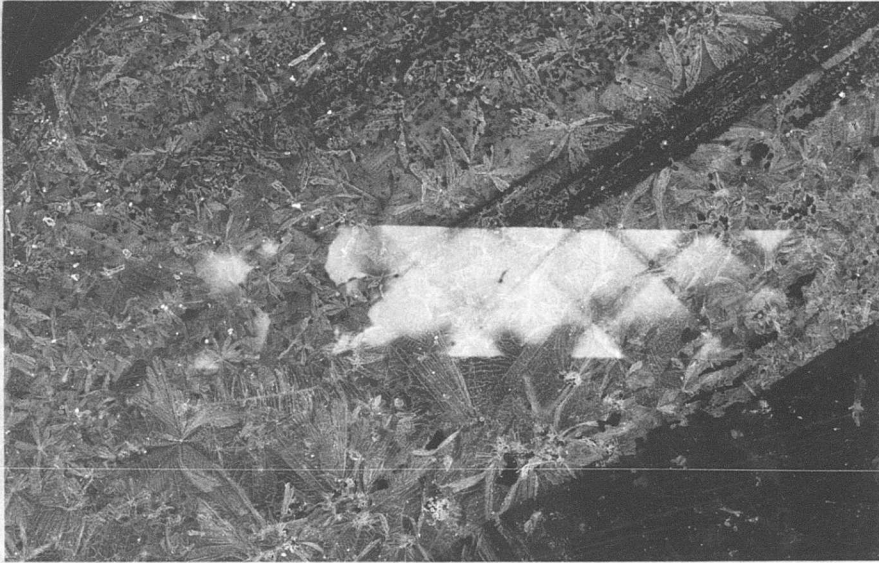
Two specimens reinforced with glass fibers at $\pm 45^{\circ}$ and containing bubbles were tested. Both these $\pm 45^{\circ}$ specimens exhibited extreme sensitivity to the presence of voids. Figures 13 and 14 illustrate this significant aspect of composite behavior. Failure was a shear type and was accompanied by local stacked cracks at crossover points and some unbonding away from the crossover points.

Figure 13. Failure Initiated by Bubbles in $\pm 45^\circ$ Cross-Ply, Fiberglass-Reinforced Tensile Specimen (1.6X).

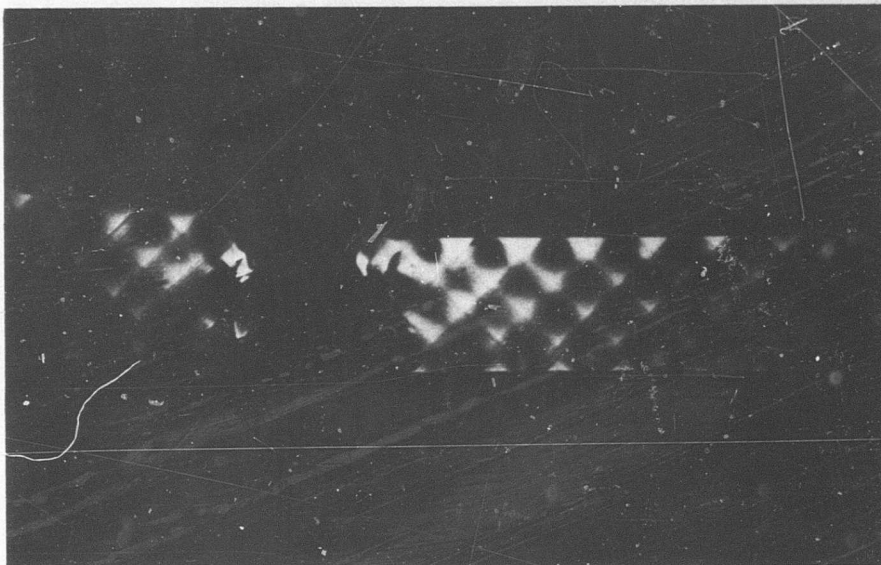
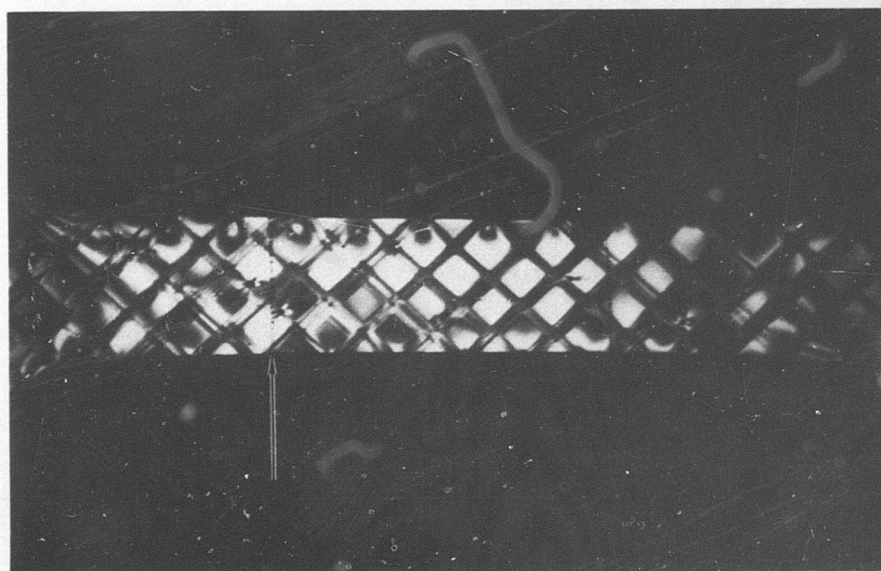
Figure 14. Failure Initiated by Bubbles in $\pm 45^\circ$ Cross-Ply, Fiberglass-Reinforced Tensile Specimen (1.6X).

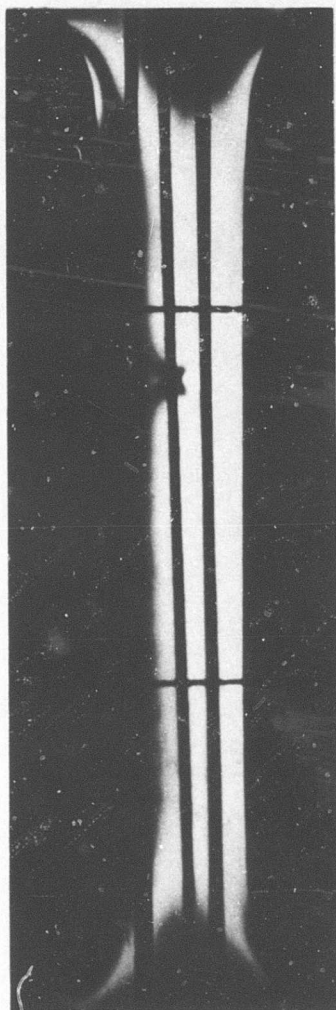
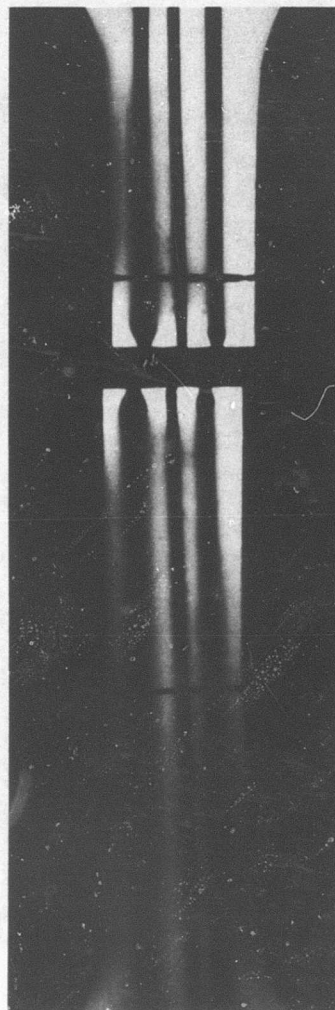
The difficulties encountered in fabrication of Morganite-reinforced composites make assessment of the effects of flaws somewhat inconclusive. However, some observations can be made. In all cases where there were damaged fiber bundles (damage caused by cutting approximately 1/3 fiber bundle), fracture occurred through the damaged fiber site. The concentrated stress pattern seen in Figure 15a is due to the damaged fiber bundle. Figure 15b shows a brittle-type fracture passing through the region of damage. Although there was considerable scatter in the ultimate stress values for the Morganite-reinforced specimens, damaged fiber bundles distinctly reduced the load carrying capacity.

Figure 15. Influence of Damaged Morganite Fiber Bundle
On Failure (1.7X).

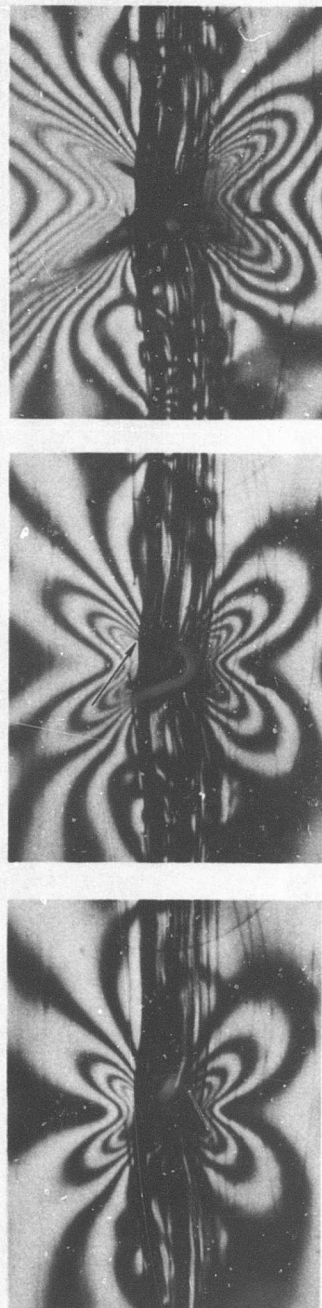
A very interesting crack growth formation was observed in the vicinity of a void in a 0° Morganite-reinforced specimen. Figure 16a shows a stress pattern around the void similar to the classical pattern found around a hole in a plate subjected to tension. The arrow in Figure 16b points to the tip of an advancing crack. Figure 16c shows the fully developed crack curving away from the void. Final specimen failure occurred at the grips. A posttest high-magnification photograph of the void region is presented in Figure 17. Examination under the microscope revealed that there was no fiber fracture in the vicinity of the void or cracks.

Figure 16. Crack Formations Near Void in Morganite-Reinforced Tensile Specimen (6.6X).

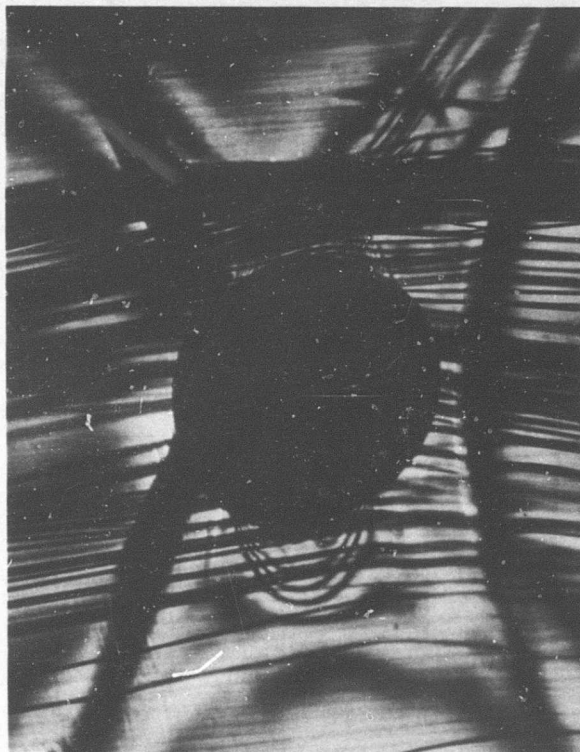
Figure 17. Posttest Detail of Void and Cracks in Morganite-Reinforced Tensile Bar (35X).

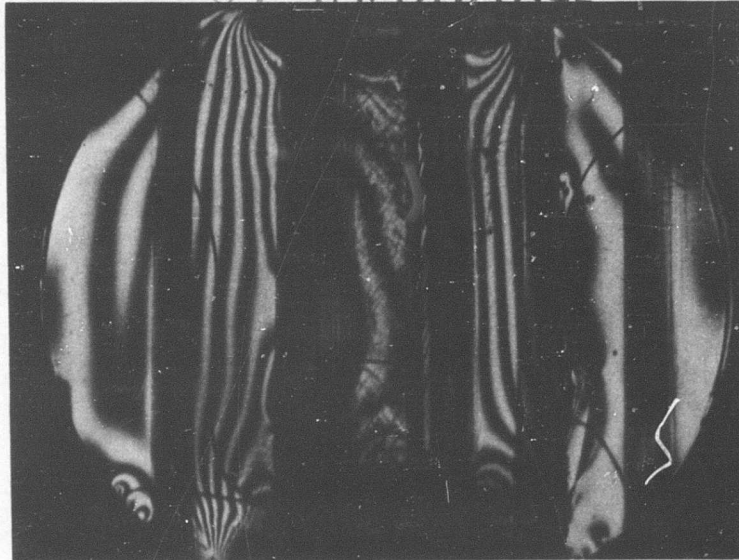
Three unidirectional fiberglass-reinforced disks were tested to failure. As the diametral compressive load was applied to each of these disks, a crazing became apparent toward the center. This crazing was accompanied by a lower rate of load increase (under constant crosshead rate). Further loading resulted in vertical cracks (i.e., perpendicular to the induced tensile stress) through or near fiber bundles. Figure 18 shows a 0° fiberglass-reinforced disk just after failure while still under load. The lack of clarity in the central region of the disk is caused by matrix crazing.

Figure 18. Unidirectional Fiberglass-Reinforced Disk Failing Under Diametral Compression (5.5X).

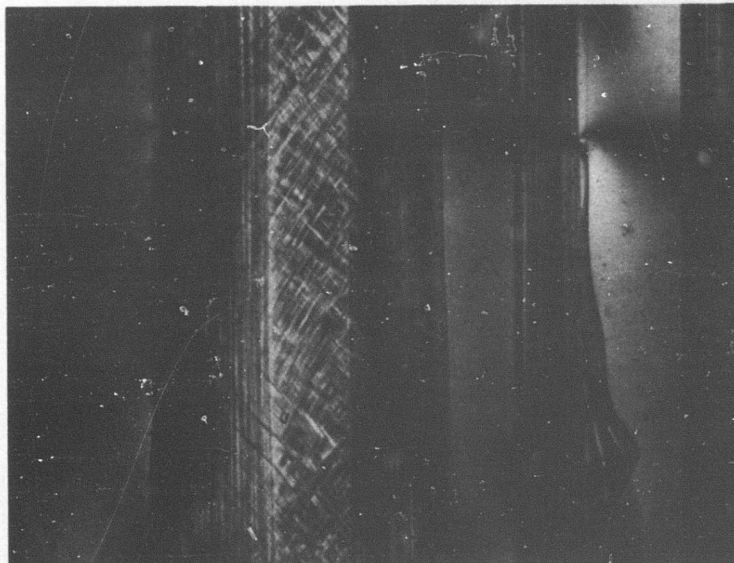
Figure 19. Posttest Detail of Failed Disk (8X).

Figure 19 is a posttest detail of the crazed region. It can be observed in both these photographs that the crazing tends to be confined by the adjacent fiber bundles.

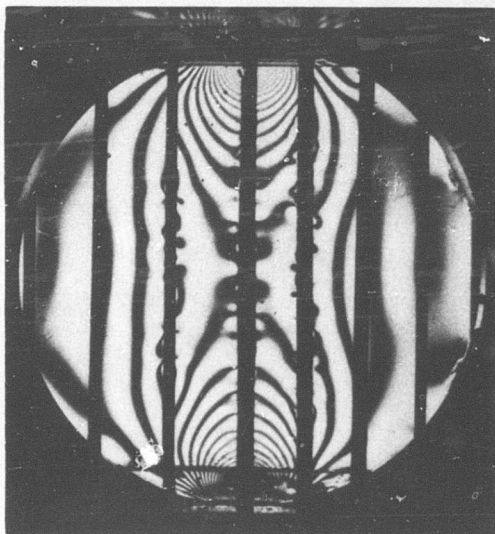
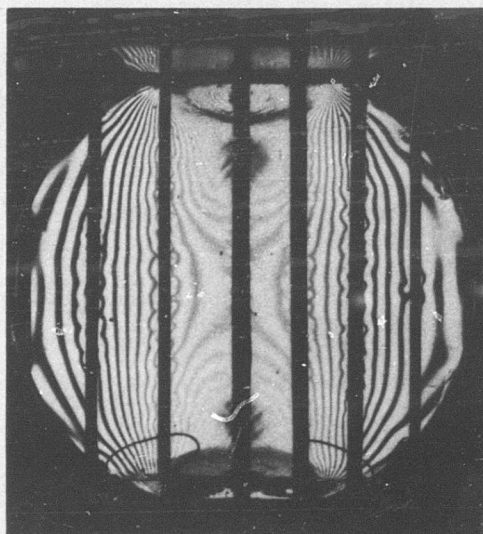
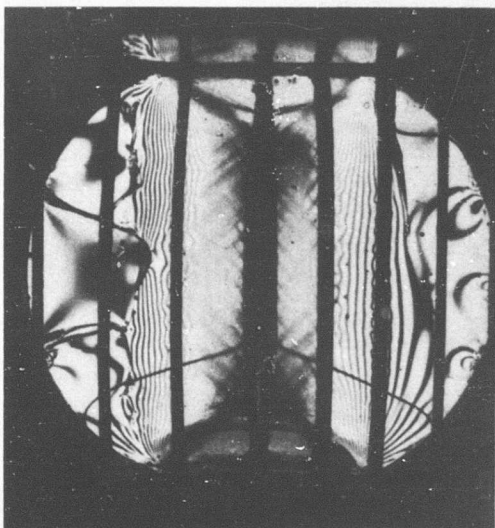
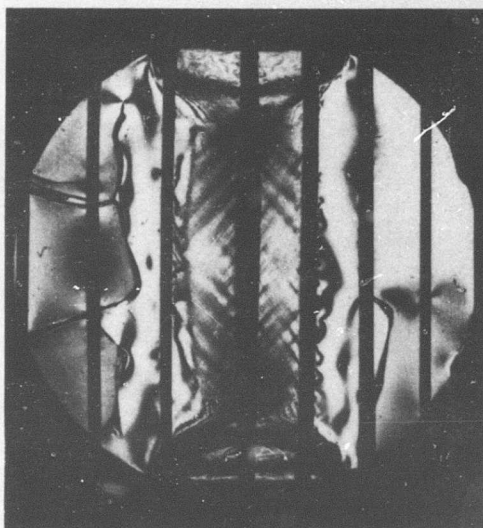
Several aspects of failure in the Morganite-reinforced disks were observed to be different from those in the fiberglass disks. Figure 20 shows the diametral compression of a 0° Morganite-reinforced disk. Some unbonding developed at very low load at the central fiber bundle near the center of the disk. Figures 20a and 20b show fiber bundles away from the central one progressively exhibiting unbonding with increasing compressive load. The crazing phenomenon described above is also apparent in these photographs. It can be seen that the matrix crazing of the Morganite-reinforced disk is much finer than that observed in the fiberglass-reinforced disk. Again, the crazing is confined between the two fiber bundles adjacent to the central one. A large vertical crack finally propagated within the central fiber bundle. Large secondary fractures can be seen at the left in Figures 20c and 20d. Figure 20d is a posttest study made with transmitted, polarized light.

Figure 20. Failure of Unidirectional Morganite-Reinforced Disk Under Diametral Compression (3.7X).

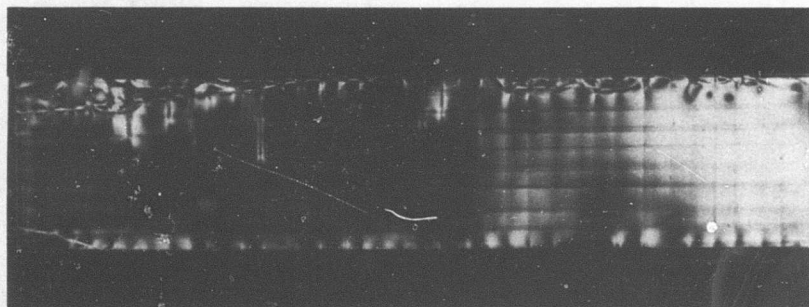
The first biaxial strip test specimen was fiberglass-reinforced with a 0° - 90° fiber orientation. Stainless-steel doublers were bonded to the specimen with epoxy 820 and then bolted. Specimen dimensions between doublers were 5.82 inches by 1.25 inches by 0.085 inch. The specimen and doubler assembly is shown in Figure 21. Testing was performed on an Instron machine. Uniform loading was obtained until a bond failure between the doubler and specimen occurred. Posttest examination revealed that after bond failure the load was unequally distributed among the bolts, resulting in the failure shown in Figure 22.

Even though failure was not achieved in the central gage region, some observations can be made about a propagating crack in the 0° - 90° fiber configuration. The crack propagation trajectory was substantially parallel to the horizontal fiber bundles. Stacked cracks were evident at vertical fiber bundles near the main crack. Also, there was unbonding of several vertical fiber bundles away from the propagating crack.

Figure 22. Posttest Condition of Biaxial Strip Specimen—Circularly Polarized Light (0.8X).

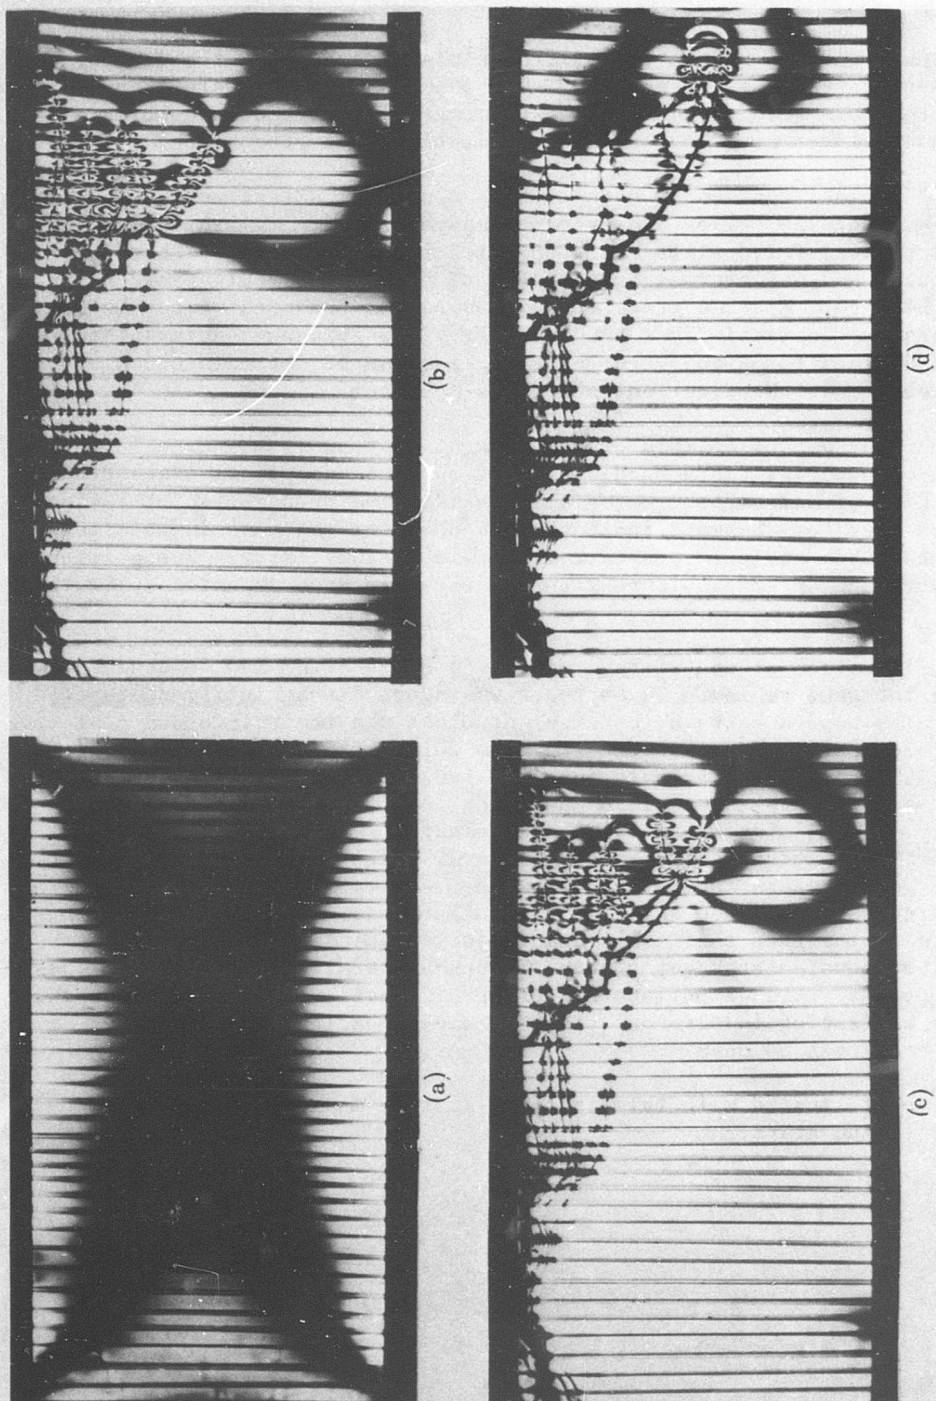
In Figure 23a, the specimen is seen to have a uniform stress pattern in the central region of the plate. However, premature failure initiated in the upper left corner of the plate and propagated toward the right. Loading was continued, and an interesting sequence of photographs (Figures 23b through 23d) was obtained. Stacked crack formations can be observed where the many cracks cross the vertical fiber bundles. Previous evidence (uniaxial tests) that stacked crack formation occurred after passage of the main crack was visually confirmed. No fiber unbonding was apparent.

A very important aspect of this crack propagation test is the crack bifurcations which occur at fiber bundles. Most current analytical crack propagation studies of anisotropic materials consider the propagation of a single crack which does not change direction. The observations made in this test indicate that this analytic approach may be in serious error. Recognition of the importance of crack bifurcation has recently been reported by Smith (Ref. 4).

Figure 23. Failure of Unidirectional Fiberglass-Reinforced Biaxial Tensile Strip (0.76X).

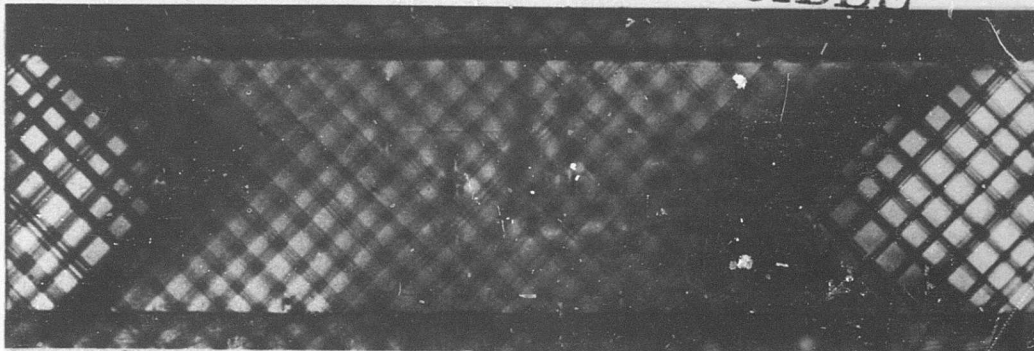
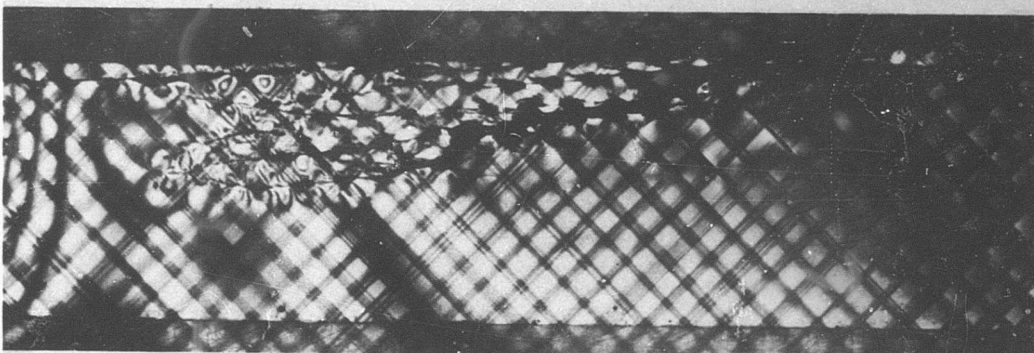
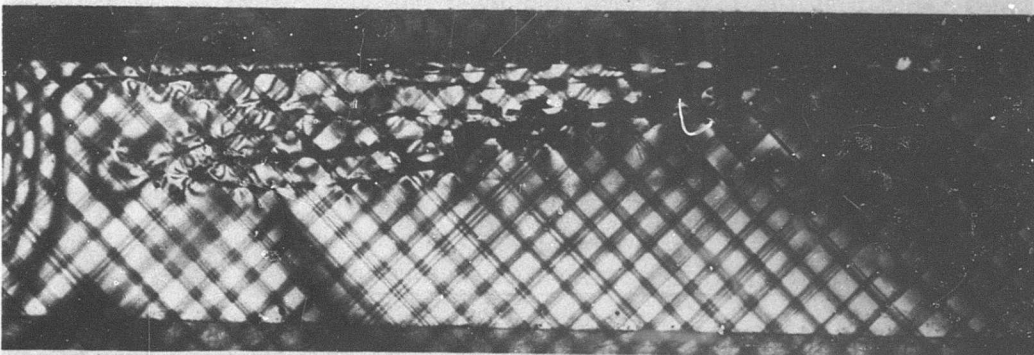
Further modification of end-fixture attachments was attempted to achieve failure in the gage region. An approach was adopted which utilized tapered plastic plates bonded between the steel doublers and the reinforced plate specimen. The entire end assembly was then bolted. Glass fiber-reinforced plates of $\pm 45^{\circ}$ and 0° - 90° orientation were tested using this approach. Figure 24a shows the $\pm 45^{\circ}$ specimen under low load. Channeling of the stresses by the $\pm 45^{\circ}$ fiber orientation is clearly evident in this photograph. Further loading caused a grip failure, which initiated at a bubble within the region where the tapered plastic piece was bonded to the specimen. Loading was continued and complete failure was achieved. Noteworthy in the failure is the fact that the crack trajectories almost invariably passed through fiber bundle crossover points. Stacked cracks were evident at these crossover points. Also important are crack bifurcation and, in some cases, two cracks coalescing to form one crack. Some unbonding away from the advancing crack can be seen.

Figure 24. Failure of $\pm 45^\circ$ Glass-Reinforced Biaxial Strip Specimen (1.6X).

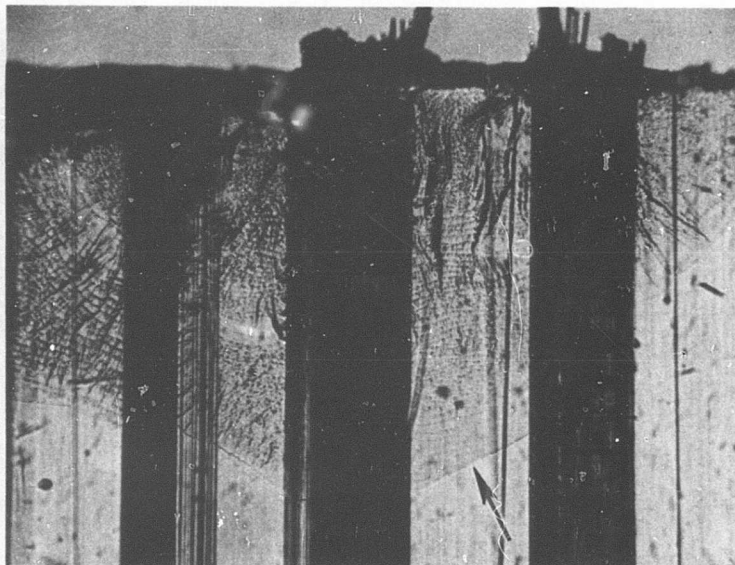
Figure 28. Detail of Fatigue Failure (after 737 cycles) of Unidirectional Glass-Reinforced Composite (50X).
