USAAVLABS TECHNICAL REPORT 69-42

**FLAW POINT AND DYNAMIC
MICROPHOTOELASTICITY INVESTIGATION**

A. A. Caputo

June 1969

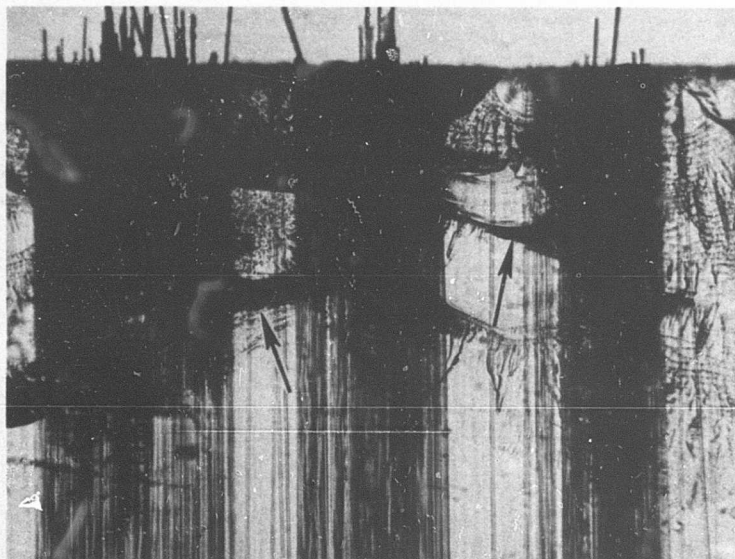
Figure 29 shows another unidirectional glass composite which failed after undergoing only 234 cycles. Although there was some evidence of heating, the effect was not nearly so pronounced as that shown in Figure 28. Larger cracks across the fiber bundles (arrows) extend into the matrix between the bundles. There was no load decay before failure. The difference between the two failure modes could be explained by a difference in temperature rise in the two specimens.

Figure 29. Detail of Fatigue Failure (after 234 cycles) of Unidirectional Glass-Reinforced Composite (50X).

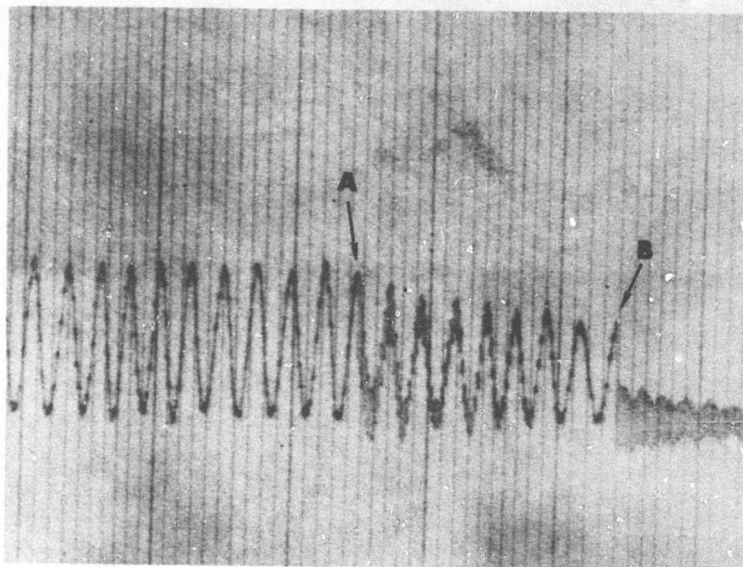
Cross-ply (0° - 90°) specimens were tested: fracture occurred much more slowly, and was usually accompanied by several cycles of decreasing load. In Figure 30, a portion of a load-time oscillograph trace is reproduced which illustrates the load decay. The first cycle of decreased load is at A, and fracture occurred at B. Fatigue failure of all 0° - 90° specimens was associated with transverse fiber bundles. A 0° - 90° cross-ply specimen which fractured into three pieces (A, B, and C) is shown in Figure 31. Some stacked cracks accompanied this failure, although they are not nearly so closely spaced as those observed in the static test series.

Figure 30. Portion of Load-Time Oscillograph Trace of 0°-90° Specimen Showing Load Decay Before Failure.

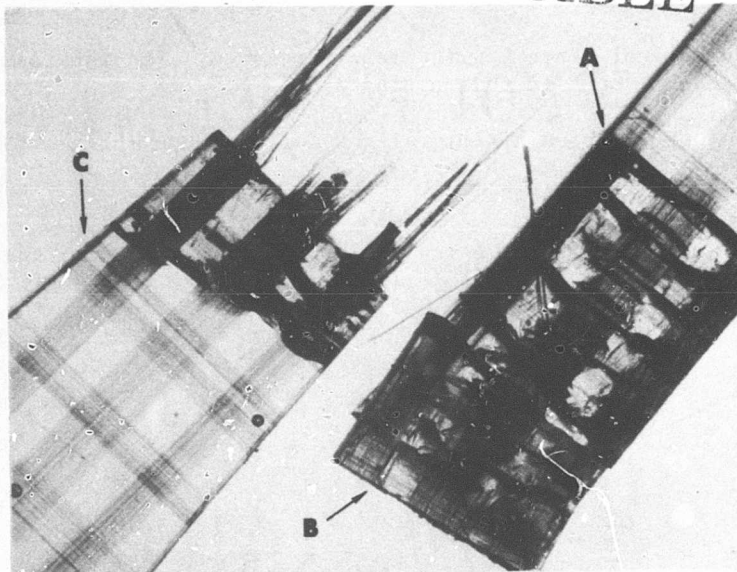
Figure 31. Fatigue Failure of Cross-Ply Glass-Reinforced Composite (12X).

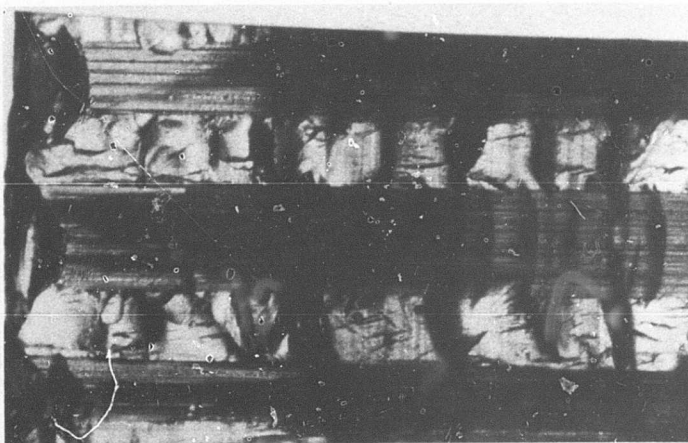
Figure 32. Detail of Fatigue Failure of Cross-Ply Glass-Reinforced Composite (23X).

Figure 32 is a detail of piece A with piece B removed. The interlaminar fracture surface can be seen in this photograph.
