SUBJECT: Operational Report - Lessons Learned, Headquarters, 520th
Transportation Battalion, Period Ending 30 April 1970

DEPARTMENT OF THE ARMY
HEADQUARTERS, 520TH TRANSPORTATION BATTALION (AM&S) (GS)
APO 96289

SUBJECT: Operational Report - Lessons Learned 520th Transportation Battalion
(AM&S) (GS) Period Ending 30 April 1970, RCS CSFOR-65 (R2)

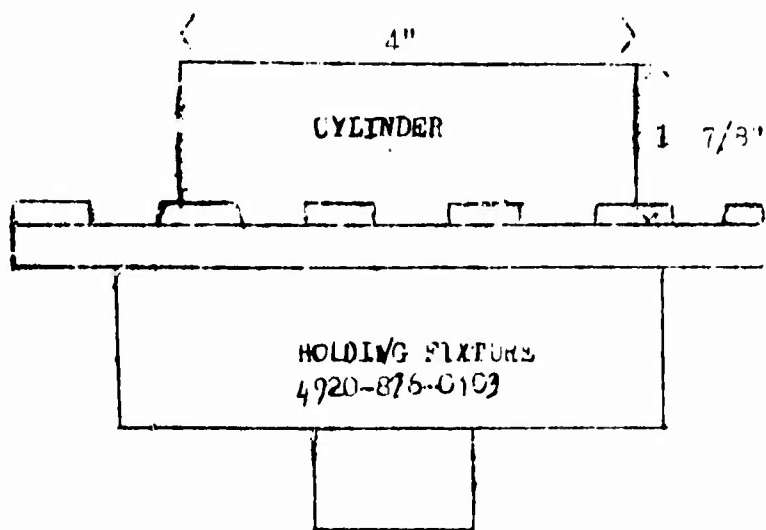
INCL-2

(a) Observation: To assist in the assembly and grease packing of the UH-1 main driveshaft, a modification can be added to the holding fixture (FSN 4920-876-0131). It is placed on top of the holding fixture as shown in the inclosed diagram (Inclosure 2).

(b) Evaluation: The modification is made of aluminum and consists of a cylinder 17/8" high and 4" in diameter. The fixture stabilizes the driveshaft during assembly and also aids in grease retention as it prevents the driveshaft from sliding down into the coupling. During periods of storage the cylinder is left in place to maintain the grease wall of .020-.030 inches above the top of the splines.

UH 1 DRIVESHAFT MODIFICATION

(c) Recommendation: That the described fixture be utilized to stabilize the driveshaft during assembly, and in maintaining the grease wall as required in accordance with TM 55-1520-210-35-2 and TM 55-1520-210-20.
