NOLTR 70-136

DEVELOPMENT, TEST AND EVALUATION OF
THE ROCKET LAUNCHER SAFETY AND ARMING
DEVICE (MLU-53/B)

1 SEPTEMBER 1970

UNITED STATES NAVAL ORDNANCE LABORATORY, WHITE OAK, MARYLAND

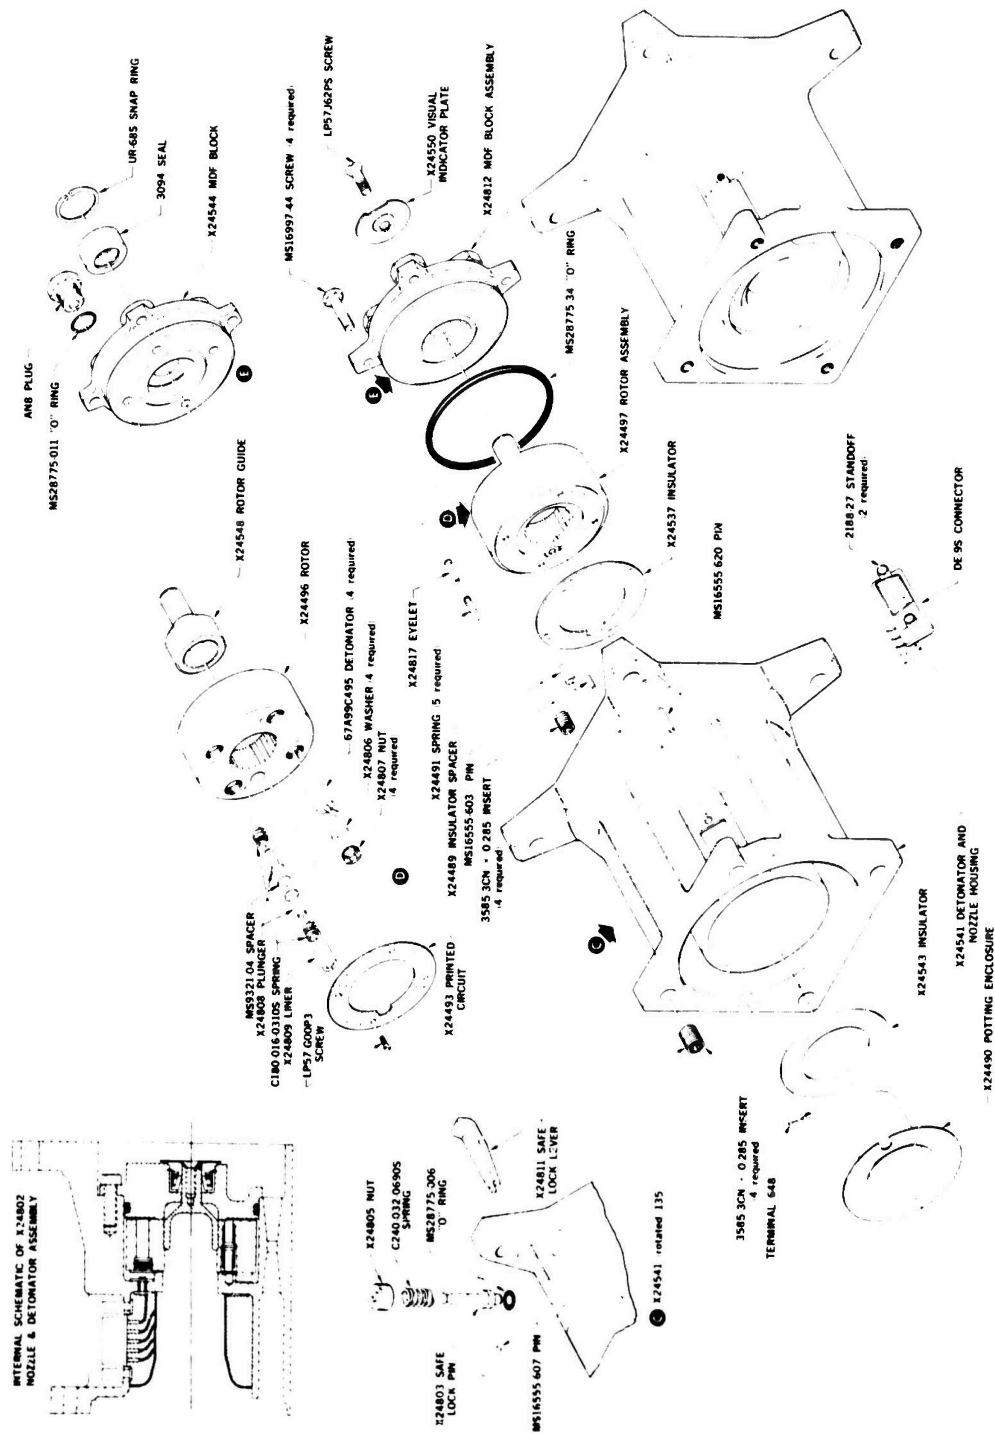
FIG. 13 PHASE II DETONATOR & NOZZLE ASSEMBLY & MDF BLOCK

c. DETONATOR ROTOR AND NOZZLE ASSEMBLY (see Fig. 13). A major redesign was required in the detonator rotor and nozzle assembly as a result of development testing and added functional requirements. A rotary switch replaced the micro switches, and the mild detonating fuze block was relocated to a position coplanar with the aft end of the assembly. Safe lock and inertial lock features were incorporated to insure safe handling of the unit. The entire detonator rotor and rotary switch assembly was sealed to prevent contamination of switch parts. The nozzles were configured into the housing die to eliminate contour milling.

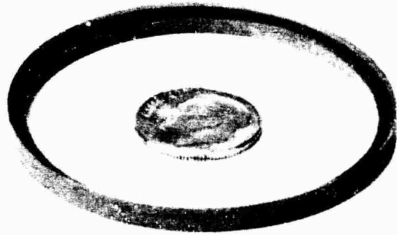
FIG. 24 RULON "J" SEAL RING

b. Contamination of the rotor seal ring by carbonaceous combustion by-products caused severe rotor drag.

48. After the incoming calibration by NOL, all units were modified to reflect design changes (f) and (i) of Table 10. Item (i) was accomplished by removing the steel seal ring and replacing it with a Rulon "J" ring (Fig. 24). Item (f) required milling the surface of the rotor housing thrust face and inserting a steel washer around the rotor shaft to replace the removed material. A retest of all units was performed following modification. Results of the recalibration are given in Figure 28. A further shift downward in the arming speed was apparent from these tests. The disarm speed shifted downward slightly, but was almost the same as shown by the data in Figure 27.
