SUBJECT: Operational Report - Lessons Learned, Headquarters, 520th  
Transportation Battalion, Period Ending 31 July 1970 (U)

DEPARTMENT OF THE ARMY  
HEADQUARTERS, 520TH TRANSPORTATION BATTALION (AM&S) (GS)  
APO 96289

SUBJECT: Operational Report - Lessons Learned 520th Transportation Battalion  
(AM&S) (GS) Period Ending 31 July 1970, RCS CSFOR-65 (R2)

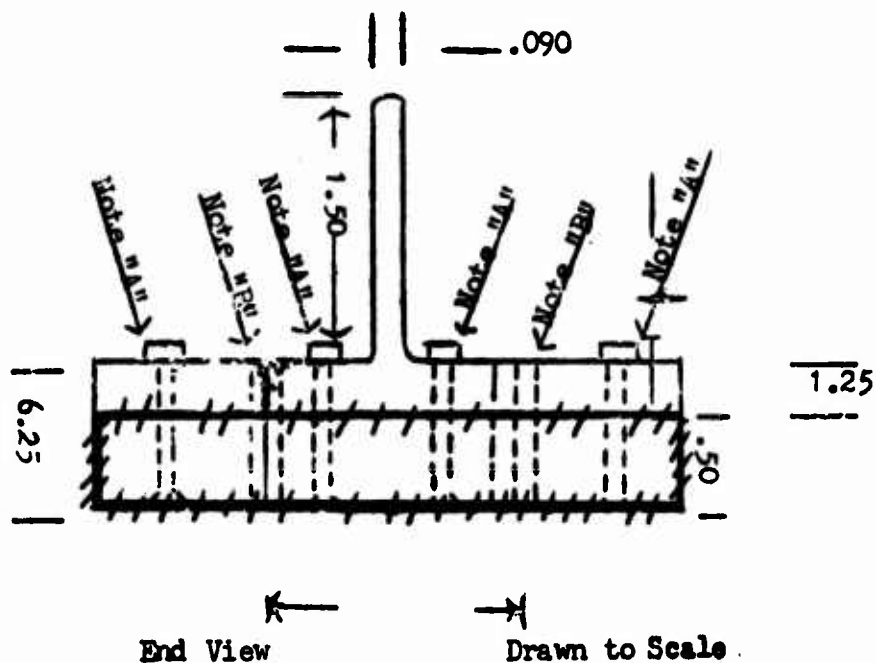
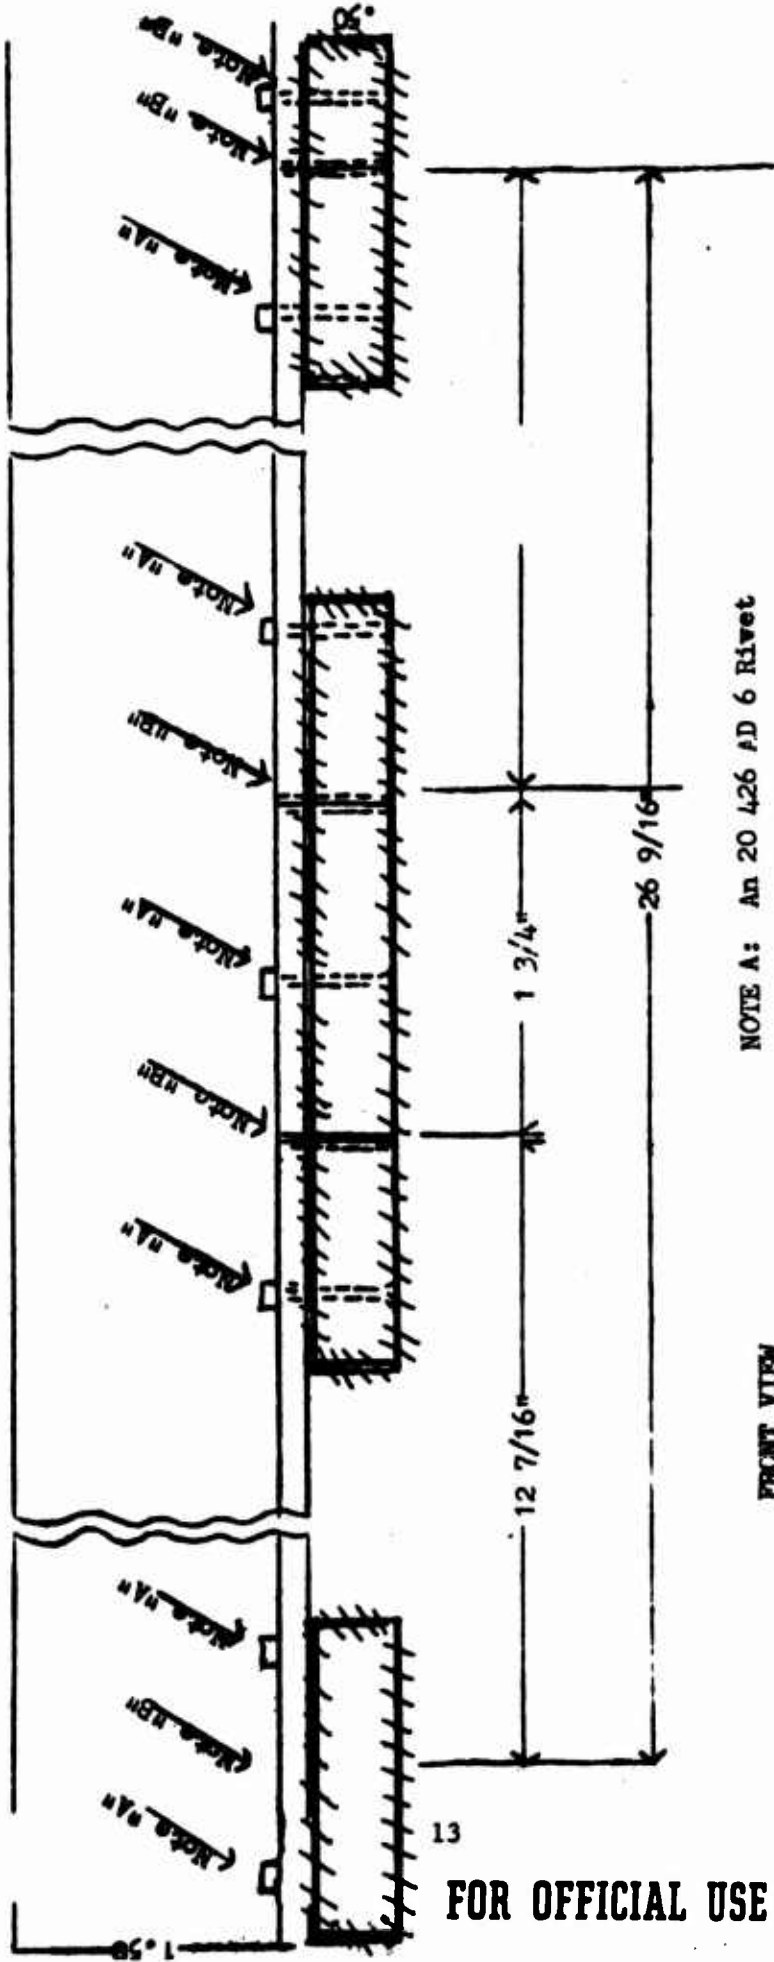
ILLUSTRATION .1

(a) Observation: A locating tool for drilling mounting holes in new center engine decks on UH-1D and H model aircraft should be mounted to the deck to insure proper alignment of the fixture holes. (Incl-1a, 1b)

(b) Evaluation: This tool is used on the inboard leg of the tripod engine mount assembly. It is mounted transversely to the engine deck and  
INCL

bolted to the deck using the right and left rear engine mounting holes located at station 200, LBL13 and RBL13. The center engine mount bolt holes are then drilled using a 1/4" bit. The fixing tool is then removed, and proper installation of the center engine deck can be completed.

The areas outlined in red are  $\frac{1}{2}$  inch spacers rivited to the "T" extrusions to provide clearance for the drain channels mounted on the engine deck.

(c) Recommendation: That the above stated procedures be included as a part of the appropriate TM. A DA Form 2028 has been submitted.

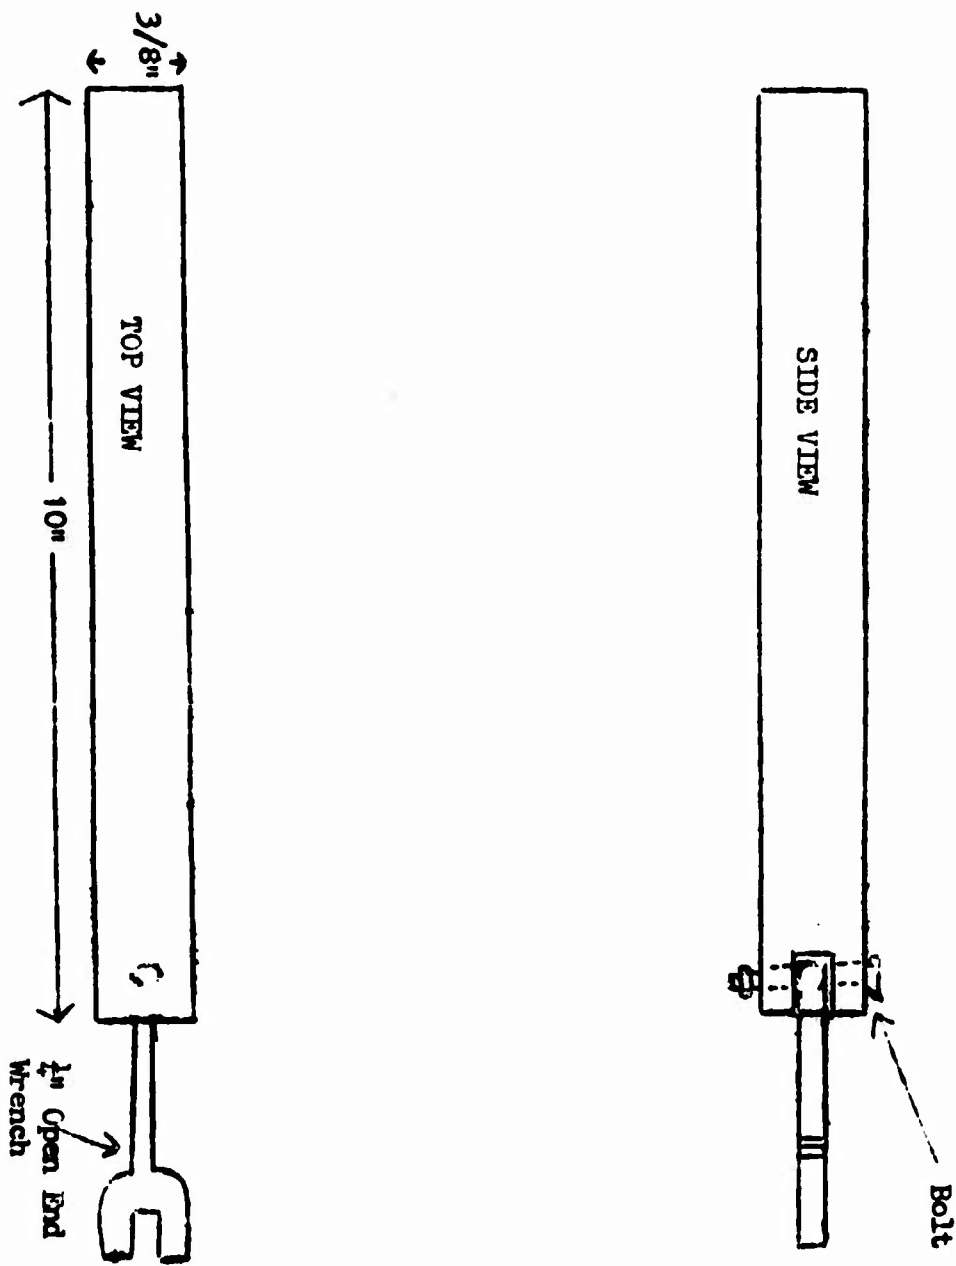
Incl 3

(a) Observation: The special tool (FSN 5120-763-7565, PN 6798292) for adjusting the idle speed on the T63-A and T63-5A Allison engine is not always available.

(b) Evaluation: The special tool listed above may be locally manufactured from a piece of 3/8" round stock cut 10" long and a 1/4" open wrench; Cut the 1/4" open end wrench in half. Slot one end of the 3/8" stock to accept the cut end of the 1/4" wrench and drill a hole through both the stock and wrench. Secure the wrench to the stock with a nut and bolt. (Incl-2). To allow for proper movement insure that the wrench can move freely from side to side.

Adjustment tool for OH-56A idle speed.

(c) Recommendation: That units requiring this tool have their machine shops manufacture a sufficient number to meet their work requirements.
