**COATINGS FOR LIGHTING PROTECTION OF  
STRUCTURAL REINFORCED PLASTICS**

**TECHNICAL REPORT AFML-TR-70-303 Pt. I**

March 1971

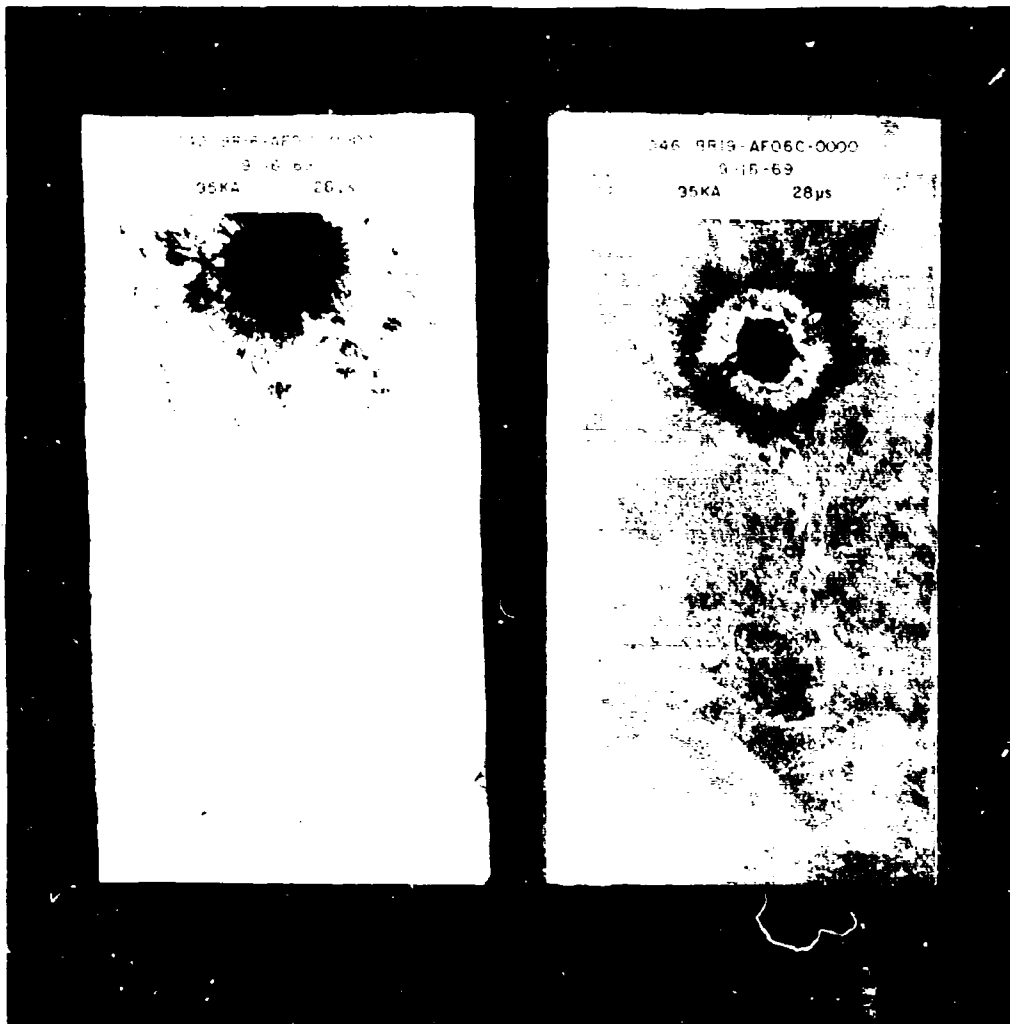
Figure 16. LIGHTNING DAMAGE TO ALUMINUM FOIL COATED BORON EPOXY COMPOSITES

At the discharge level, i.e., 100 KA, the epoxy glass scrim cloth layer offers no additional protection to the composite. This result was also observed in the tests involving a Kapton dielectric layer between the composite and the aluminum foil. Visible damage to the Kapton film undercoat was minimal or nonexistent. The metal foil was able to dissipate the energy of these discharges and prevent current penetration into the boron or graphite fibers.

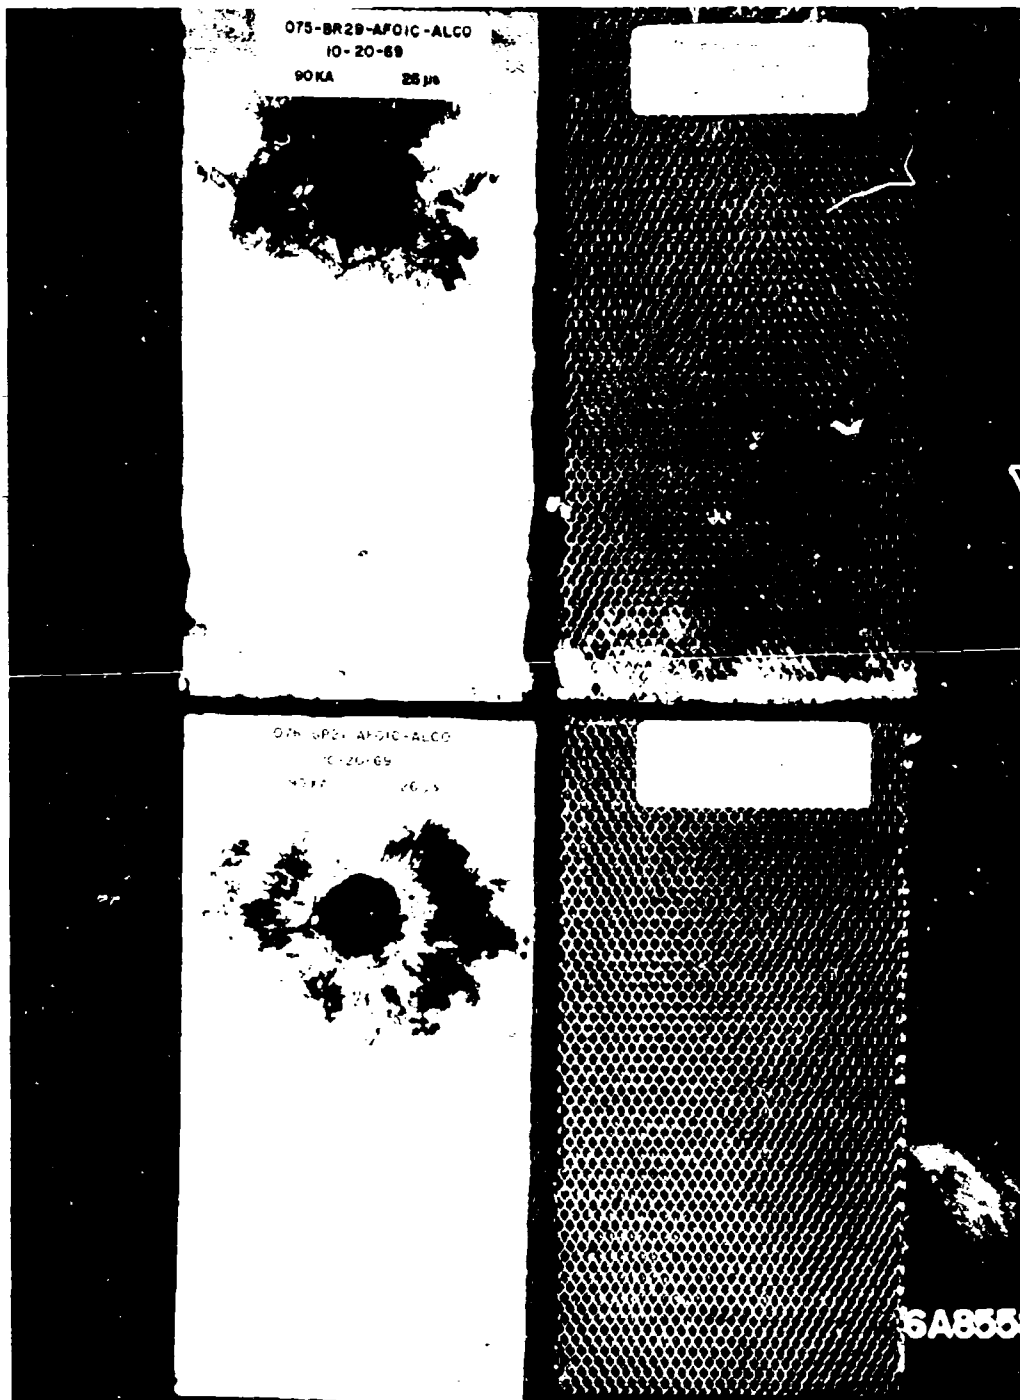
Figure 1. LIGHTNING DAMAGE TO ALUMINUM MESH AND SANDWICH PANEL FACE SHEET

Sandwich panels with aluminum core and boron epoxy or graphite epoxy face sheets are also protected by one mil thick aluminum foil coatings. The test results shown in Figure 21 illustrate that neither the front nor back side received damage when tested with both the coating and the core grounded. The damage to the coating was comparable to that displayed by flat laminates. No damage to the boron or graphite panels was visible to the eye in either case. The aluminum foil can withstand

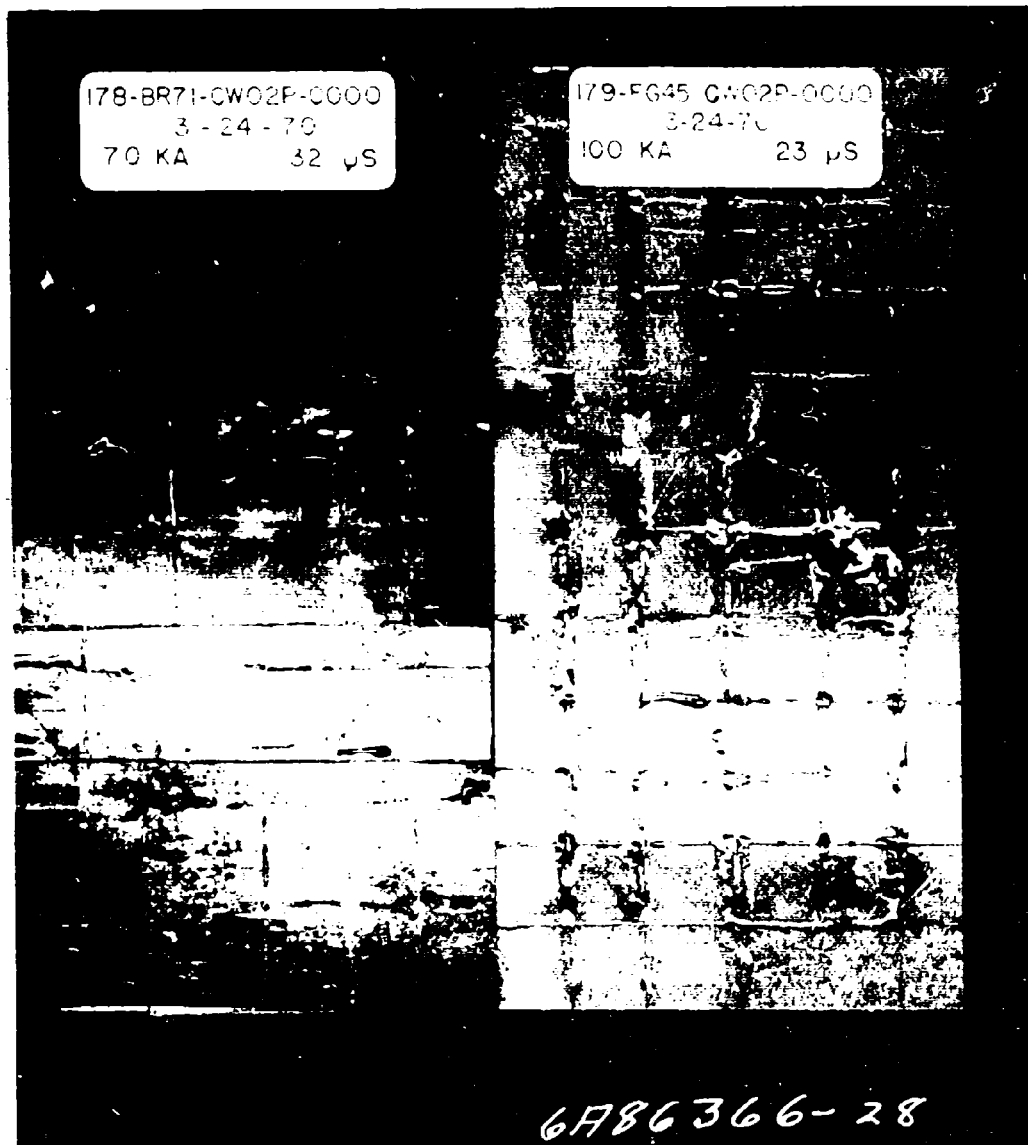
Figure 28 LIGHTNING DAMAGE TO BORON EPOXY AND GLASS REINFORCED CONTROL LAMINATES COATED WITH COPPER WIRES

A glass fiber reinforced panel (No. 179) was coated with copper wires in a similar fashion. Discharge to this panel left many of the wires at the edges still intact, but destroyed the wires as well as their resin binder which were more centrally located (Figure 28). The copper wires were very efficient in their prevention of damage to this panel. The type of behavior observed appears to be a combination of wire conduction coupled with some surface flashover to ground.

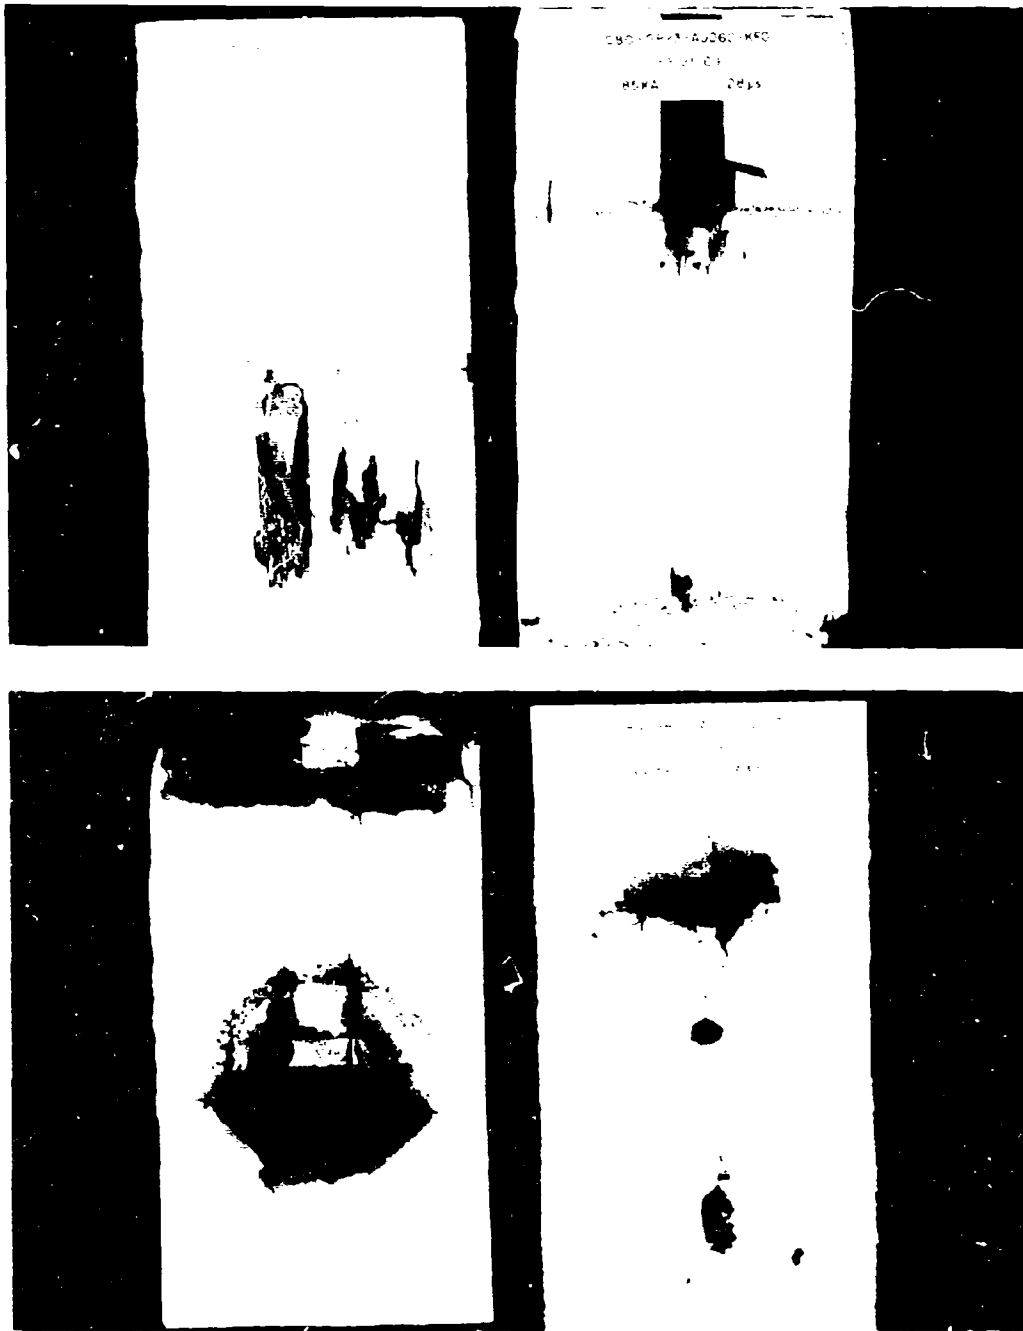
Figure 50 SIMULATED LIGHTNING DISCHARGE DAMAGE TO HIGH MODULUS COMPOSITES COATED WITH ALUMINUM PIGMENTED PAINTS

Conventional aluminum and copper filled paints provided excellent lightning protection for the glass reinforced test panels but poor protection for high modulus composites. These paints provide surface flashover due to their electrical properties; the arc will remain exterior to a panel unless it is guided into or through the substrate by conducting

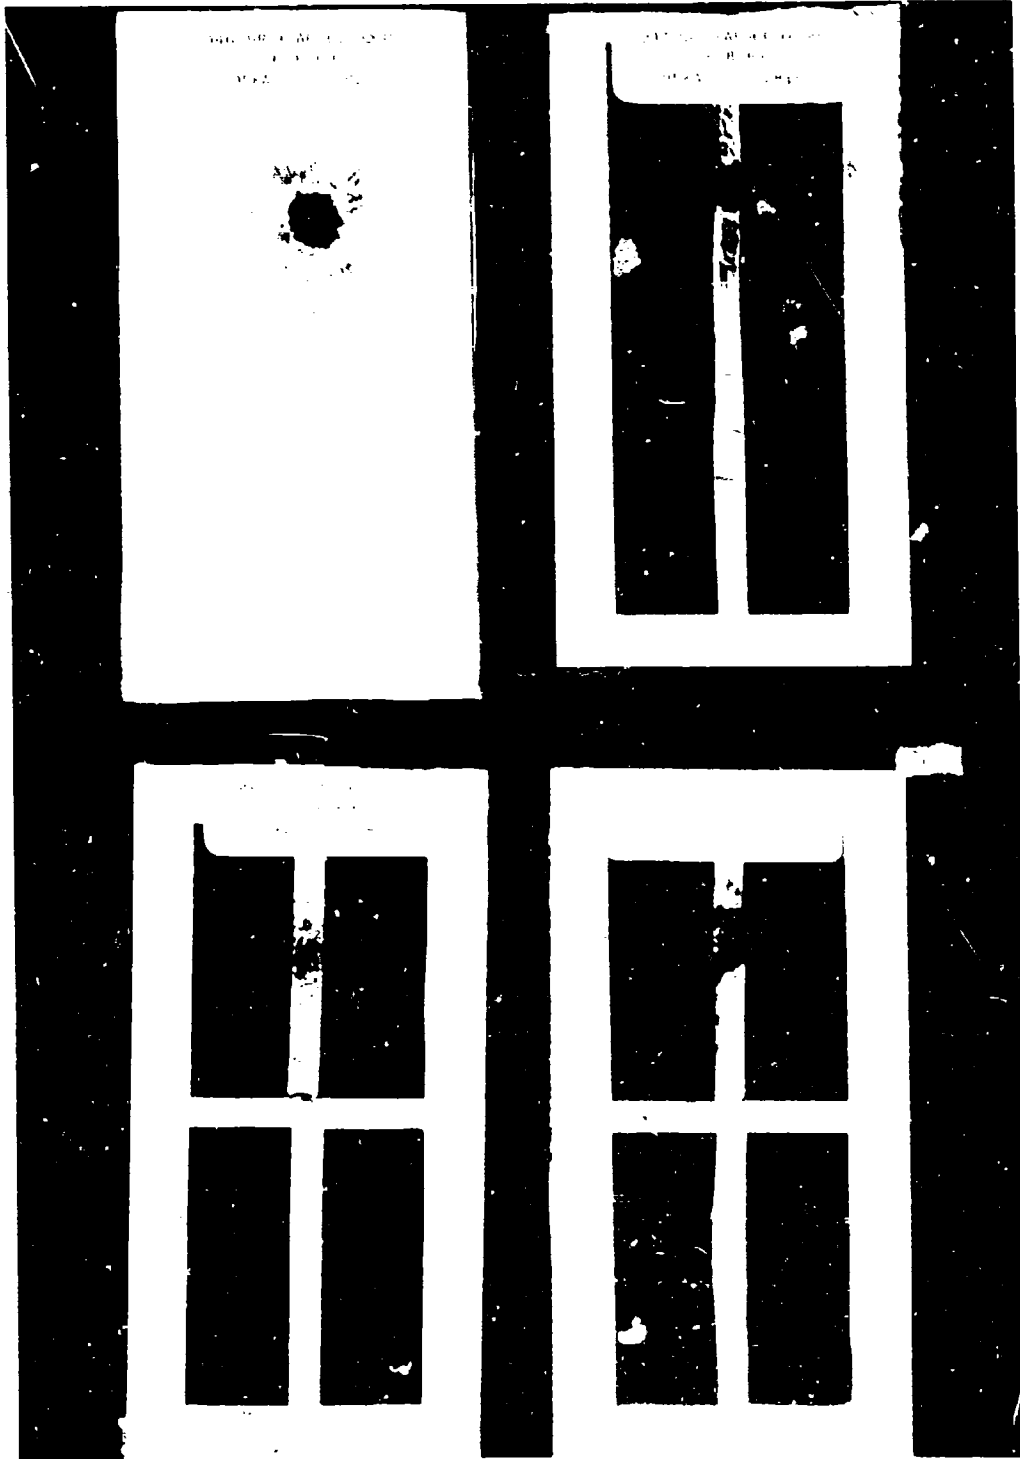
Figure 12

A burned front surface of the substrate was produced and a small crack was observed on the back side of the substrate.

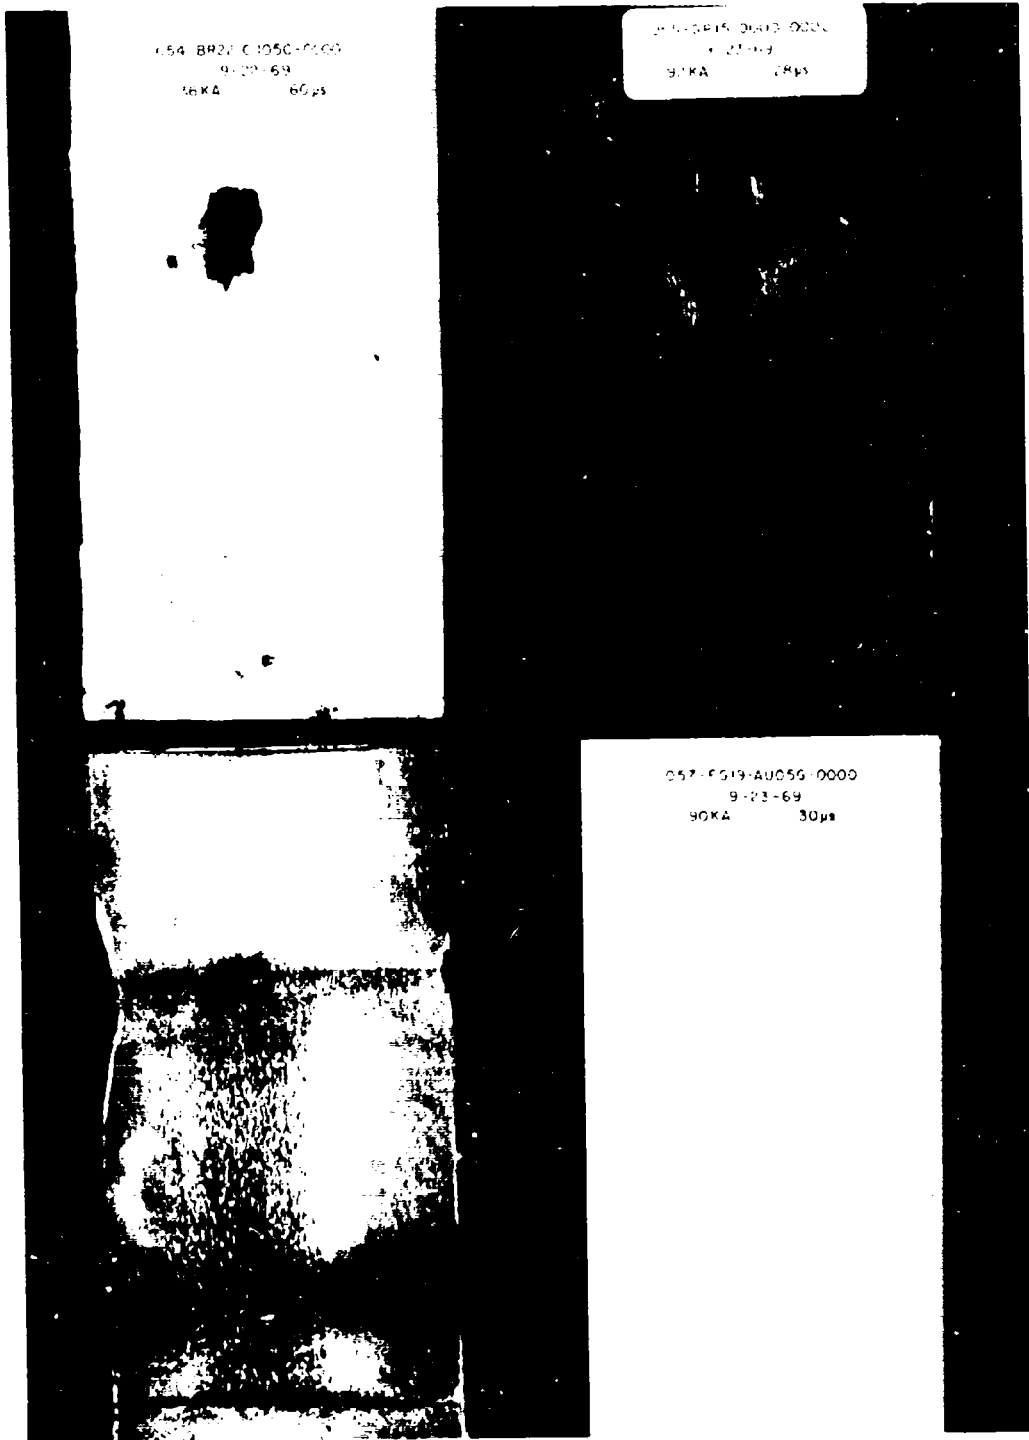
Figure A-14

A small crack was observed on the back side of the substrate, also the coating was badly burned and peeled.

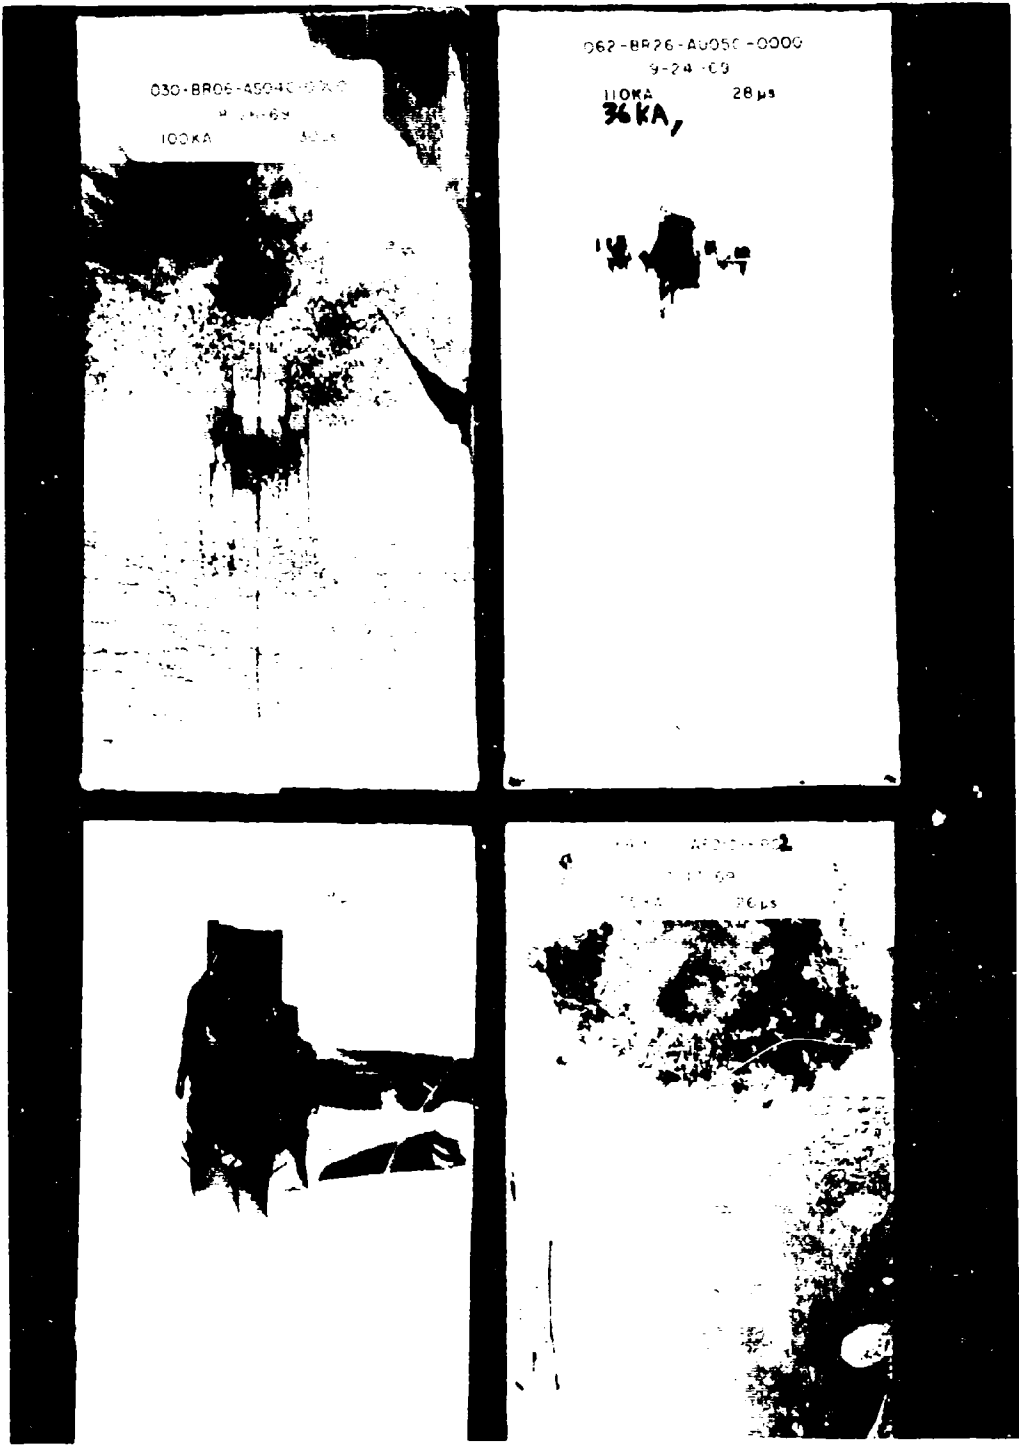
Figure A-16

The substrate was severely damaged.

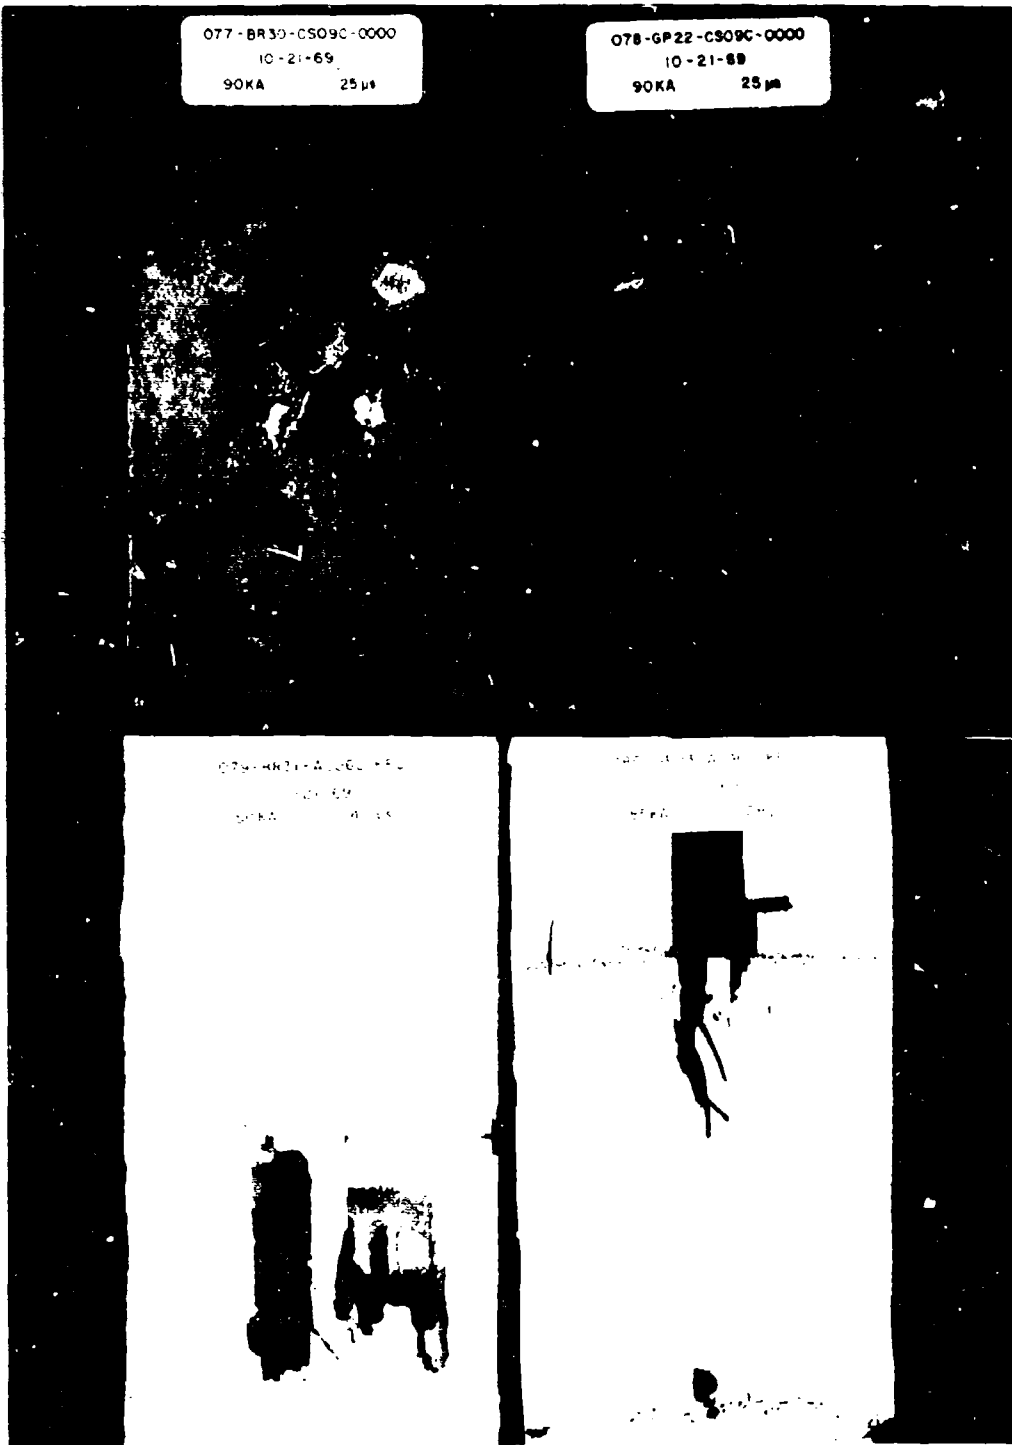
Figure A-20

No damage to the substrate was observed.
