COATINGS FOR LIGHTNING PROTECTION OF STRUCTURAL REINFORCED PLASTICS

TECHNICAL REPORT AFML TR-70-303 PART II

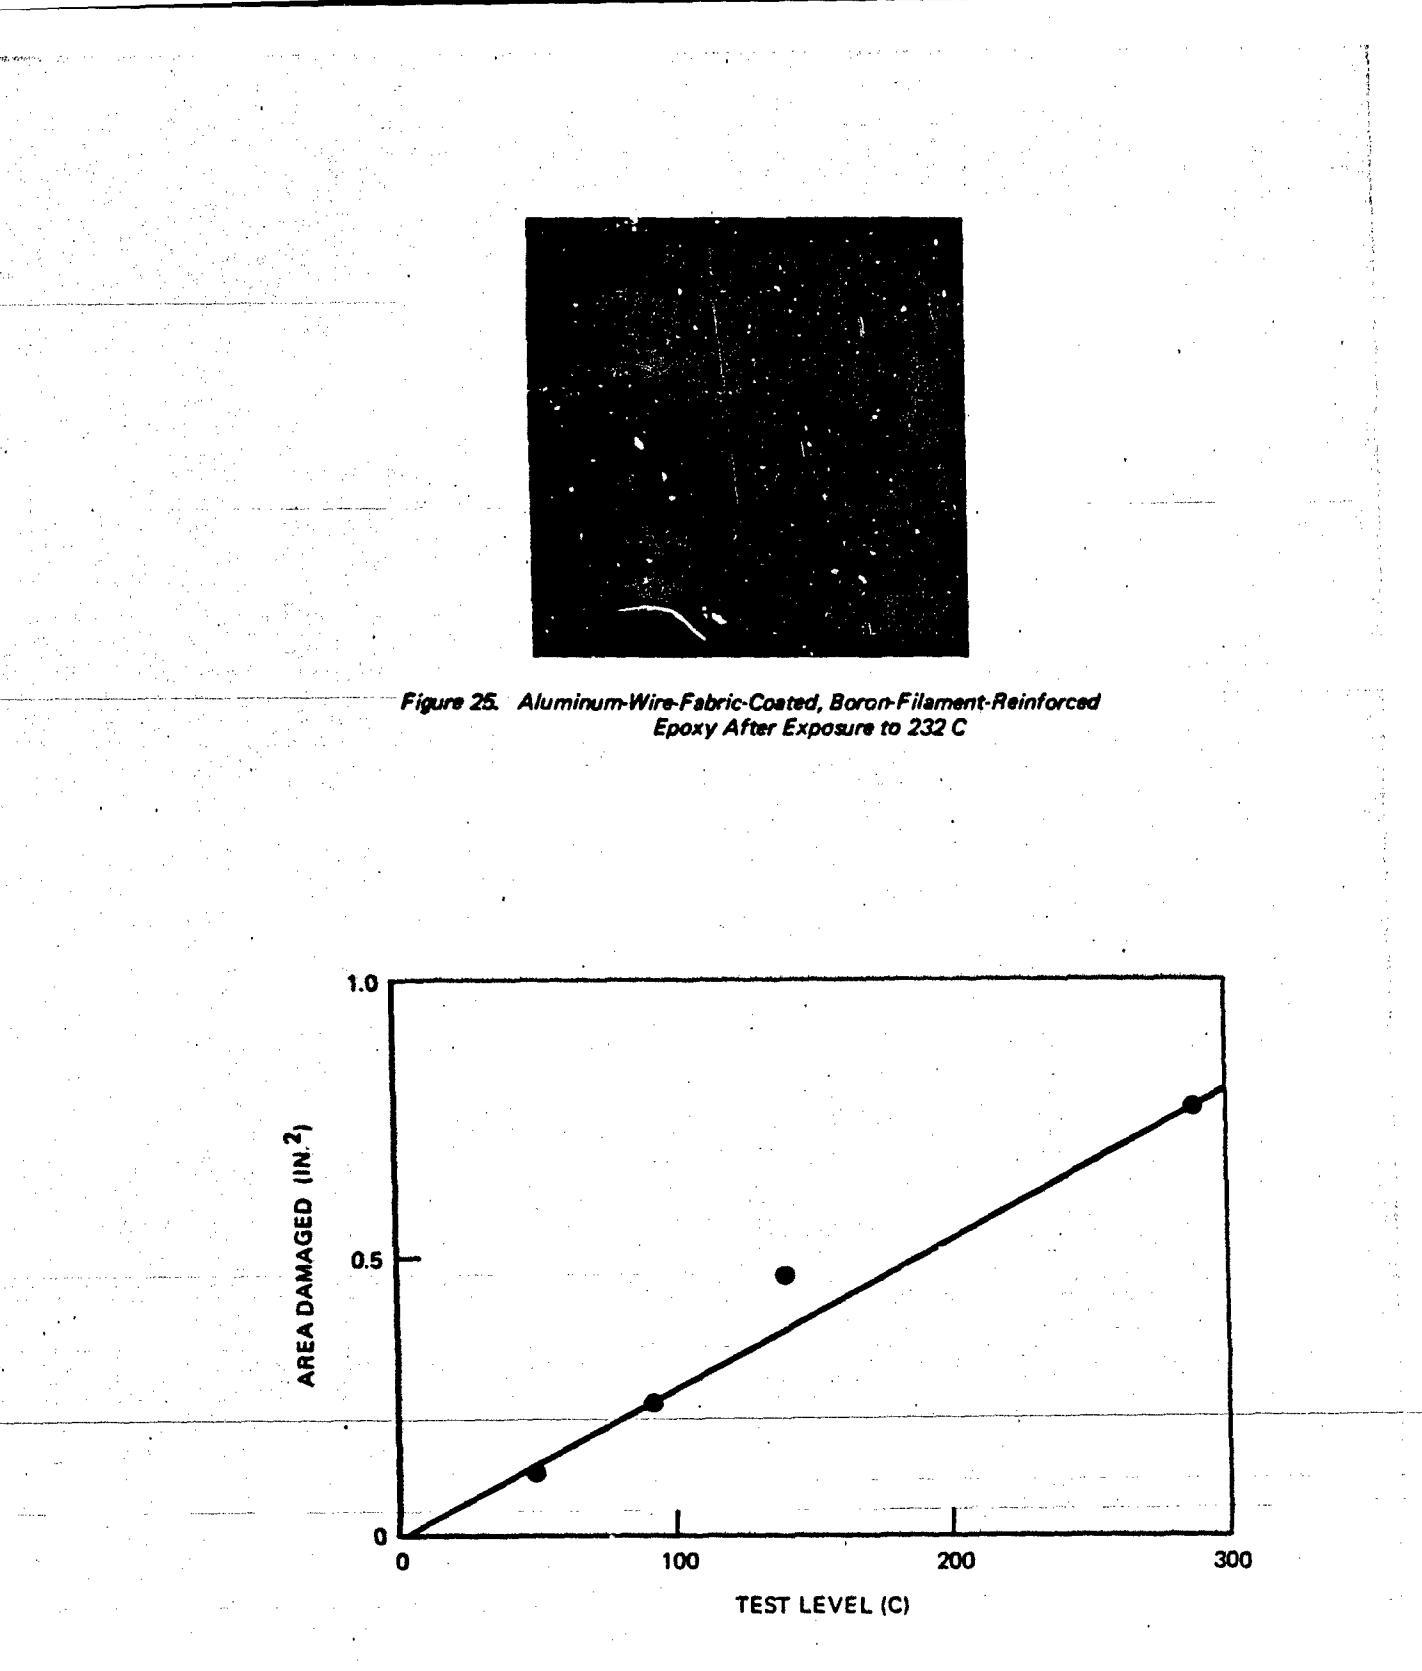
When the arc did not wander on the coating surface, burning damage to the coating and the composite substrate occurred. Furthermore, the damage to five-ply boron laminates appears to be linear with the number of coulombs transferred. Figure 26 shows the relationship between the size of the hole and the test level in coulombs for 200 by 200 mesh, aluminum wire fabric coated, boron-filament-reinforced laminates. The area damaged increases linearly with an increase in the test level. Residual mechanical properties of the laminates indicate the damage was restricted to the visible burn areas. Generally, the boundaries of the burn zone were quite sharp.

Figure 26. Damage Versus Coulombs Transferred for 200 by 200 Mesh, Aluminum-Wire-Fabric-Coated, Boron-Filament-Reinforced Laminates
