# LIGHTNING EFFECTS RELATING TO AIRCRAFT PART I - LIGHTNING EFFECTS ON AND ELECTROMAGNETIC SHIELDING PROPERTIES OF BORON AND GRAPHITE REINFORCED COMPOSITE MATERIALS

F.A. Fisher High Voltage Laboratory General Electric Company

W.M. Fassell Materials and Processes Laboratory Aeronutronic Division Philco-Ford Corporation

Technical Report AFAL-TR-72-5

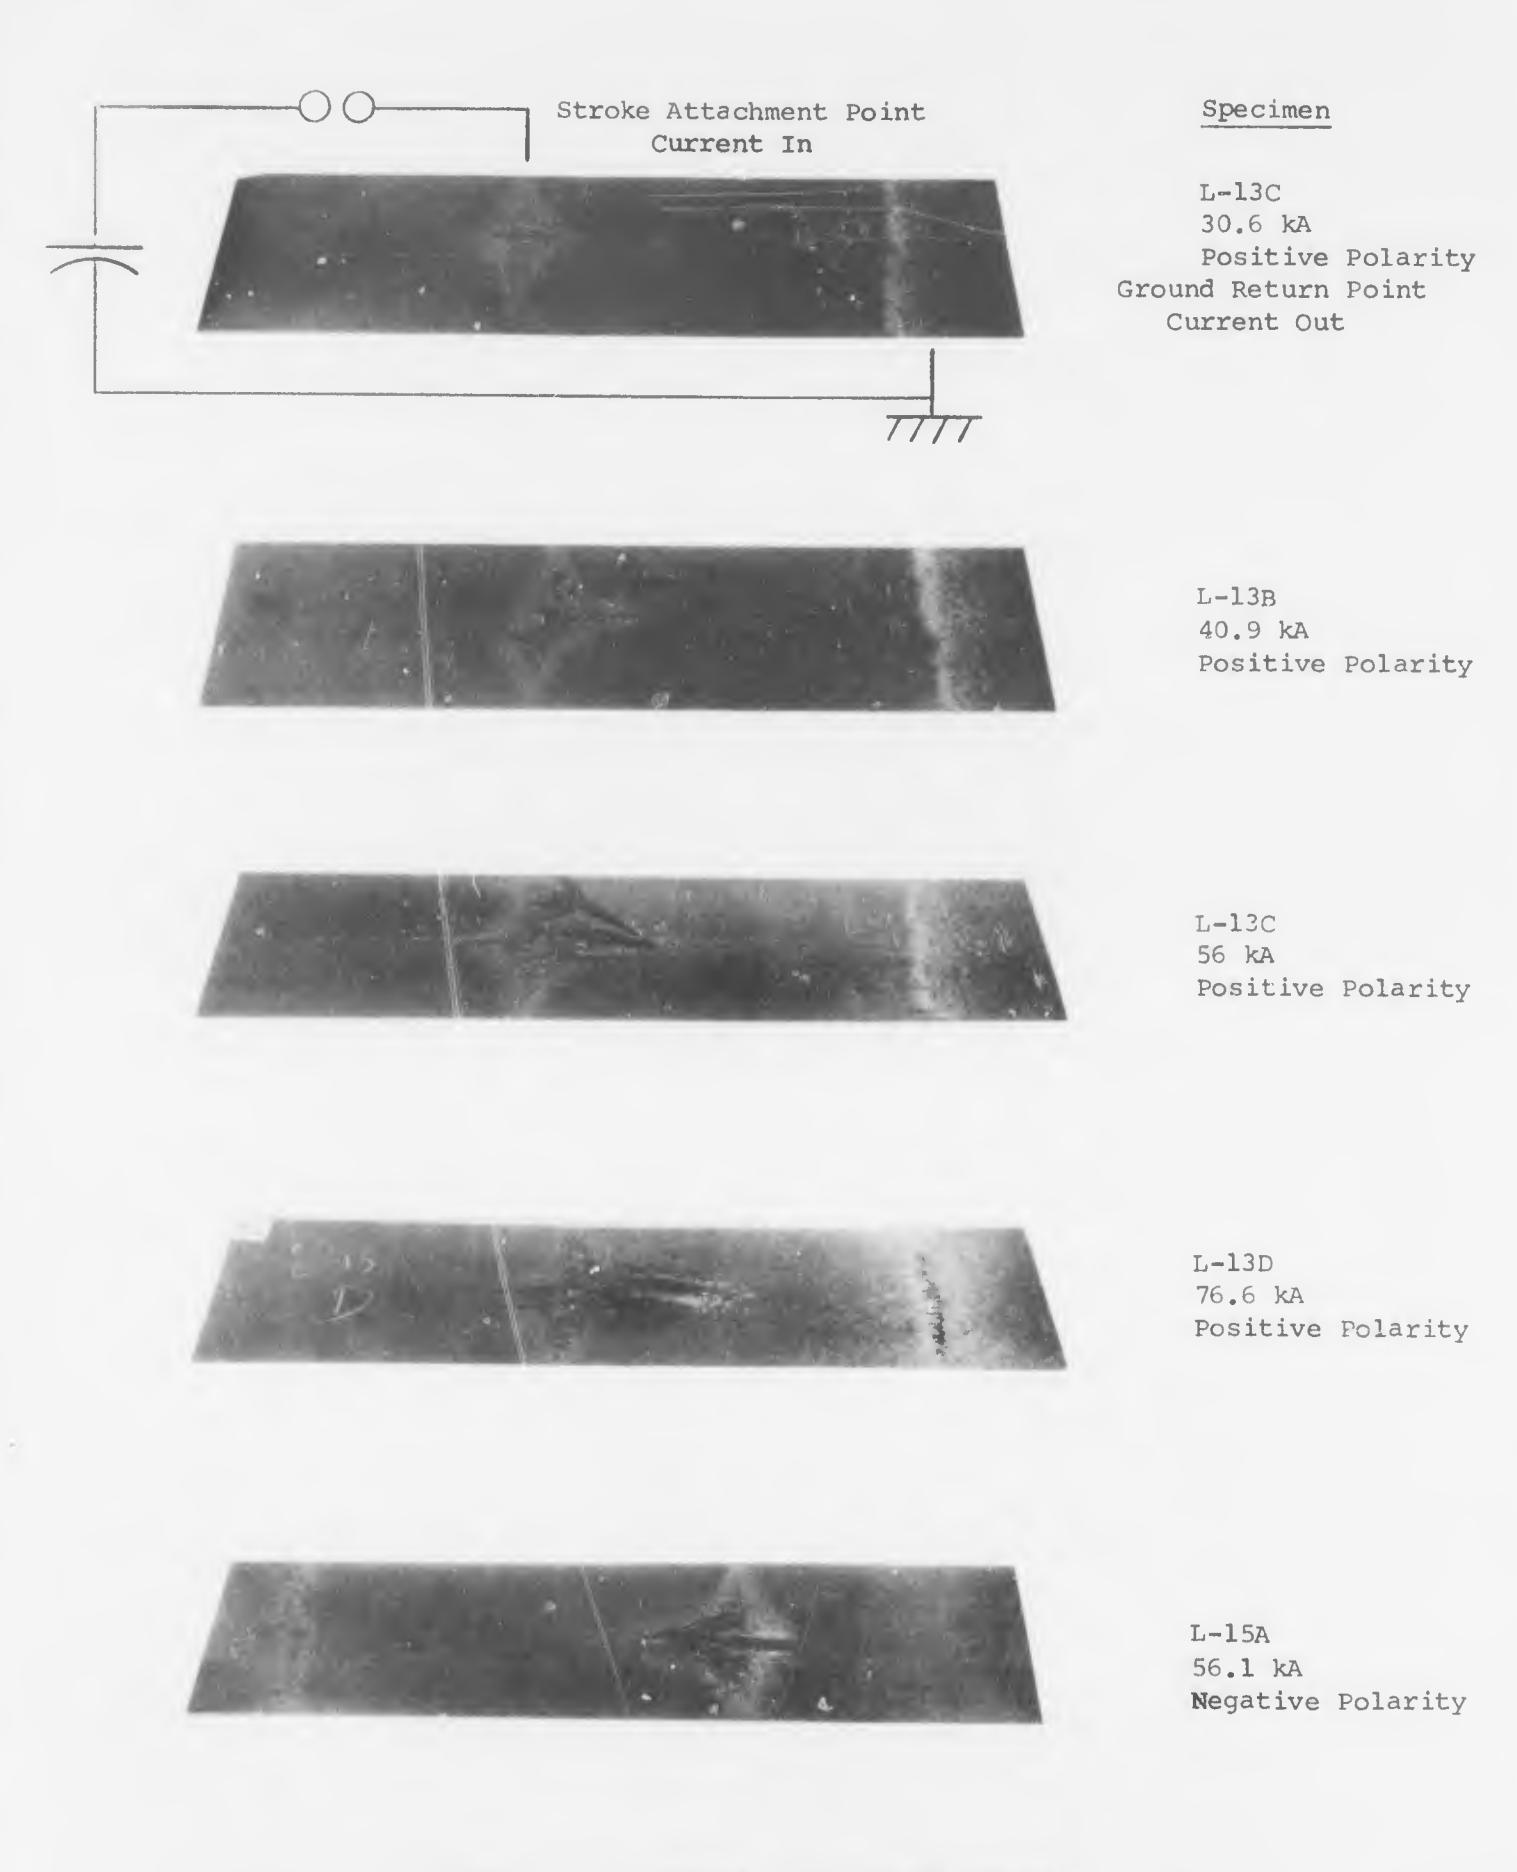
A photograph of the damage to this panel is shown on Figure 3. On this uncoated sample the damage was confined mostly to the arc attachment point. At this point there was a diamond-shaped burn approximately 1.2" wide along the long axis of the sample and about 2.7" wide transverse to the sample axis. Fibers were Lifted on both the top ply and the ply

FIGURE 3 - Damage to Uncoated Samples

underneath it. The back of the panel was not damaged. Apparently current flowed from the top ply into the ply underneath and was then carried out toward the edges of the panel, thus causing pyrolysis of the underlying plies as well as pyrolysis to the top ply. The current then apparently flowed through the graphite material to the grounded end and then flowed back up through the plies to the ground structure at the end of the panel. Near the grounded end of the panel there was again pyrolysis of the fibers, apparently only on the top ply. There was no damage at the back of the panel at the ground end. Between the arc and attachment point and the grounded end of the sample there was apparently no further damage, at least to the surface ply.

The previous samples were tested with a positive polarity discharge, one involving <u>electron</u> flow from the arc attachment point into the high voltage electrode and into the generator. Sample L-15A was tested with a negative polarity discharge, one with electron flow from the electrode into the arc attachment point in order to see if polarity effects made any difference. They did not. Damage was virtually identical to that observed on Sample L-13A at the same current level. A photograph of this panel is also shown on Figure 3.

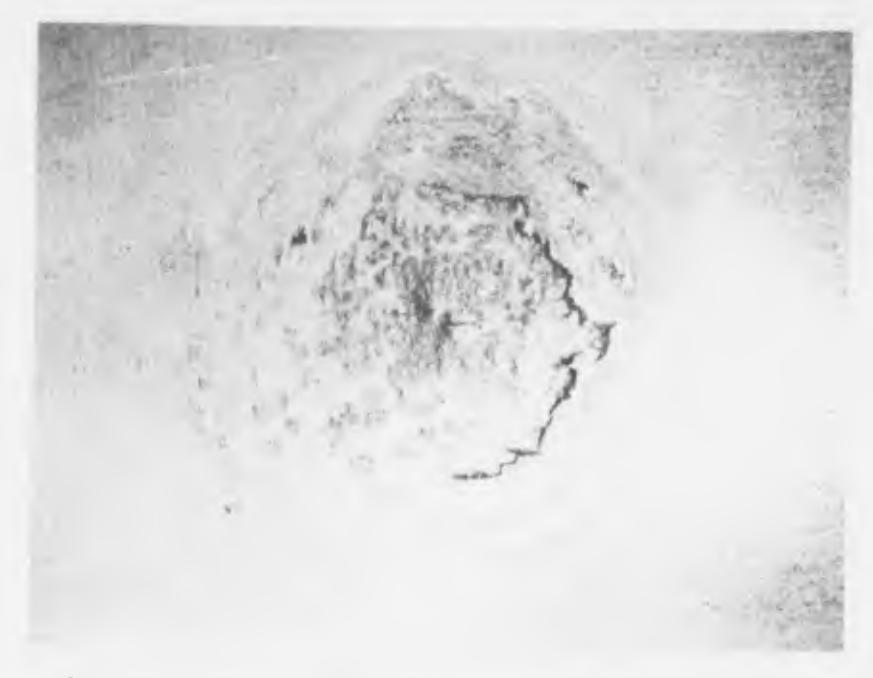
3X Enlargement of Burn at Arc Attachment Point

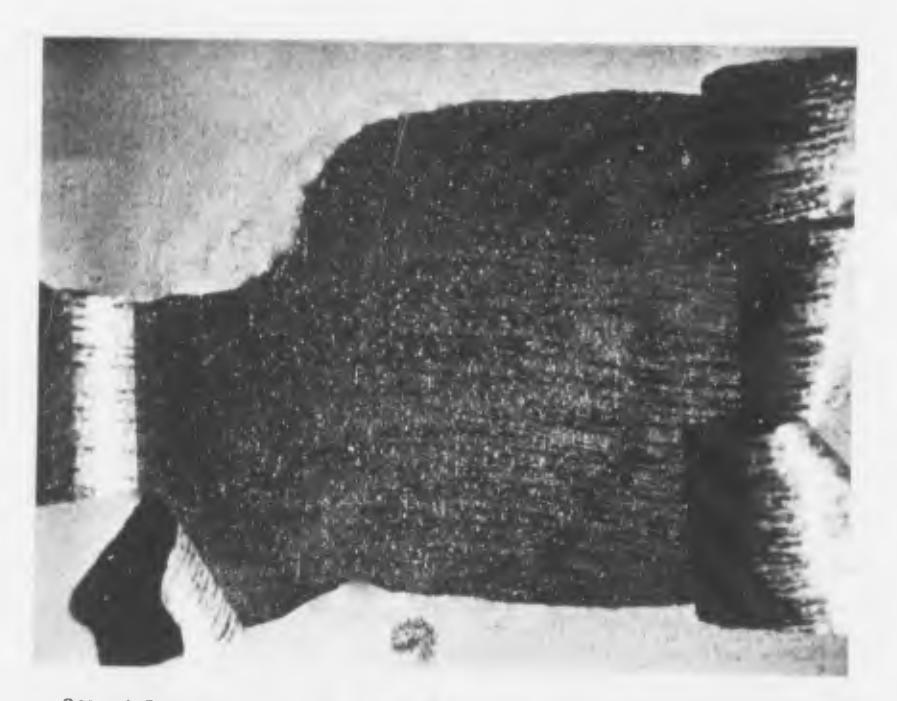
3X Enlargement of Peeled Nickel Coating

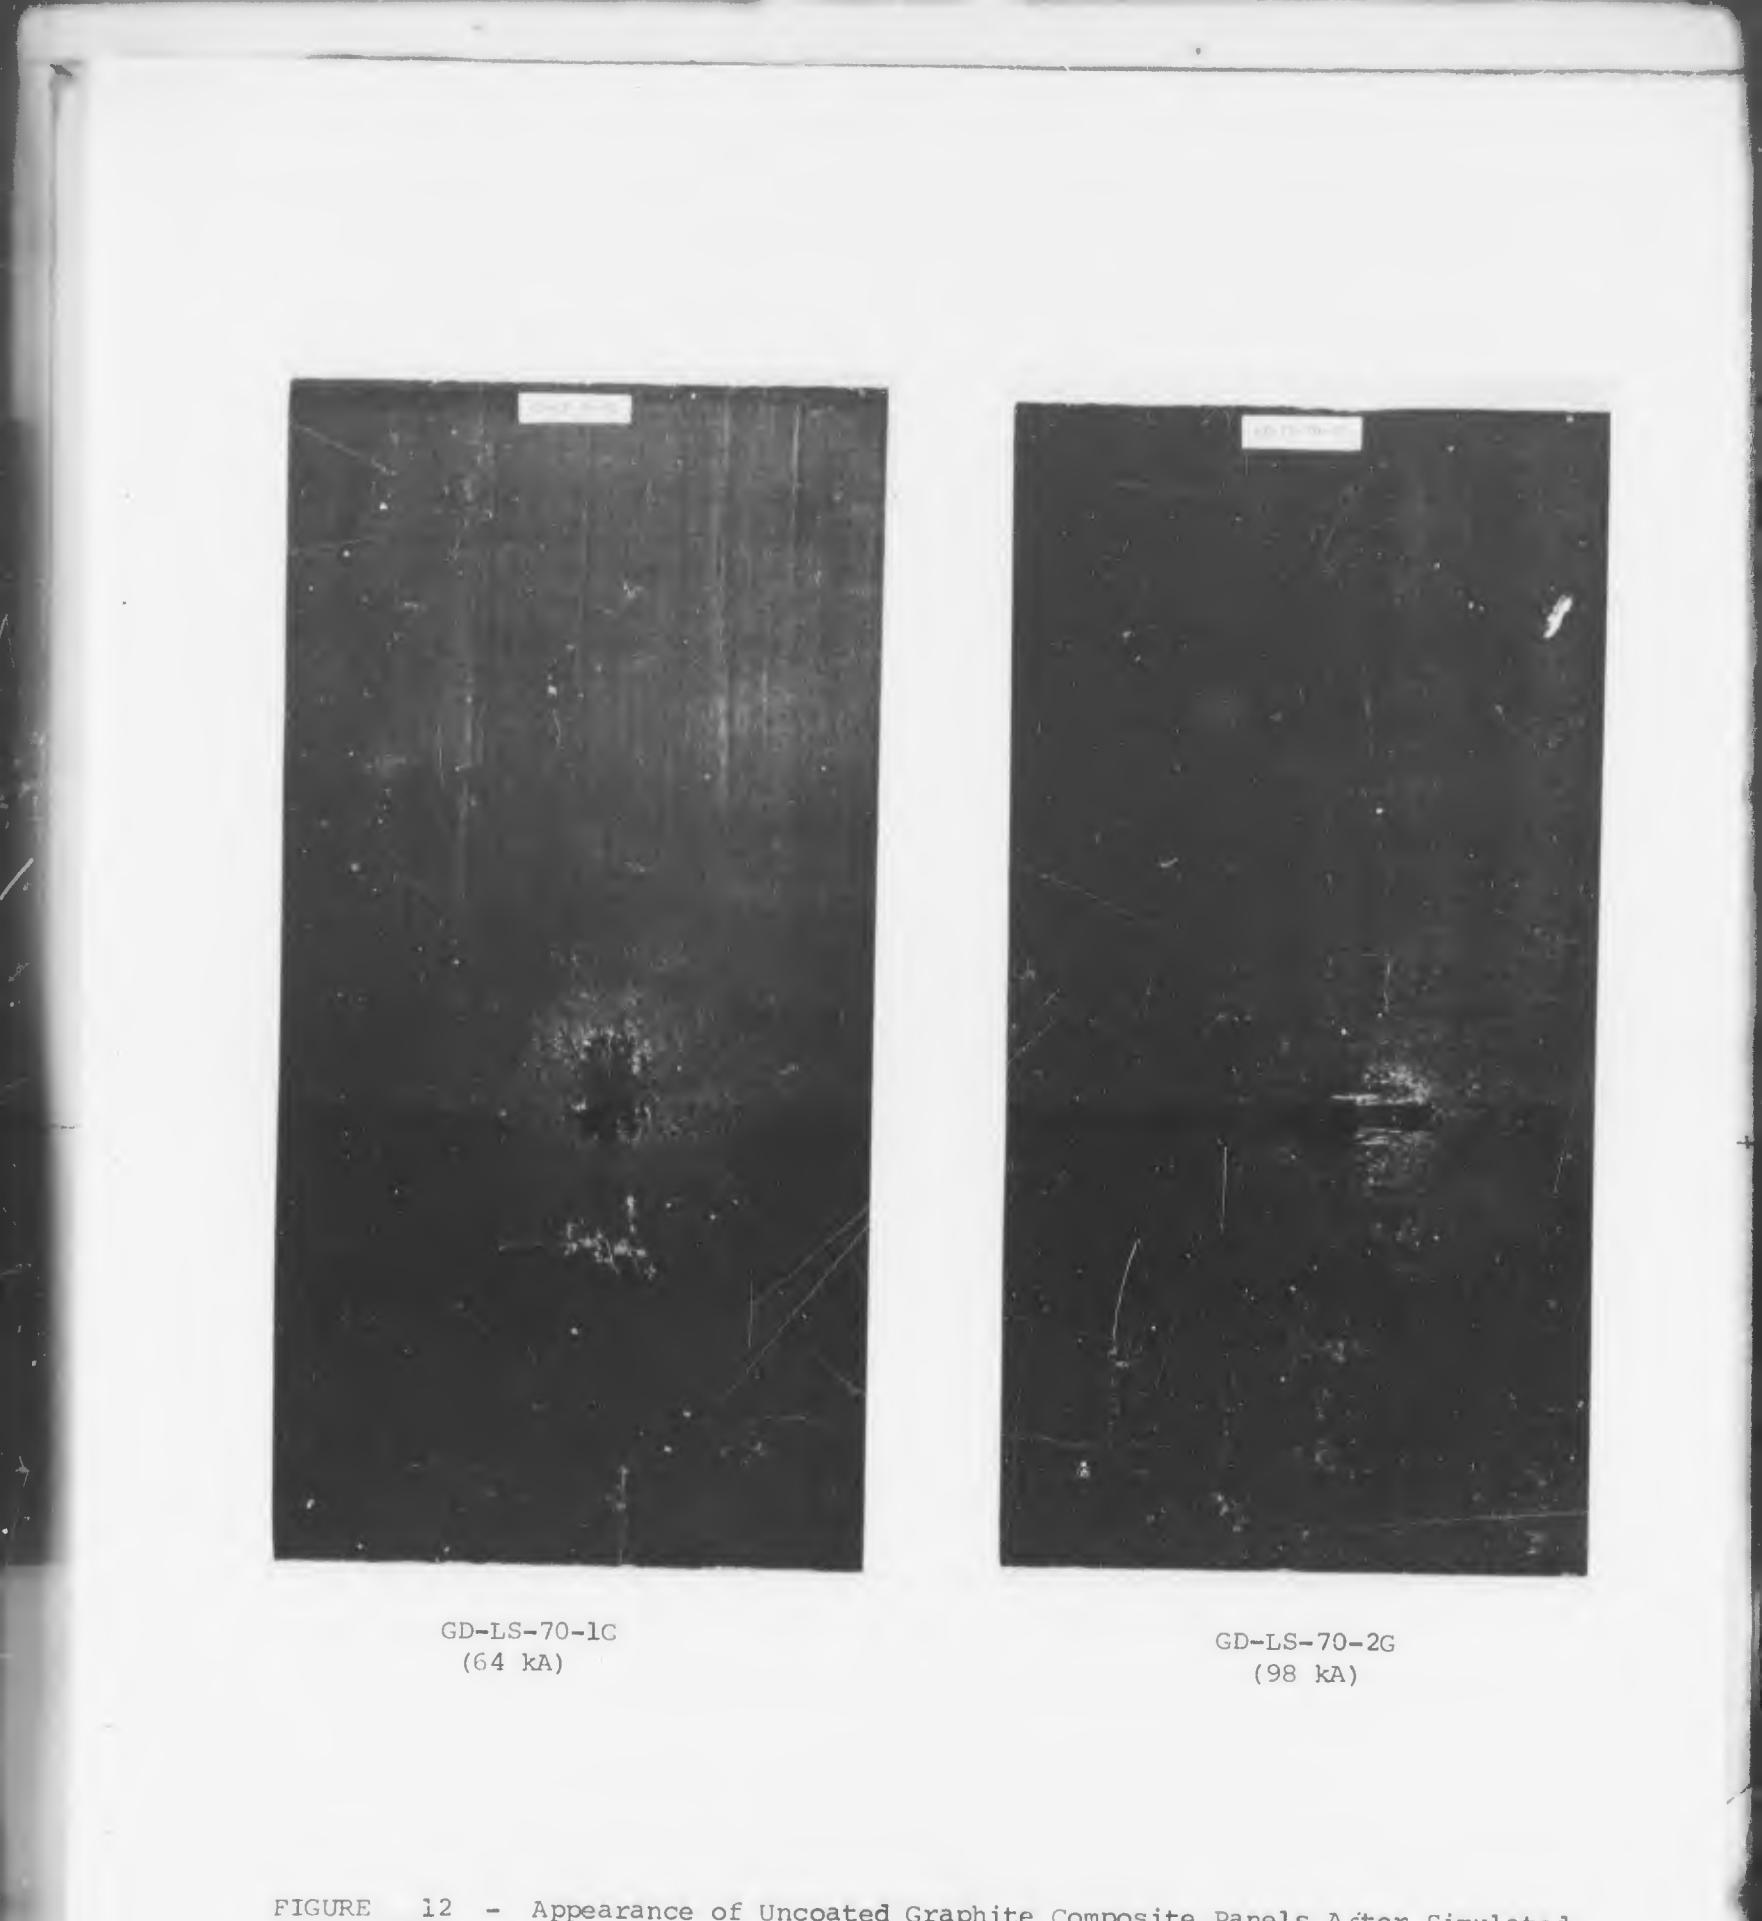
IGURE 12 - Appearance of Uncoated Graphite Composite Panels After Simulated Lightning Tests of the panel. On Sample GD-LS-70-1G one does not note as much of this ply effect. These samples have 16 plies as contrasted to the 4 plies of the samples previously discussed. There was no damage to the back of the panel.

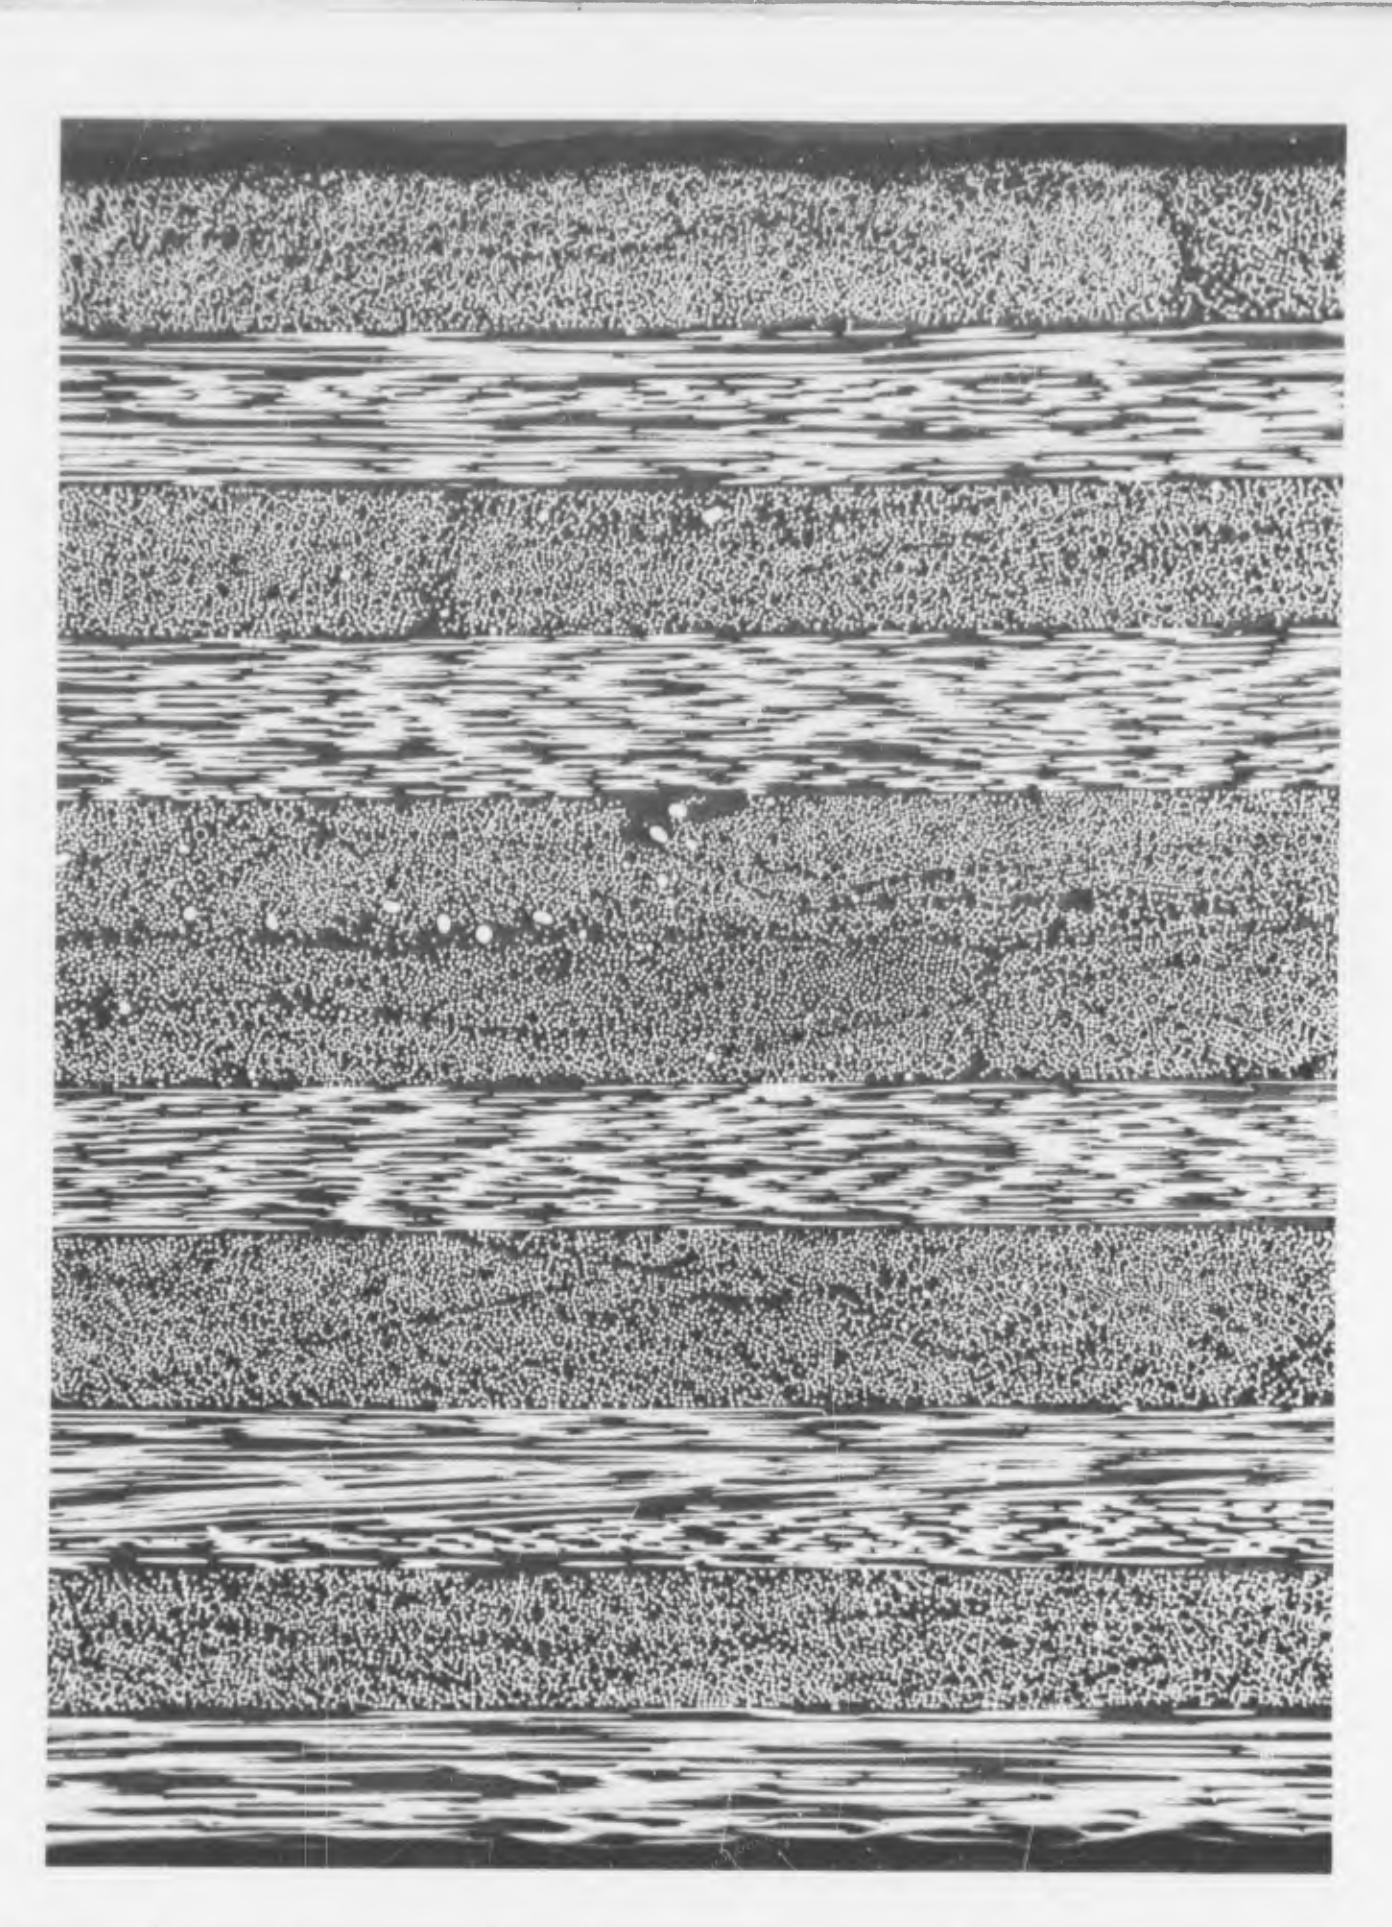
FIGURE 25 - 80X Photomicrograph of Panel GD-LS-70-1G. No Delamination Cracks (Panel Front is at Bottom)

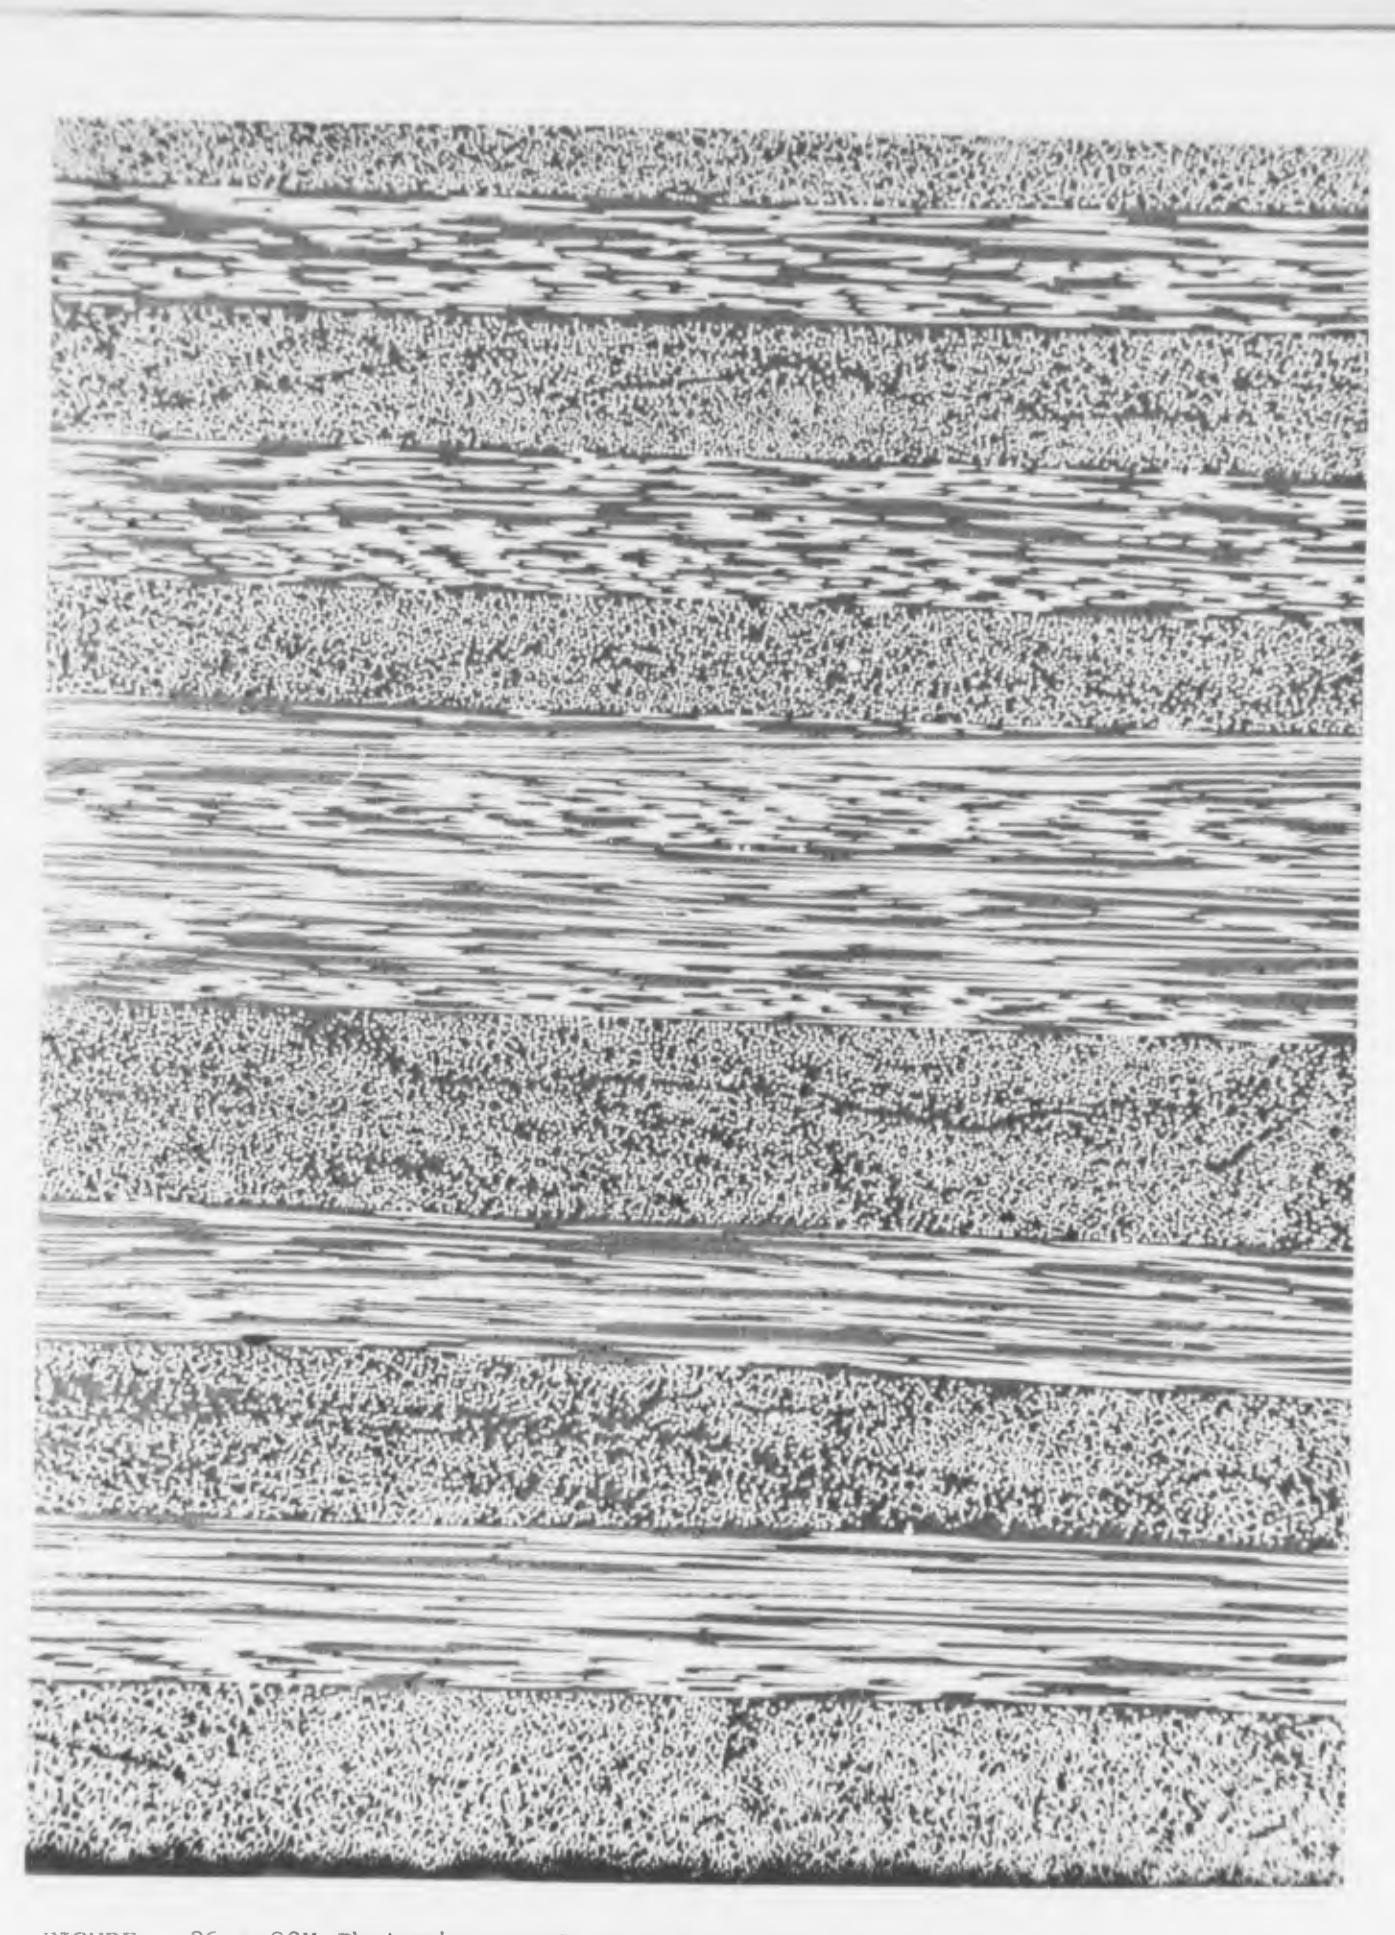
FIGURE 26 - 80X Photomicrograph of Panel GD-LS-70-2G. No Delamination Cracks (Panel Front is at Bottom)

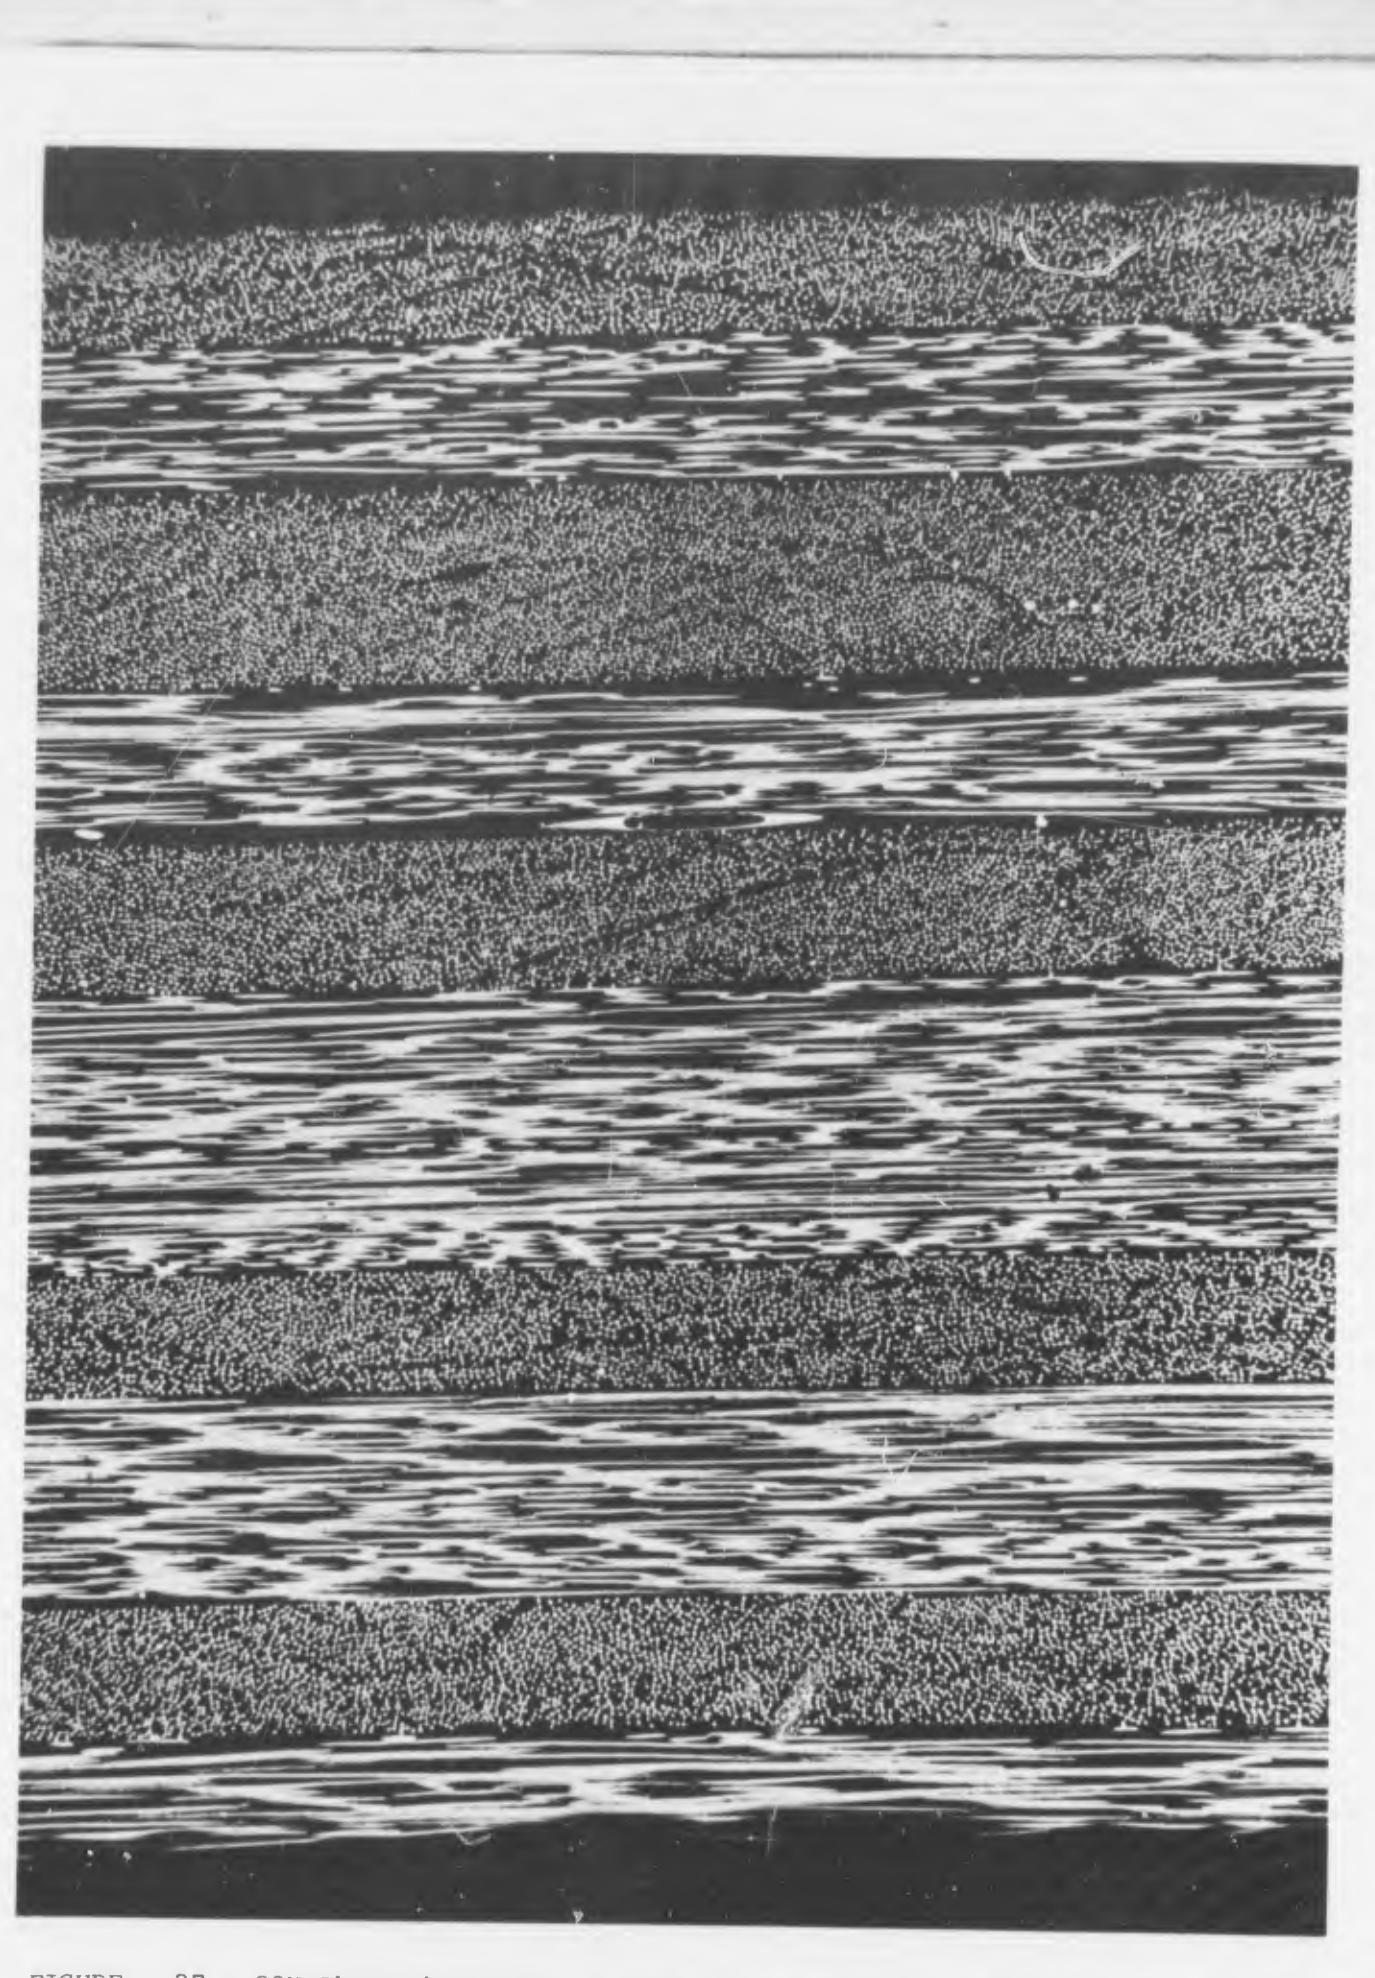
FIGURE 27 - 80X Photomicrograph of Panel GD-LS-70-3G. No Delamination Cracks (Panel Front is at Bottom)

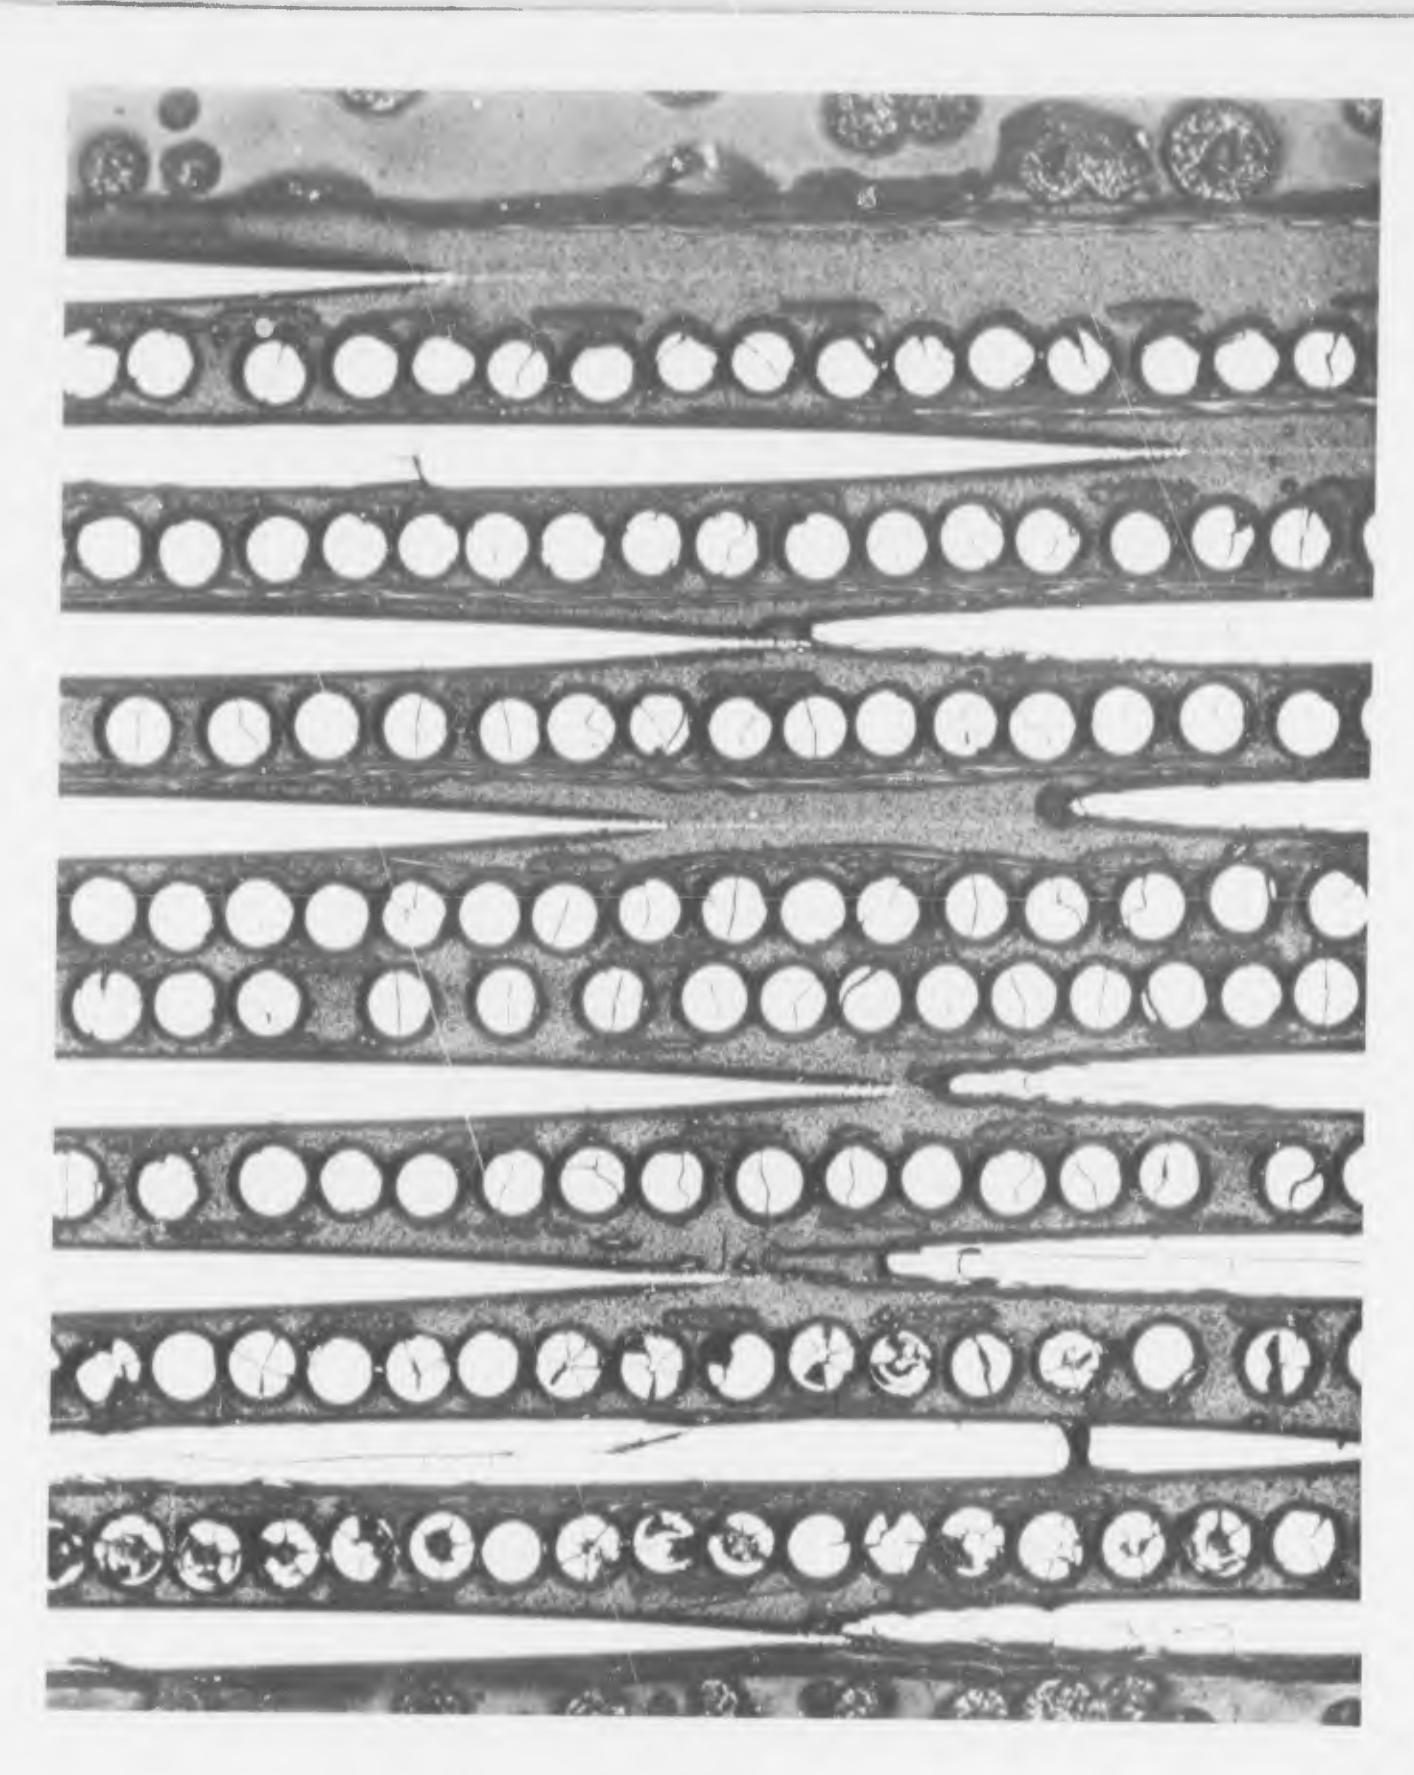
GD-LS-70-1B (56 kA)

Photomicrographs of the boron samples are shown on Figures 45 through 48 and show some extremely interesting patterns. On these photomicrographs the front face of the panel again appears at the bottom of the figure. On sample GD-LS-70-1B only the bottom (on the photomicrograph), or surface rows of fiber are damaged. Cracks on other filaments are polishing cracks. The typical starshape cracking on the bottom filaments has been observed in other programs and occurs at a current density of about 10<sup>5</sup> amperes per square centimeter. This photograph thus provides some evidence that the current was confined, partially at least, to the plies next to the stricken face. The photomicrographs of panels GD-LS-70-2B and -3B show damage on all of the vertical plies. The damage is less intense on panel -3B than on -2B, which agrees with the visual observations of the panel surface, the short beam shear test, and the resistance measurements. Panel GD-LS-70-4B shows severe damage on all plies. This series of photographs is an excellent example of the progressive increase in the degree of damage as the arc current is increased. 48, which shows the vertical destruction of almost every filament, is Figure typical of the melting of the W2B5 core by excessive current.

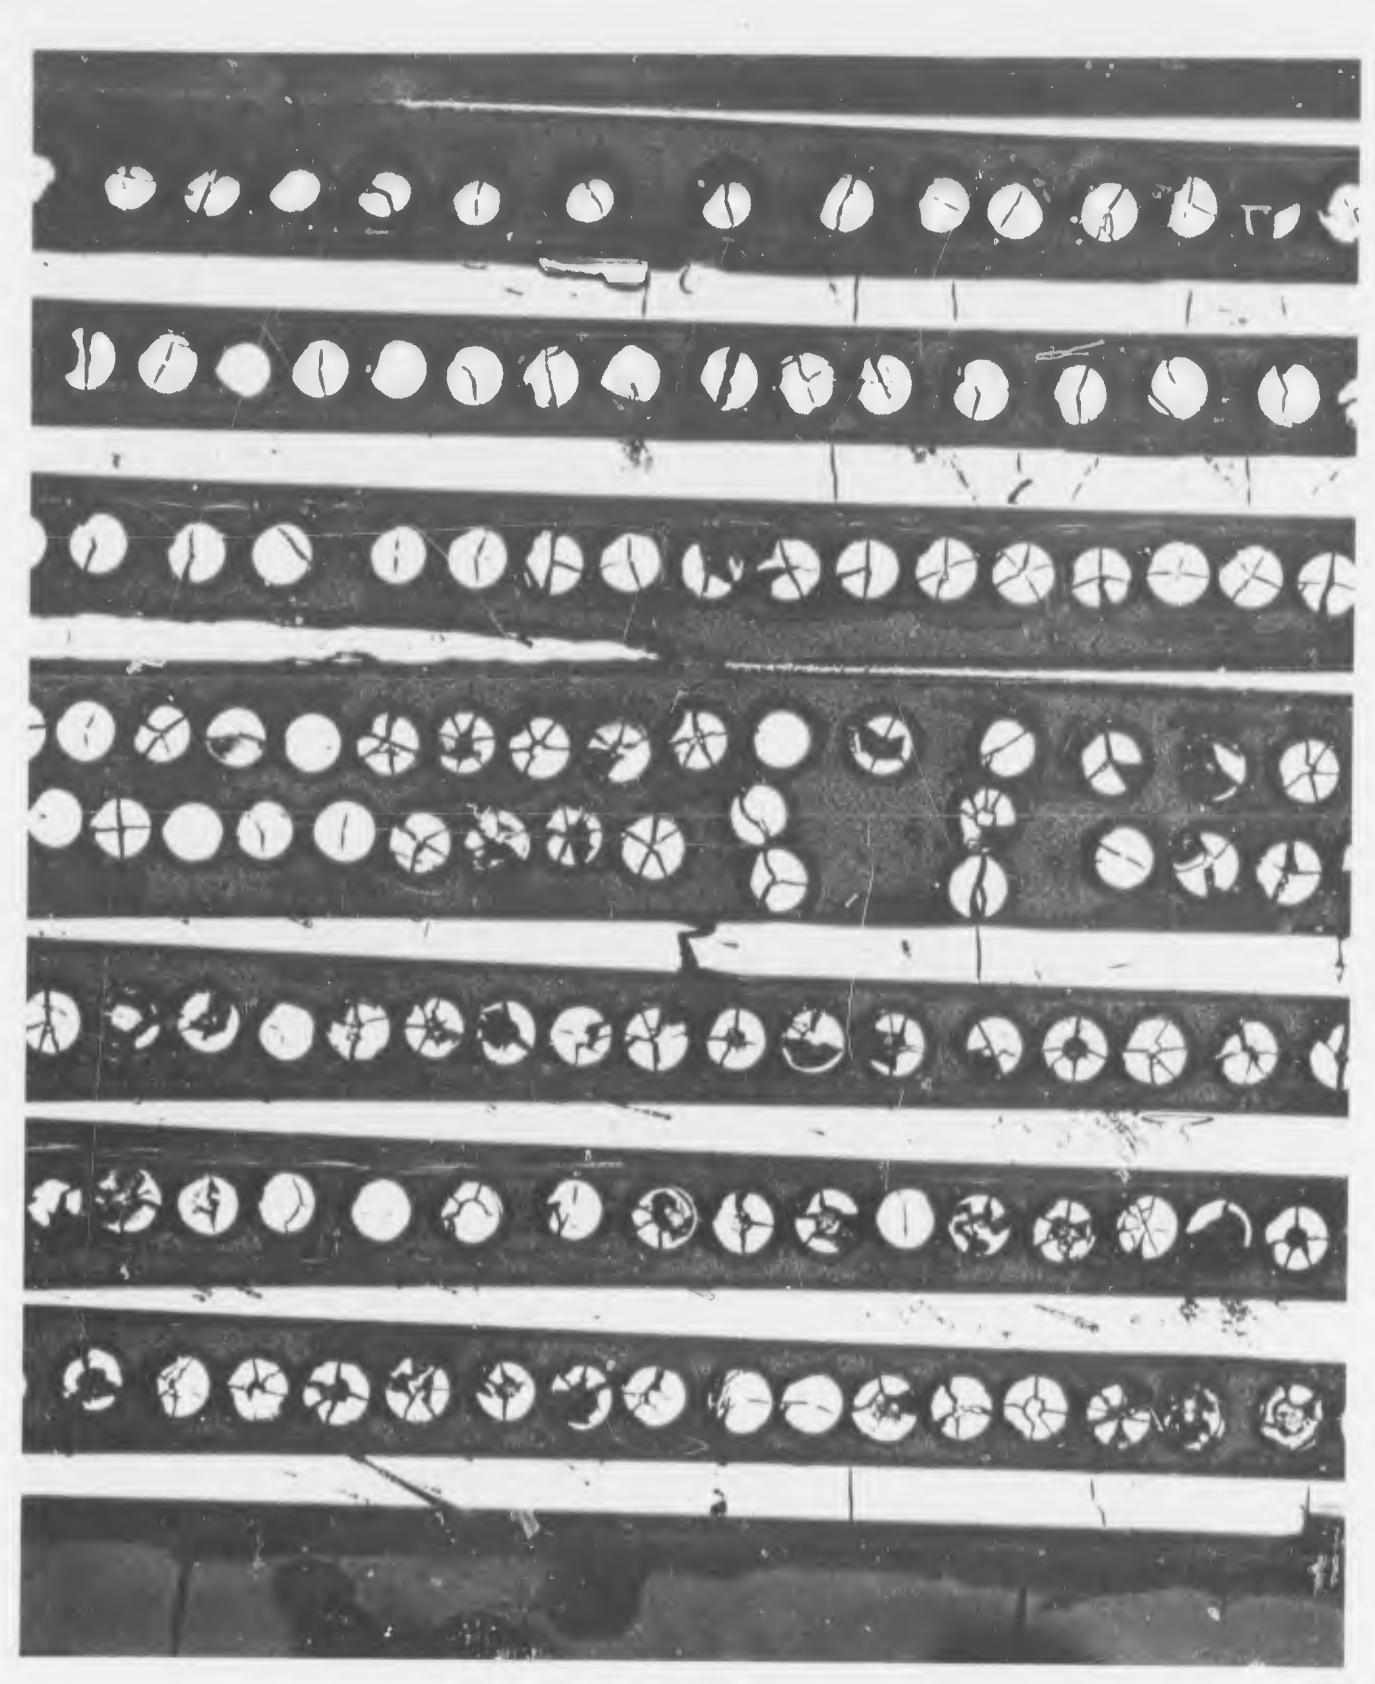
GD-LS-70-3B (88 kA)

FIGURE 46 - 80X Photomicrograph of Tested Panel Showing Star-Shaped Damaged Filaments Dispersed. Note Beginning of Delamination at Bottom of Photograph. Panel Front at Bottom.

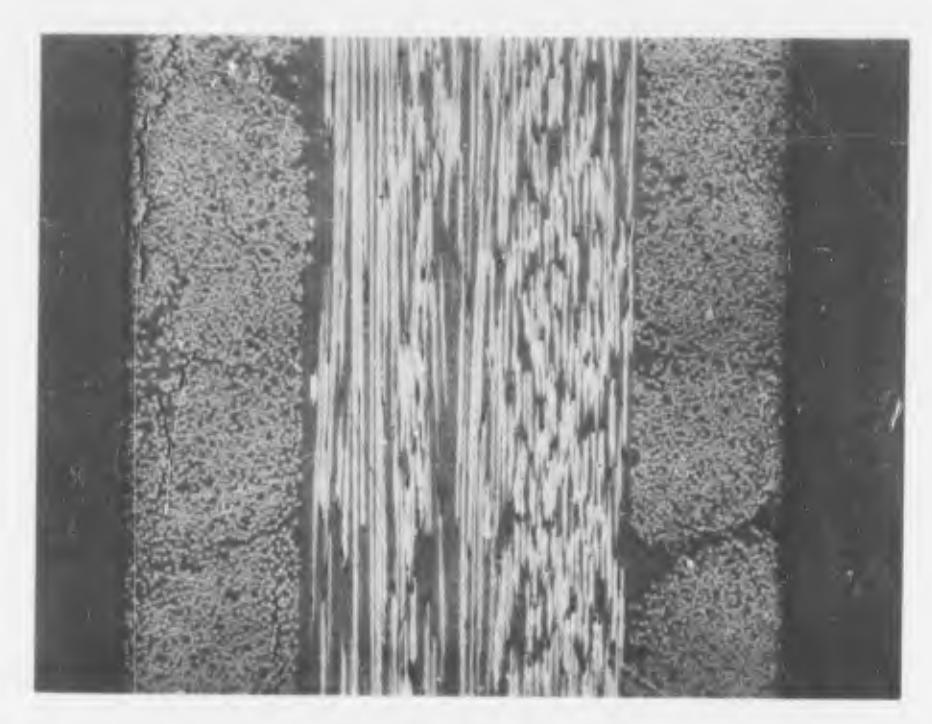
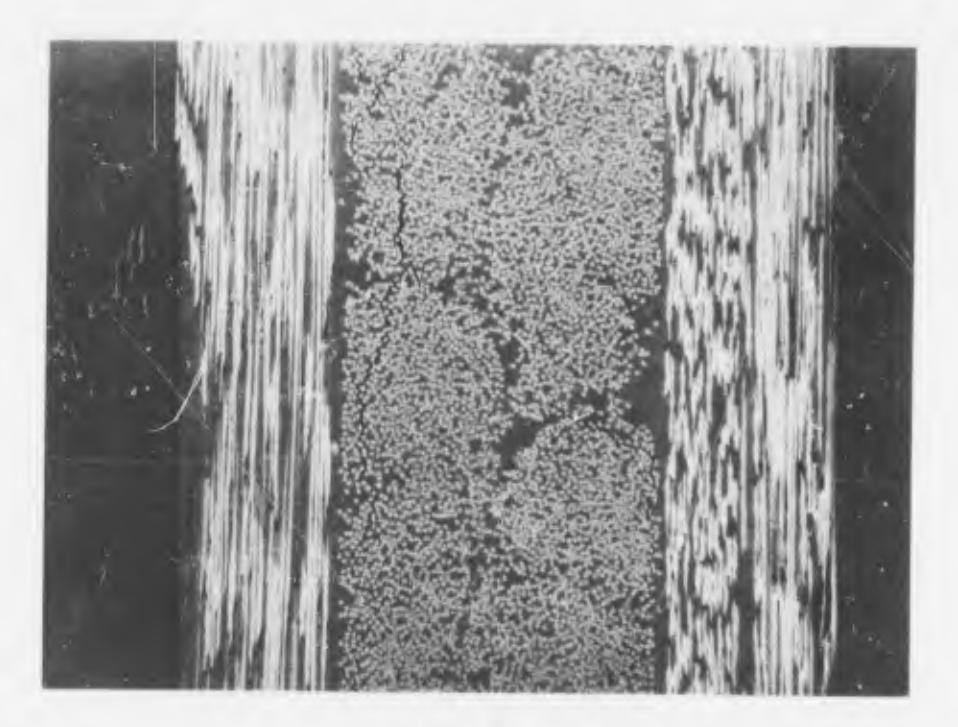
FIGURE 79 - 100X Photomicrograph of a Damaged Area of Graphite Fiber/ Epoxy Panel After Exposure to Simulated Lightning Discharge
