# LIGHTNING EFFECTS RELATING TO AIRCRAFT PART I - LIGHTNING EFFECTS ON AND ELECTROMAGNETIC SHIELDING PROPERTIES OF BORON AND GRAPHITE REINFORCED COMPOSITE MATERIALS

F.A. Fisher High Voltage Laboratory General Electric Company

W.M. Fassell Materials and Processes Laboratory Aeronutronic Division Philco-Ford Corporation

Technical Report AFAL-TR-72-5

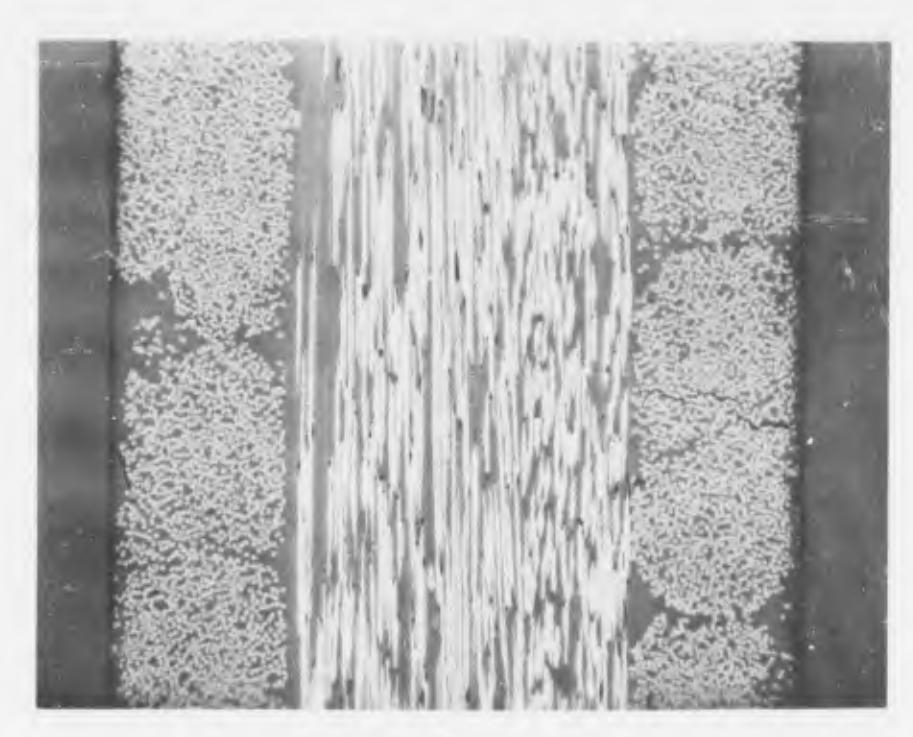
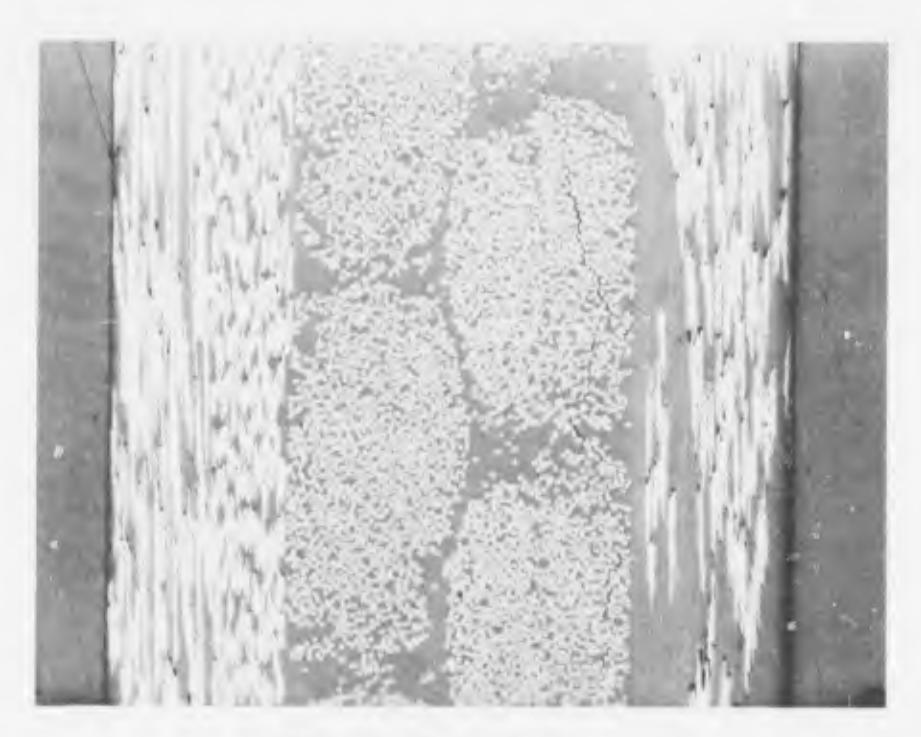
FIGURE 80 - 100X Photomicrograph of a Damaged Area of Graphite Fi Epoxy Panel After Exposure to Simulated Lightning Dis

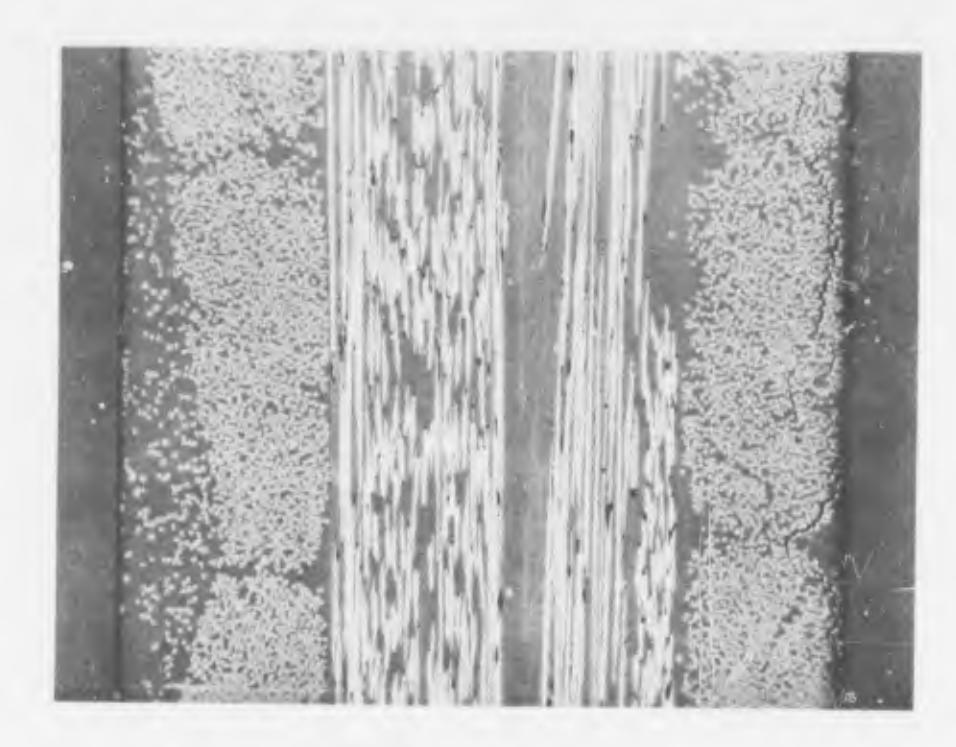
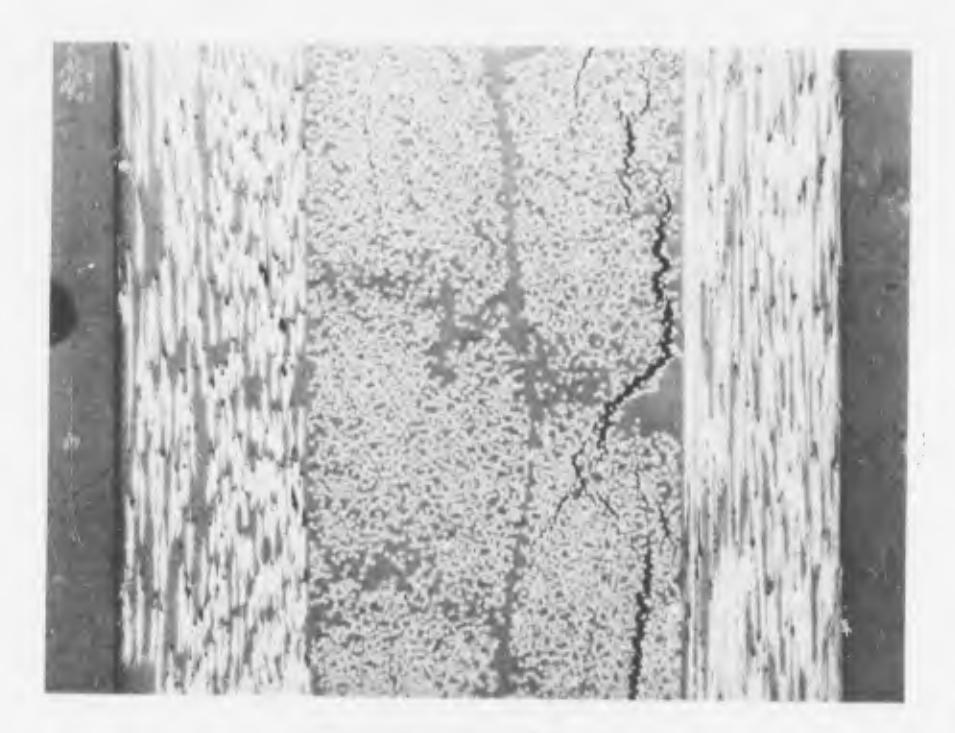
FIGURE 81 - 100X Photomicrograph of a Damaged Area of Graphite Fiber/ Epoxy Panel After Exposure to Simulated Lightning Discharge

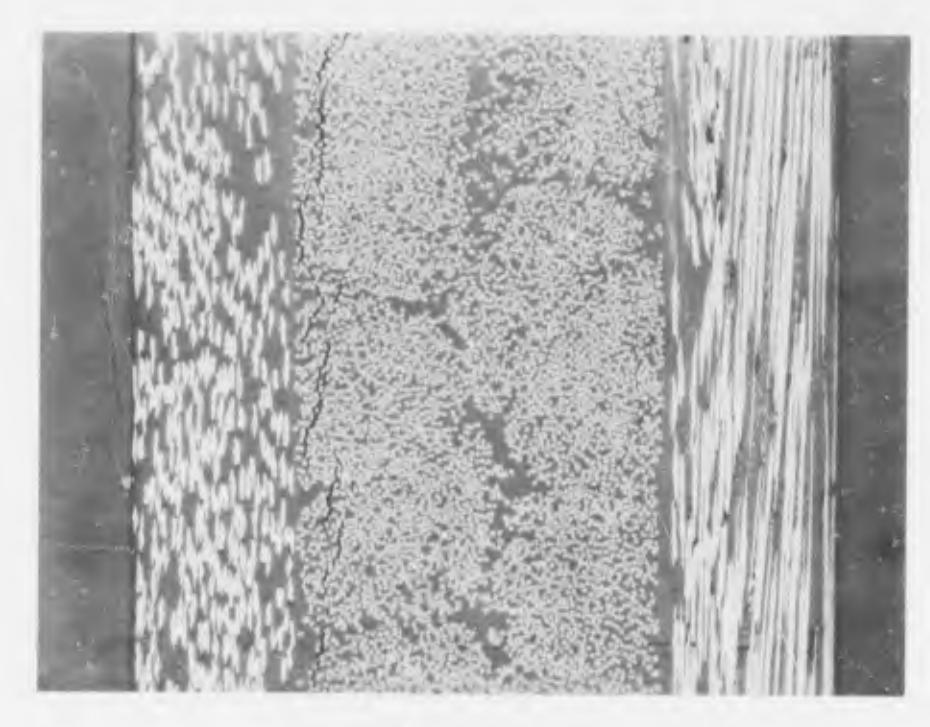
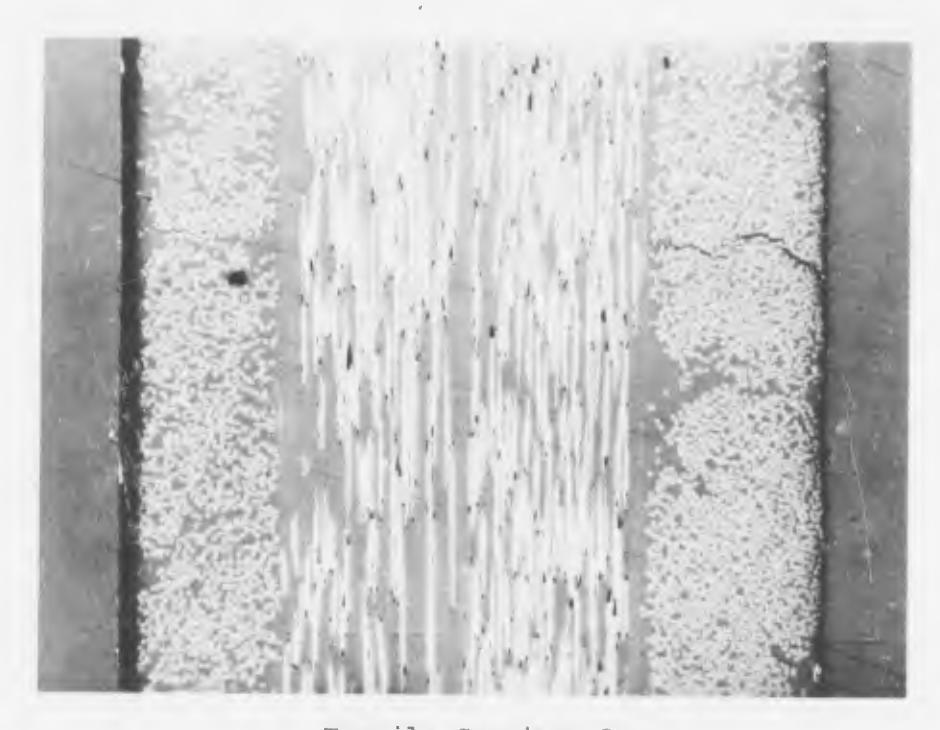
FIGURE 82 - 100X Photomicrograph of a Damaged Area of Graphite Fiber/Epoxy Panel After Exposure to Simulated Lightning Discharge

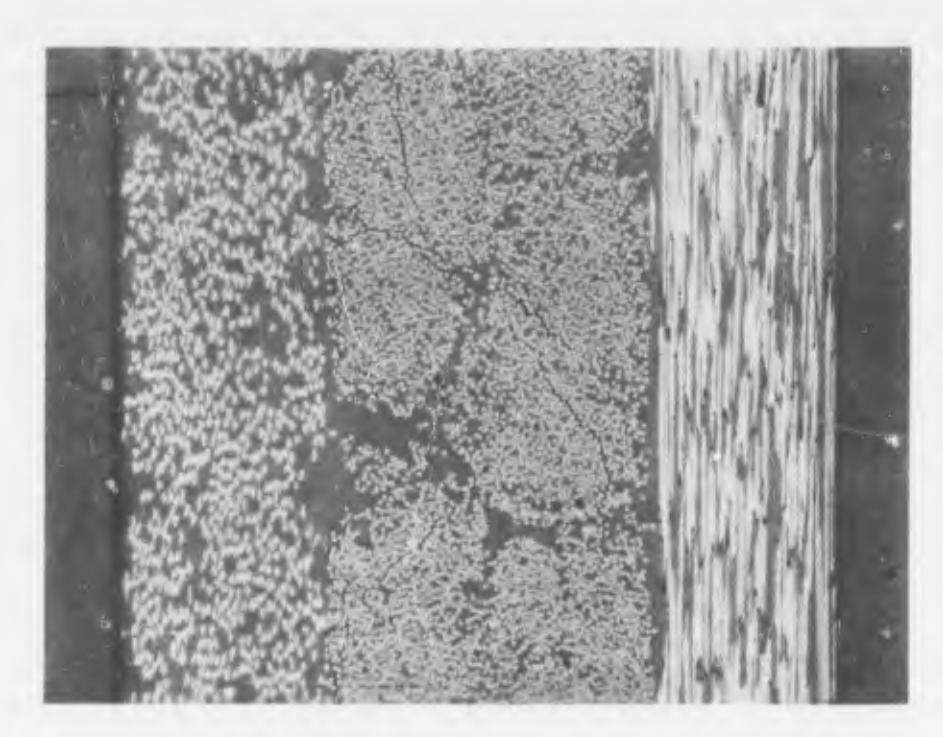
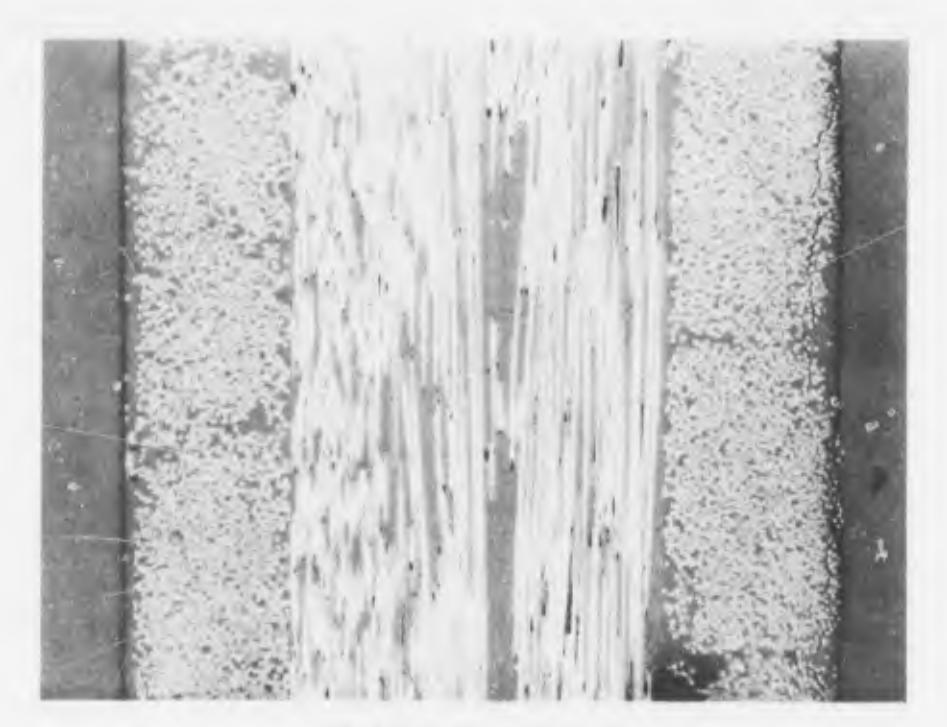
FIGURE 83 - 100X Photomicrograph of a Damaged Area of Graphite Fiber/Epoxy Panel After Exposure to Simulated Lightning Discharge

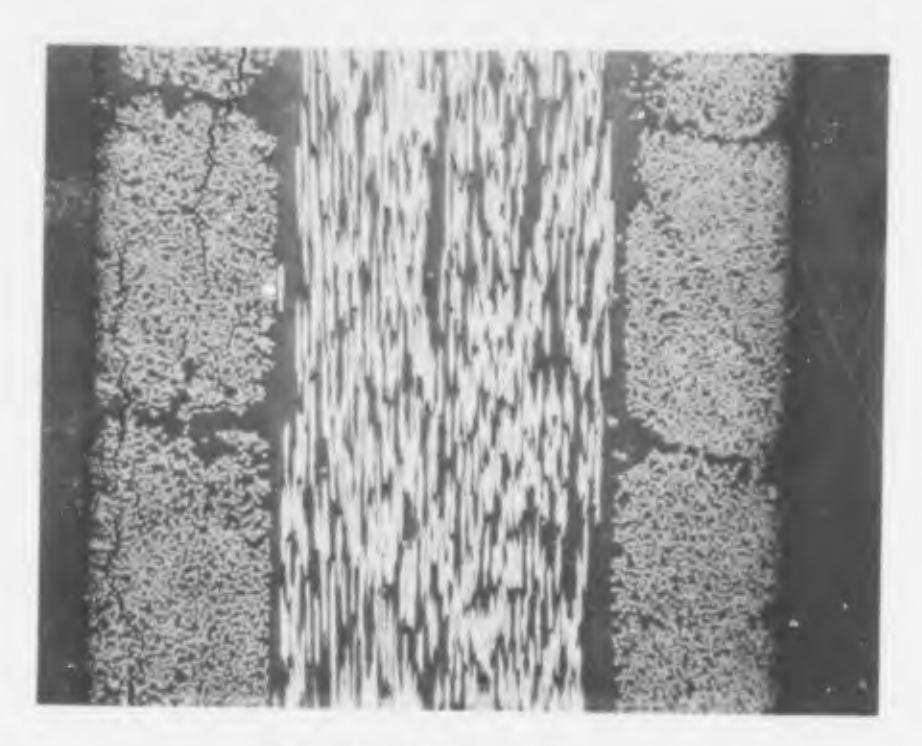
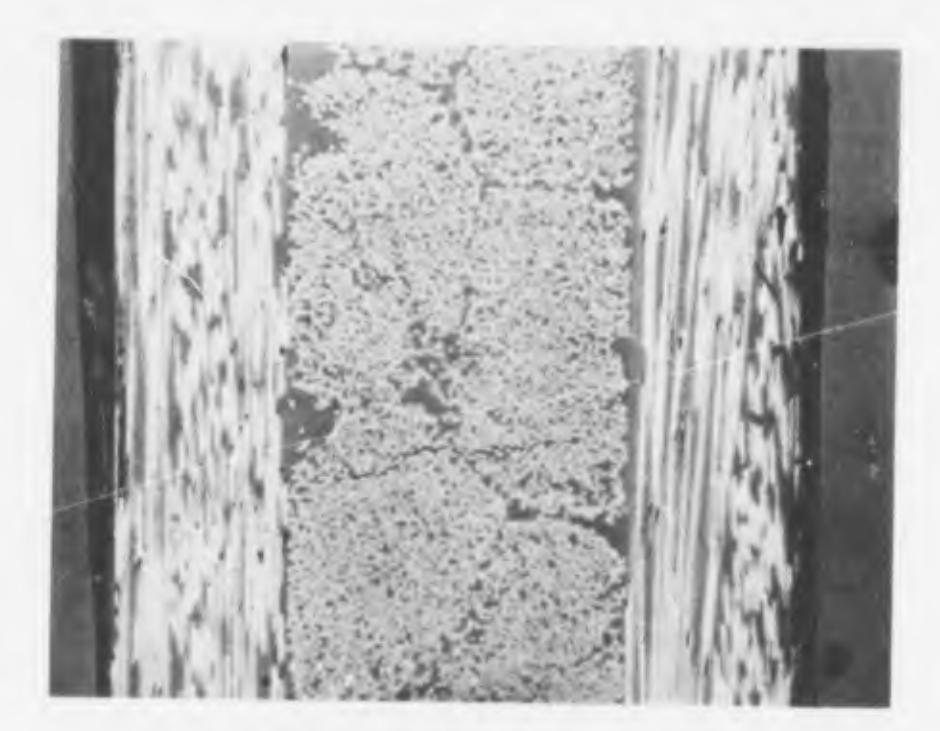
FIGURE 85 - 100X Photomicrograph of a Damaged Area of Graphite Fiber/Epoxy Panel After Exposure to Simulated Lightning Discharge

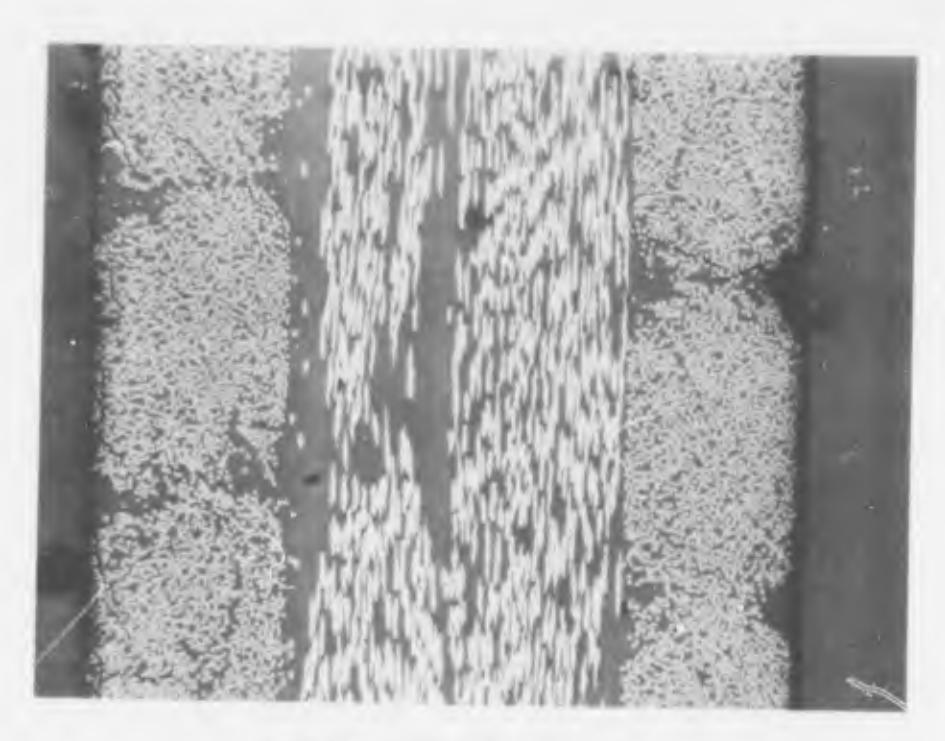
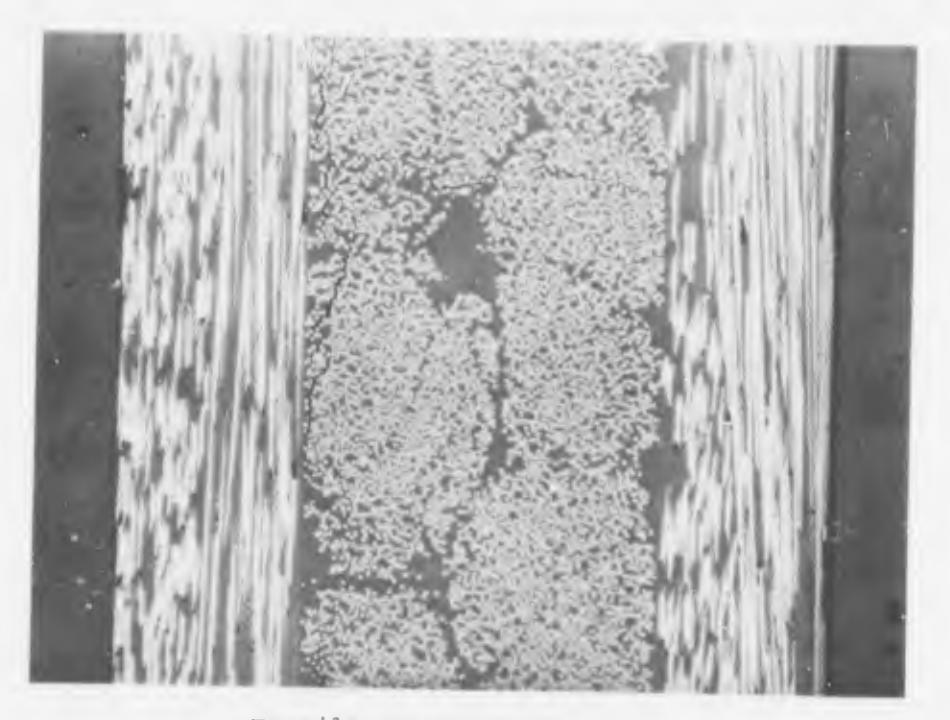
FIGURE 86 - 100X Photomicrograph of a Damaged Area of Graphite Fiber/ Epoxy Panel After Exposure to Simulated Lightning Discharge

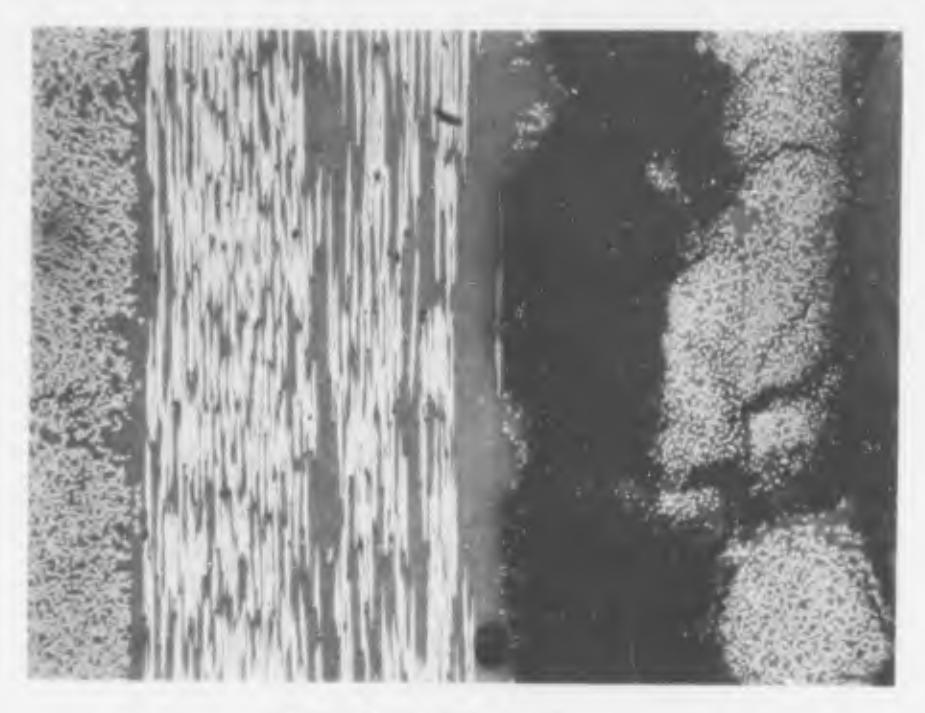
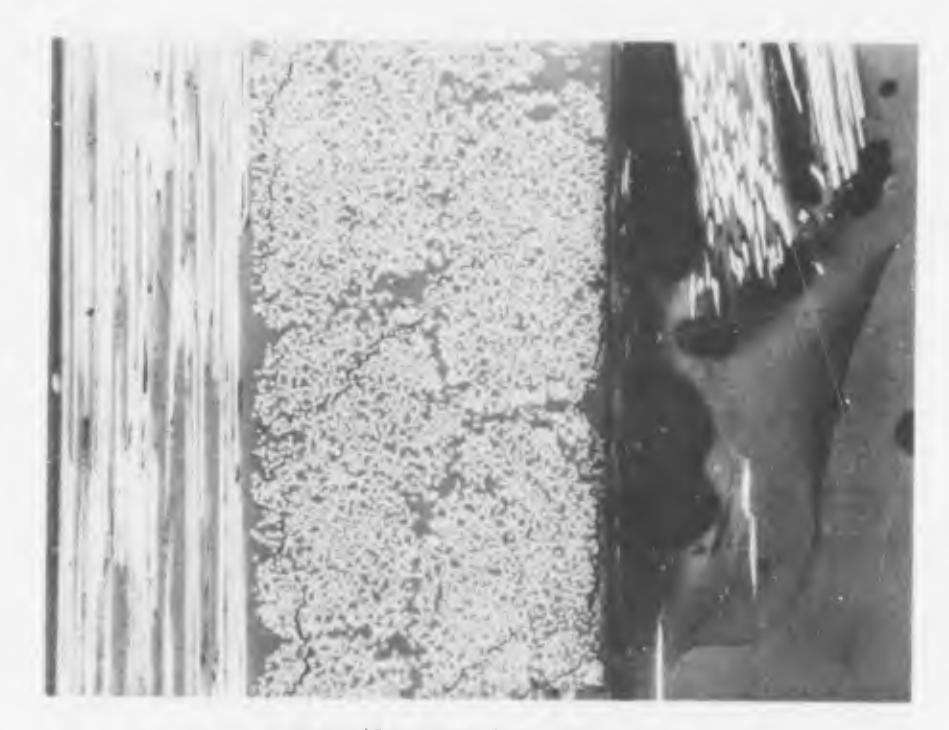
On panel LS-70-4, tested at 184 kA, it is interesting that the tensile strengths of specimens 1 and 2 are normal while specimen 3 is significantly stronger in spite of the massive damage to the top ply shown on Figure 87. Specimen 3 was, of course, immediately below the stroke-attachment point. Again, the fibers and resin on the two inner plies of this specimen do not look any different than do the fibers and resin on specimens further from the strokeattachment point or on panel LS-70-3 which was tested at a 57.5 kA level. On photomicrograph 3a of Figure 87 one can see a considerable amount of blacken-

FIGURE 87 - 100X Photomicrograph of a Damaged Area of Graphite Fiber/ Epoxy Panel After Exposure to Simulated Lightning Discharge

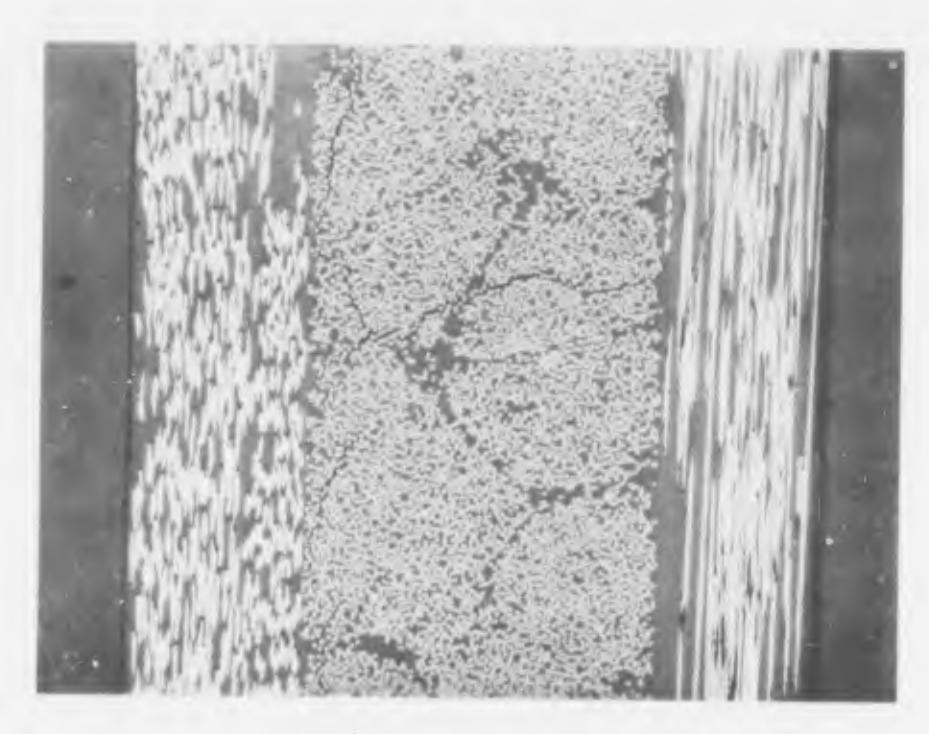
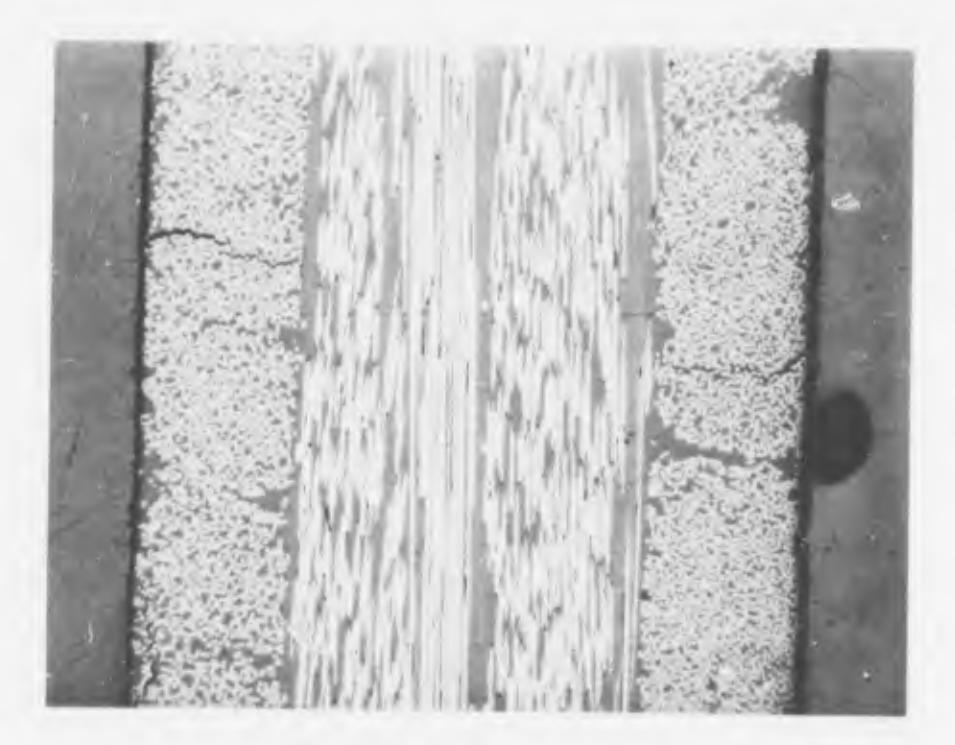
FIGURE 88 - 100X Photomicrograph of a Damaged Area of Graphite Fiber/ Epoxy Panel After Exposure to Simulated Lightning Discharge

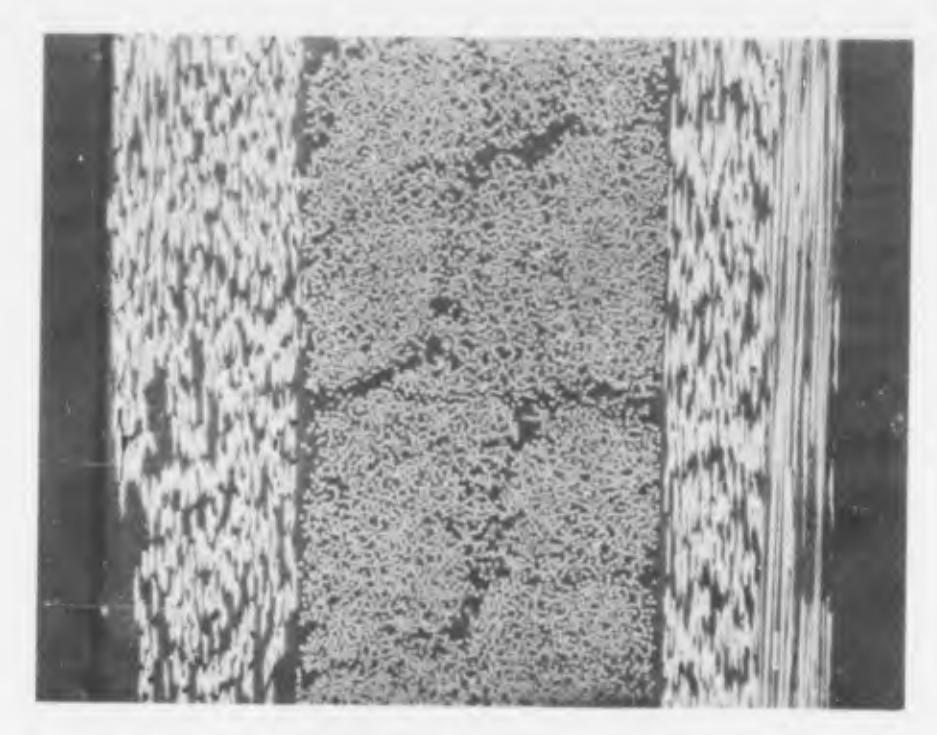
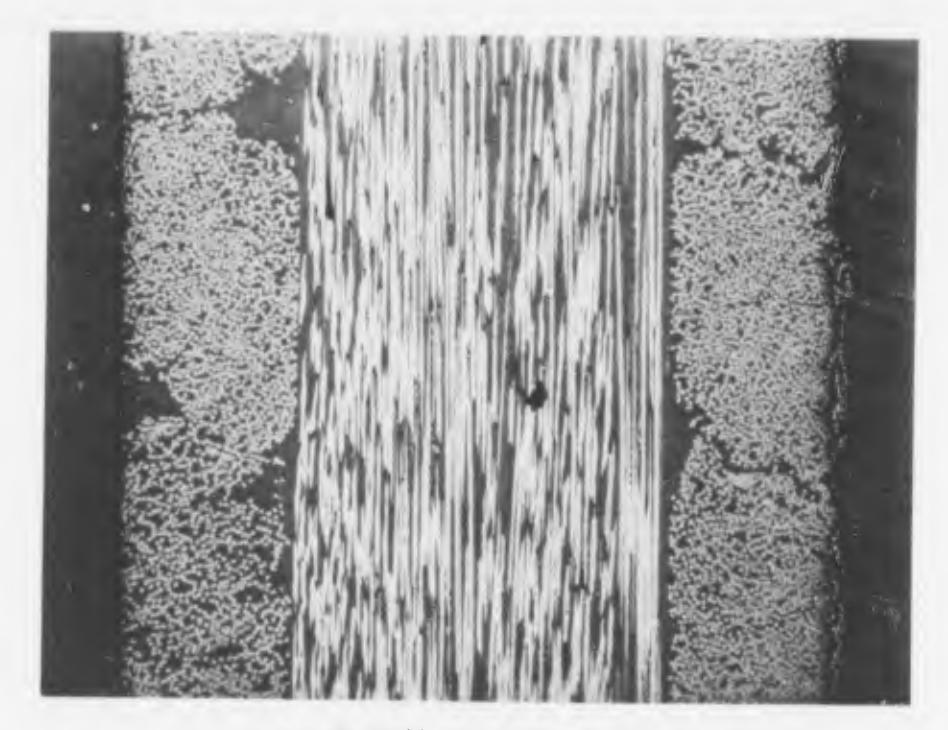
FIGURE 89 - 100X Photomicrograph of a Damaged Area of Graphite Fiber/ Epoxy Panel After Exposure to Simulated Lightning Discharge

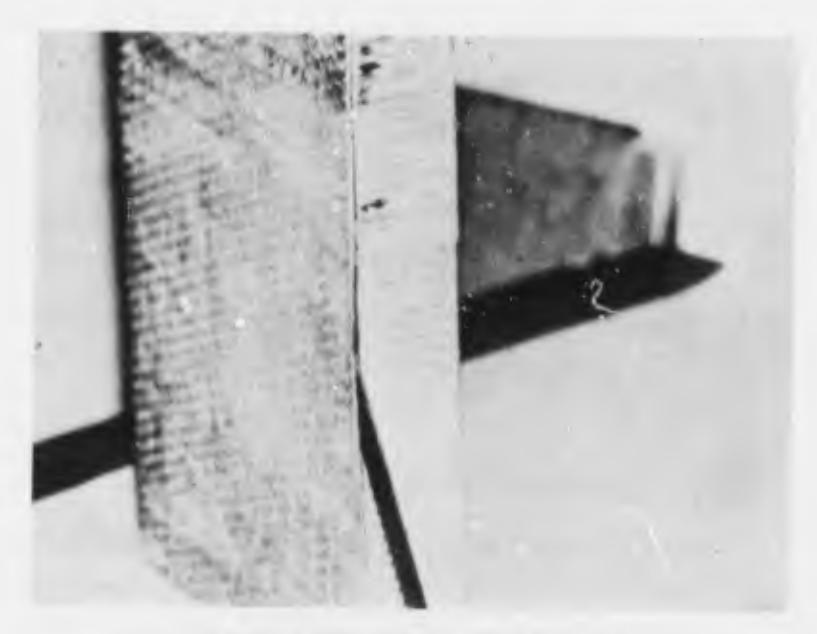
This panel received two tests, the first at 154 kA and the second at 203 kA. At the 154 kA level, there was apparently no damage to the panel except a slight discoloration of the surface. The amount of this discoloration was far less than was observed on the silver-paint coated samples at a much lower current level. At the second level of 203 kA, there was some pitting of the surface accompanied by a mechanical separation of the laminated surface from the honeycomb filler. Presumably the mechanical shock associated with the arc cracked the adhesive joining the panel to the honeycomb. Pictures of the resulting damage are shown on Figures 110-B and 110-C.

C. Sample BR-103-1 (Boeing Panel) Showing Delamination caused by 203 kA Test Current
