TECHNICAL REPORT AFATL-TR-74-70

**PLASTIC FRANGIBLE PROJECTILE  
GUN FUNCTION TEST**

**Stephen J. Bilsbury, Major, USAF  
GUNS AND ROCKETS BRANCH  
GUNS AND ROCKETS DIVISION**

FINAL REPORT: March 1974

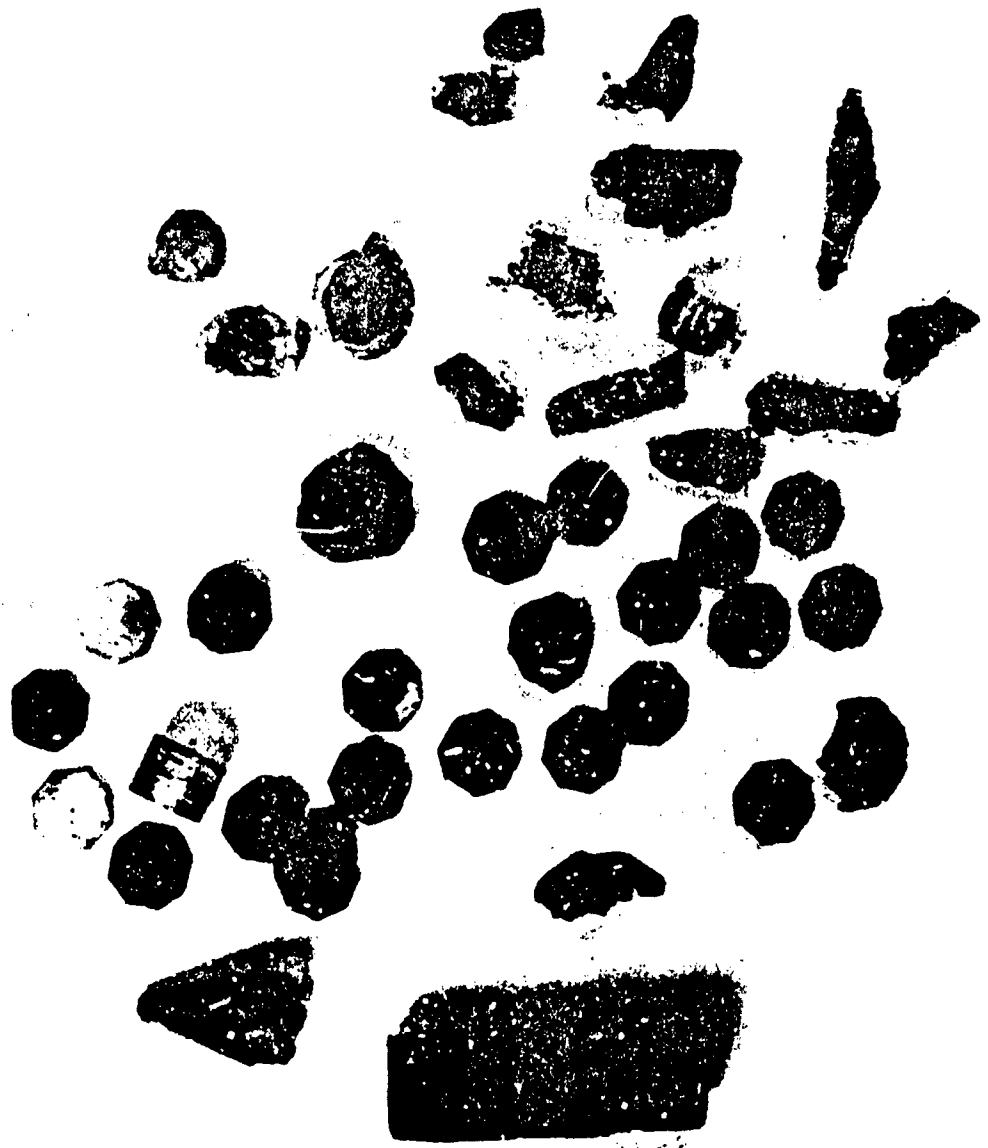
Figure 4. Plastic Frangible Projectiles After Impact On Soft Sand At 45° Angle Obliquity

3. There was no evidence of any intact projectiles in the target backstop, which was soft sand at a 45° angle with the horizontal (See Figure 4).
4. Fragments of Projectiles picked up at the target backstop provided the following observations:

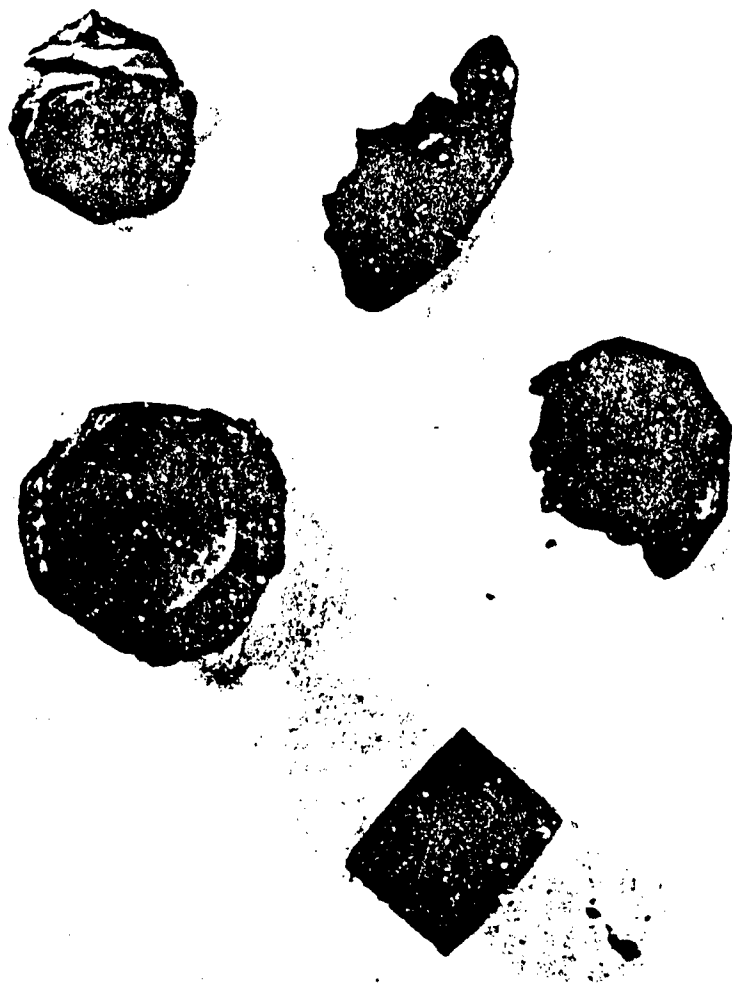
- a. It was noted that in several cases, groups of washers stayed together; however, they were not welded together and came apart easily in the hand (See Figure 10).

Figure 10. Metal Platelets of Plastic Frangible Projectiles  
Obtained at Target Backstop

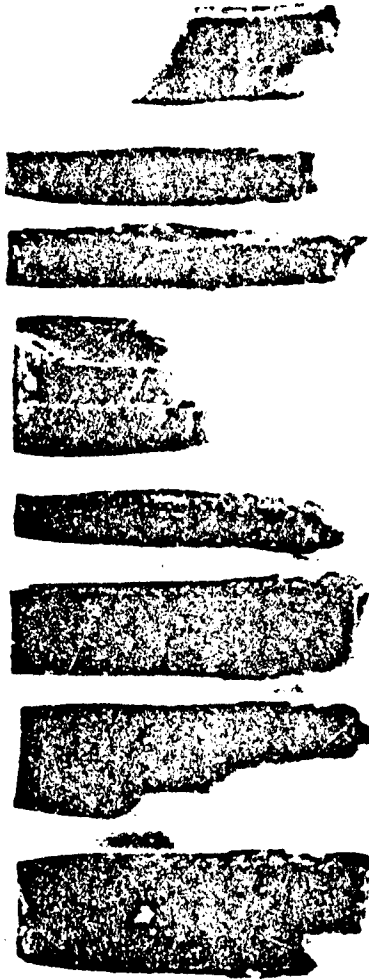
- b. The plastic is being cold-formed to the extent that it is being squeezed between the washers, which are under compression due to acceleration. This occurs from the leading edge of the rotating band to the projectile base. (See Figures 11 and 12).

- d. There is little evidence of a good bond between the projectile tip and the body, i.e., those fragments observed indicated an almost smooth, as molded, surface, with no indication that interfacial melting had taken place. (See Figures 11 and 13).

Figure 11. Plastic Fragments of Plastic Frangible Projectiles  
Obtained at Target Backstop (Reverse)

1. Should the current design be continued, a positive method should be devised to assure the integrity of the bond between the tip and projectile body.
2. An improved plastic encapsulation design should be devised.

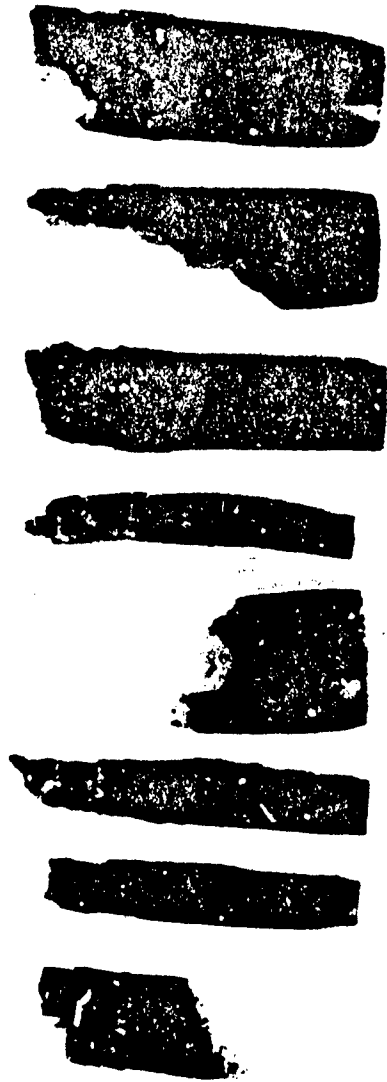
- c. One almost intact plastic projectile body showed that gun gas is apparently escaping around the lands and grooves, thus darkening the projectile body forward of the rotating band (See Figures 12 and 13).

Figure 12. Plastic Fragments of Plastic Frangible Projectiles  
Obtained at Target Backstop (Obverse)

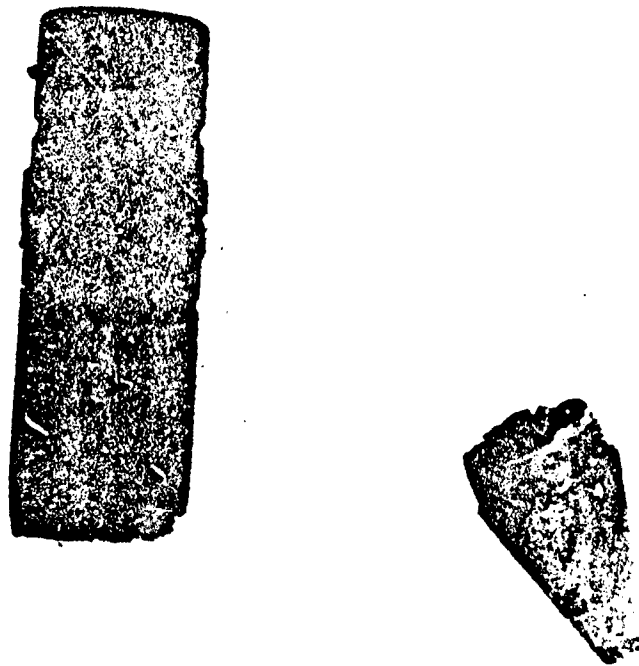
Figure 13. Plastic Sections

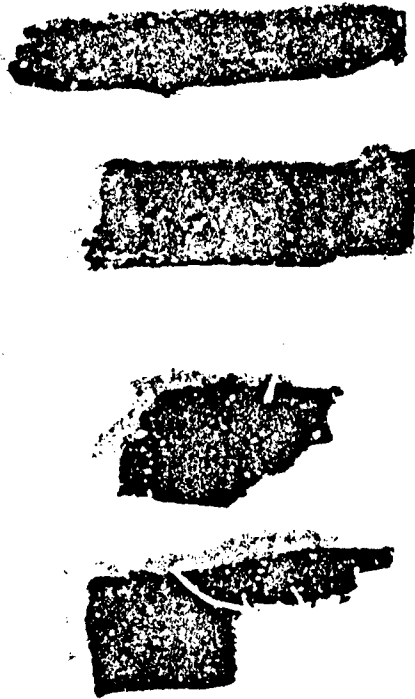
5. Fragments of projectiles picked up in front of the gun muzzle show that:
  - a. In some cases, gun gas was getting into the interior of the projectile. (See Figure 14).

- b. The plastic body is breaking along the sharp edges of the octagonal platelet (independent of engraving by the lands and grooves of the barrel). See Figures 14 and 15).

Figure 14. Plastic Fragments Obtained  
At Gun Muzzle (Reverse)

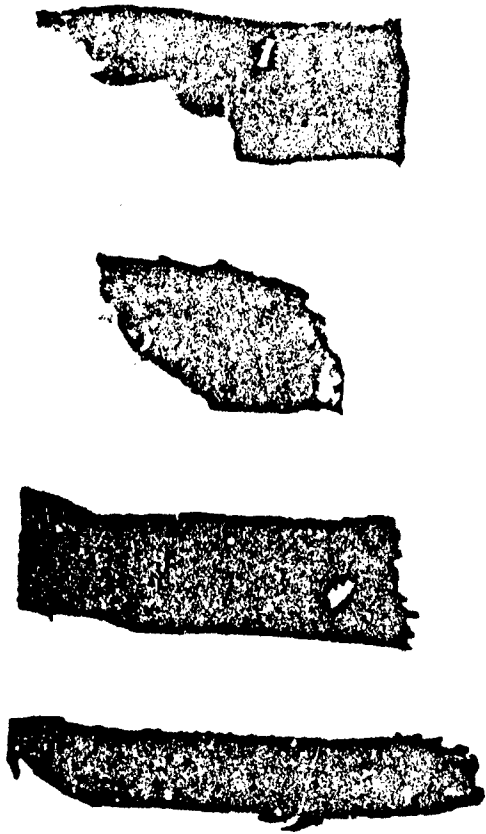
Figure 15. Plastic Fragments Obtained  
At Gun Muzzle (Obverse)
