Petrographic Analysis of Cores from Plant 42

E. Rae Reed-Gore, Kyle Klaus, and Robert D. Moser

October 2016

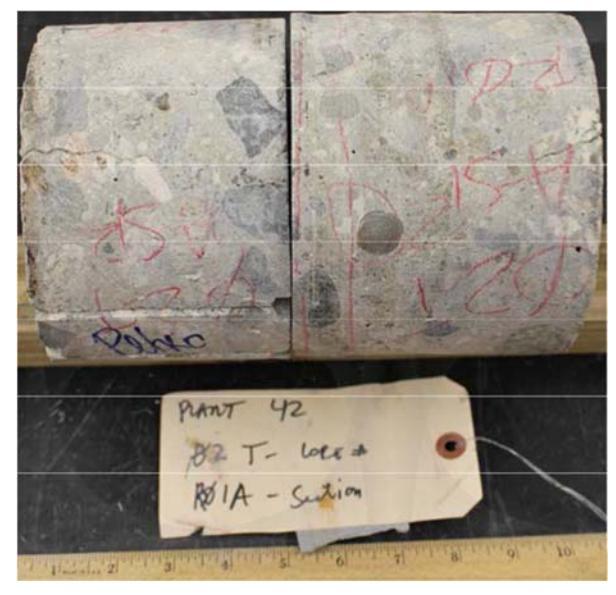
The as-received core 160143-1 (02T) is shown in Figure 2. The core was 8.5 inches long and 6 inches in diameter. There were 2 cracks greater than 0.5mm in width, one extends 3 in into core, extends through 2 coarse aggregates and terminates at a coarse aggregate. The second crack extends 3.5 in into core, extends around 1 coarse aggregate, but through 4 others. Carbonation staining is within the top inch from the surface. There was some staining along the longer crack, indicating the crack was most likely a shrinkage crack from construction. There was minor aggregate distress observed, but no severe ASR deterioration observed. See Figure 3 for low and high magnification microscopy images of 160143-1 (02T).

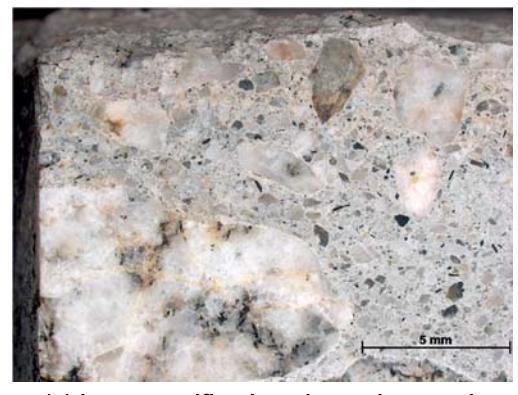
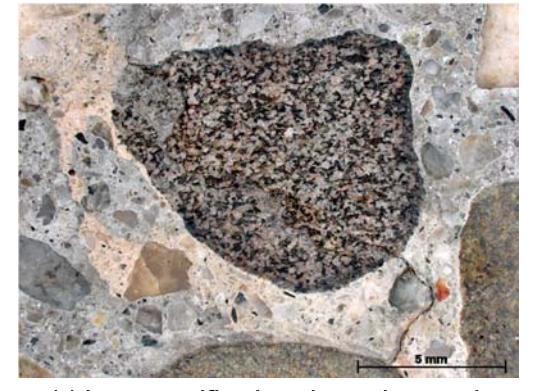
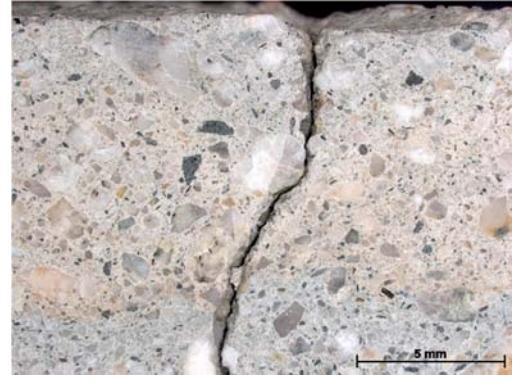
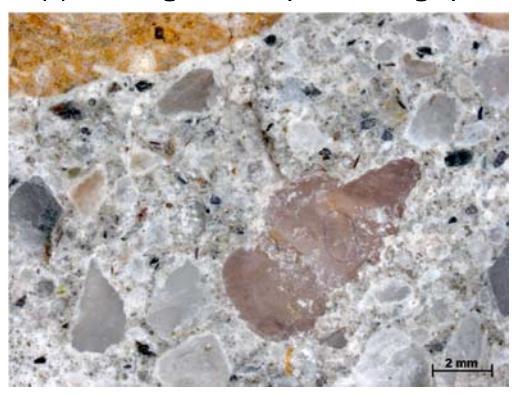
Figure 3. Low and High magnifications of 160143-1 (02T). (a) minor carbination sataining at the surface, (b) carbination stainging and crack at the surface, (c) carbination staining around cracked aggregate, (d) high magnification to see fine aggregate and cement, minir cracking.

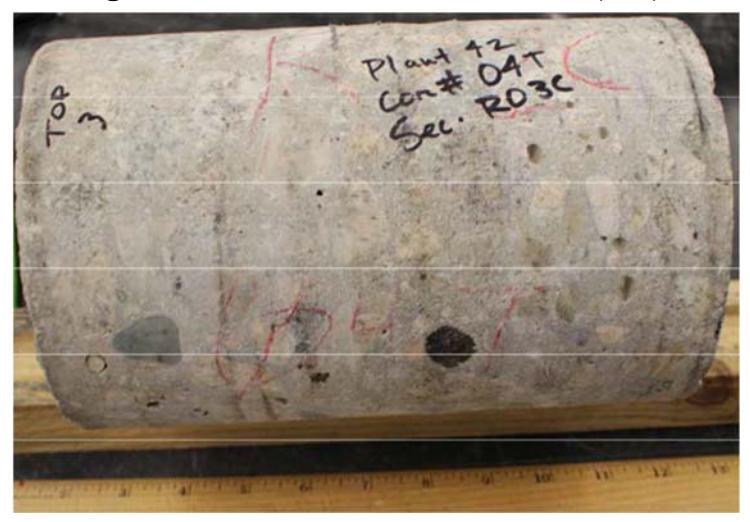
Figure 4. The as-received core 160143-2 (04T).

The as-received core 160143-2 (04T) is shown in Figure 4. The core was 8.75 inches long and 6 inches in diameter. A crack over 2 in into concrete, greater than 0.5mm width, extends through 2 coarse aggregates and terminates at a coarse aggregate. Carbonation staining is within the top inch from the surface, mainly around aggregates. There was some staining along the longer crack, indicating the crack was most likely a shrinkage crack from construction. Air voids are infilled with precipitates (ettringite and calcium hydroxide). A void, seen in Figure 5 (b), appears to be from an aggregate that popped out earlier or from a large entrapped air void

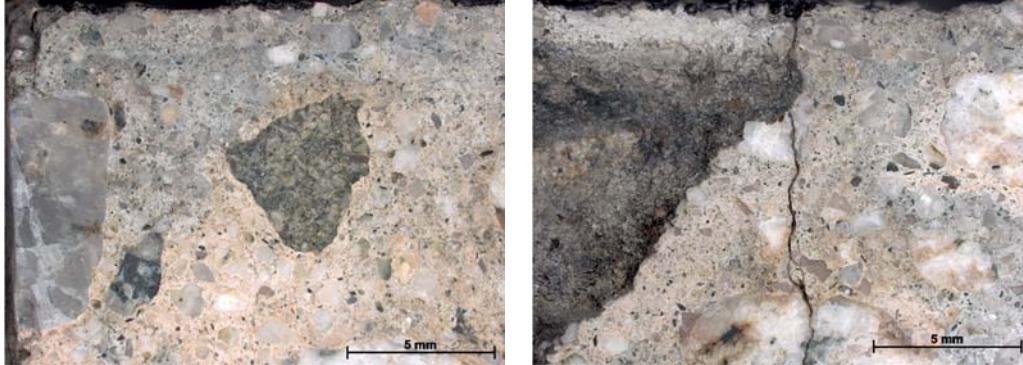
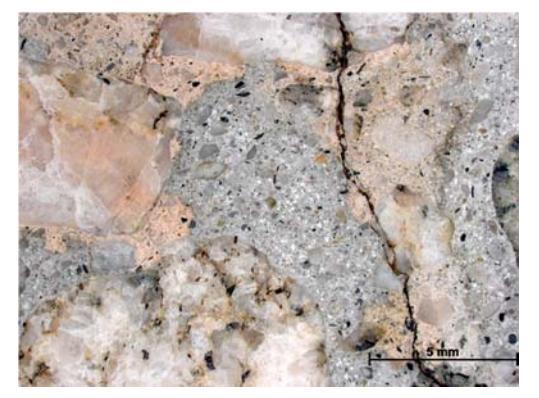
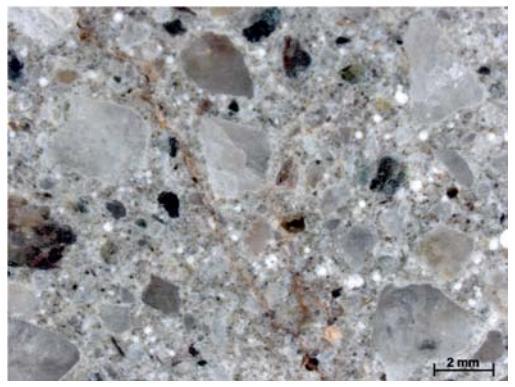
Figure 5. Low and High magnifications of 160143-2 (04T). (a) carbination sataining at the surface, (b) carbination stainging, crack at the surface, and large void most likely due to aggregate pop out, (c) carbination staining around cracked aggregate, (d) high magnifiction to see fine aggregate and cement, minir cracking.

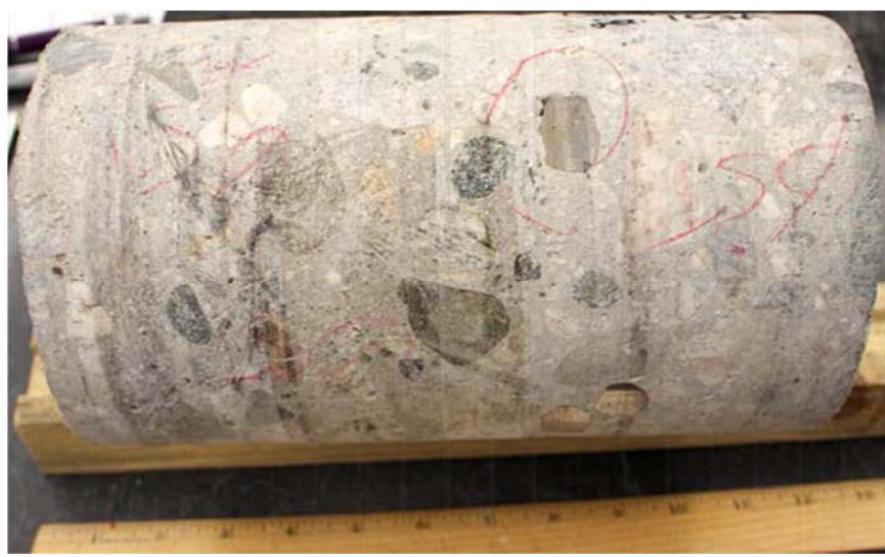
Figure 6. The as-received core 160143-3 (05T).

The as-received core 160143-3 (05T) is shown in Figure 6. The core was 9.75 inches long and 6 inches in diameter. There was minor carbonation staining within an inch of the surface. A crack was observed to extend 3mm, was less than 0.1 mm width and terminates at a coarse aggregate. Some crack was observed in the coarse aggregate of which followed the foliated fabric of the aggregate. Voids were partially infilled with a white deposit, most likely ettringite and calcium hydroxide. See Figure 7 for low and high magnification microscopy images of 160143-1 (02T).

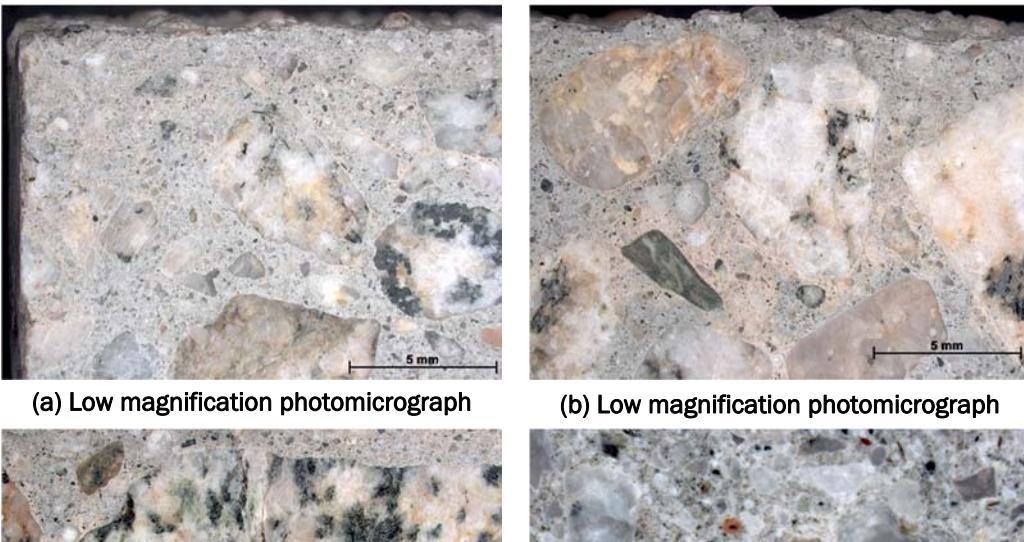
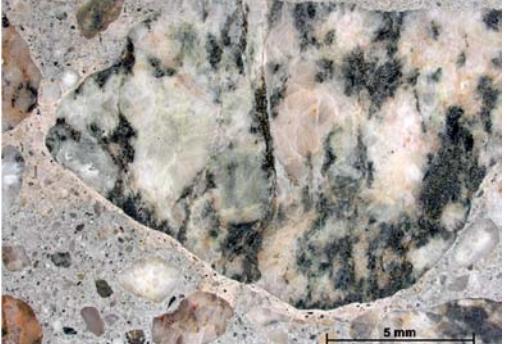
Figure 7. Low and High magnifications of 160143-3 (05T). (a) minor carbination sataining at the surface, (b) carbination stainging at the surface, (c) carbination staining around cracked aggregate, (d) high magnification to see fine aggregate and cement.

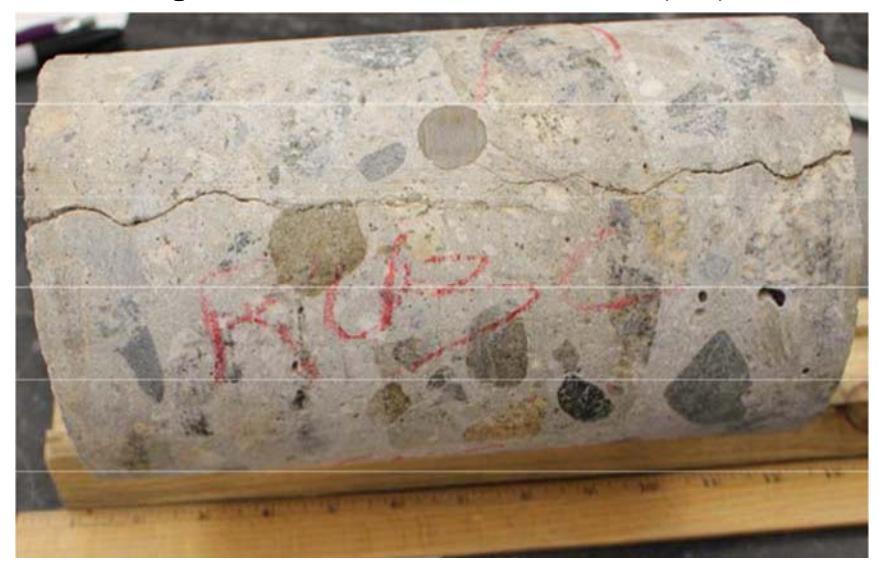
Figure 8. The as-received core 160143-4 (08T).

The as-received core 160143-4 (08T) is shown in Figure 8. The core was 9.5 inches long and 6 inches in diameter. The large vertical crack in as received core caused sample to separate upon cutting core. The crack did not appear to go through any coarse aggregates. Minor carbonation staining within an inch of the surface was observed. There was no visible signs of ASR gel or damage due to ASR gel expansion. Voids were partially infilled with a white deposit, most likely ettringite and calcium hydroxide. See Figure 9 for low and high magnification microscopy images of 160143-4 (08T).

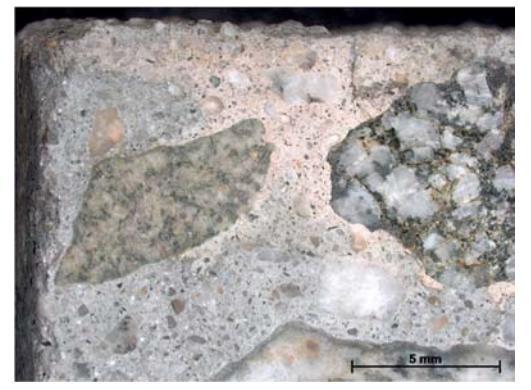
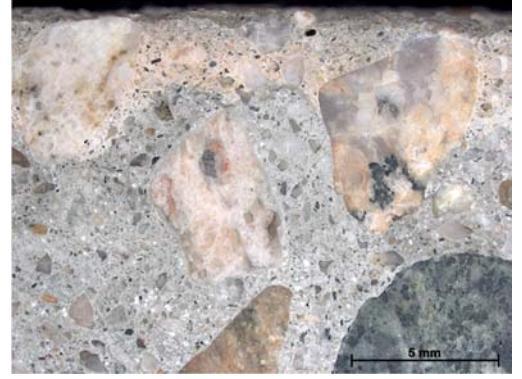
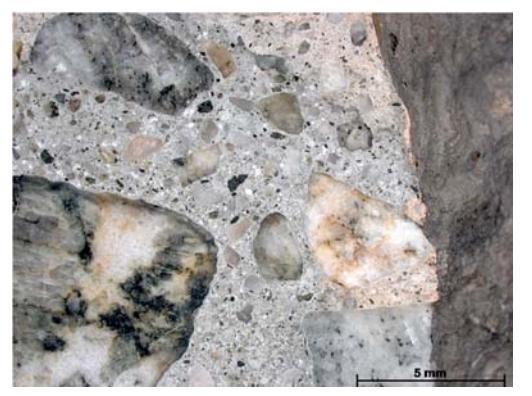
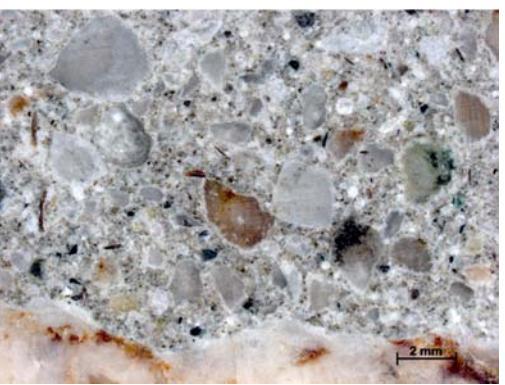
Figure 9. Low and High magnifications of 160143-4 (08T). (a) minor carbination sataining at the surface, (b) carbination stainging at the surface, (c) carbination staining following preexisting crack, (d) high magnification to see fine aggregate and cement.

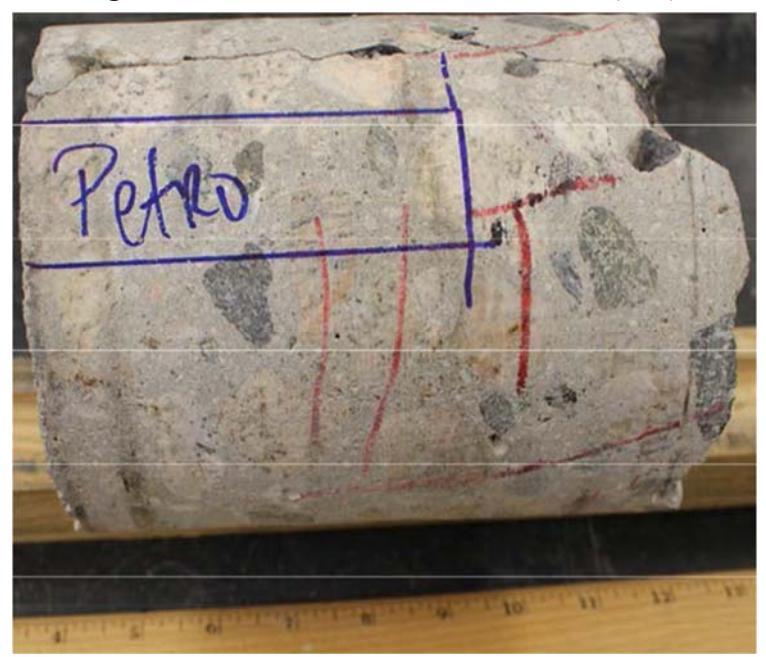
Figure 10. The as-received core 160143-5 (11T).

The as-received core 160143-5 (11T) is shown in Figure 10. The core was 6.5 inches long and 6 inches in diameter. Very minor staining at surface is due to carbonation and deeper in sample oxidation of iron oxide inclusions in aggregates. Voids were partially infilled with a white deposit, most likely ettringite and calcium hydroxide. There were 2 vertical cracks observed, the first extended 20mm, greater than 0.2 mm wide and terminates in a coarse aggregate. The second crack extended 12mm and terminated at a coarse aggregate, and was greater than 0.1mm width. This sample contained large entrapped air voids (greatest was 3/8" x $\frac{1}{4}$ "). A coarse aggregate has cracking throughout the aggregate, cracks follow the foliation of the aggregate and does not appear to extend into paste. Some of the microcracks appear to be infilled with gel, evidence of minor ASR. See Figure 11 for low and high magnification microscopy images of 160143-5 (11T).

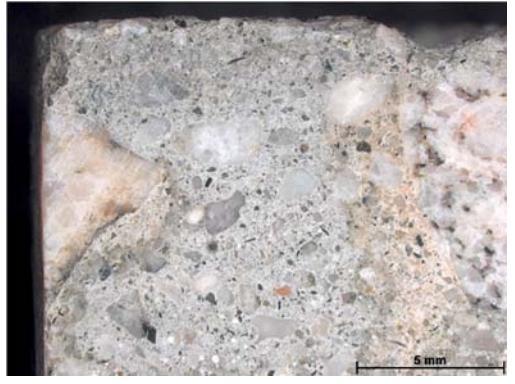
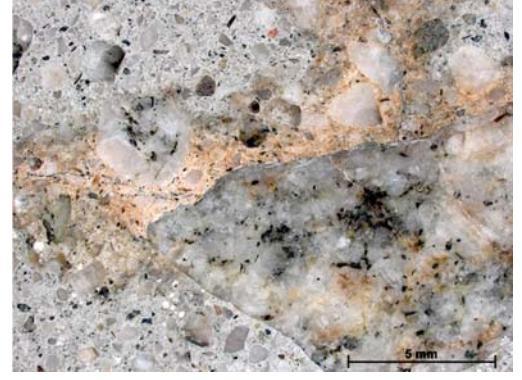
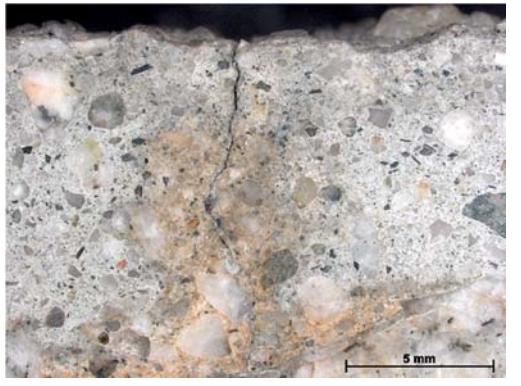
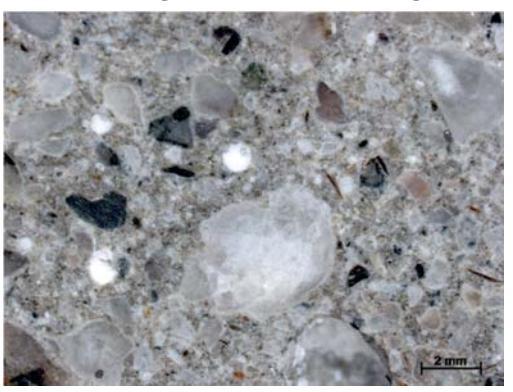
Figure 11. Low and High magnifications of 160143-5 (11T). (a) minor carbination sataining at the surface, (b) carbination stainging at the surface following older crack, (c) carbination staining around coarse aggregate, (d) high magnification to see fine aggregate and cement.

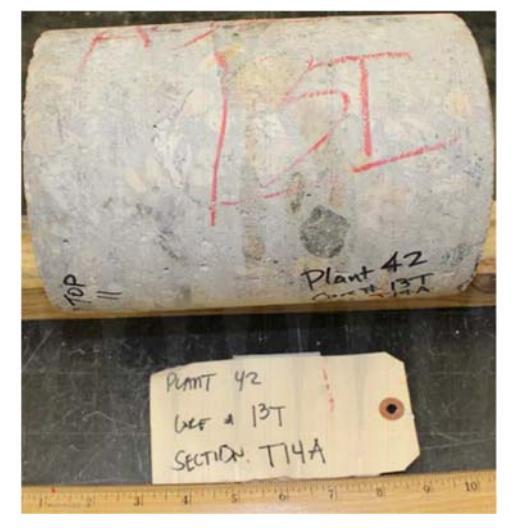
Figure 12. The as-received core 160143-6 (13T).

The as-received core 160143-6 (13T) is shown in Figure 12. The core was 6.75 inches long and 6 inches in diameter. Minor carbonation staining within a half inch of the surface was observed. There was no visible signs of ASR gel or damage due to ASR gel expansion. Voids were partially infilled with a white deposit, most likely ettringite and calcium hydroxide. A crack, 11mm deep and less than 0.1mm width, was observed. Carbonation staining was observed along this crack. See Figure 13 for low and high magnification microscopy images of 160143-6 (13T).

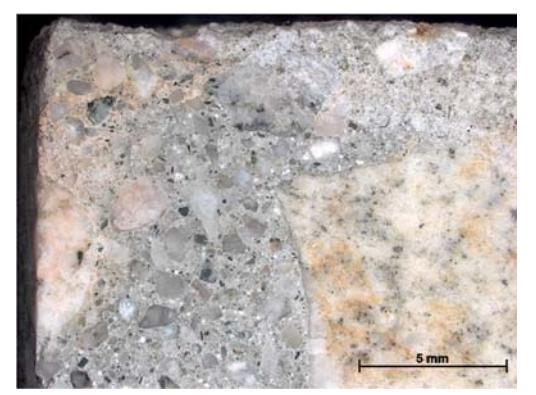
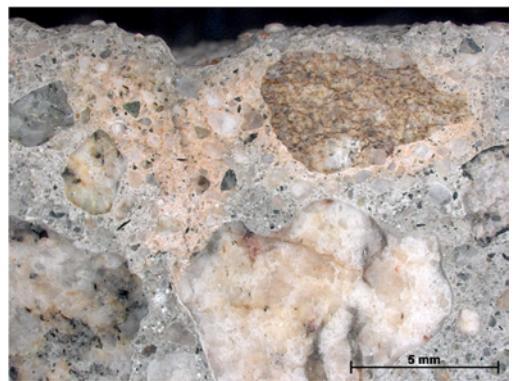
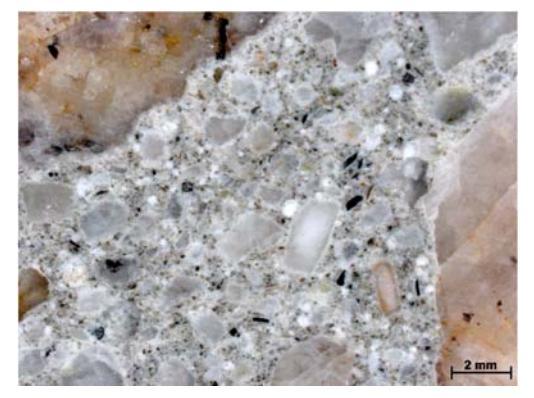
Figure 13. Low and High magnifications of 160143-6 (13T). (a) minor carbination sataining at the surface, (b) carbination stainging at the surface around coarse aggregates, (c) high magnification to see fine aggregate and cement.

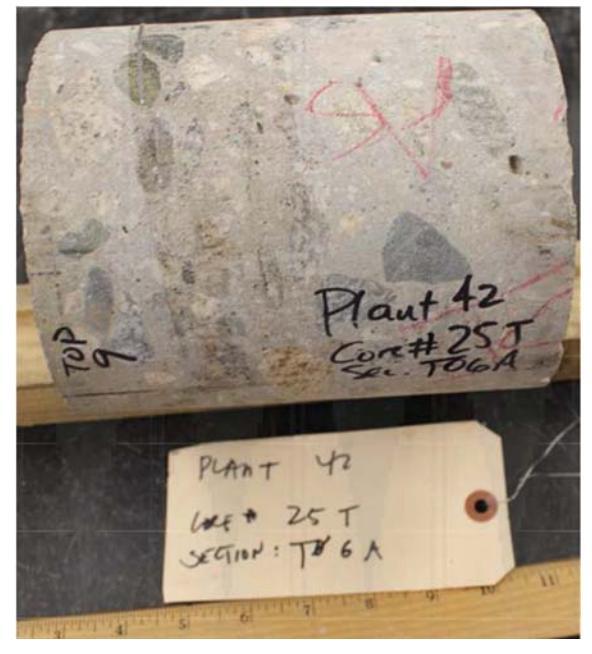
The as-received core 160143-7 (25T) is shown in Figure 14. The core was 7.5 inches long and 6 inches in diameter. Minor carbonation staining within an inch of the surface was observed. There was no visible signs of ASR gel or damage due to ASR gel expansion. Voids were partially infilled with a white deposit, most likely ettringite and calcium hydroxide. A crack extends 45mm from the surface and was greater than 0.5mm width. The crack extended around 1 coarse aggregate, but through 2 others, likely due to mechanical stresses. See Figure 15 for low and high magnification microscopy images of 160143-7 (25T).

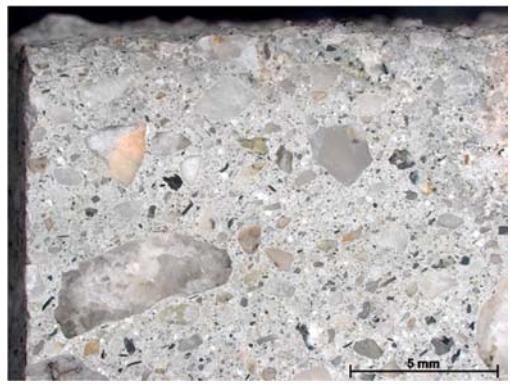
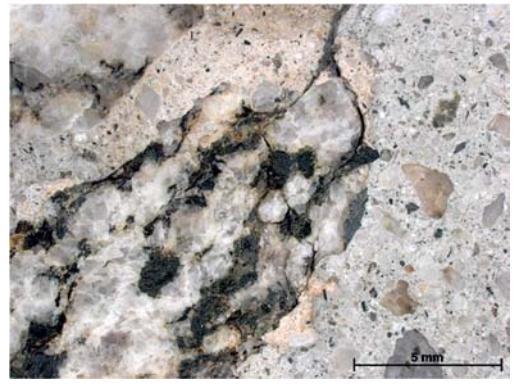
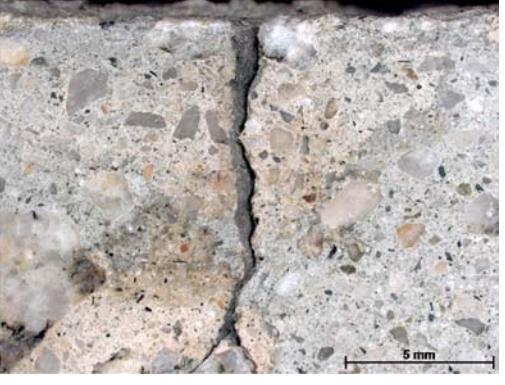
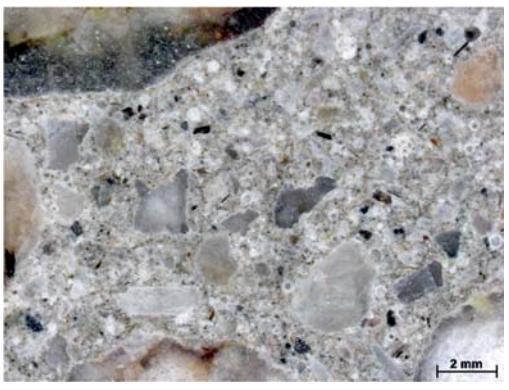
Figure 15. Low and High magnifications of 160143-7 (25T). (a) little to no carbination sataining at the surface, (b) carbination stainging at the surface following older crack, (c) carbination staining around cracked coarse aggregate, (d) high magnification to see fine aggregate and cement.

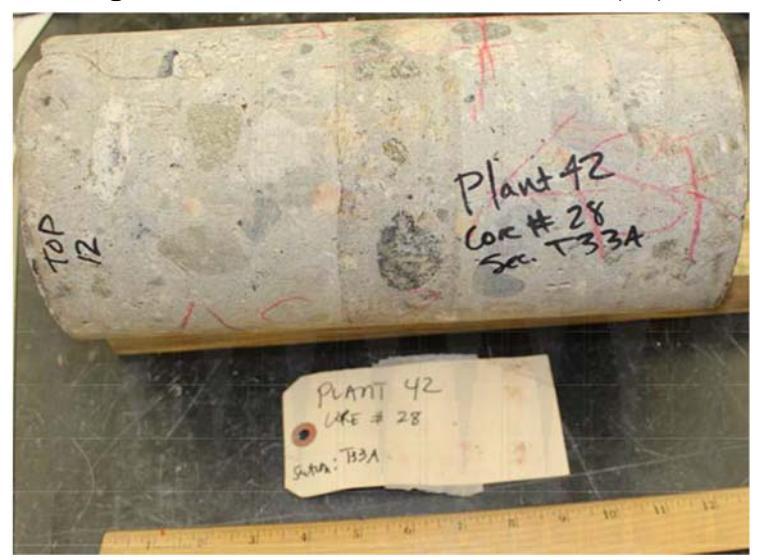
Figure 16. The as-received core 160143-8 (28).

The as-received core 160143-8 (28) is shown in Figure 16. The core was 9.875 inches long and 6 inches in diameter. Minor carbonation staining within an inch of the surface was observed. There was no visible signs of ASR gel or damage due to ASR gel expansion. Voids were partially infilled with a white deposit, most likely ettringite and calcium hydroxide. A crack extended through the sample, greater than 0.5mm width, but sample remained intact. The crack did not extend through any aggregates except the edge of one at 3 in in depth. See Figure 17 for low and high magnification microscopy images of 160143-8 (28).

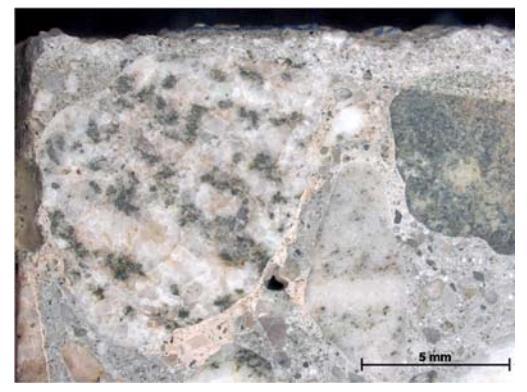
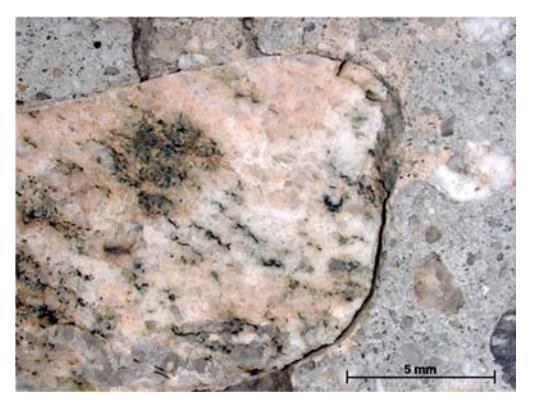
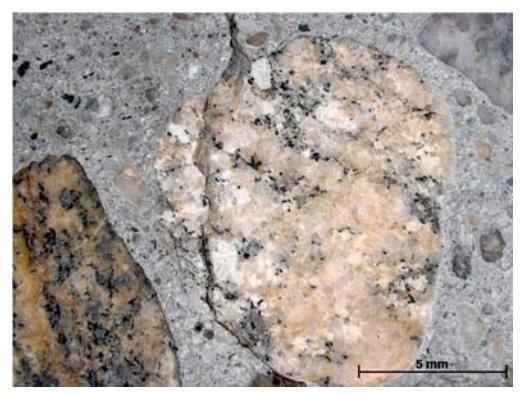
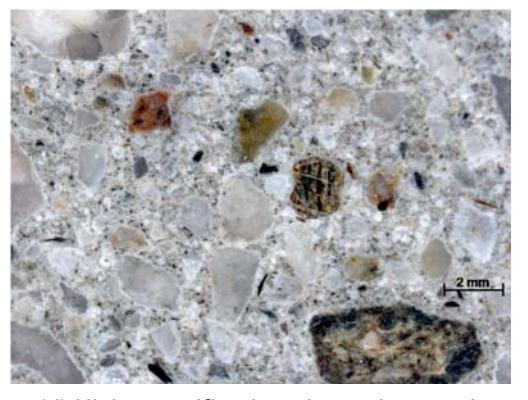
Figure 17. Low and High magnifications of 160143-8 (28). (a) minor carbination sataining at the surface, (b) carbination stainging following crack around coarse aggregate, (c) crack extending through coarse aggregate, (d) high magnification to see fine aggregate and cement.

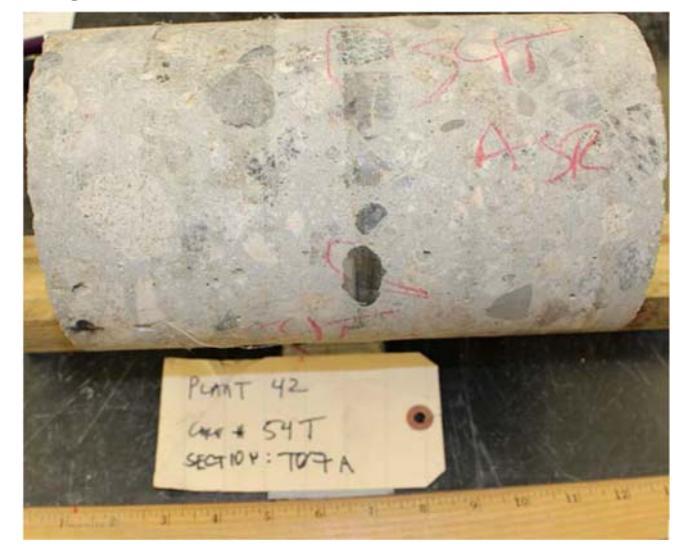
The as-received core 160143-9 (54T) is shown in Figure 18. The core was 6.75 inches long and 6 inches in diameter. Minor carbonation staining within an inch of the surface was observed. There was no visible signs of ASR gel or damage due to ASR gel expansion. Voids were partially infilled with a white deposit, most likely ettringite and calcium hydroxide. A crack at surface was 7mm deep and less than 0.1 mm in width, and terminates at a coarse aggregate. Coarse aggregate near the surface show signs of chemical weathering at grain boundaries within the aggregate, most likely due to wetting at the surface. Similar aggregates look like a gneiss and show no sign of weathering of chemical alteration with depth. See Figure 19 for low and high magnification microscopy images of 160143-9 (54T).

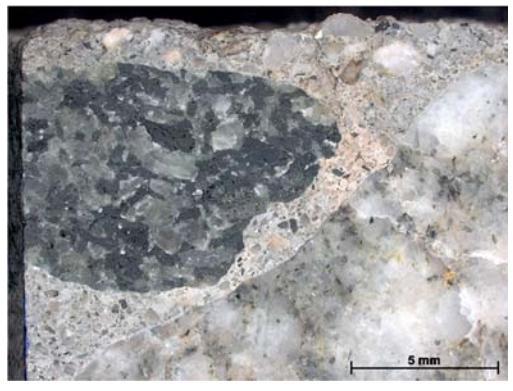
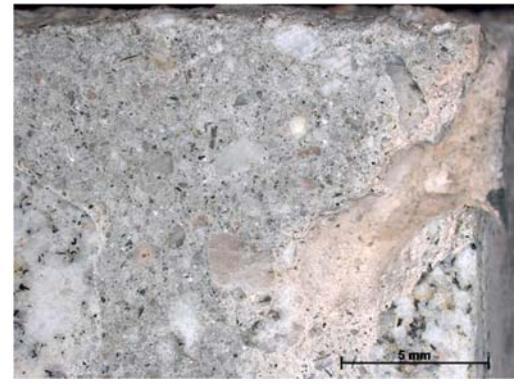
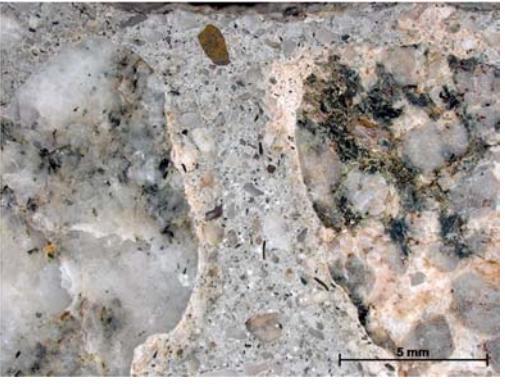
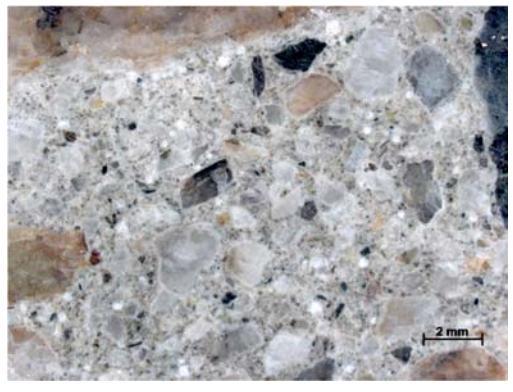
Figure 19. Low and High magnifications of 160143-9 (54T). (a) minor carbination sataining at the surface, (b) carbination stainging following coarse aggregate, (c) carbination staining in older void, (d) high magnification to see fine aggregate and cement.

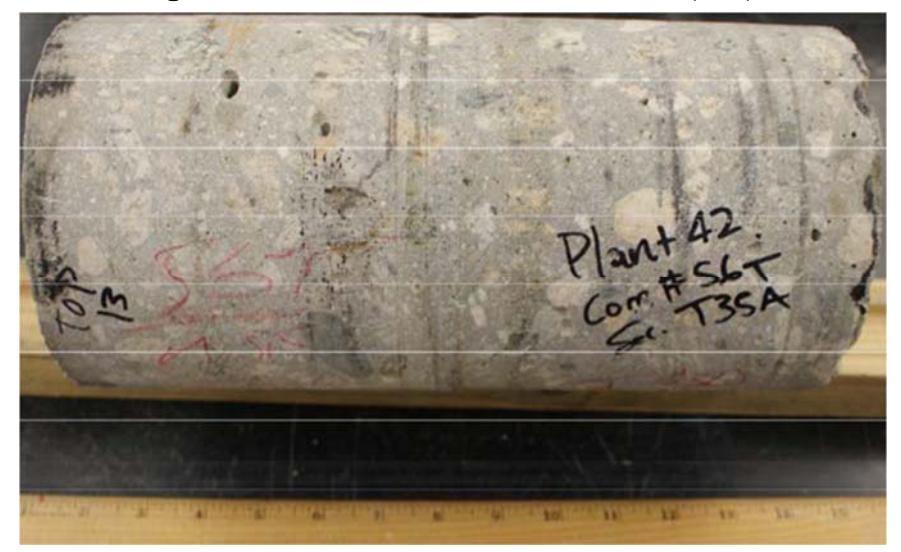
Figure 20. The as-received core 160143-10 (56T).

The as-received core 160143-10 (56T) is shown in Figure 20. The core was 9.5 inches long and 6 inches in diameter. There was no visible signs of ASR gel or damage due to ASR gel expansion, and no visible staining due to carbonation. Voids were partially infilled with a white deposit, most likely ettringite and calcium hydroxide. Two cracks were observed, both 20mm deep and greater than 0.2mm width. See Figure 21 for low and high magnification microscopy images of 160143-10 (56T).

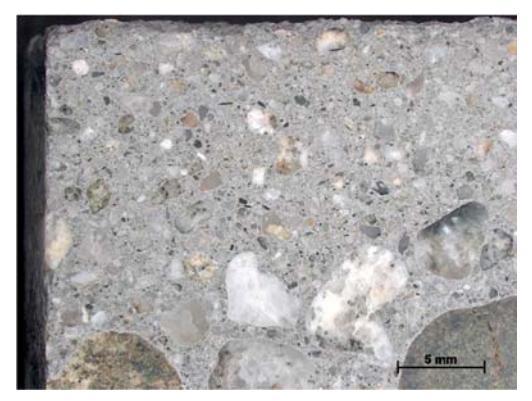
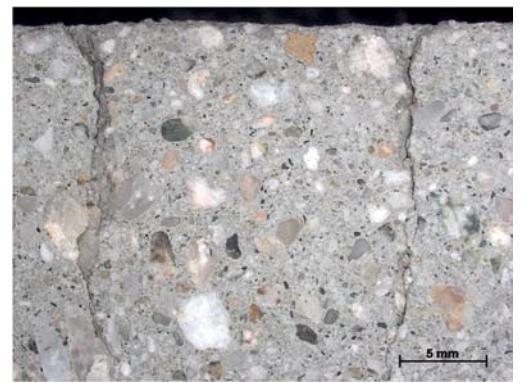
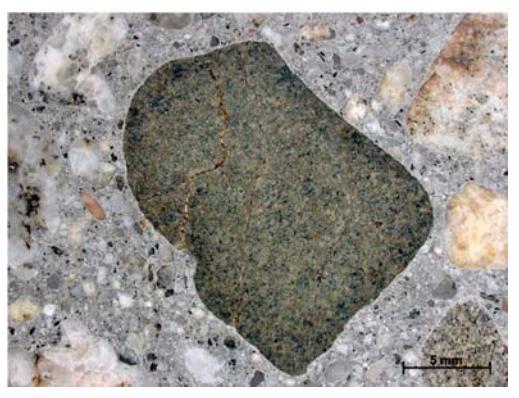
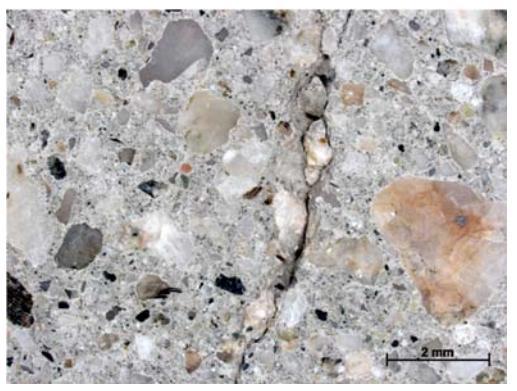
Figure 21. Low and High magnifications of 160143-10 (56T). (a) little to no carbination sataining at the surface, (b) cracks at the surface of the sample, (c) crack in coarse aggregate with iron staining, (d) high magnification to see fine aggregate and cement with cracking.

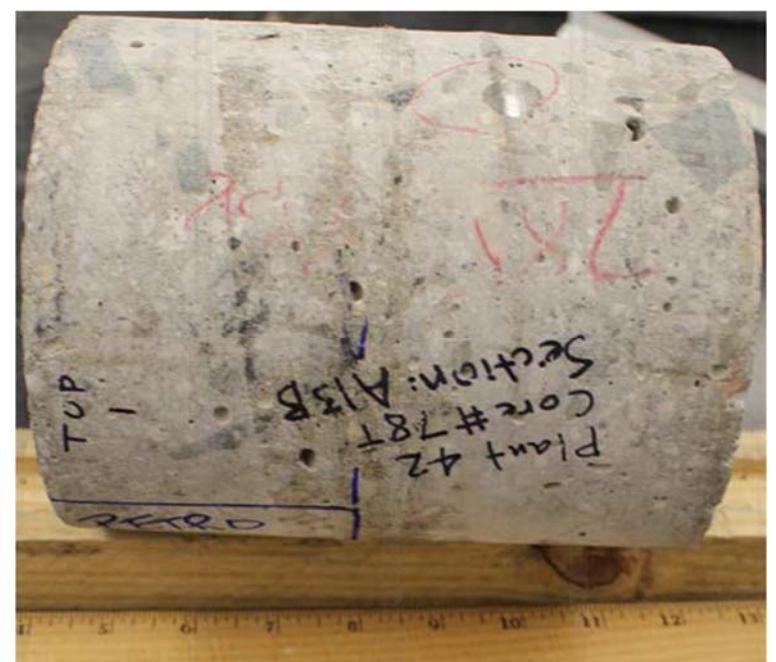
The as-received core 160143-11 (78T) is shown in Figure 22. The core was 6.75 inches long and 6 inches in diameter. Minor carbonation staining within an inch of the surface was observed. There was no visible signs of ASR gel or damage due to ASR gel expansion. Voids were partially infilled with a white deposit, most likely ettringite and calcium hydroxide. A crack was observed that extends 15mm from the surface and was less than 0.1mm in width. See Figure 23 for low and high magnification microscopy images of 160143-11 (78T).

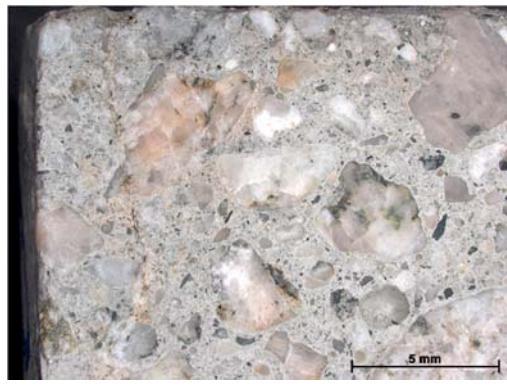
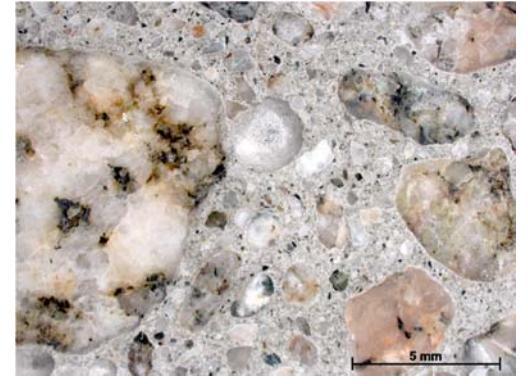
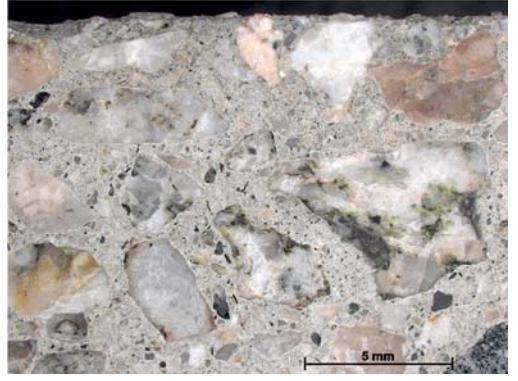
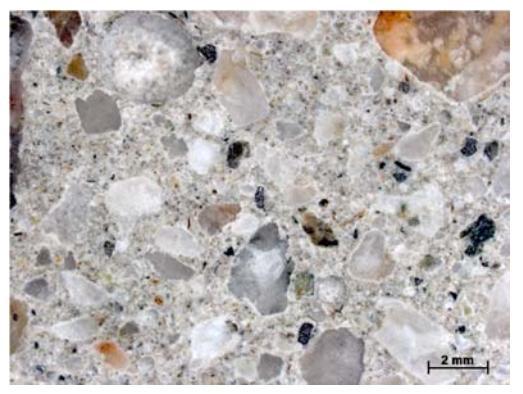
Figure 23. Low and High magnifications of 160143-10 (56T). (a) little to no carbination sataining at the surface, (b)little to no satining at the surface, (c) very little destress seen within the sample, (d) high magnification to see fine aggregate and cement.

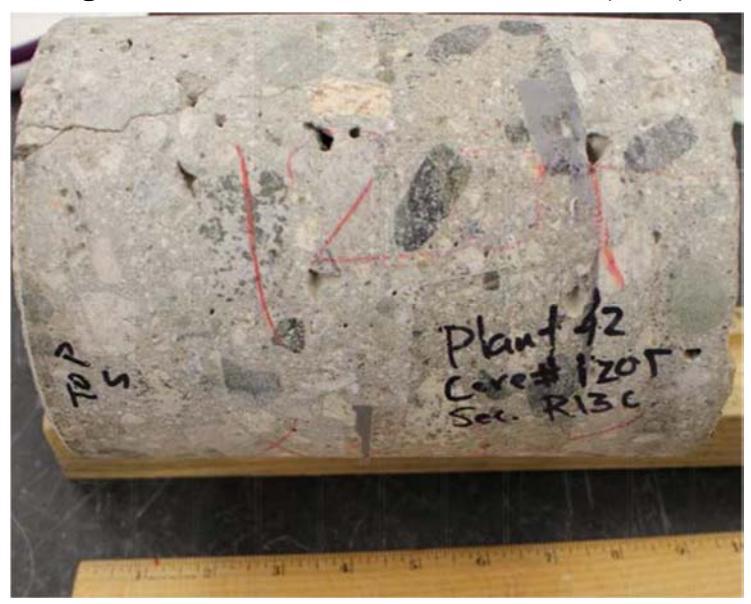
Figure 24. The as-received core 160143-12 (120T).

The as-received core 160143-12 (120T) is shown in Figure 24. The core was 7.75 inches long and 6 inches in diameter. There was no visible carbonation staining observed. There was no visible signs of ASR gel or damage due to ASR gel expansion. Voids were partially infilled with a white deposit, most likely ettringite and calcium hydroxide. A crack was observed at the surface, extends 30mm into sample and was less than 0.1mm in width. See Figure 25 for low and high magnification microscopy images of 160143-12 (120T).

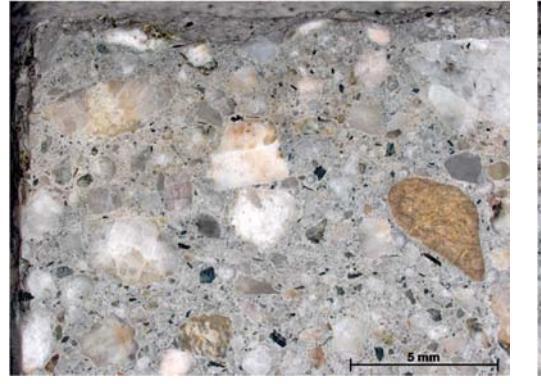
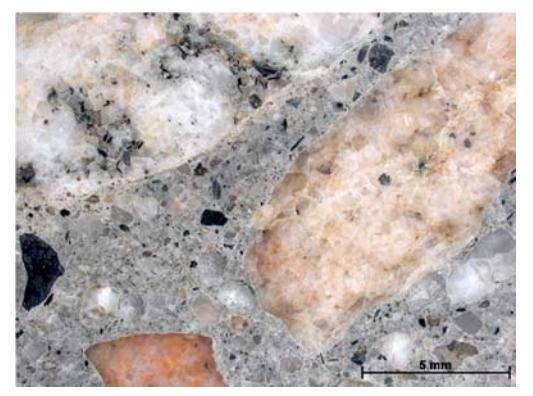
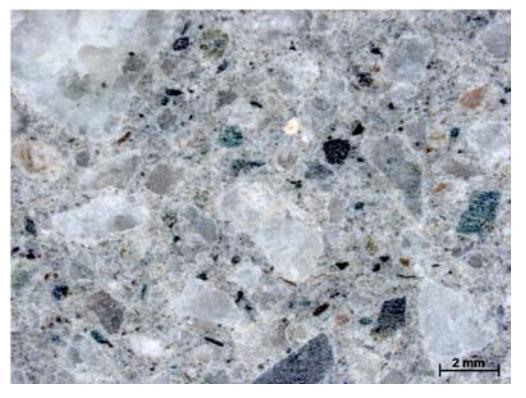
Figure 25. Low and High magnifications of 160143-12 (120T). (a) little to no carbination sataining at the surface, (b) fine crack at the surface of the sample, (c) minor staining around coarse aggregate, (d) high magnifiction to see fine aggregate and cement.

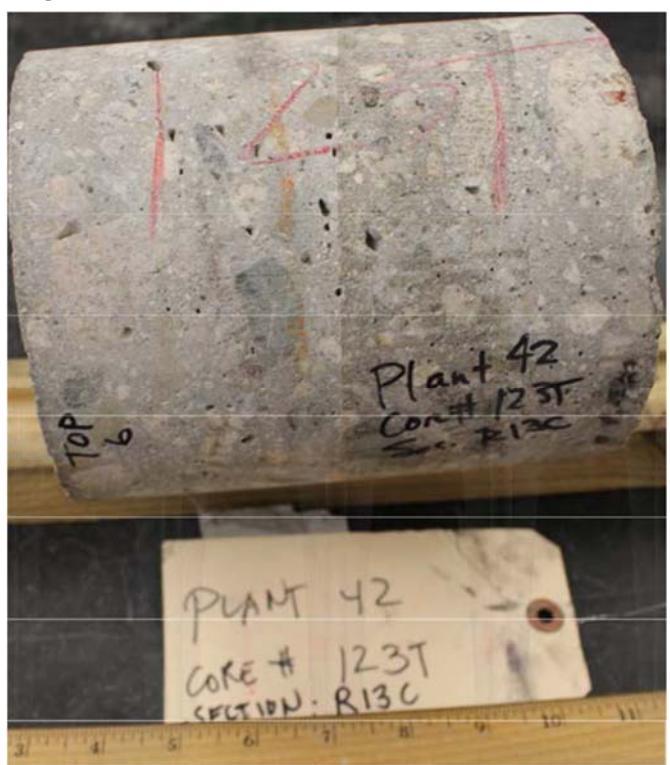
The as-received core 160143-13 (123T) is shown in Figure 26. The core was 6.625 inches long and 6 inches in diameter. Carbonation staining was observed only around large entrapped air voids. Large entrained air voids have little to no deposits of ettrignite or calcium hydroxide. There was no visible signs of ASR gel or damage due to ASR gel expansion. Two cracks were observed in the core. The first; a 3 mm crack, less than 0.2mm in width extends from the surface, terminates at a large entrapped air void $(1/4" \times 3/4")$, reappears at a coarse aggregate boundary and extends into another entrained air void $(1/8" \times 1/4")$. The second was a 15mm crack that was less than 0.1mm in width. See Figure 27 for low and high magnification microscopy images of 160143-13 (123T).

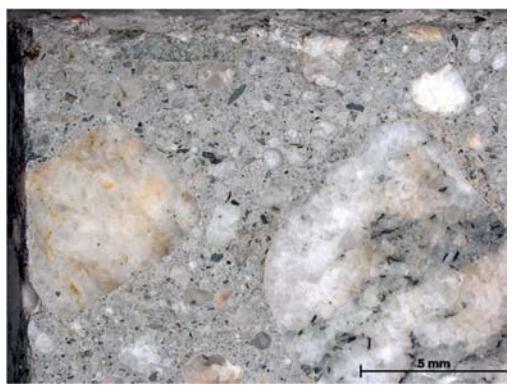
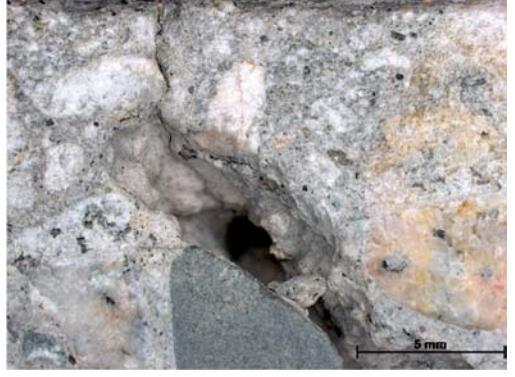
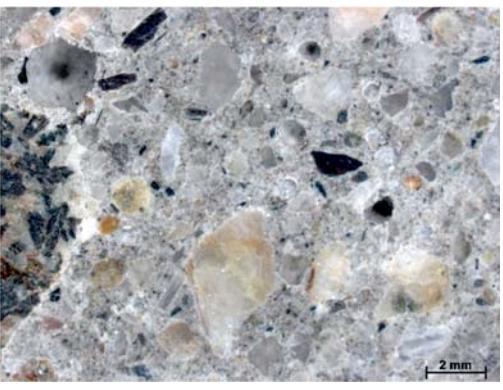
Figure 27. Low and High magnifications of 160143-13 (123T). (a) little to no carbination sataining at the surface, (b) minor staining around coarse aggregate, (c) cracking through large entrapped air void, with little to no staining, (d) high magnification to see fine aggregate and cement.

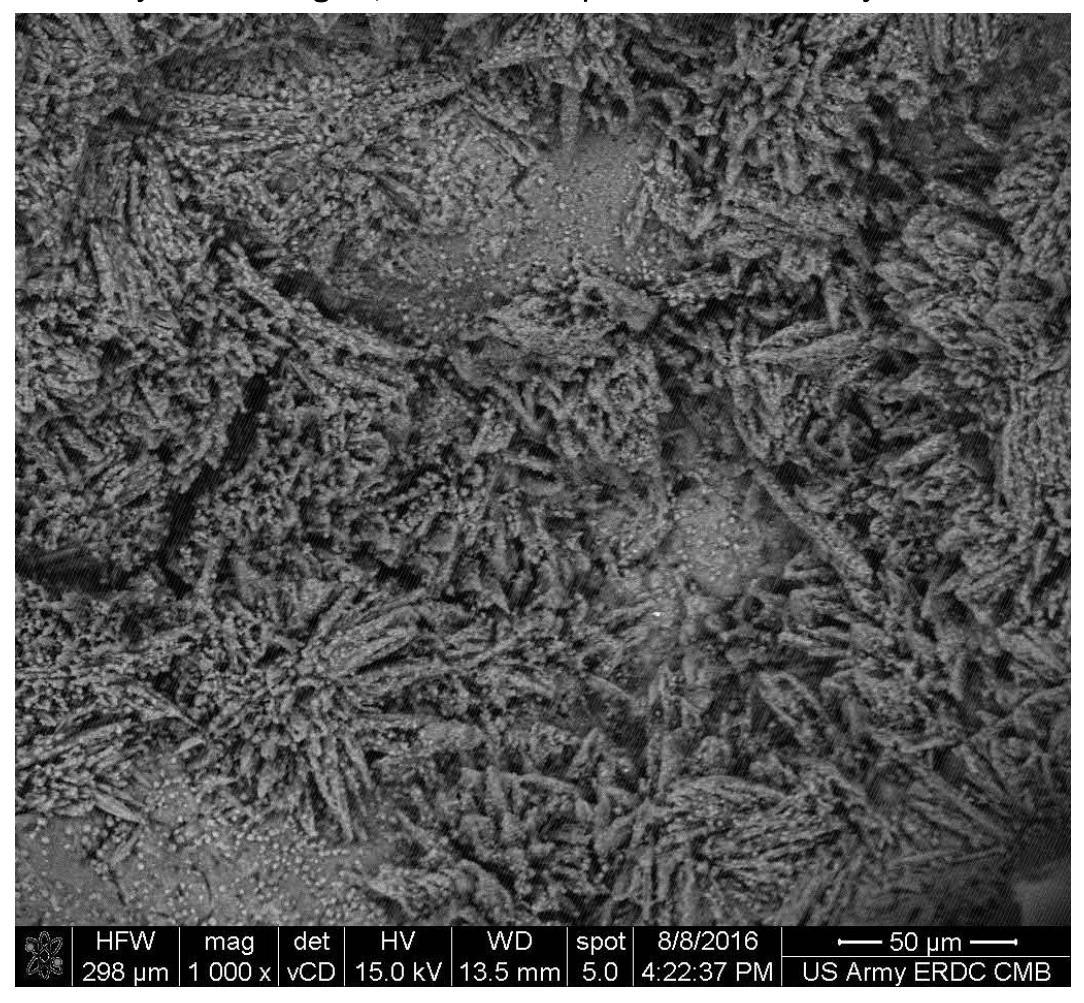
Core 160143-6 (13T) was evaluated in the SEM to determine the constituents of the white deposits that are found filling voids for most of the samples. In the image of a void, Figure 28, the radial needle-like crystals are ettrignite and the smaller particles throughout the image are calcium hydroxide. If the deposits were ASR gel, there would be no crystal form and the gel would most likely by highly cracked.

Figure 28. SEM image of a void in core 160143-6 (13T). The radial needle-like crystals are ettrignite, while the small particles are calcium hydroxide.
