Rapid-Setting Flowable Fill Performance in Cold Weather for Airfield Damage Repair

August 2018

Final report

Prepared for U.S. Air Force Civil Engineer Center 139 Barnes Drive, Suite 1 Tyndall AFB, FL 32403

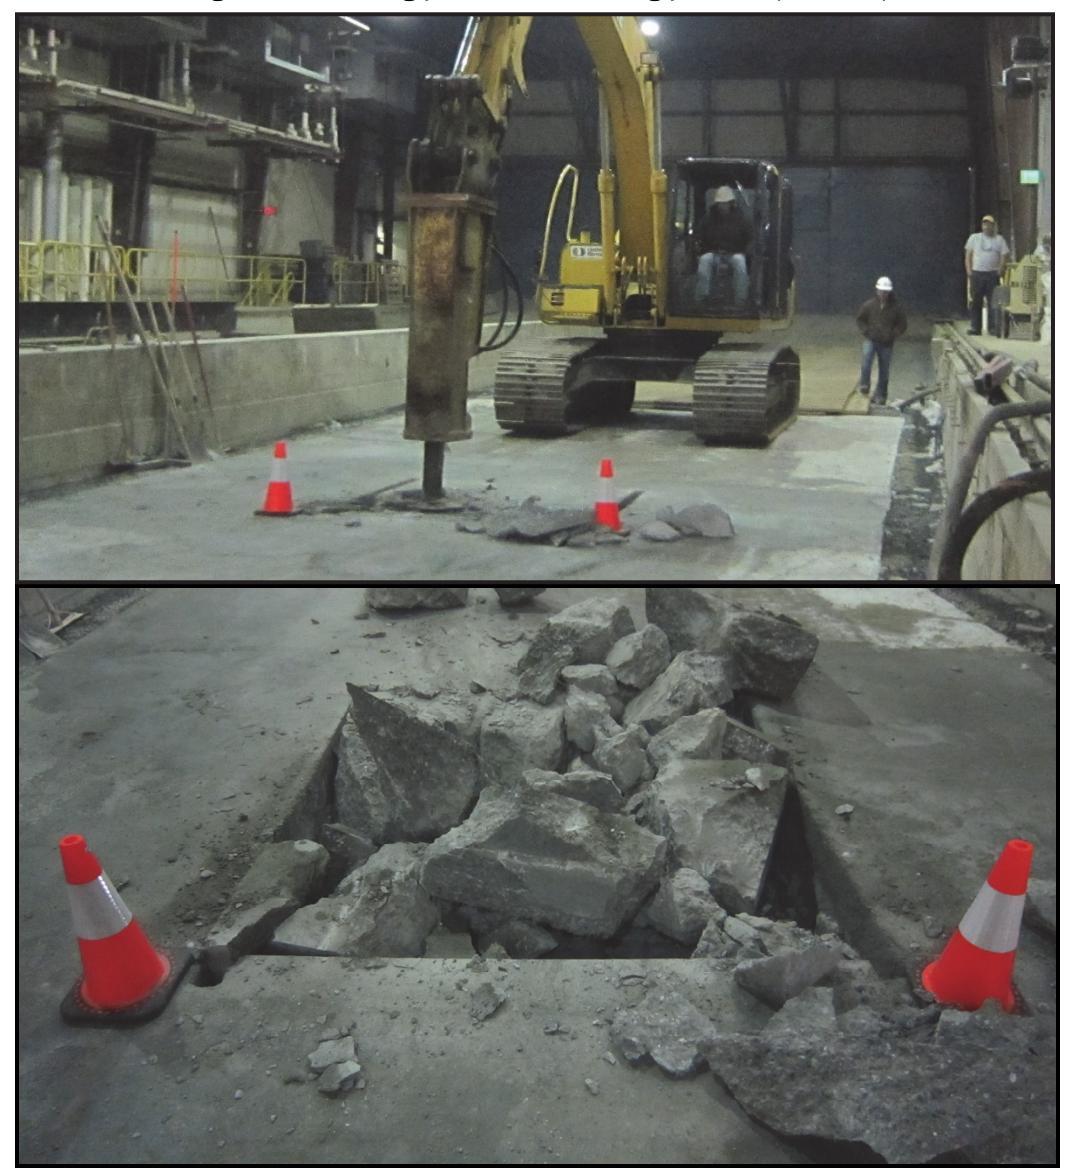
Figure 16. Existing pavement breaking process (Crater 1).

Initial attempts were made in Crater 1 to break out the sawn crater with a Bobcat S250 wheeled skid steer (Figure 3) with a pavement breaker attachment. After approximately 20 min, this approach was deemed minimally effective; the slab had been broken 11 times on the north edge at this point. Thereafter, a John Deere 135D excavator (Figure 5) with a hammer attachment was used; the slab was broken 14 times with this approach. Visually, the slab seemed harder than normal to break and also seemed very flaky near the top (broke into several small pieces). The crater was then excavated to a depth of approximately 32 in. with a John Deere 135D with a 36-in.-wide bucket and 7-in.-long teeth. Figure 16 summarizes the breaking process ultimately used for Crater 1, and Figure 17 shows debris removal and the completed Crater 1.

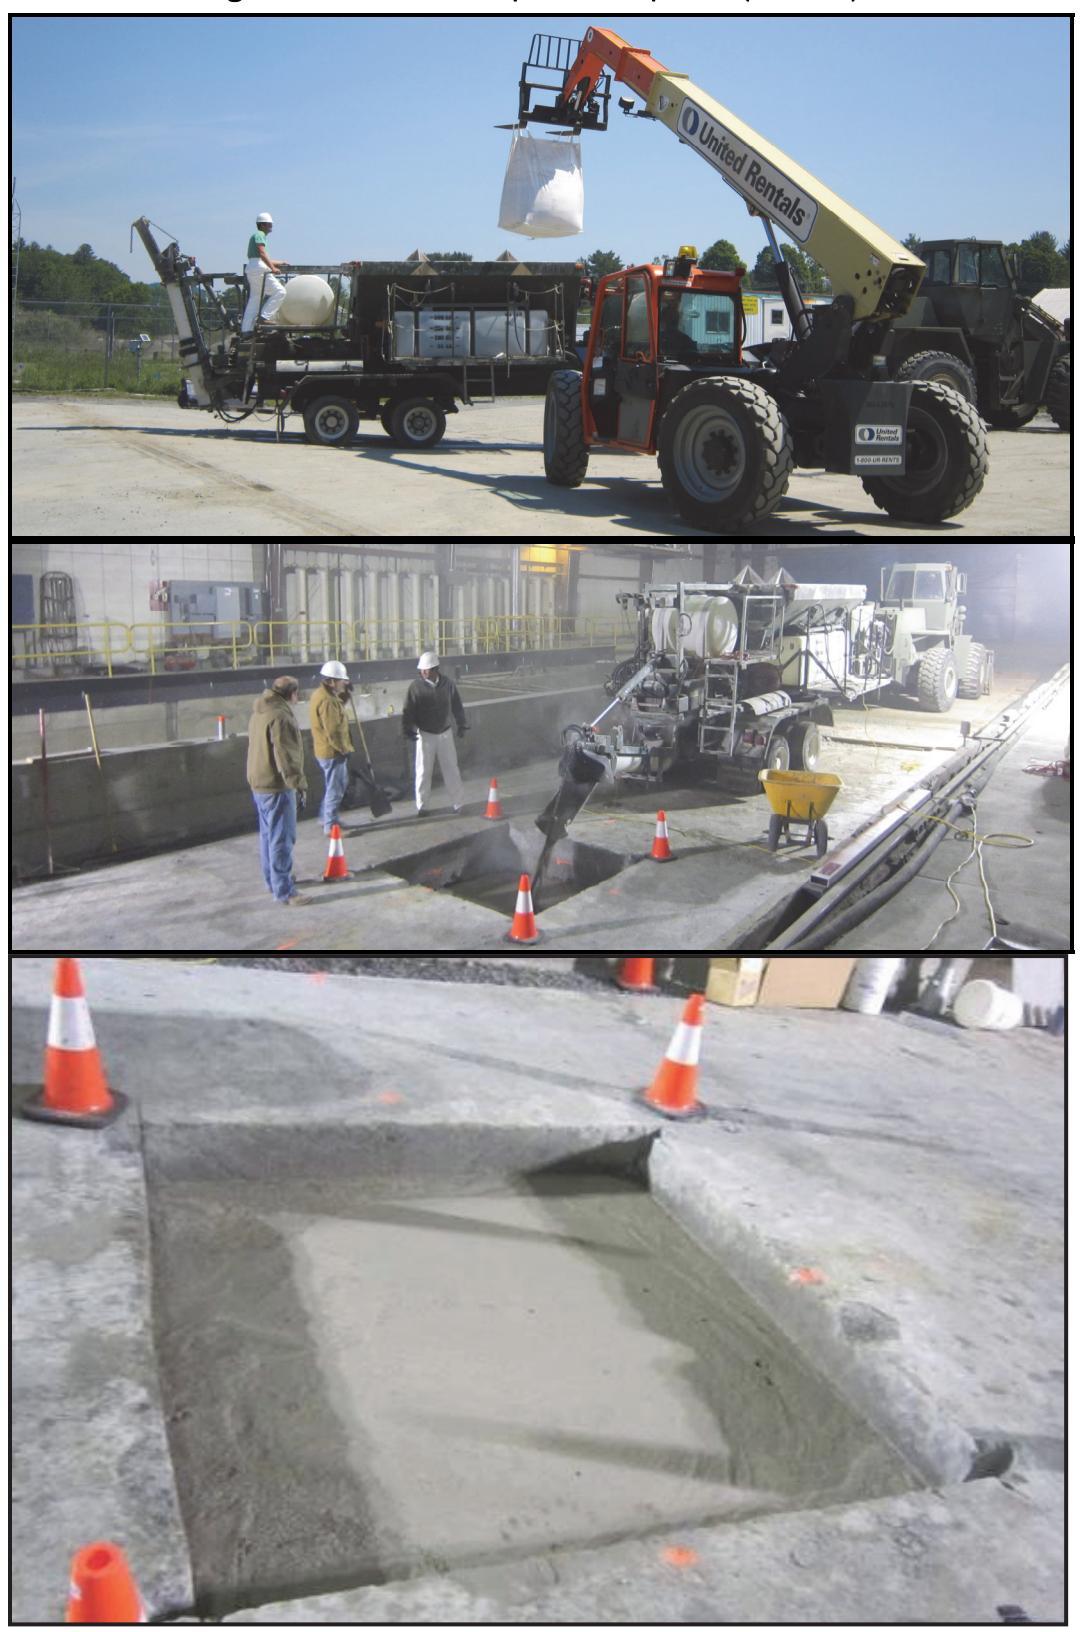
Figure 18. VMFF backfill placement photos (Crater 1).

Prior to backfill placement, a reference line was painted at a depth of 10 in. for craters where RSC was to be placed. To place VMFF, the SVM was loaded with four super sacks of material that were handled with a G6-42A forklift (Figure 6). A release agent was used on the mixer prior to beginning RSFF placement. Figure 18 provides photos of VMFF placement as backfill.

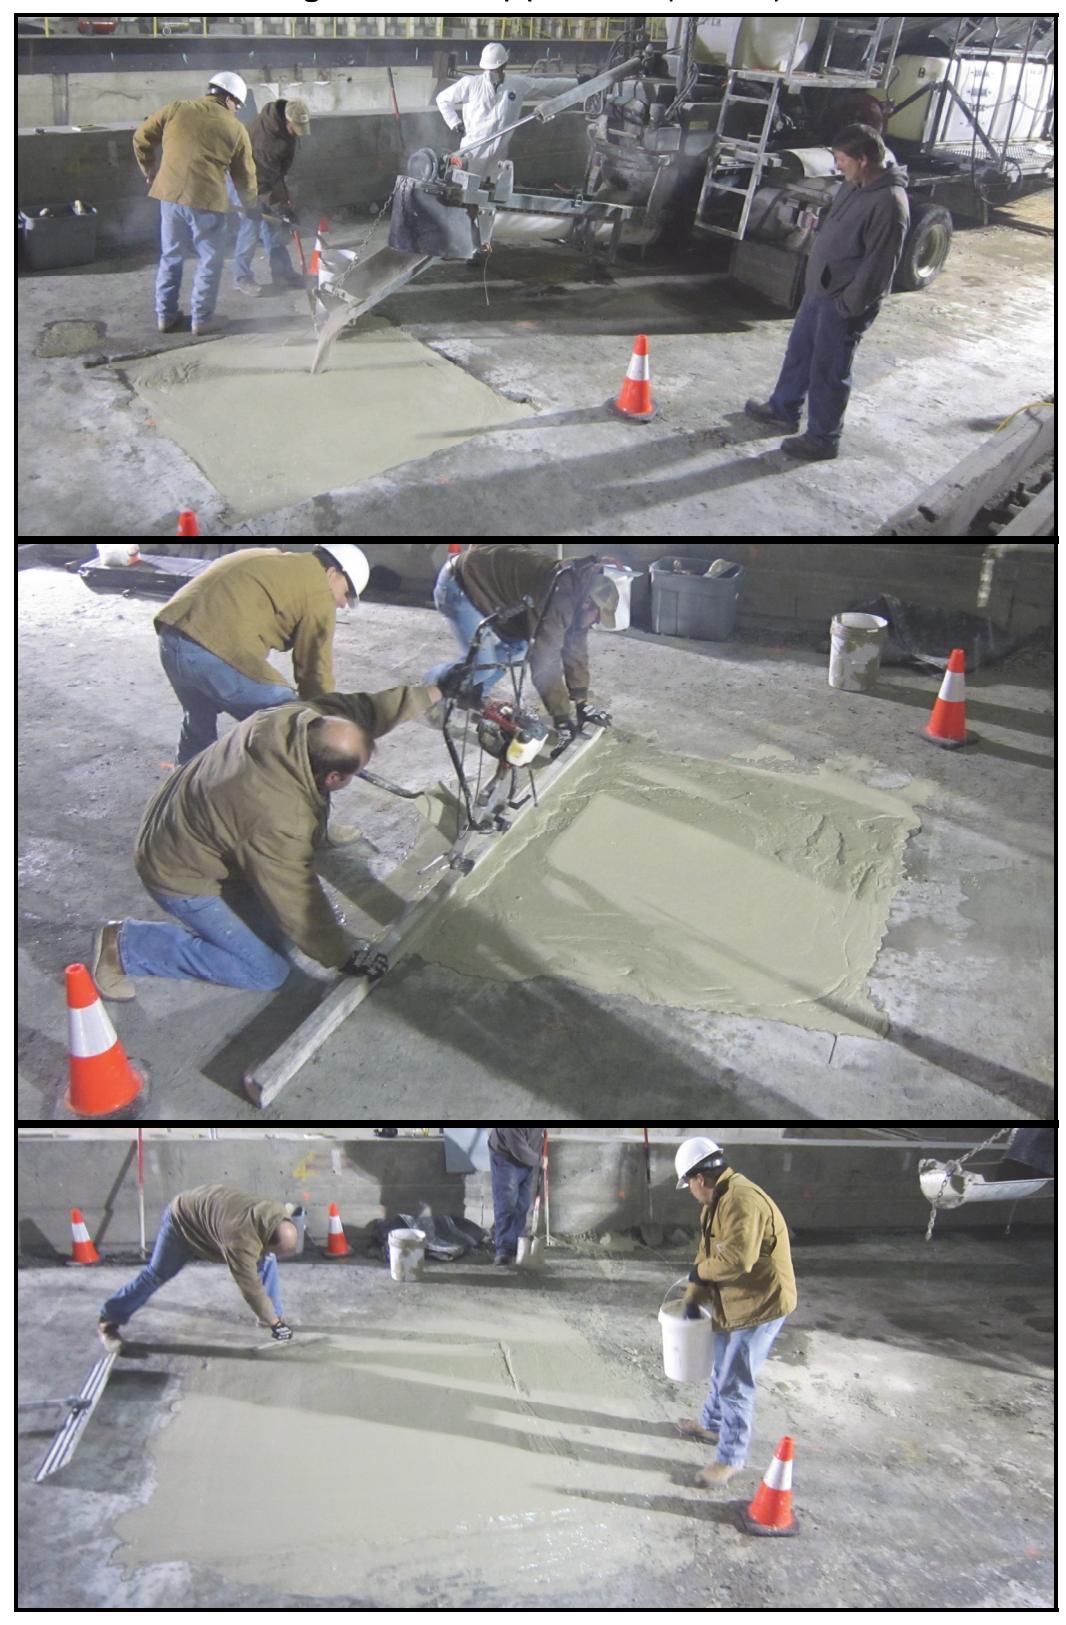
Figure 19. RSC cap placement (Crater 1).

Crater 1 RSC was placed in approximately 10 min. This material was vibratory screeded twice, and the edges were cleaned. At the time of screeding, material temperatures were around 35°F, and ambient inside temperatures were around 33°F. Some excess water/paste was skimmed from the surface to minimize shrinkage cracking potential and optimize cleanliness. The surface of RSC material can be torn by over-finishing, and tears show up as cracks in the completed repair. Minimal finishing activities should occur, and they should occur very quickly after placement. Figure 19 provides example photos of RSC cap placement.

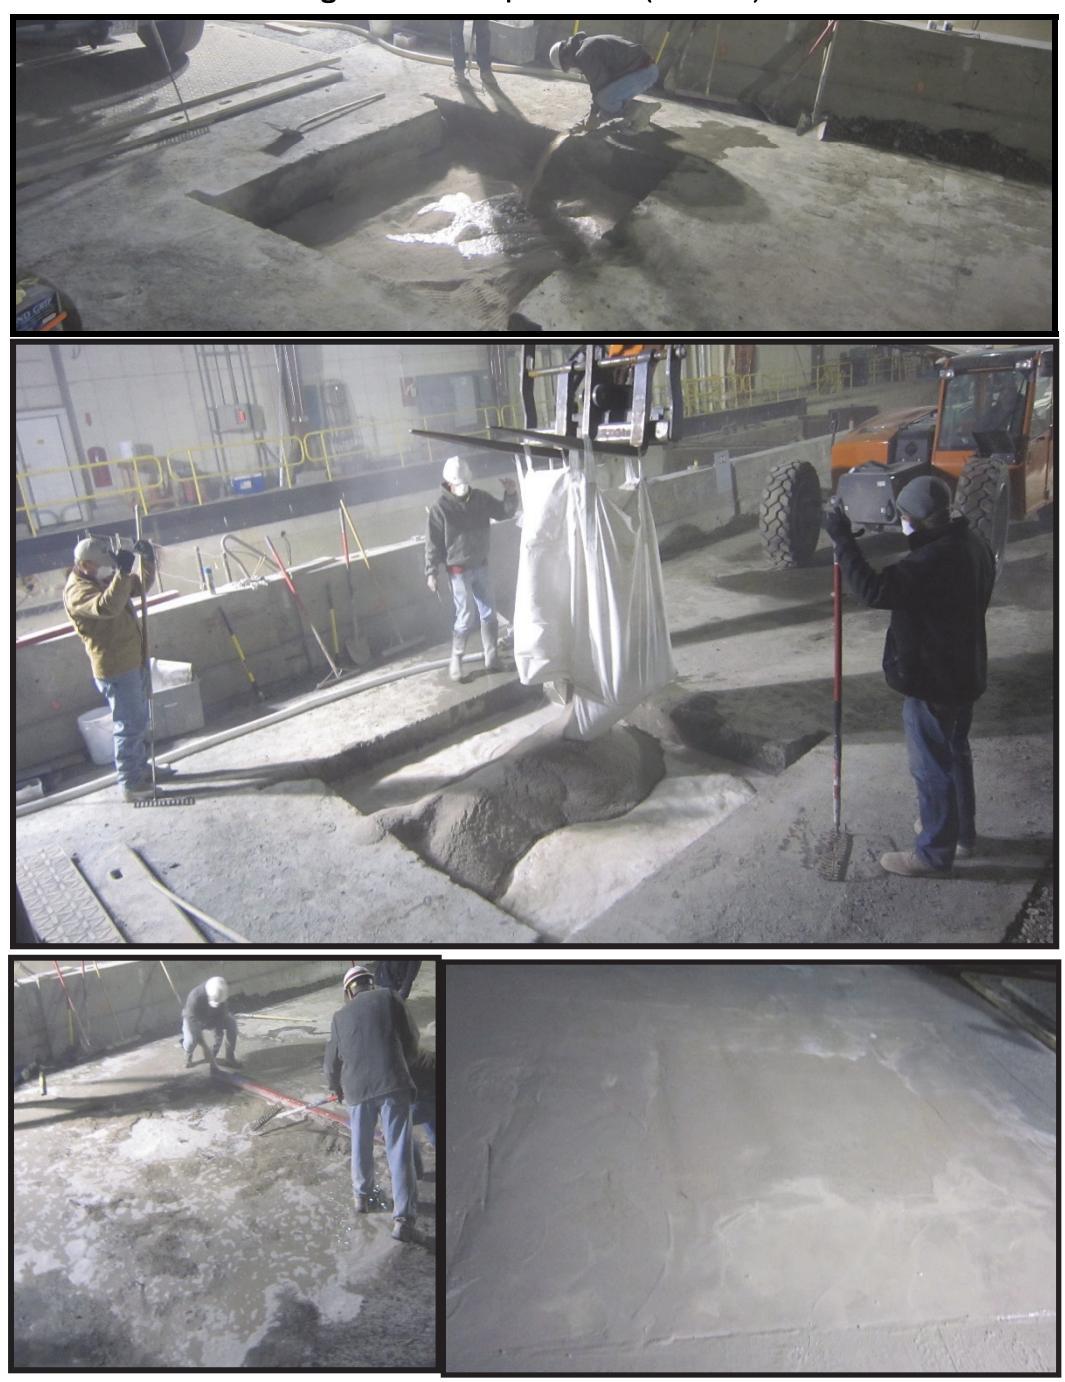
Figure 20. DPFF placement (Crater 5).

Crater 5 was not capped with RSC; instead, approximately 20 in. of DPFF was placed to evaluate the properties of DPFF in a controlled environment. Figure 20 shows summary photos of DPFF cap placement. There were approximately 4.75 super sacks of dry material utilized. Approximately 5 gal of water were introduced into the crater ahead of the first super sack that had 75 gal of water placed over it. The second super sack also had 75 gal of water applied to it, while the third and fourth super sacks had only 60 gal of water each. Only 75% of the fifth super sack was used, and an additional 20 gal of water was placed on the surface for a total of 295 gal of water. Less water is typically used for the final super sack to reduce surface moisture, which can remain even after the material has set. Finishing occurred with an aluminum bar, and the surface was bull-floated and worked with hand tools for approximately 7 min.

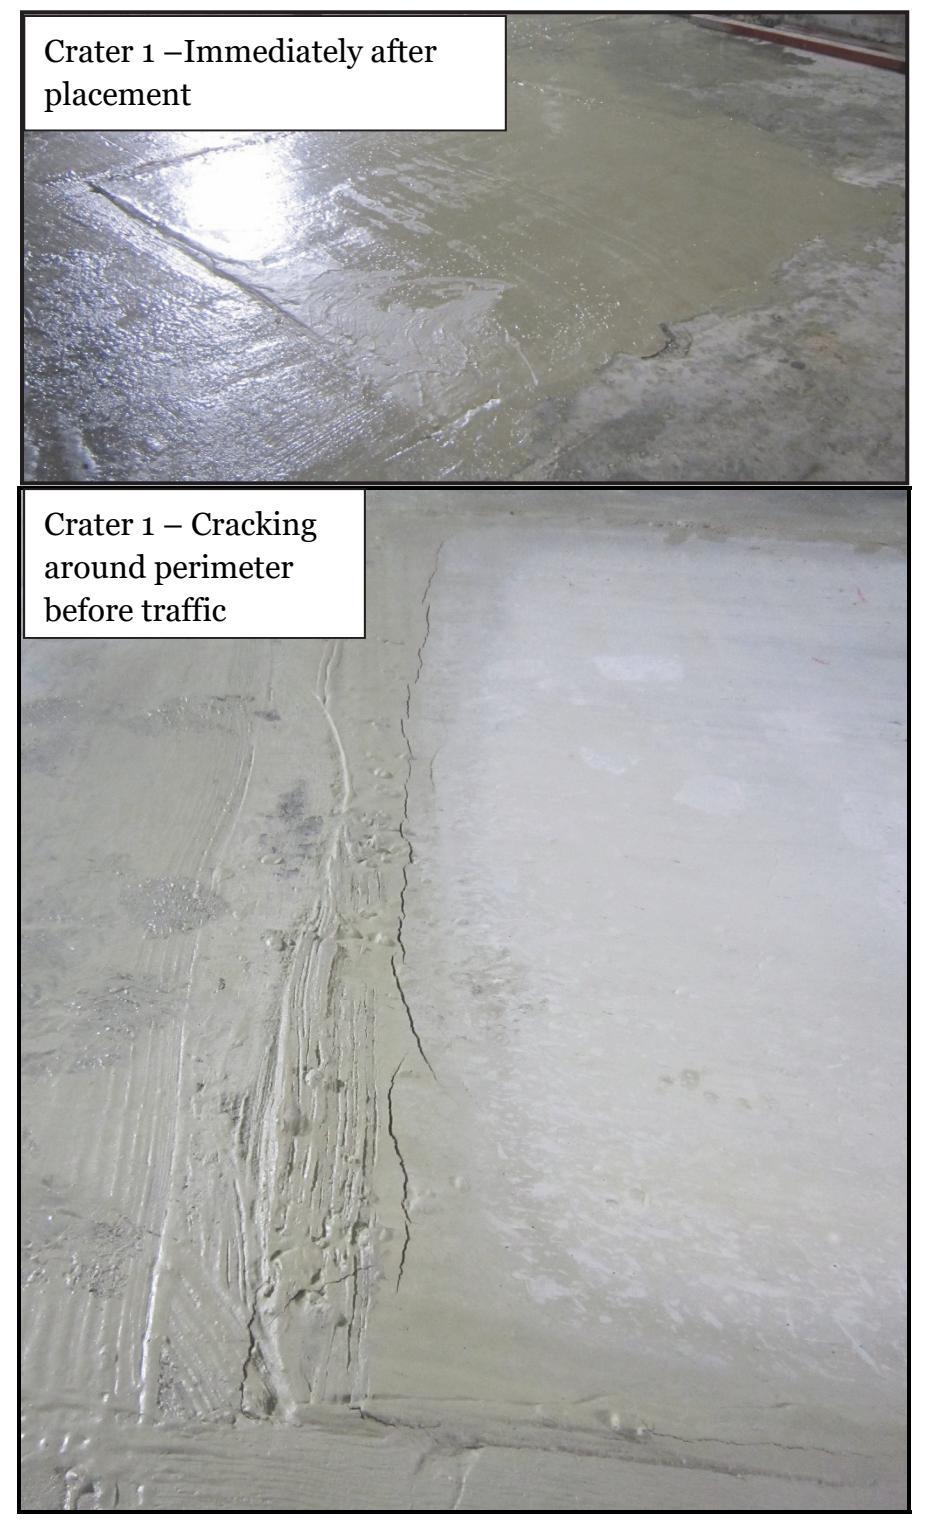
Figure 26. Visual assessments from crater repair testing – Crater 1.

4	Typical edge cracking and minor shrinkage cracking occurred where the crater was over finished. No problems were observed with setting, but curing did appear to be slower around the edges where the mix was in contact with the cold existing pavement. An estimated 1 to 2 in. around the perimeter was less cured due to colder interface temperatures.	There was no additional cracking as a result of trafficking, but there was minor expansion observed in the small shrinkage cracks.
5	There were no major problems placing DPFF as a cap over VMFF backfill.	No traffic applied
