NRL Report No. B-1583

### Report of Test

on Wind Intensity and Direction Indicating Equipment Manufactured and Submitted by Henschel Corporation, Amesbury, Massachusetts

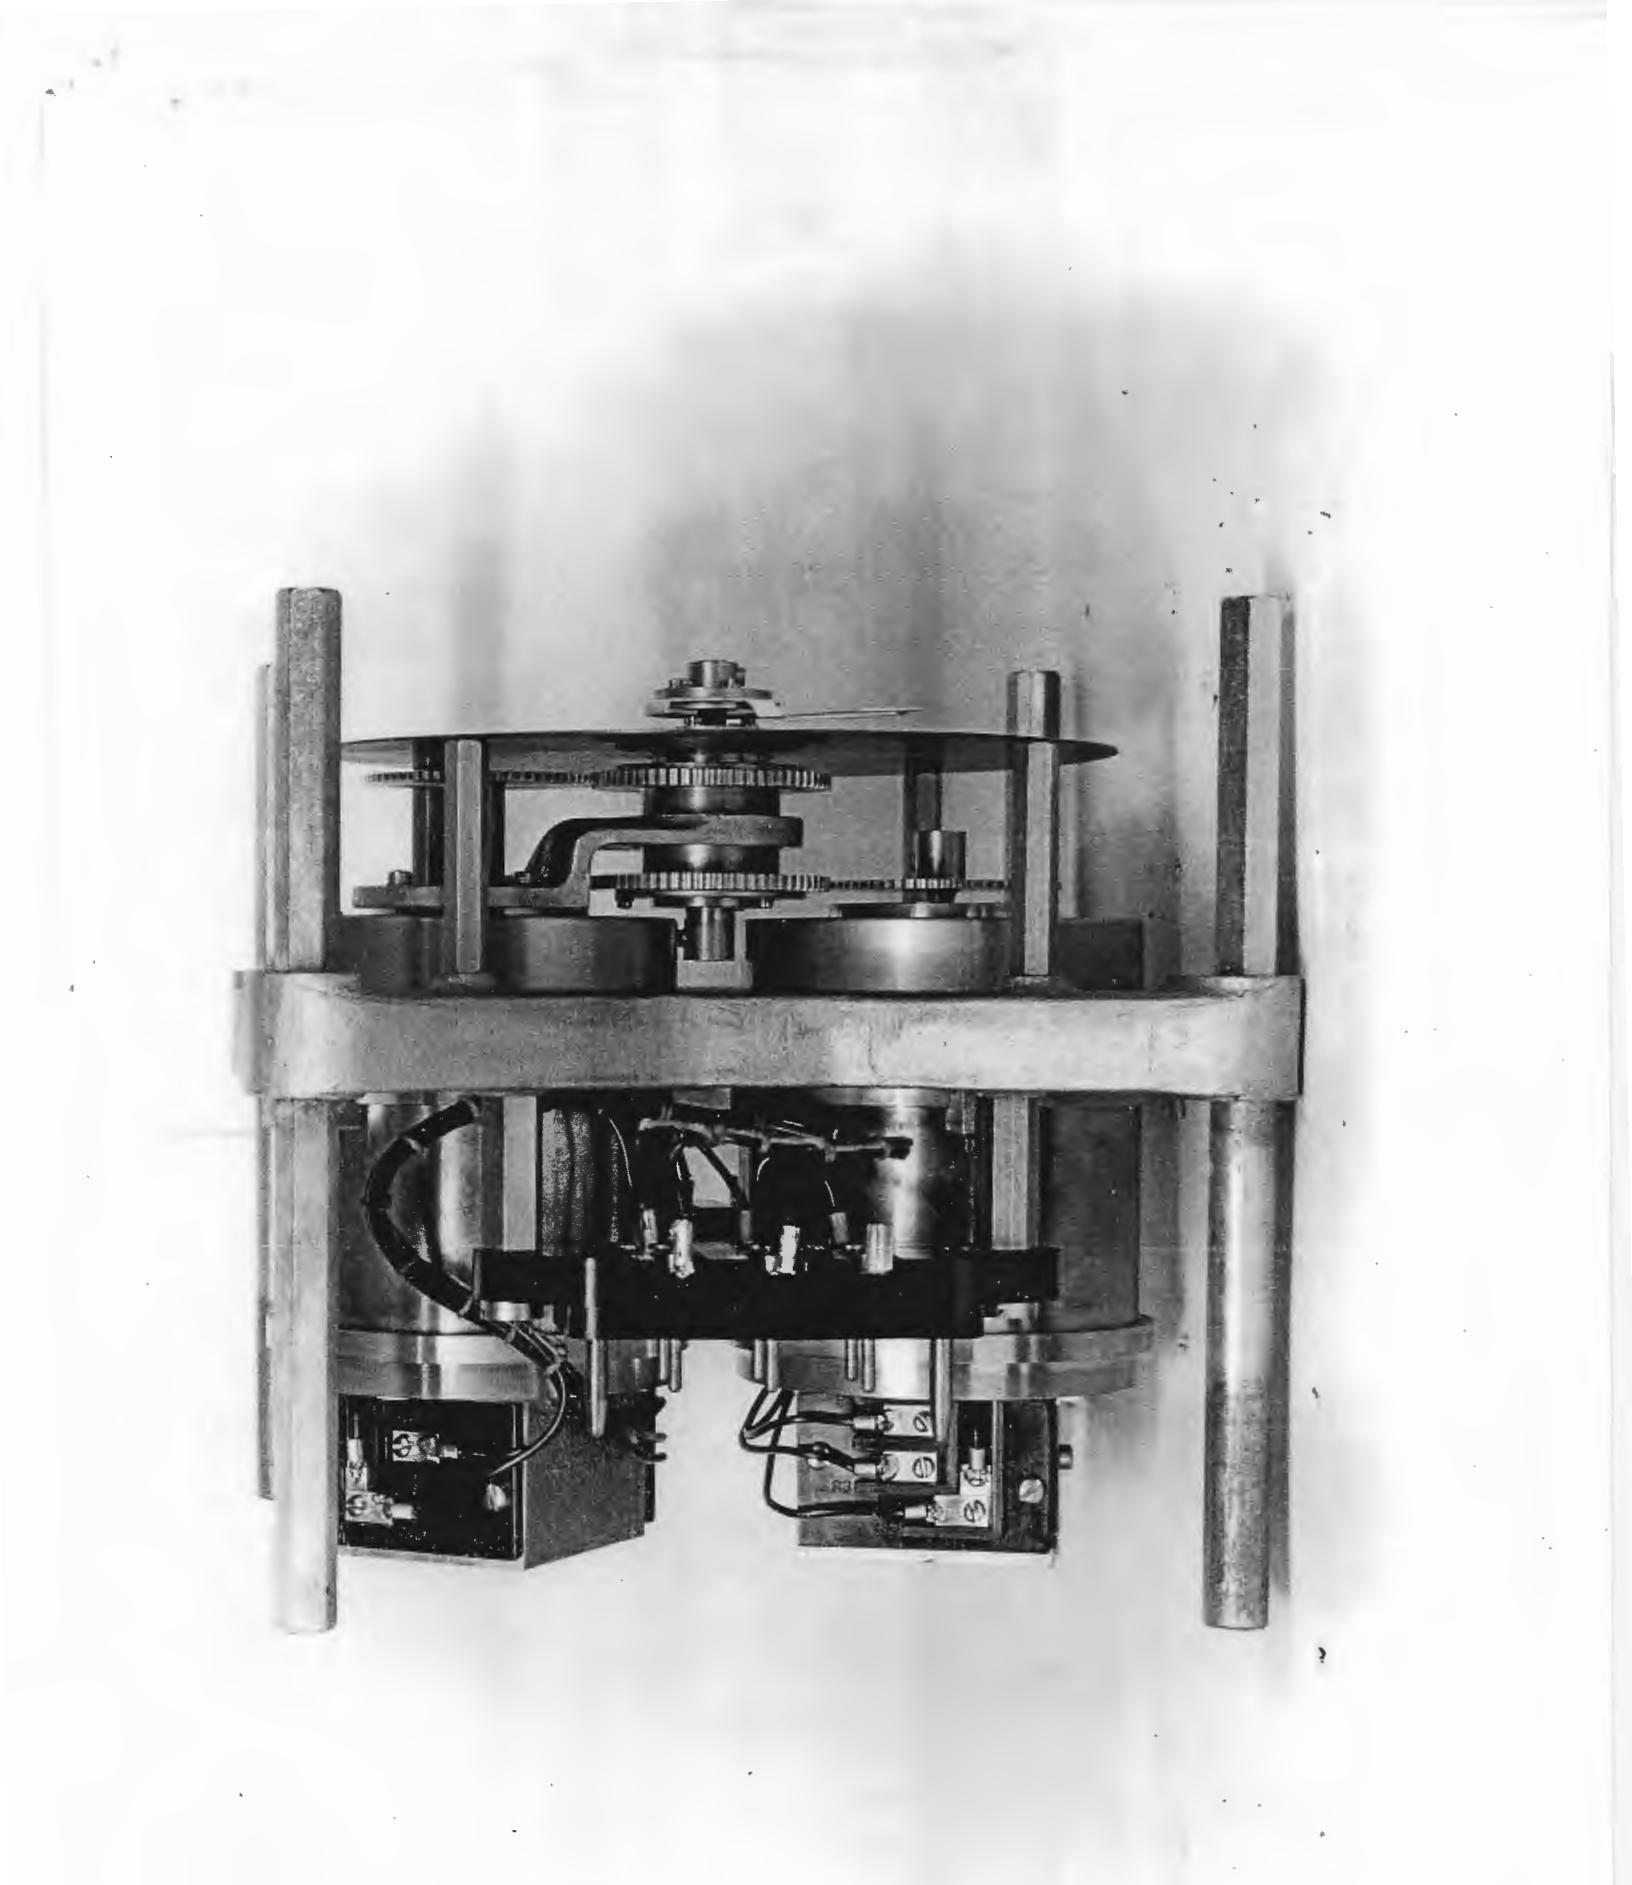
Combined Wind Direction and Wind Intensity Indicator Removed from Case.

- (a) There is considerable play in the bearings of the concentric hubs of the indicator. This is due to the use of only one single race ball bearing for each of the concentric shafts. The use of double race ball bearings is suggested.
- (b) The sleeve, pc. 24, used in the concentric assembly of the indicator was found fractured. This failure was caused by the thinness of the wall between the bore and the root of the threads.
- (c) The skirted guards on the transmitter spindles are not of the best design to prevent locking due to ice formation.
- (d) The master case had a sand hole in the rear of the main casting which permitted water to enter the case.
