TECHNICAL REPORT NO. 11850
APPLICATION TECHNIQUES
AND
METHODS FOR APPLYING FUSED
CARBIDES ON NON-LUBRICATED
WEAR SURFACES FOR HIGH VOLUME PRODUCTION

U. S. ARMY TANK-AUTOMOTIVE COMMAND
CONTRACT NO. DAAE07-71-C-0148
MM&T PROJECT NO. 4704287

June 1974

P.H.Brotzman, E.H.Drewes, N. Wulff
Firestone Tire and Rubber Company
Metallurgical Laboratory

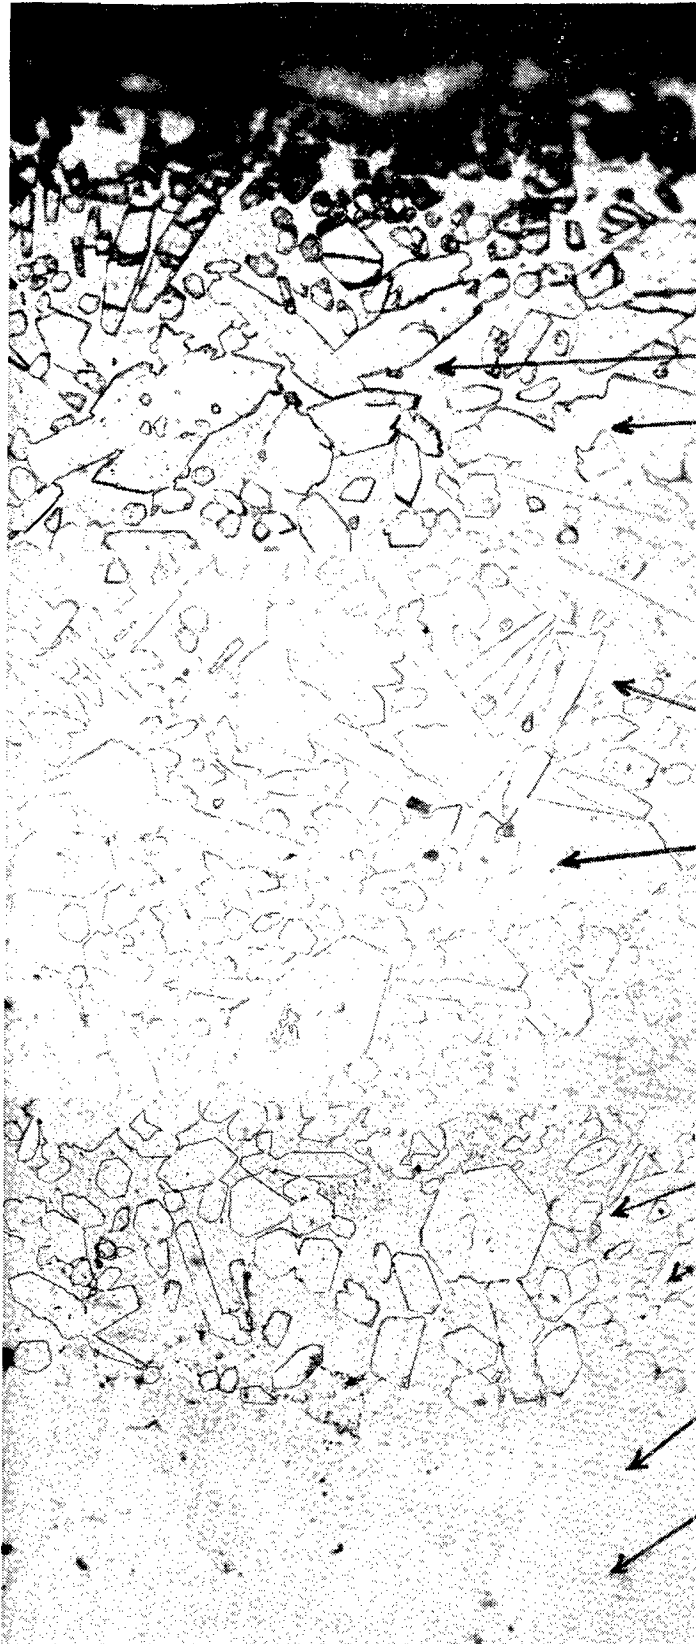
Figure 1

Code 601
Microstructure and Knoop Hardness Readings On
Hard Surface Overlay on Sprocket Window

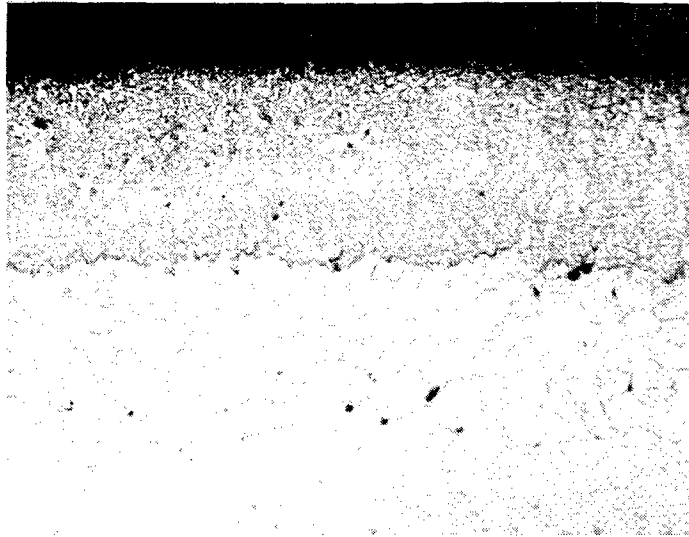
Figure 2

Code 601
50X

This shows a .020" thick deposit plus an alloyed zone in the 4140 base metal where the Chrome-Nickel-Boron brazing alloy has diffused to a depth of .020-.025". This diffusion zone has absorbed enough of the "high alloy" that it seems to be unaffected by the normalize, quench, and temper applied to the shee. The porosity in this deposit is very low.

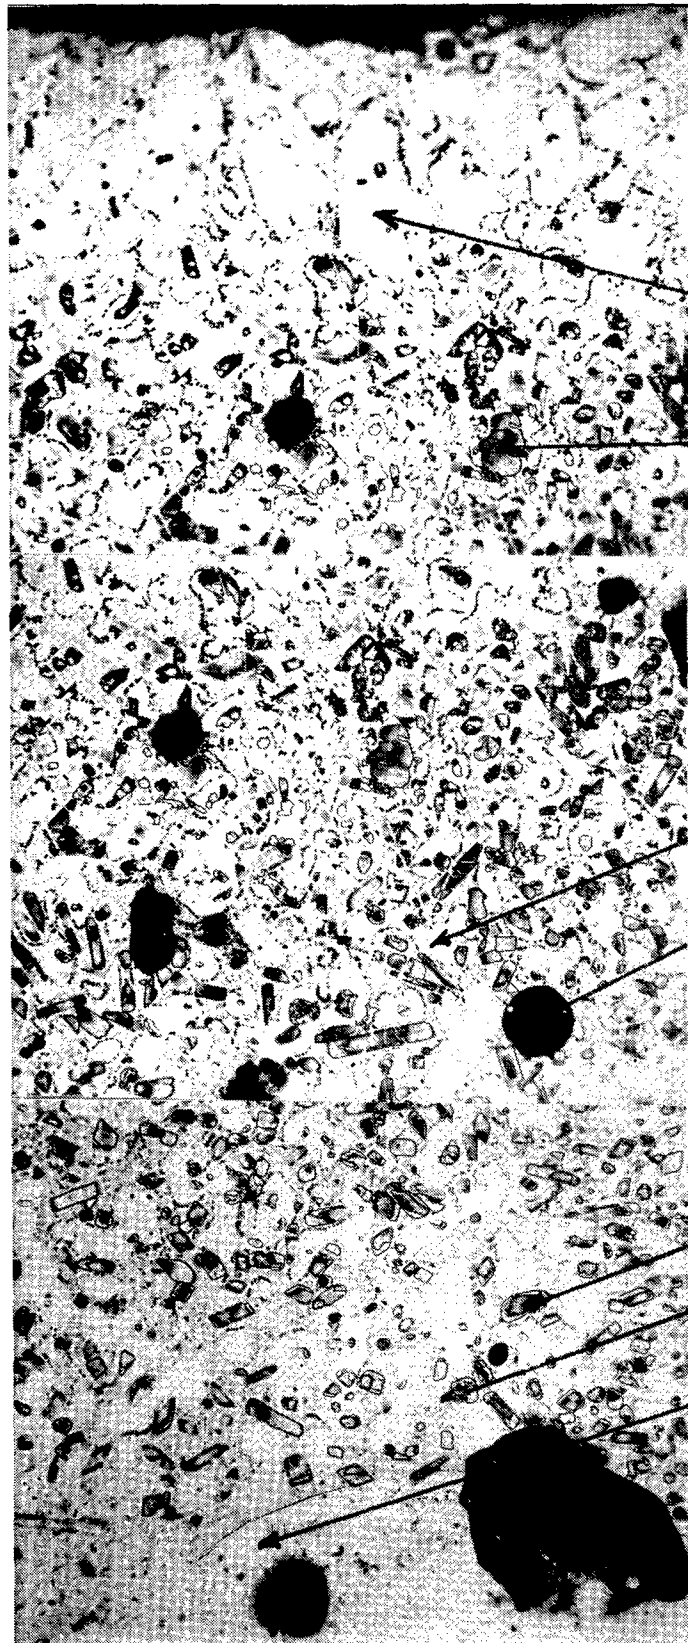
Figure 3

Code I6A
Microstructure and Knoop Hardness Readings On
Hard Surface Overlay on Sprocket Window

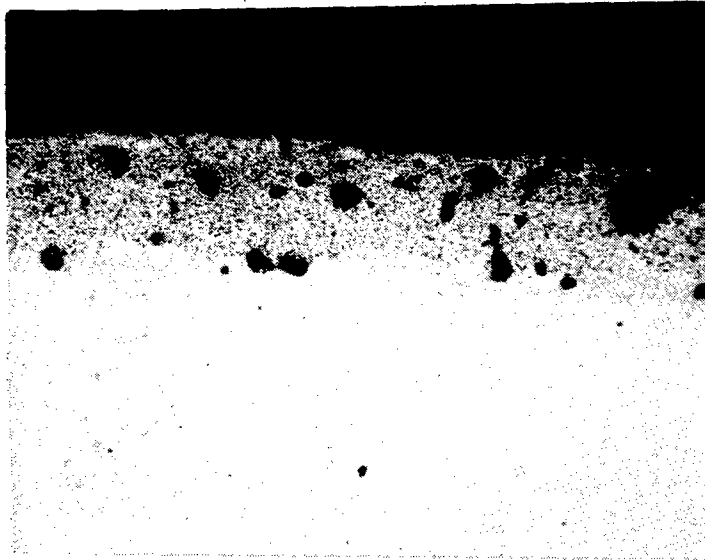
Code I6A
50X

This photo shows the .012" thick hard surface overlay with extensive porosity. These deposits have by far the largest amount of porosity of any of the four lots examined.

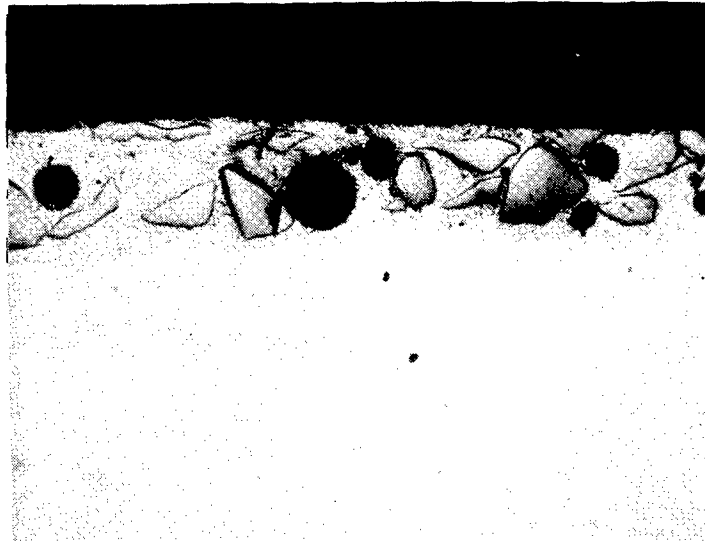
Figure 6

Code "N" Unetched
50X

This shows the massive carbides plus extensive gas porosity.

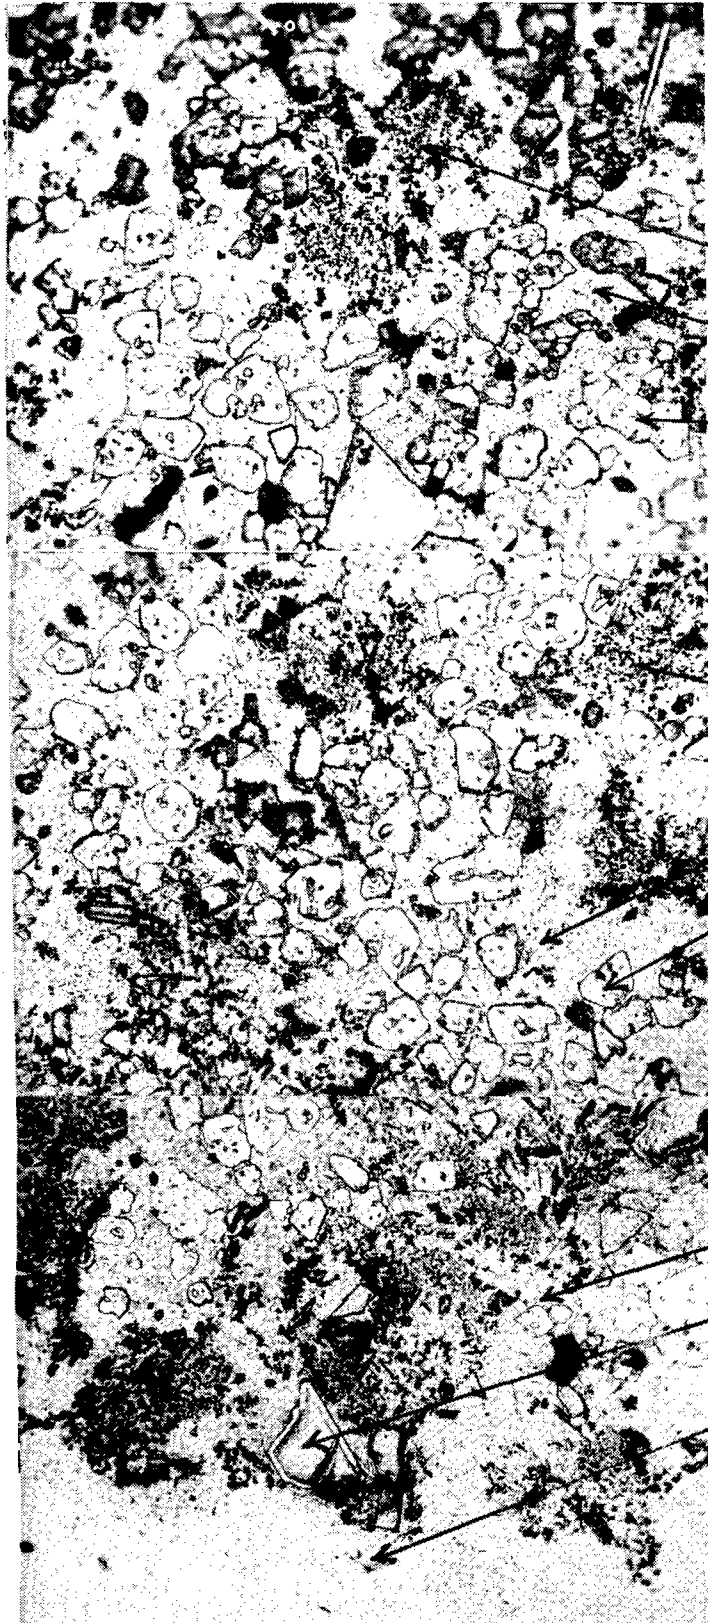
Figure 7

Code W705
Microstructure and Knoop Hardness Readings on
Hard Surface Overlay on Sprocket Window

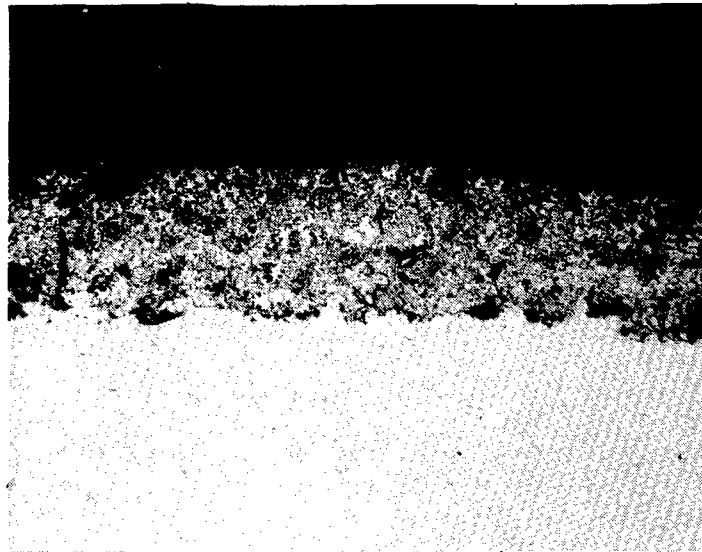
Code W705
50X

This shows the .016" thick deposit with
a moderate amount of porosity and/or
inclusions.

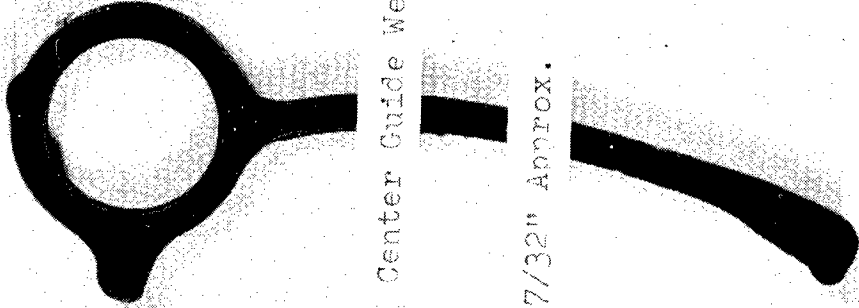
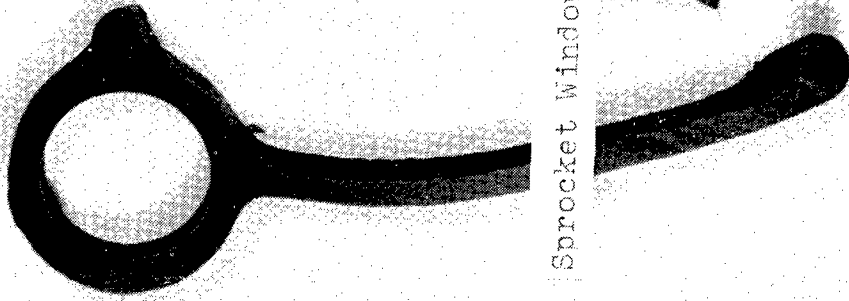
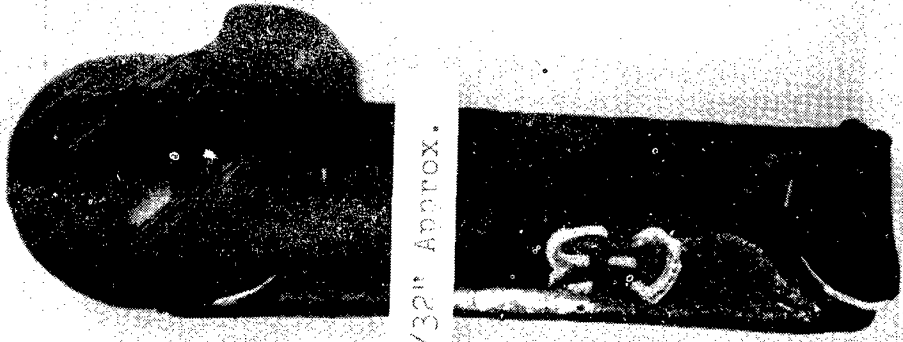
Figure 12

Grouser Wear - 13/32" Approx.

Center Guide Wear - 1/32" Approx.

Sprocket Window Wear - 7/32" Approx.

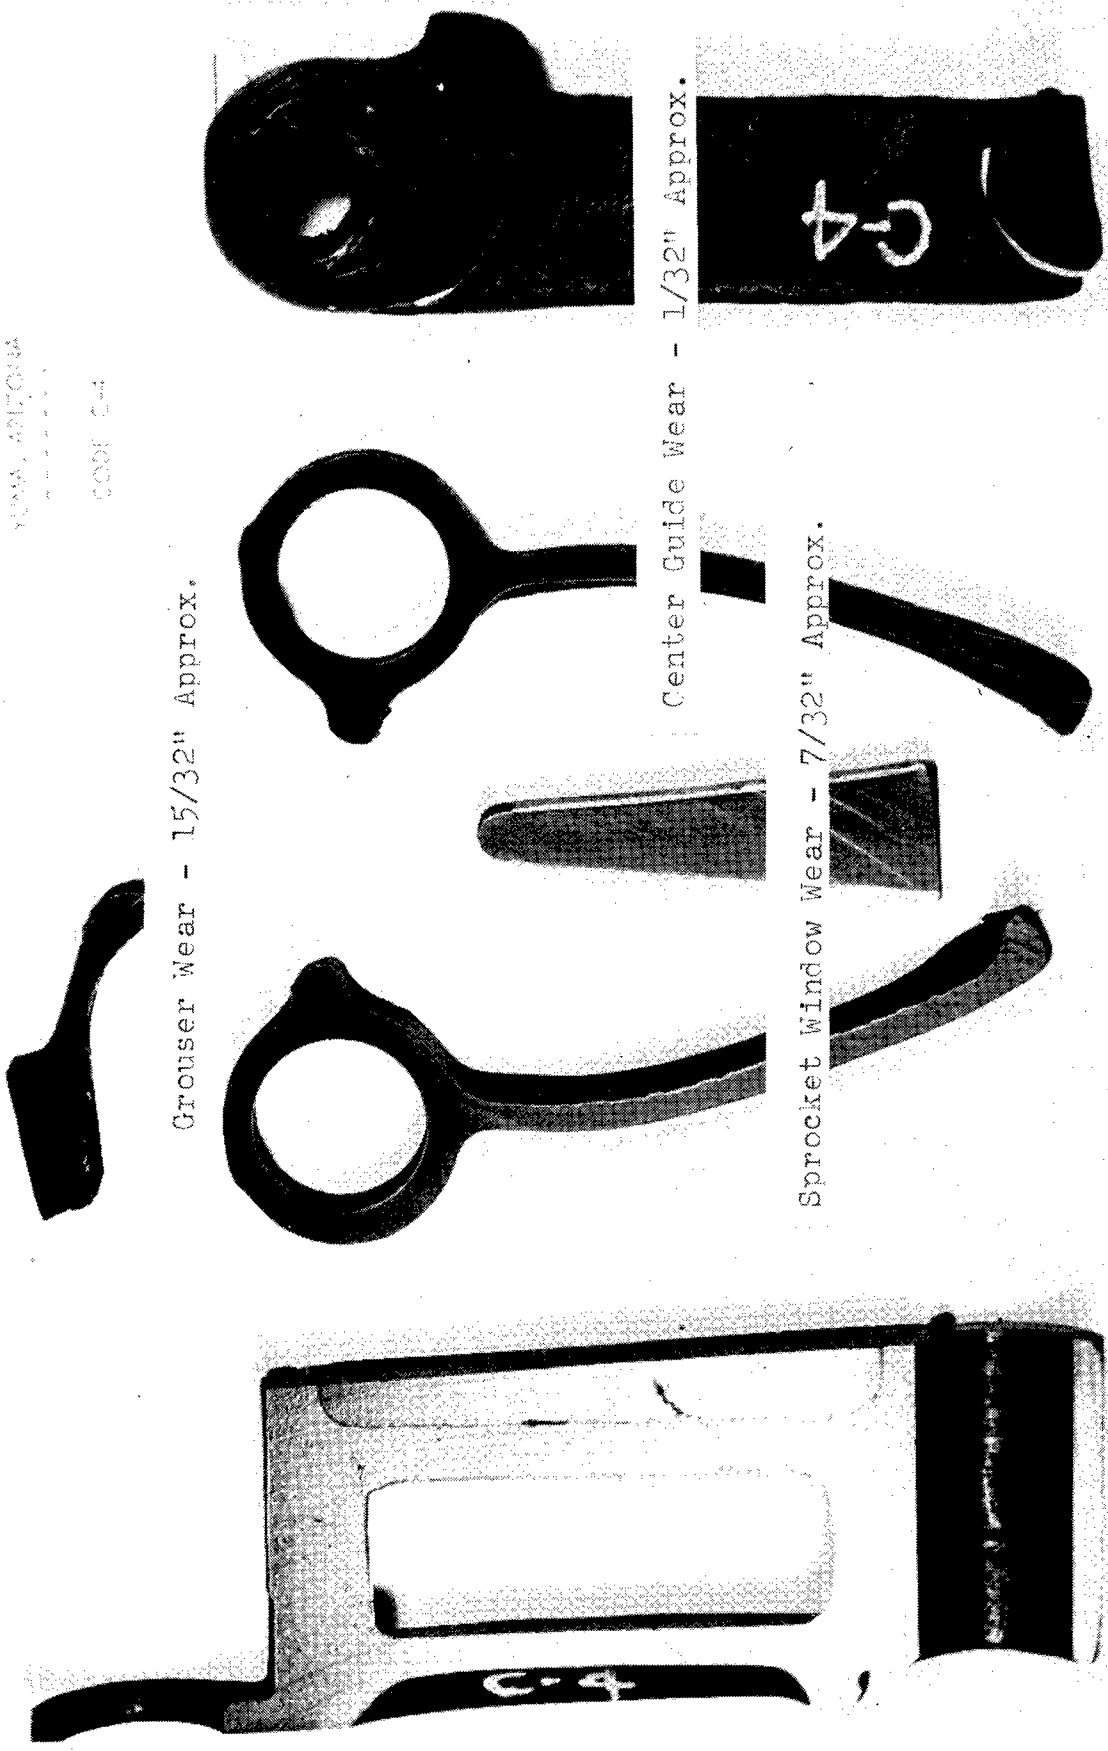
CODE C-4

Crouser Wear - 15/32" Approx.

Center Guide Wear - 1/32" Approx.

Sprocket Window Wear - 7/32" Approx.

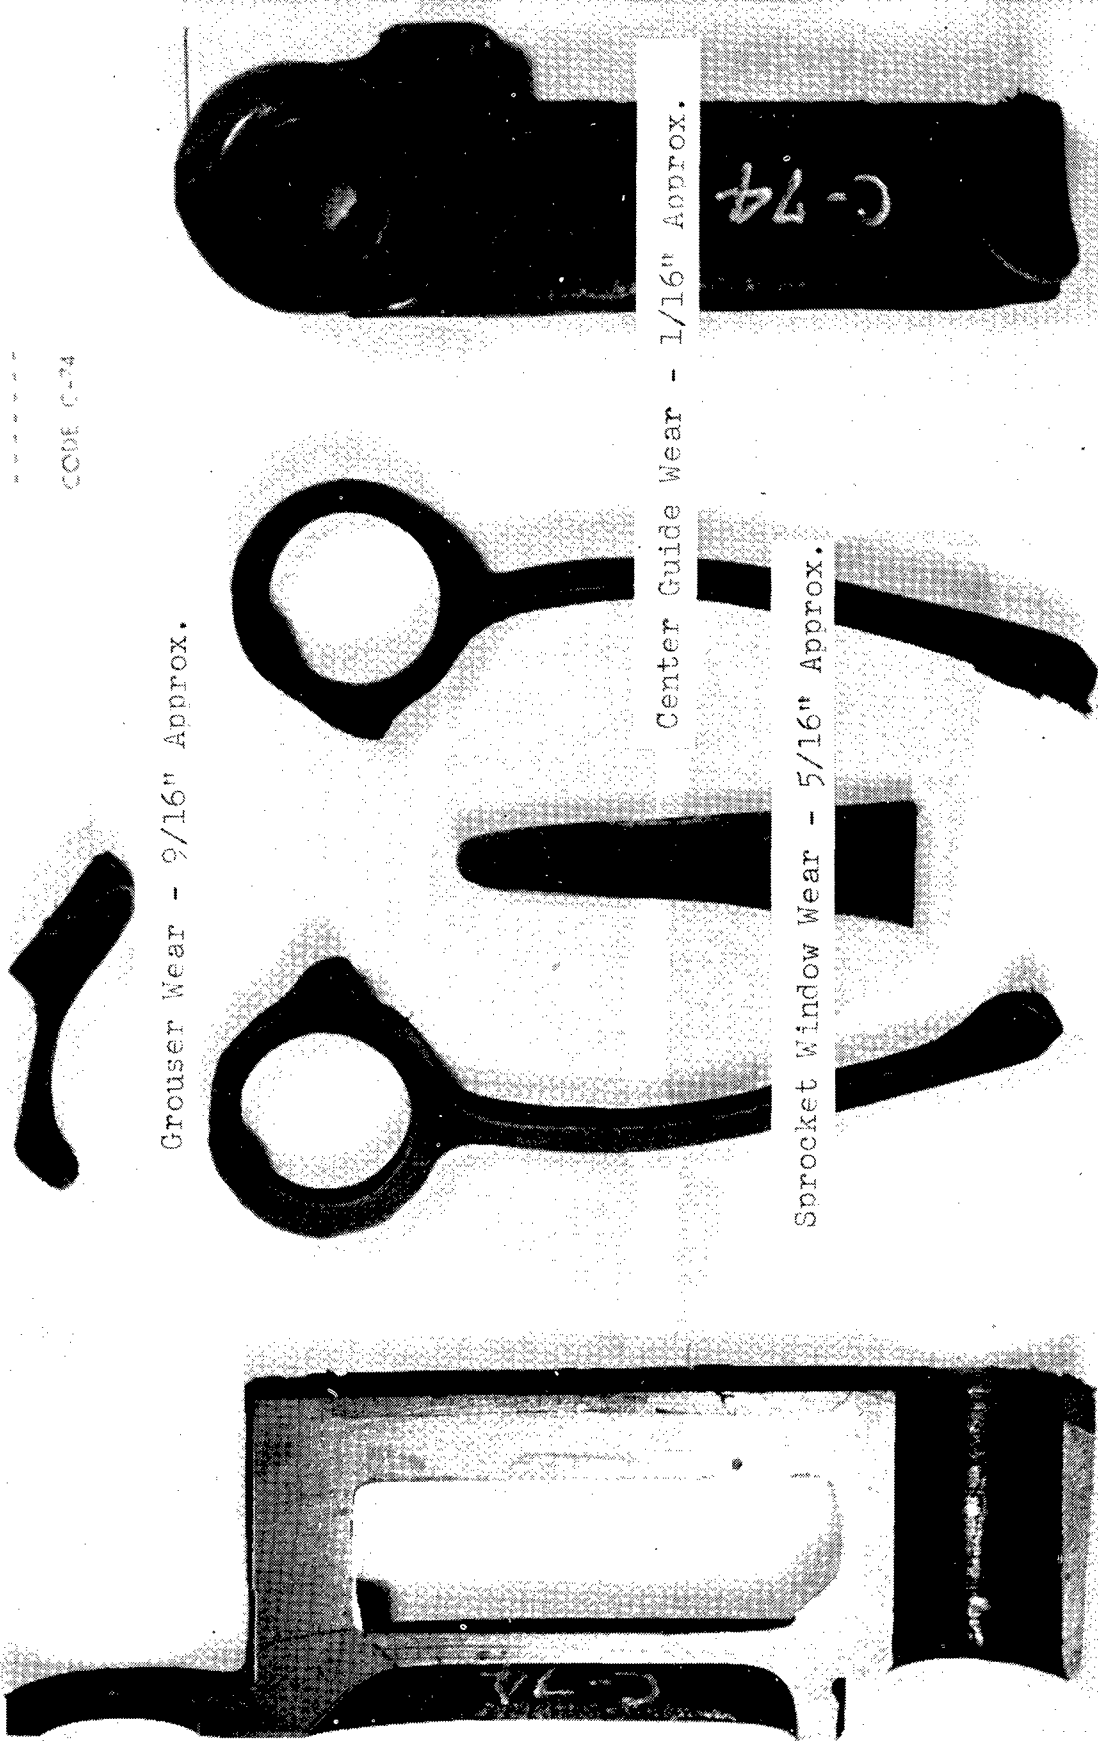
CODE C-74

Grouser Wear - 9/16" Approx.

Center Guide Wear - 1/16" Approx.

Sprocket Window Wear - 5/16" Approx.

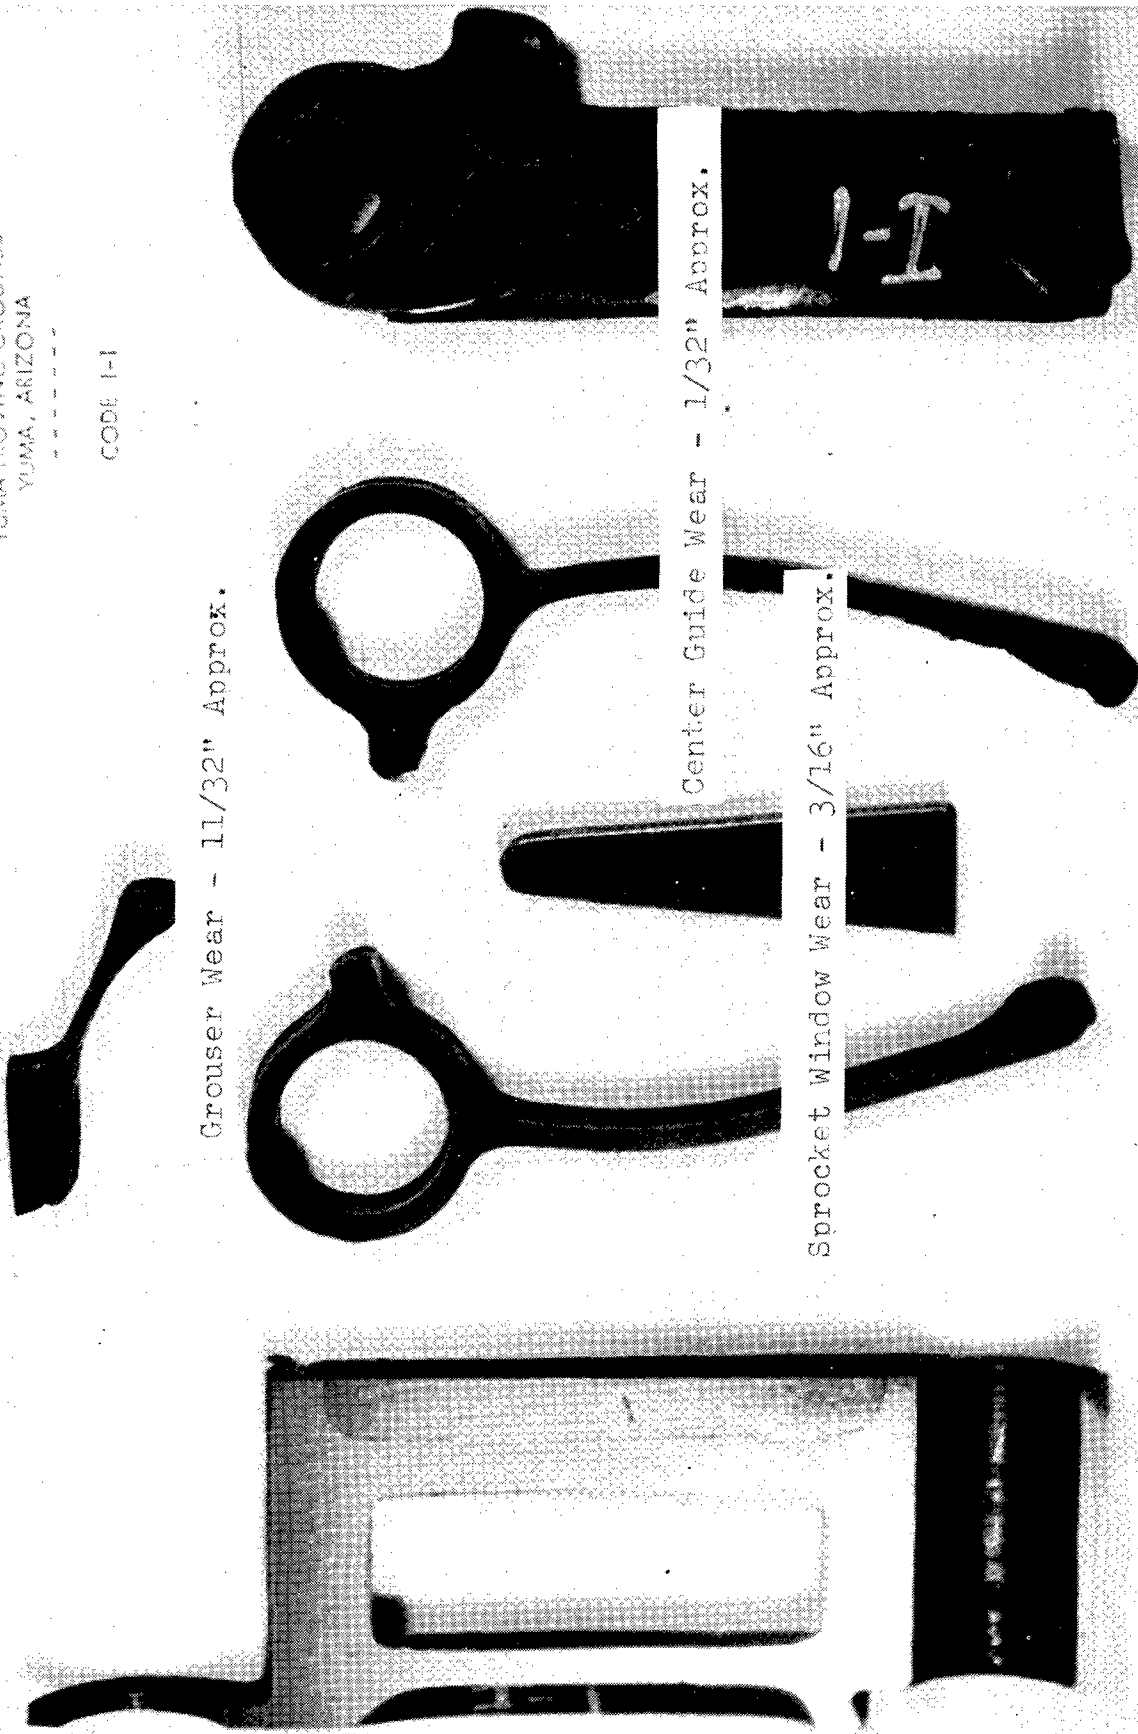
CODE I-I

Grouser Wear - 11/32" Approx.

Center Guide Wear - 1/32" Approx.

Sprocket Window Wear - 3/16" Approx.

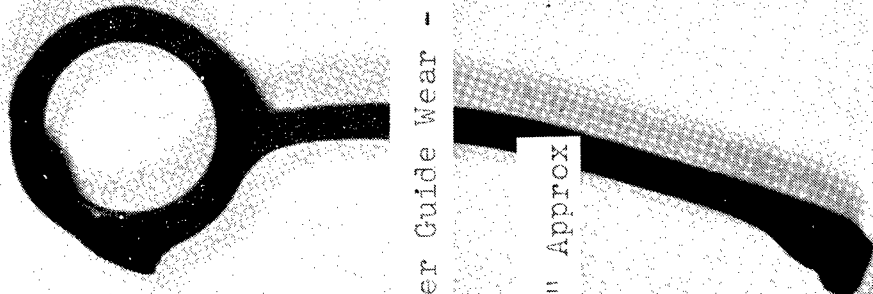
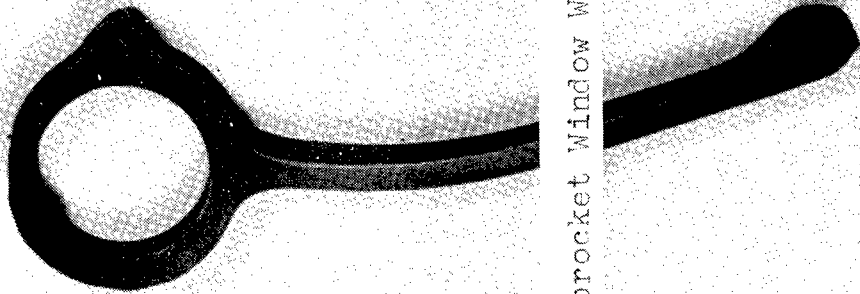
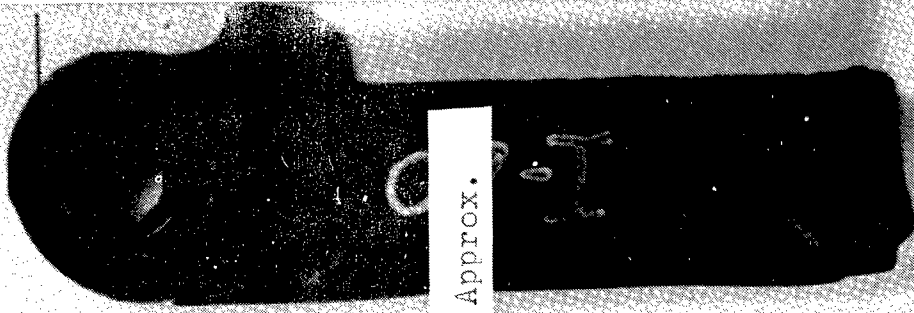
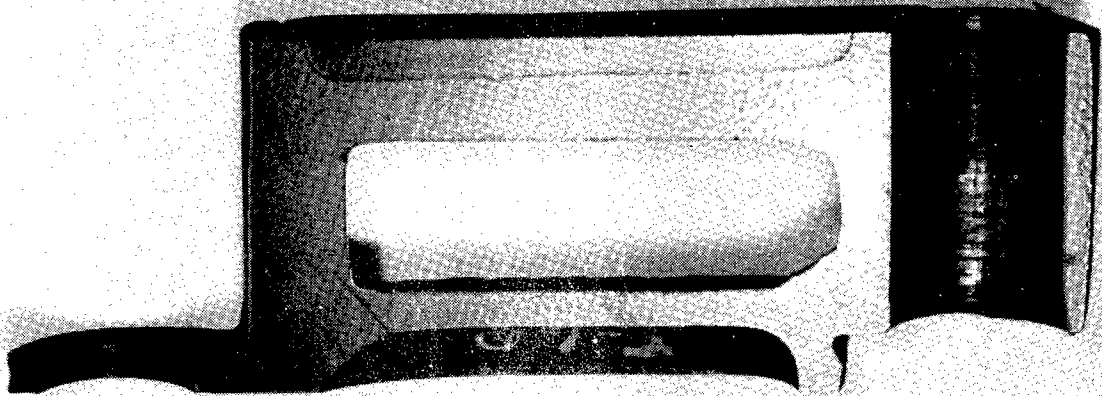
Figure 21

Crouser Wear - 17/32" Approx.

Center Guide Wear - 3/32" Approx.

Sprocket Window Wear - 11/32" Approx

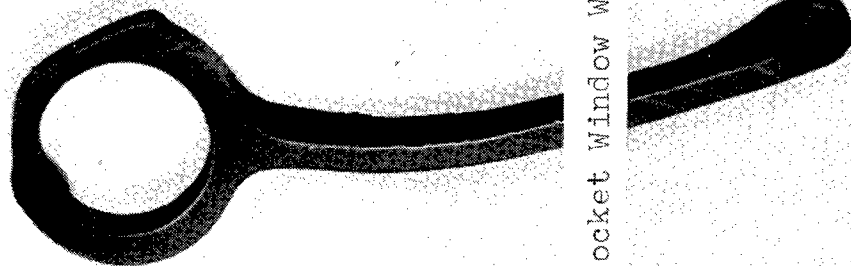
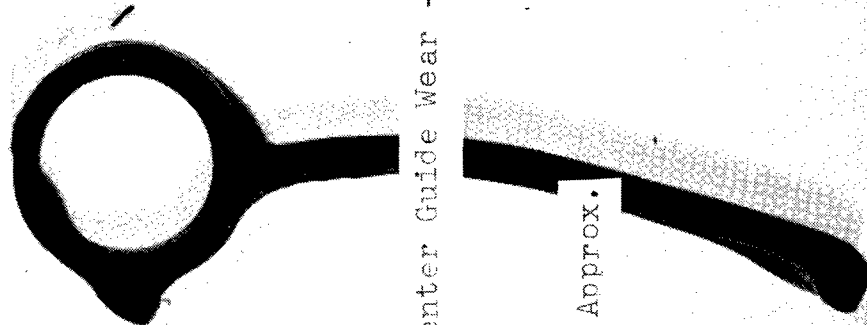
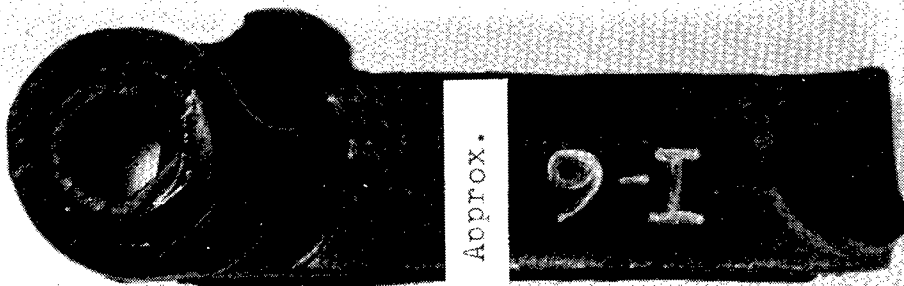
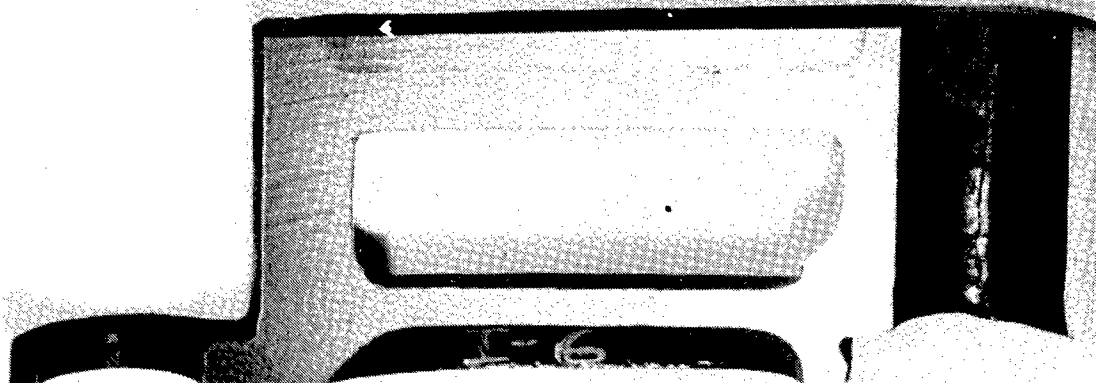
Figure 22

Grouser Wear - 21/32" Approx.

Sprocket Window Wear - 9/32" Approx.

Center Guide Wear - 3/32" Approx.

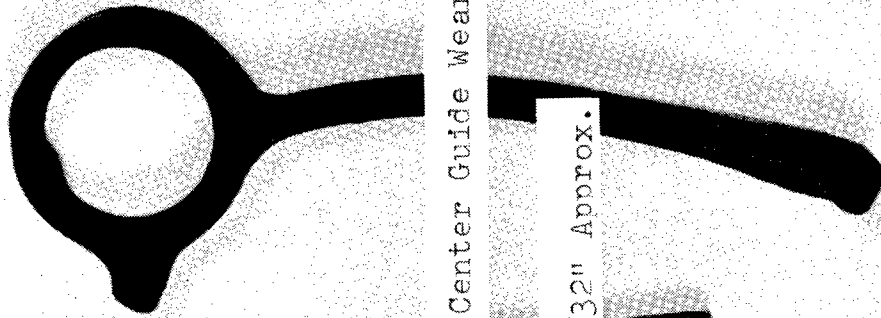
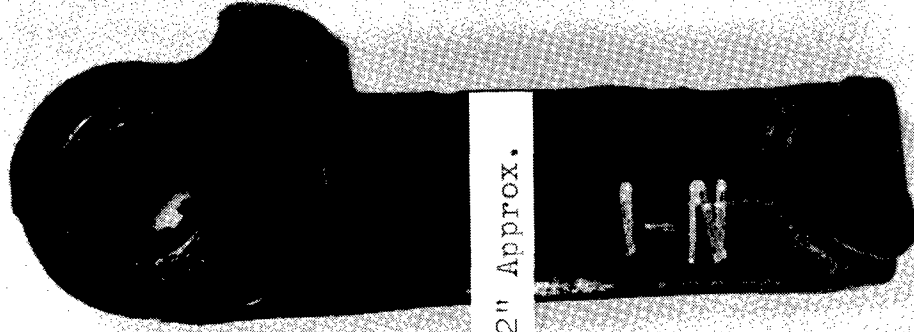
Figure 26

Grouser Wear - 13/32" Approx.

Center Guide Wear - 1/32" Approx.

Sprocket Window Wear - 7/32" Approx.

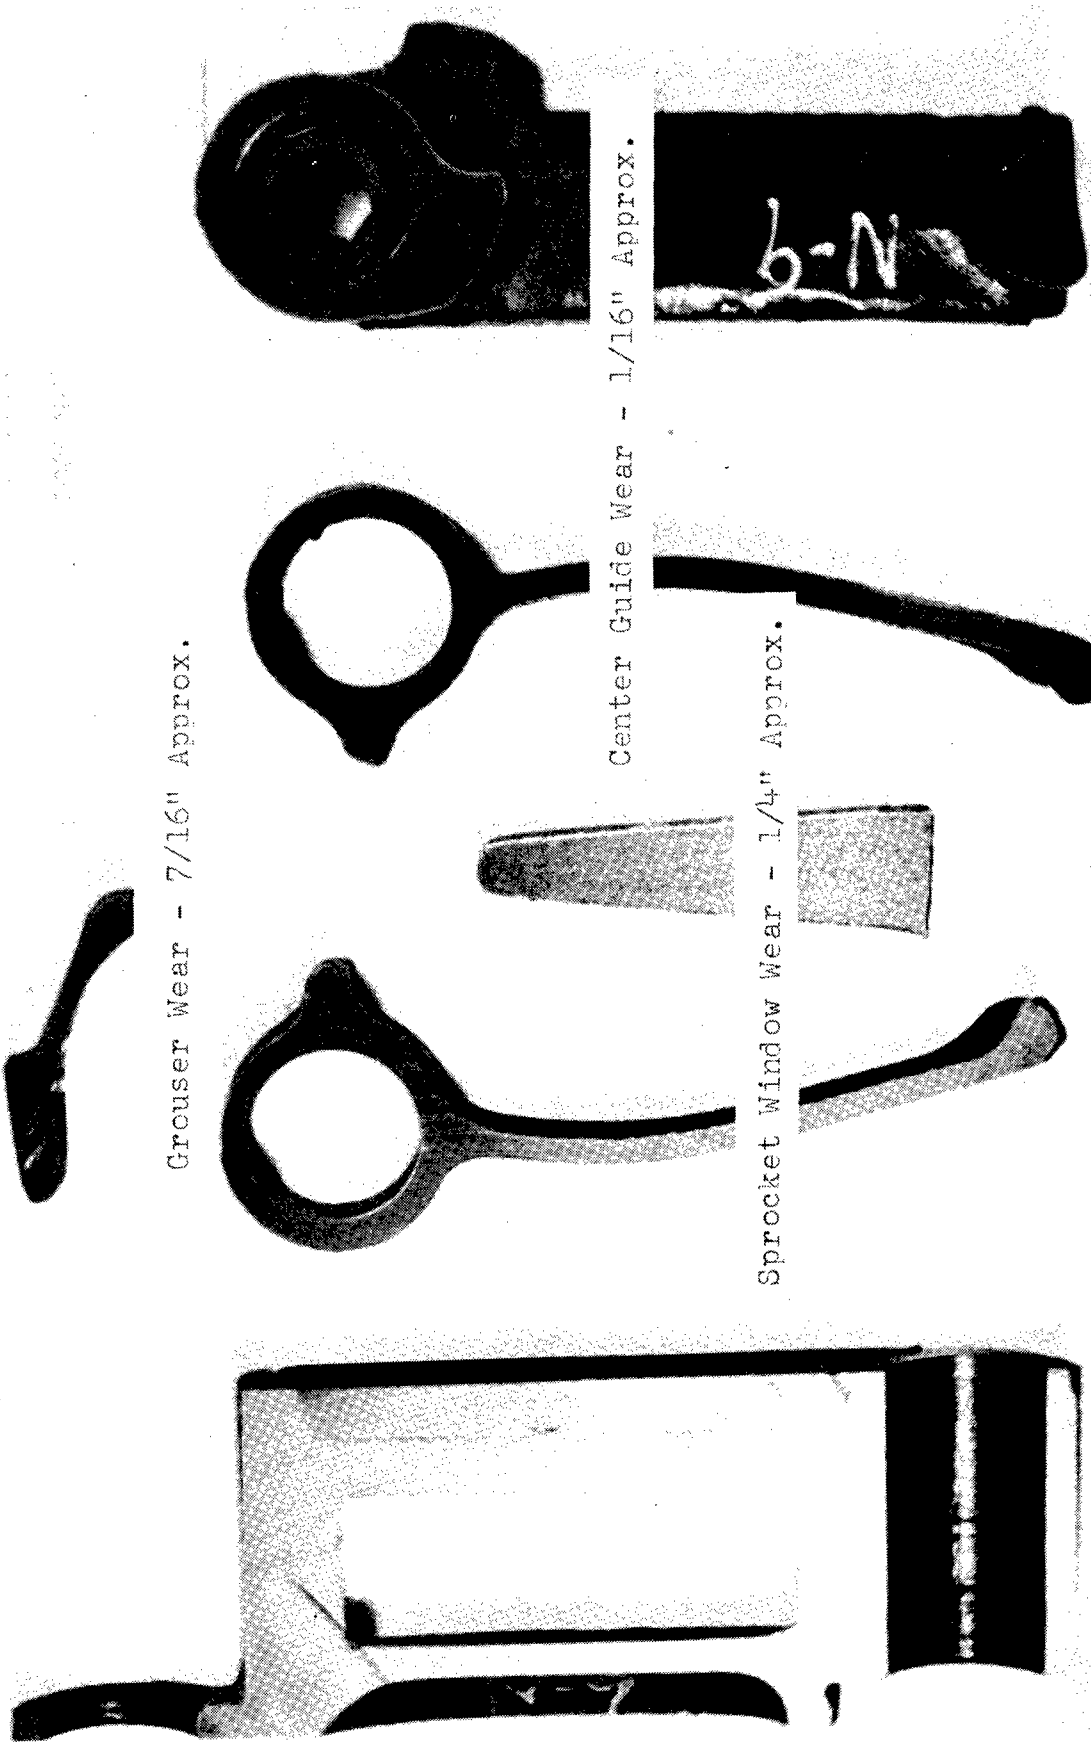
Grouser Wear - 7/16" Approx.

Center Guide Wear - 1/16" Approx.

Sprocket Window Wear - 1/4" Approx.

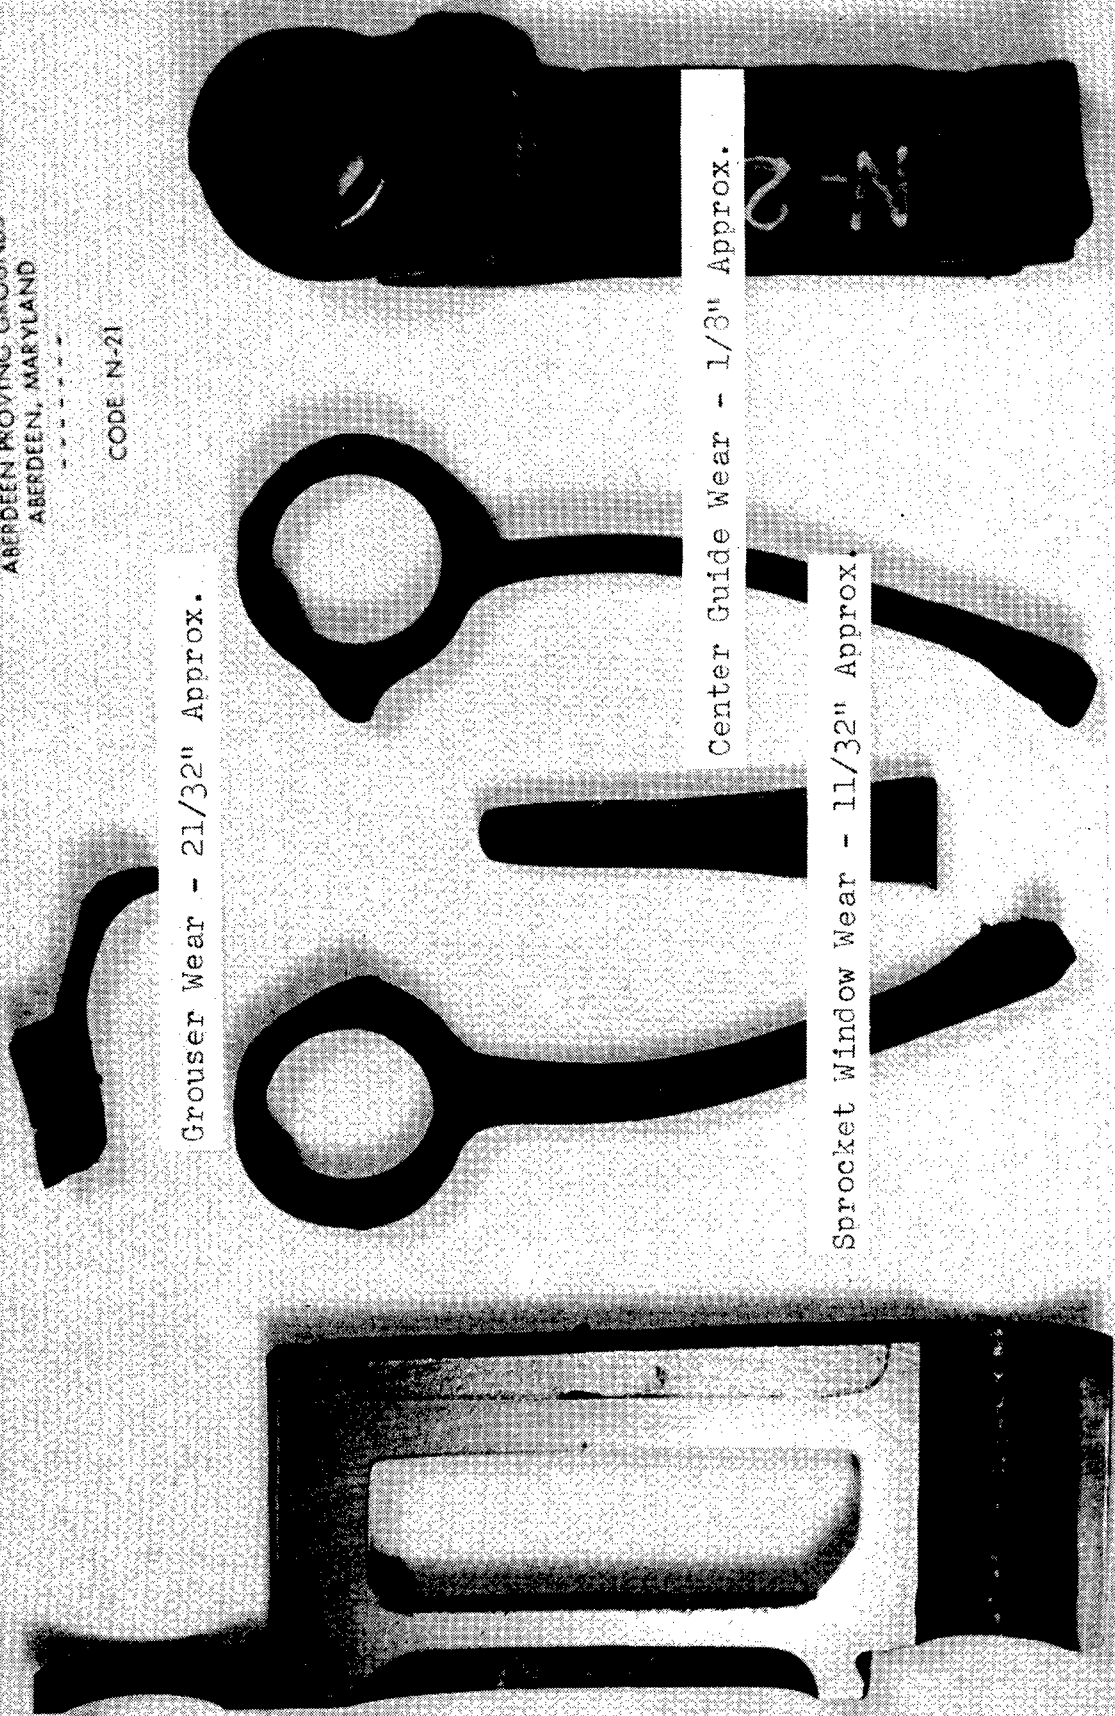
CODE N-21

Grouser Wear - $2\frac{1}{32}$ " Approx.

Center Guide Wear - $\frac{1}{8}$ " Approx.

Sprocket Window Wear - $1\frac{1}{32}$ " Approx.

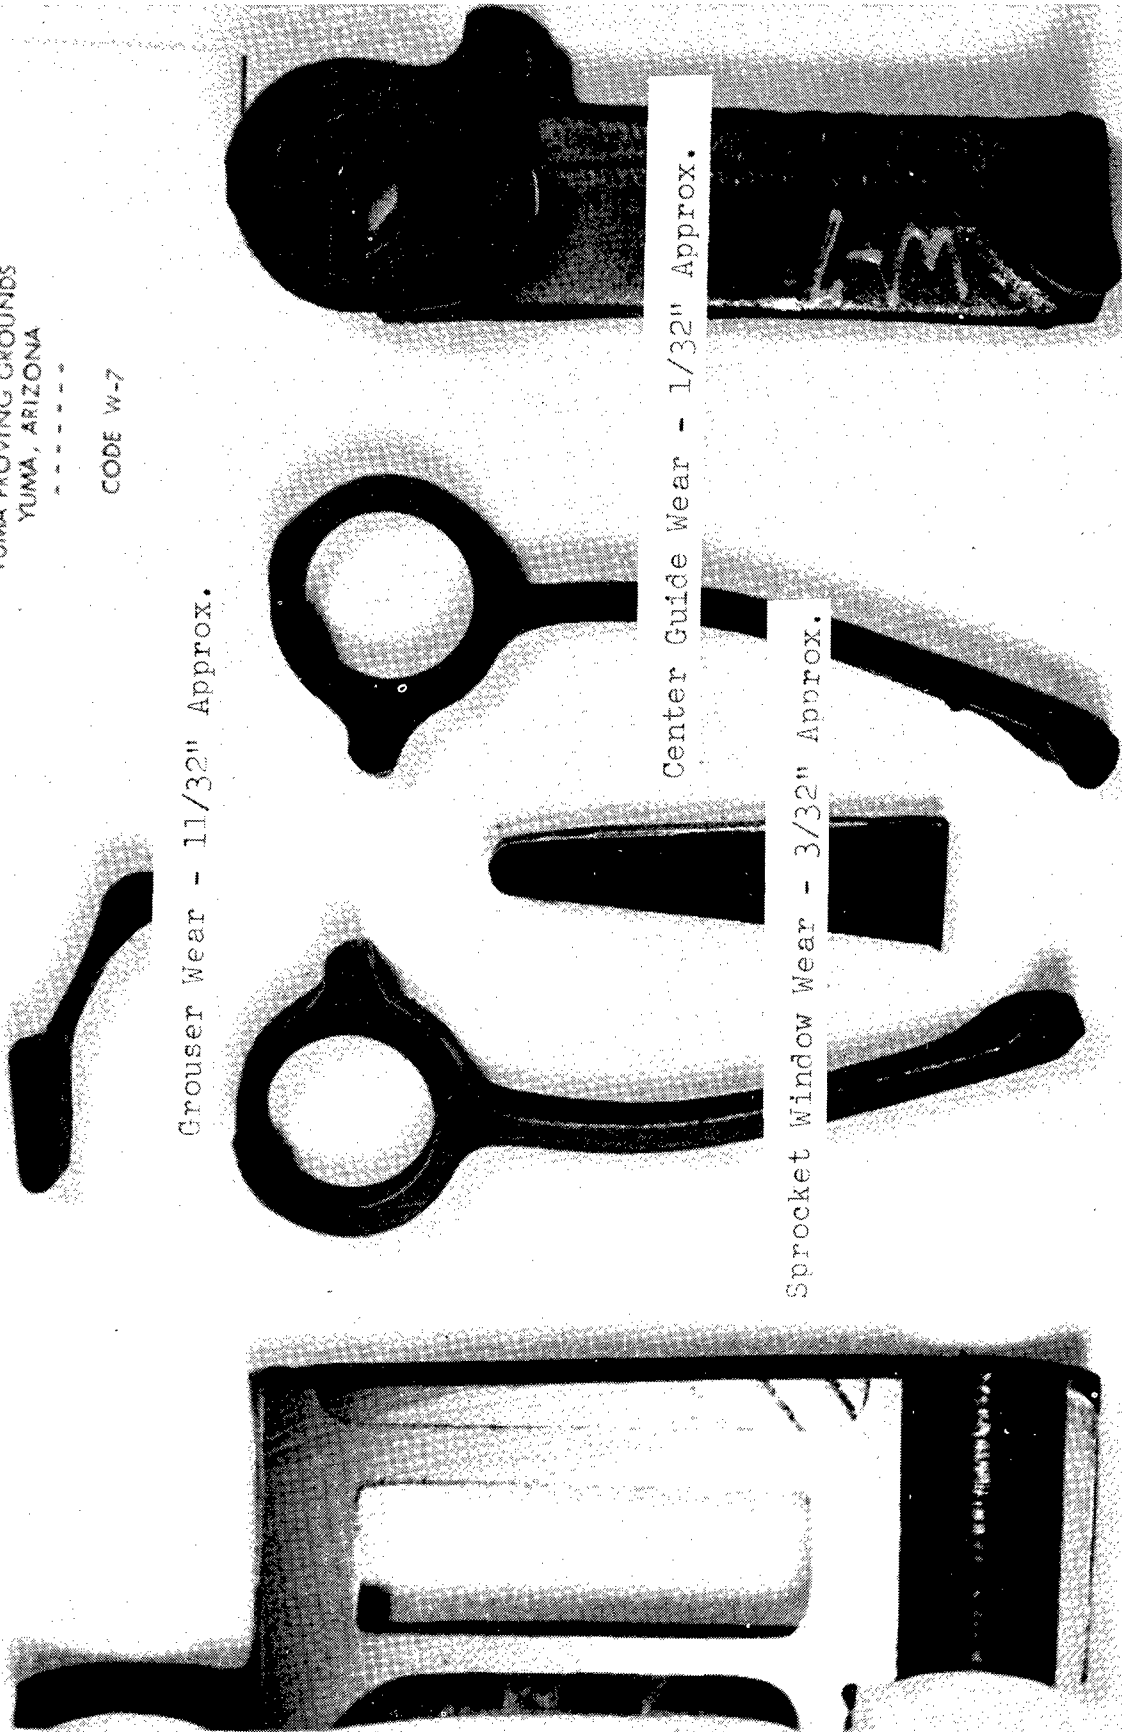
CODE W-7

Grouser Wear - 11/32" Approx.

Center Guide Wear - 1/32" Approx.

Sprocket Window Wear - 3/32" Approx.

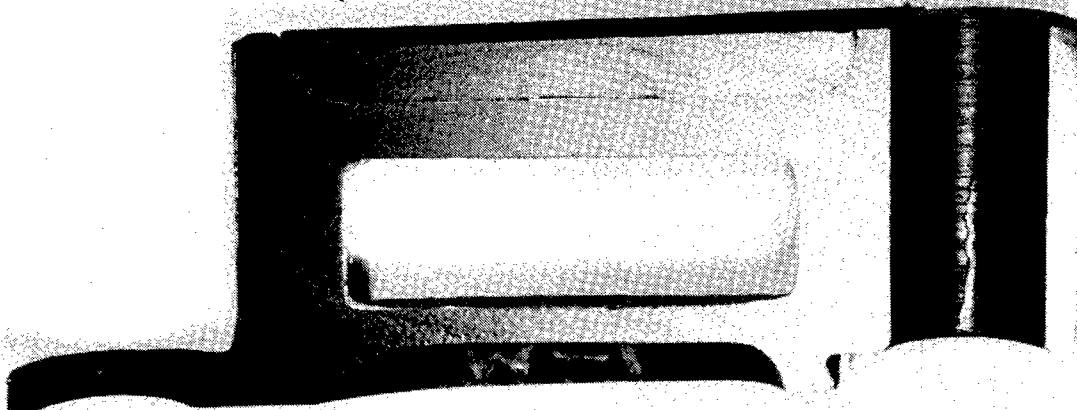
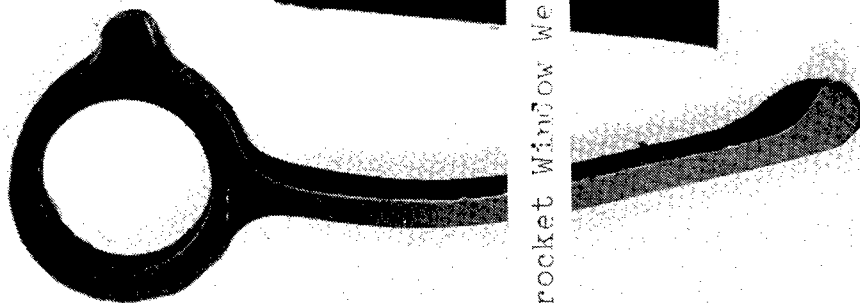
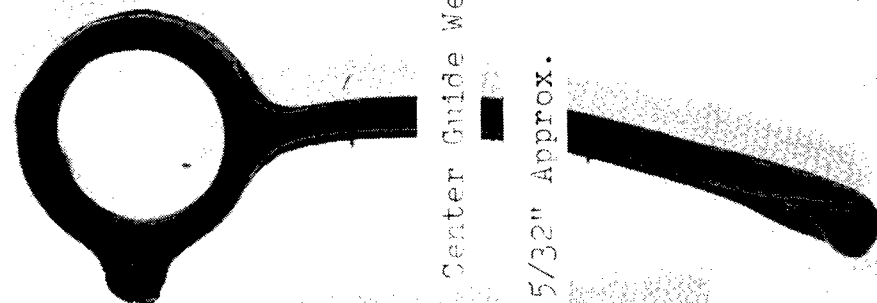
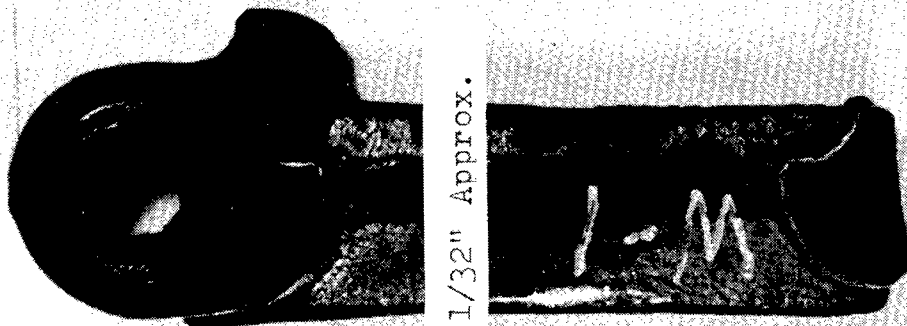
Figure 34

Grouser Wear - $15/32$ " Approx.

Sprocket Window Wear - $5/32$ " Approx.

Center Guide Wear - $1/32$ " Approx.
