TECHNICAL REPORT NO. 11850
APPLICATION TECHNIQUES
AND
METHODS FOR APPLYING FUSED
CARBIDES ON NON-LUBRICATED
WEAR SURFACES FOR HIGH VOLUME PRODUCTION

U. S. ARMY TANK-AUTOMOTIVE COMMAND
CONTRACT NO. DAAE07-71-C-0148
MM&T PROJECT NO. 4704287

June 1974

P.H.Brotzman, E.H.Drewes, N. Wulff
Firestone Tire and Rubber Company
Metallurgical Laboratory

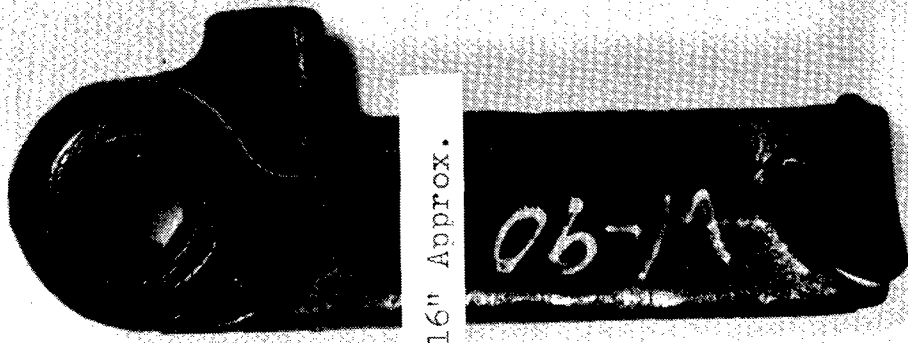
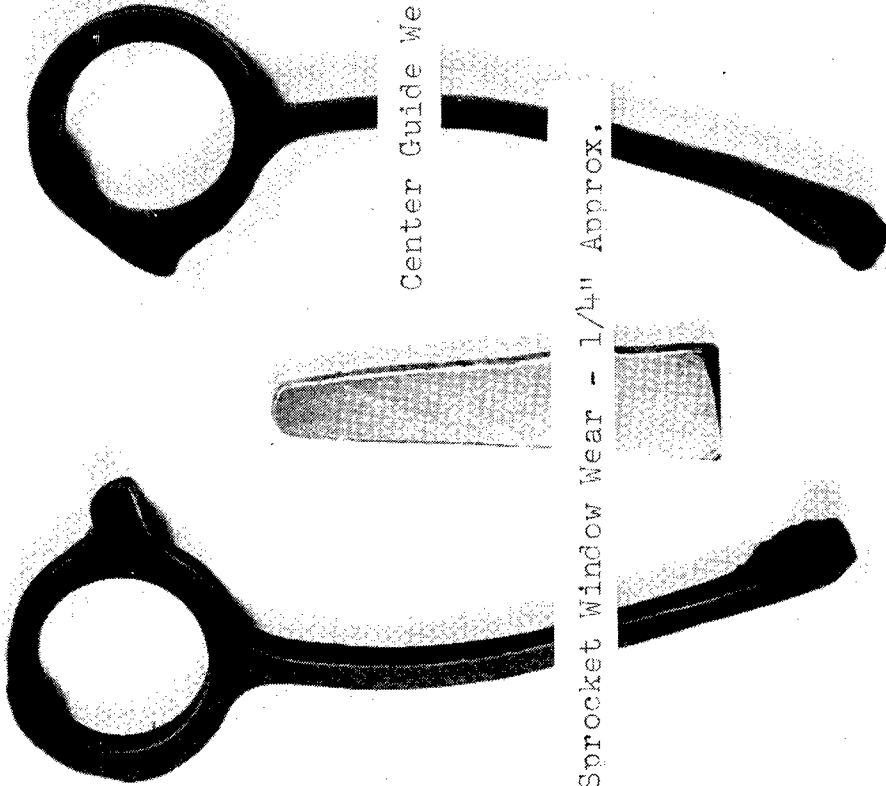
Figure 35

Grouser Wear - 17/32" Approx.

Center Guide Wear - 1/16" Approx.

Sprocket Window Wear - 1/4" Approx.
