A CRASHWORTHY ARMORED PILOT SEAT
FOR HELICOPTERS

Bernard Mazelsky

Naval Air Development Center

18 January 1974

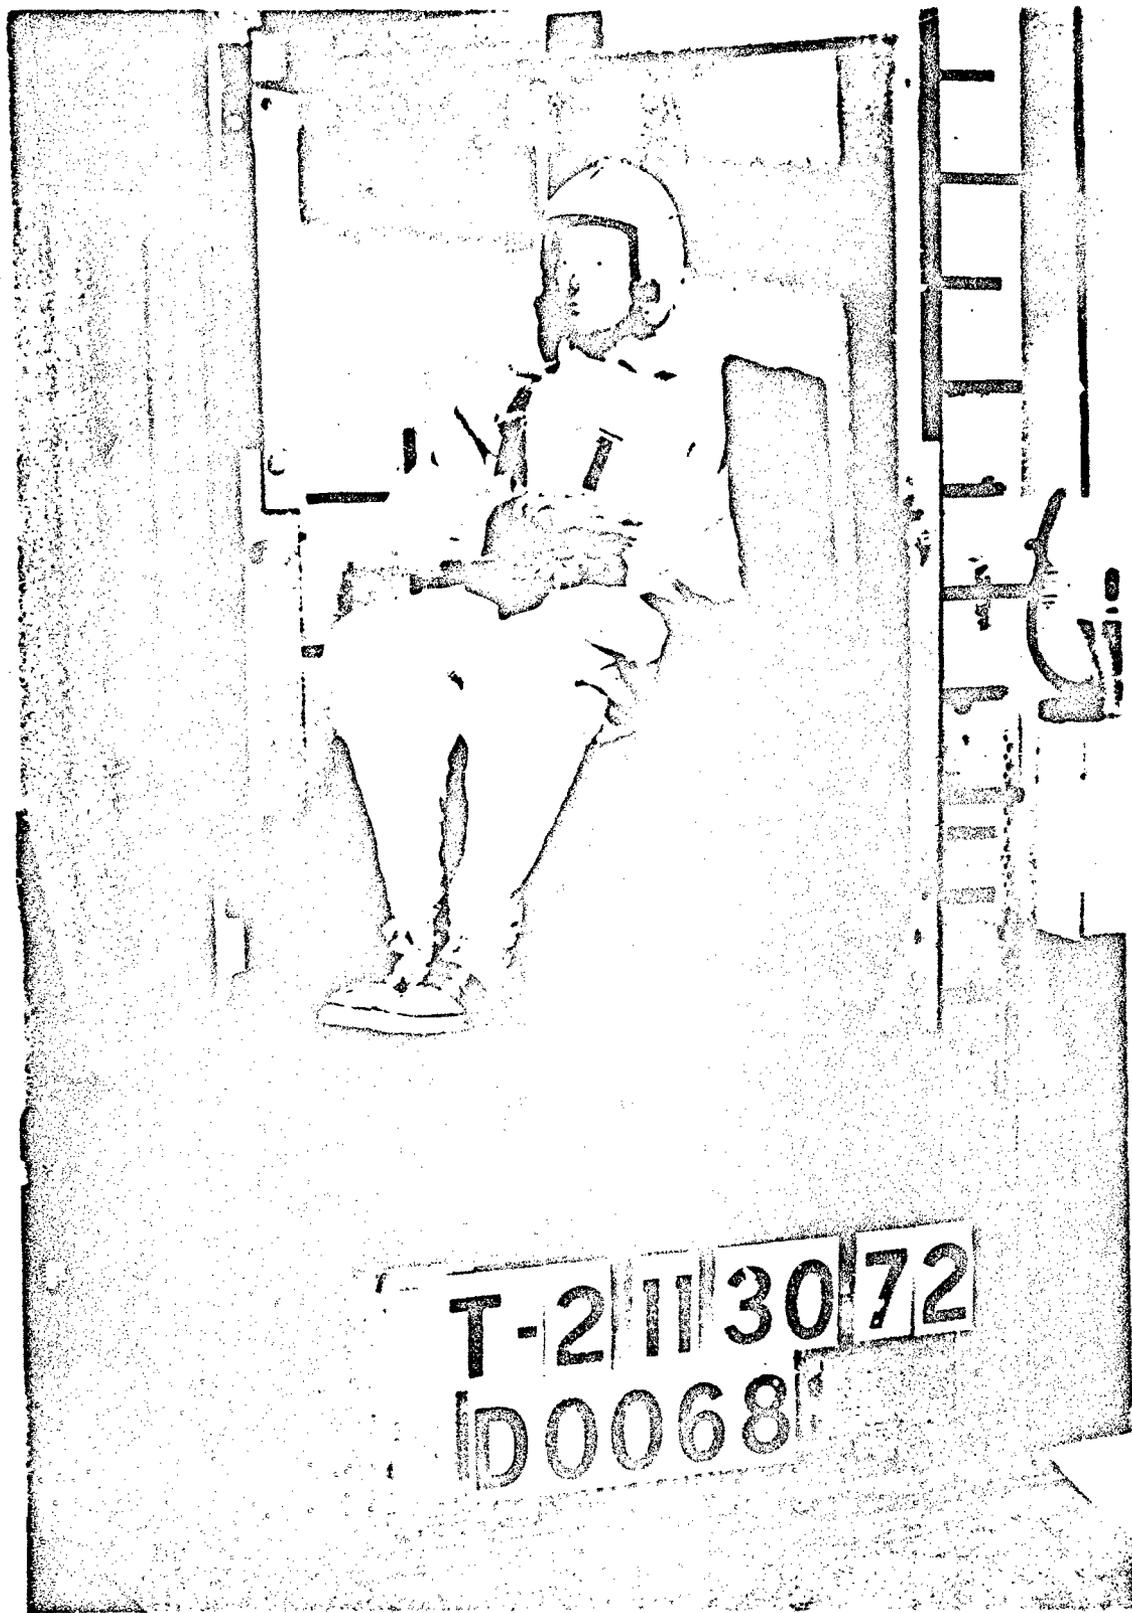
Figure 15. Position of Seat and Dummy for
ARA Drop Test

A photograph showing the position of the seat and dummy prior to a drop tower test is given in Figure 15. A 95th percentile male dummy was placed in the seat and the seat was then positioned in its rearmost horizontal location and its uppermost vertical location. The uppermost vertical location was chosen as it results in the maximum loads applied to the seat frame during an impact. All E/A lengths and the seat's location relative to the floor and frame were measured. The drop platform was then raised to the desired height and released. The G load on the seat frame was controlled by four large E/A's positioned at the bottom of the drop tower. After the impact, the lengths of all E/A's and the relative position of the seat were again measured. The difference between the initial and final positions is the motion of the seat.

of the seat in tests 1A and 1B are different because their initial positions are different. The structural integrity was maintained during the two drops. No simple structural failure was detected. The 4-way seating adjustment functioned properly after the tests.

During the drop tower tests a modification to the upper TOR-SHOKs were required in order to prevent the seat from bottoming out on the deck. The modification consisted of placing "stop" rings on the outer and inner tubes of the TOR-SHOKs. With this arrangement the upper TOR-SHOKs could not break loose as was evidenced during Test 1 and Test 2 on the drop tower. Once the rings were installed, the two drop tower tests were repeated and the seat operated properly.

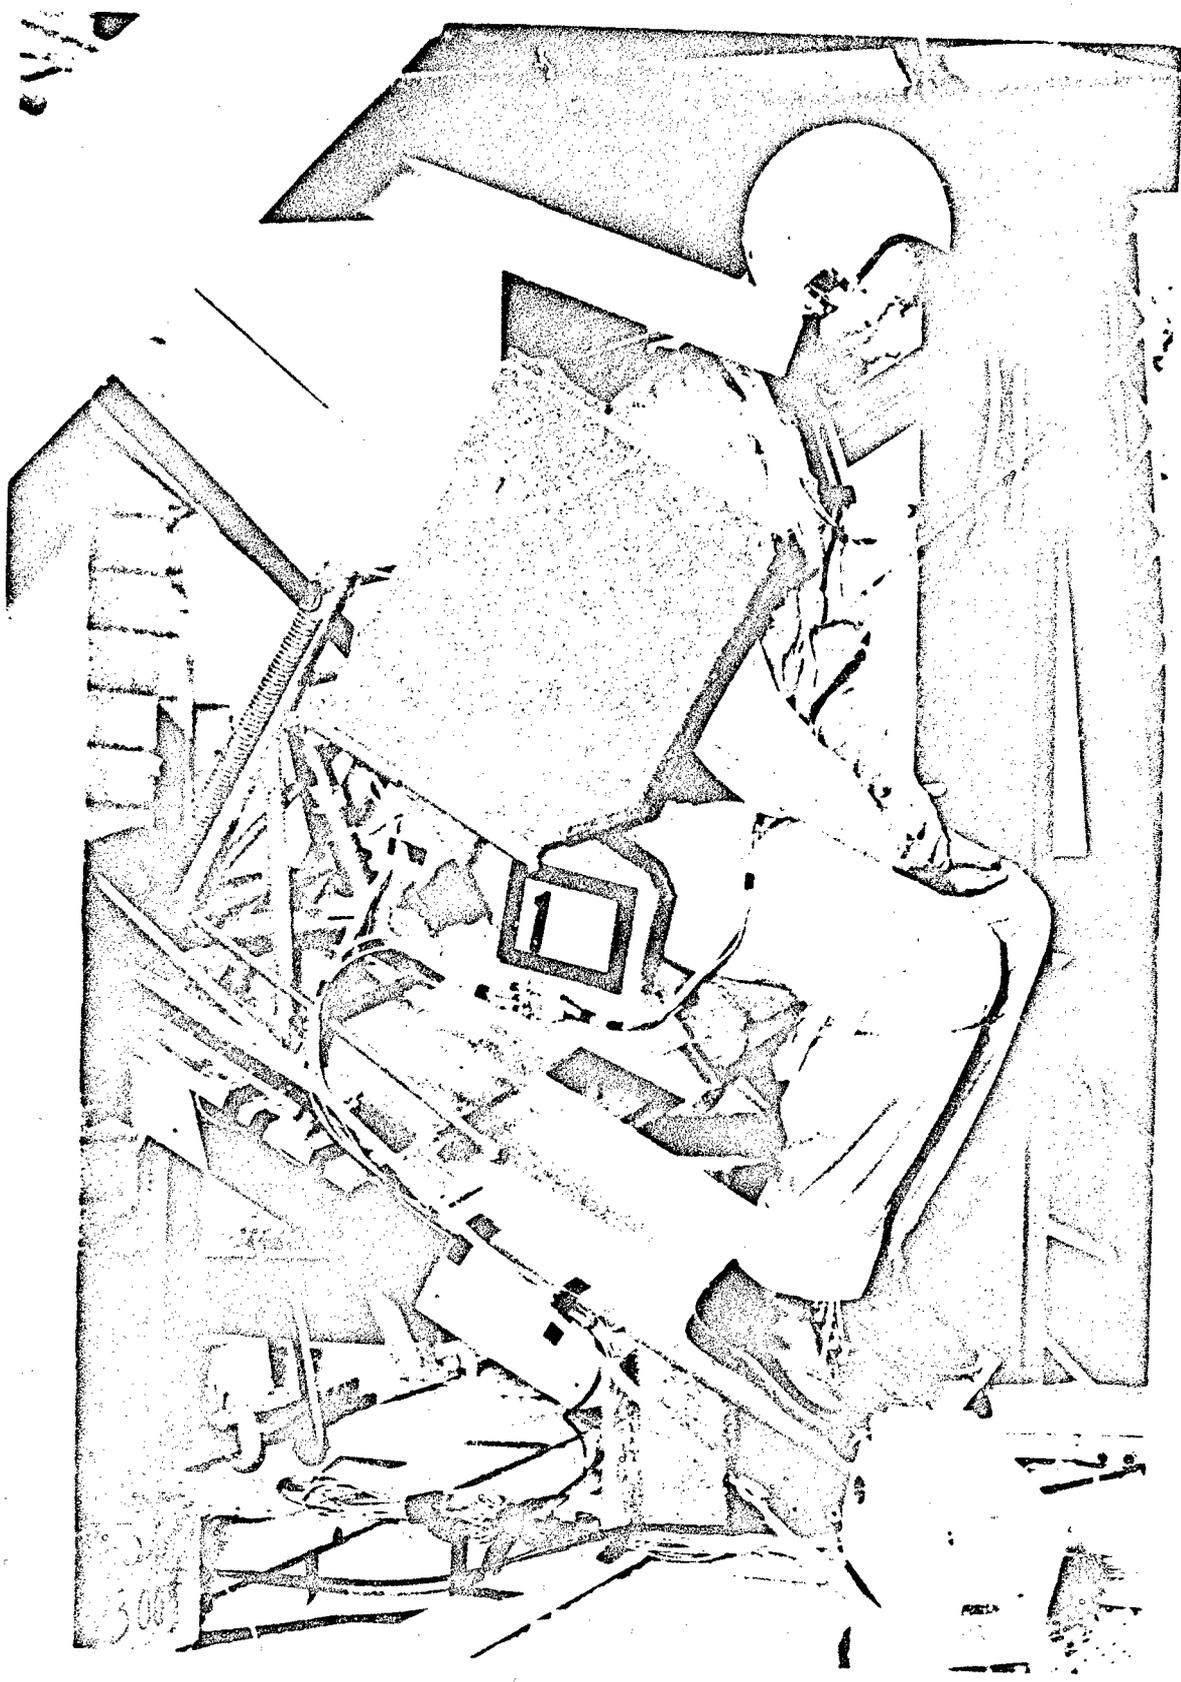
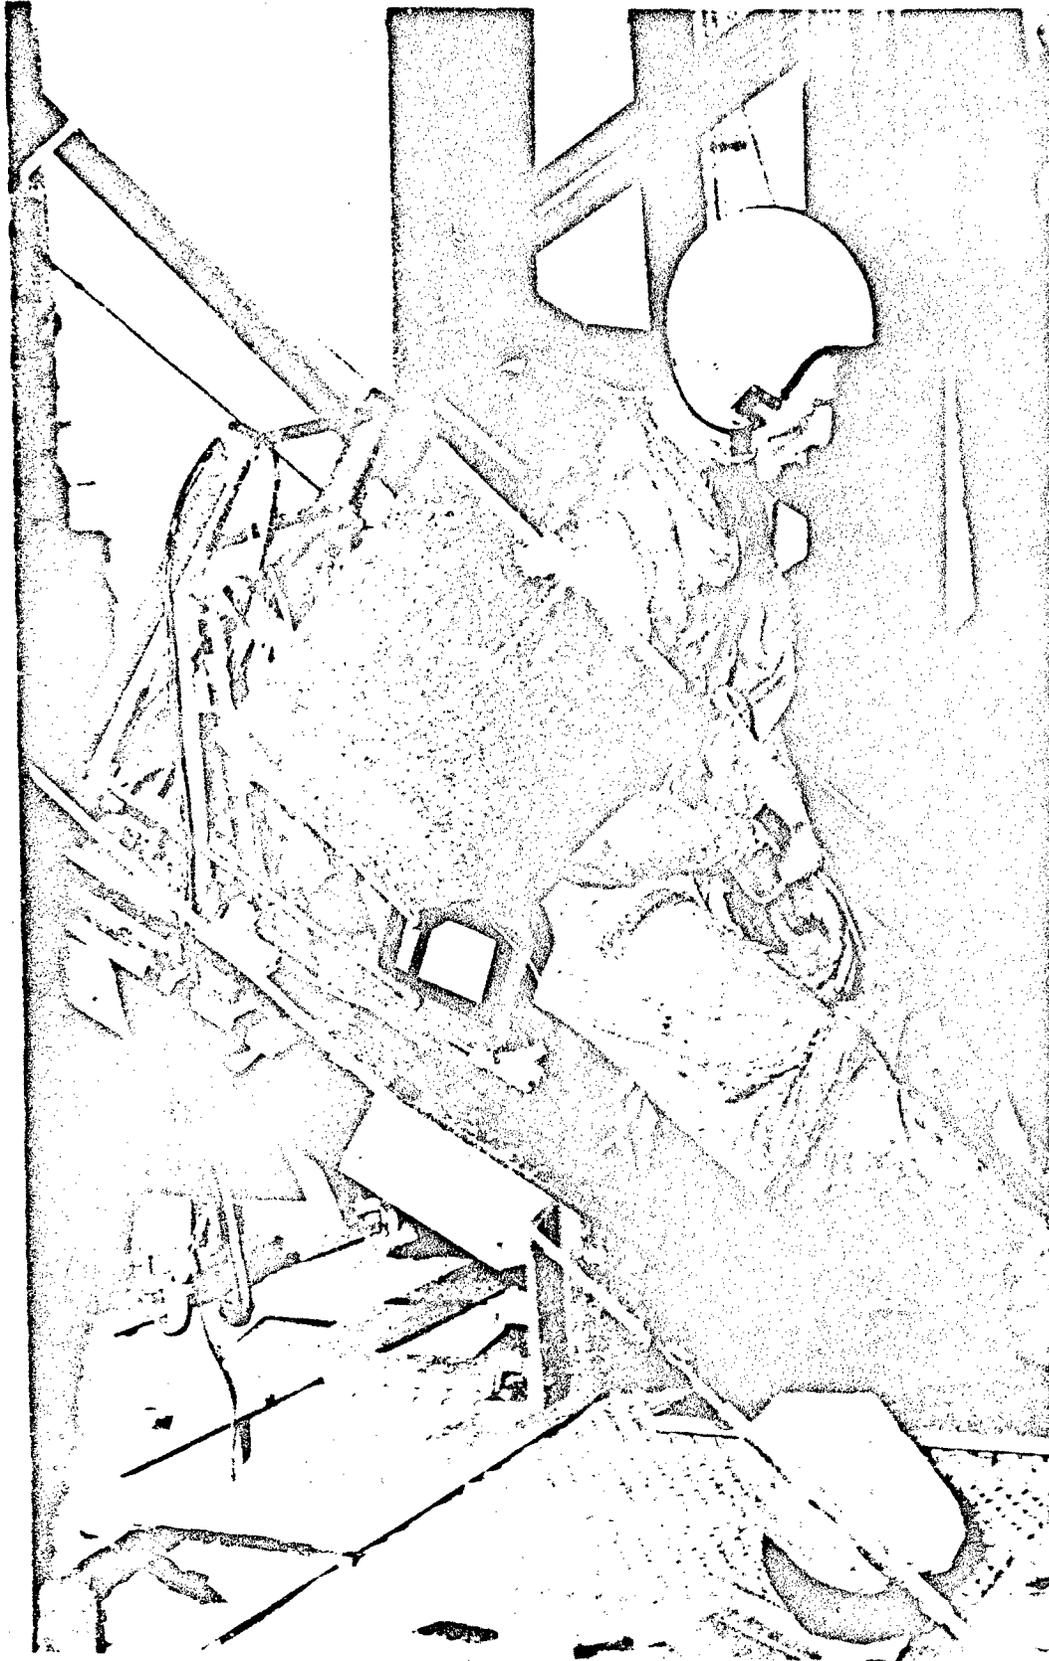
Photographs of the installation for this test are shown in Figure 19 prior to impact, and in Figure 20 after impact. "The bucket was tested in the full-down position and rear most adjustment with respect to the rails. This aft horizontal position was used for all subsequent tests. To preclude the possibility of complete breakaway of the side panel armor from the seat system, the following modifications and precautionary measures were taken for all tested seats: (1) The aft side panel adjustment hole (position used for all tests) was reamed out to a depth of 1/4 inch to insure positive locking of the spring-loaded adjustment pin, and (2) a 3/16 inch hole was drilled in the side panel lip to permit the attachment of a safety line which would preclude breakaway of the panel but not affect normal operation."

"Test I resulted in stroking and separation of the top pair of TOR-SHOK E/A's. Separation occurred at the end of the impact pulse and was followed by impact of the right forward corner of the bucket with the deck. The pitching motion of the bucket caused the bottom TOR-SHOKs to come in contact with the horizontal adjustment actuator arm deforming it, however, the seat remained firmly locked in position at all times. It was concluded that the upper E/A's required a modification to keep the inner and outer tubes from separating."

"The bucket impacted the deck at the right forward corner. Measured downward deflection of the seat was 6-5/16 inch on the right side and 4-5/8 inch on the left side. The forward pitching motion of the bucket caused the bottom TOR-SHOKs to contact and deform the horizontal adjustment actuator arm. The seat remained firmly locked in position throughout the crash test with the dummy restrained in the seat. It was concluded that the seat met the intent of the Test 1 condition of MIL-S-58095(AV)."

"Test 1A a repeat of Test 1, was conducted with modified upper E/A's which were designed so that they would not separate at the end of stroking"

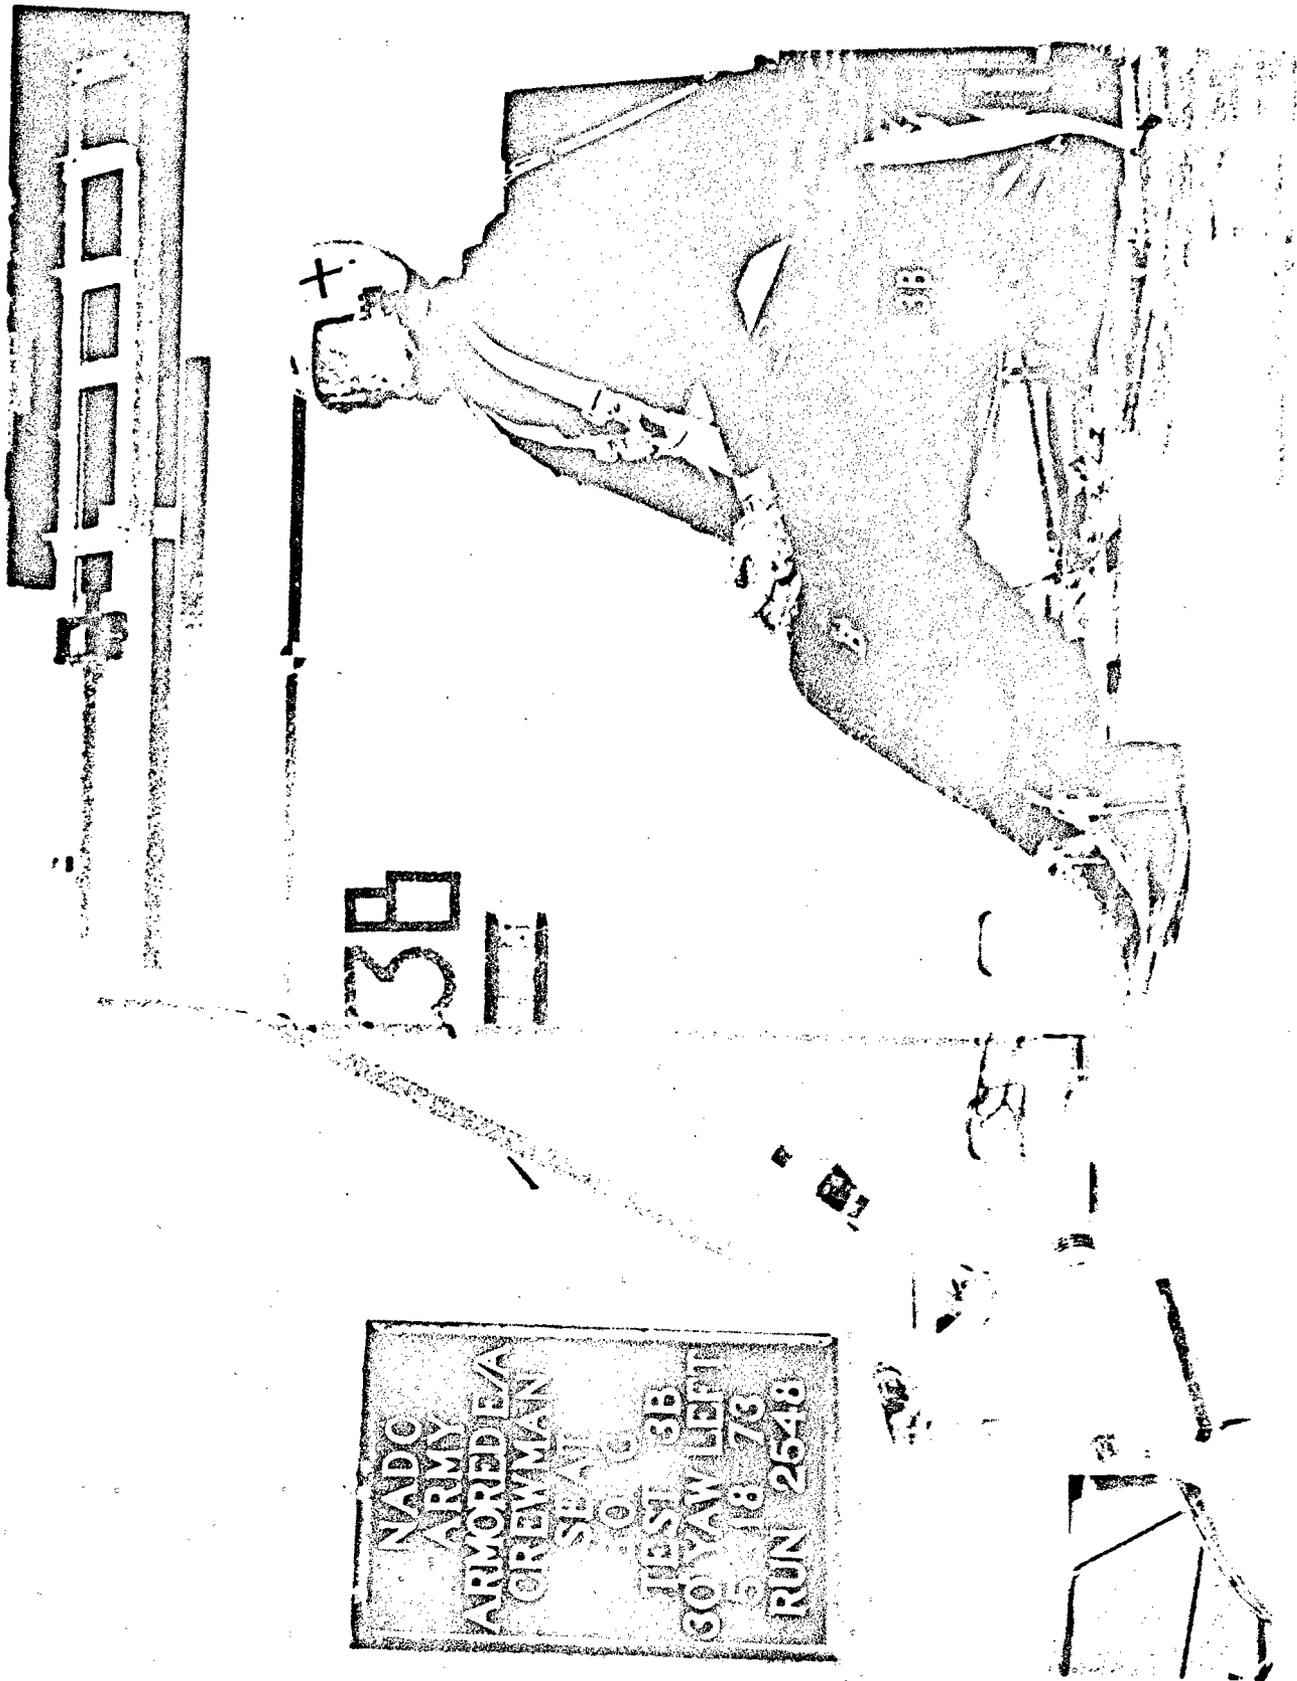
Photographs of the installation for these tests are shown in Figure 24 prior to impact and in Figure 25 after impact. The seat was subjected to the Test 2 condition of Table iV of MIL-S-58095(AV).

Test 3 and its repeat, Test 3A resulted in the failure of the bucket attachments to the TOR-SHOKs. Specifically, the ball joint rod ends failed because of insufficient heat treatment.

Test 3B was conducted with modified rod ends rated at 11,000 lbs. "Inspection of the seat after the test disclosed that the port side rail partially failed in Test 3B just before the end of the input pulse. Analysis of the data and camera coverage indicated that the threads of the tiedown bolts were stripped prior to the shear failure of the rail. Inspection of the seat after the test showed that it was intact and still attached to both rails. The damaged port side rail warped the seat so that the right forward corner of the bucket was tipped toward the deck. The dummy was fully restrained by the shoulder and lap belts. It was concluded that the seat met the intent of the Test #2 conditions of MIL-S-58095(AV). Figure 26."

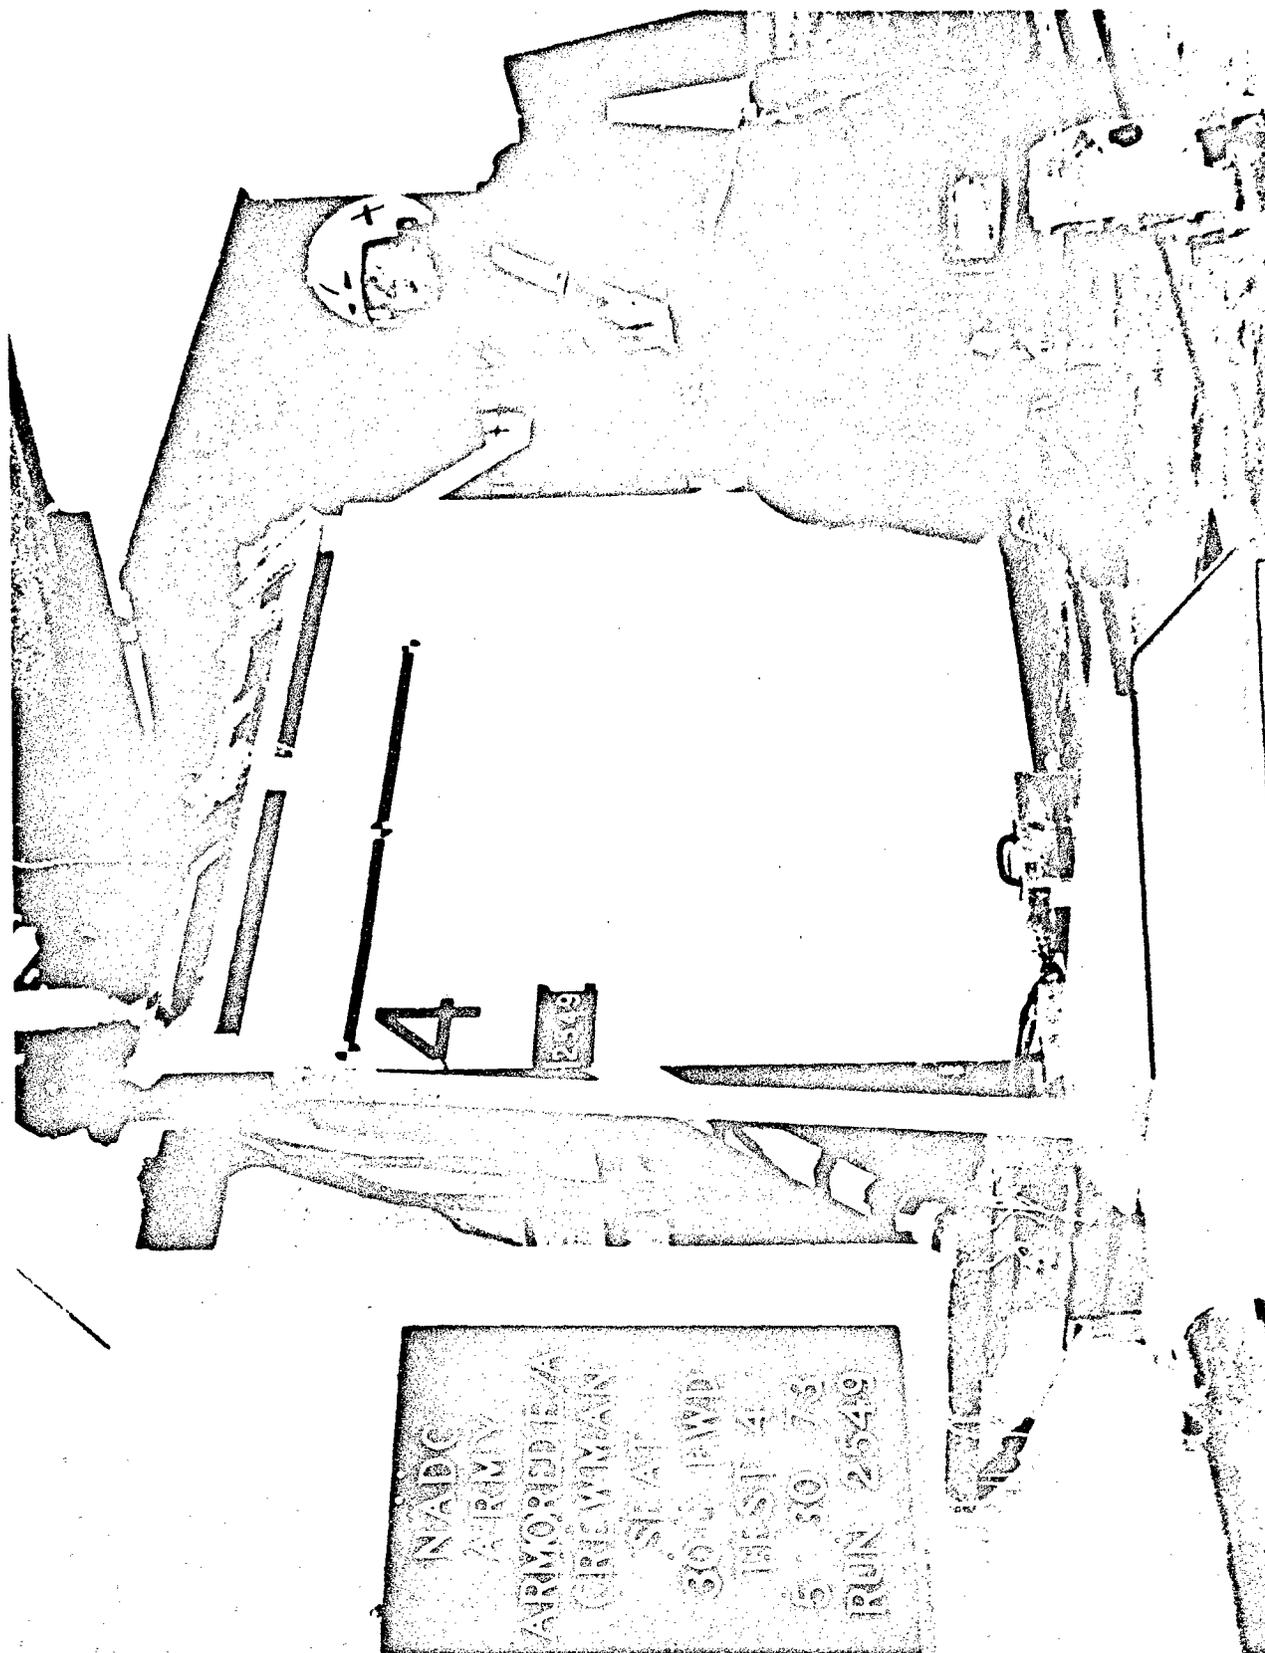
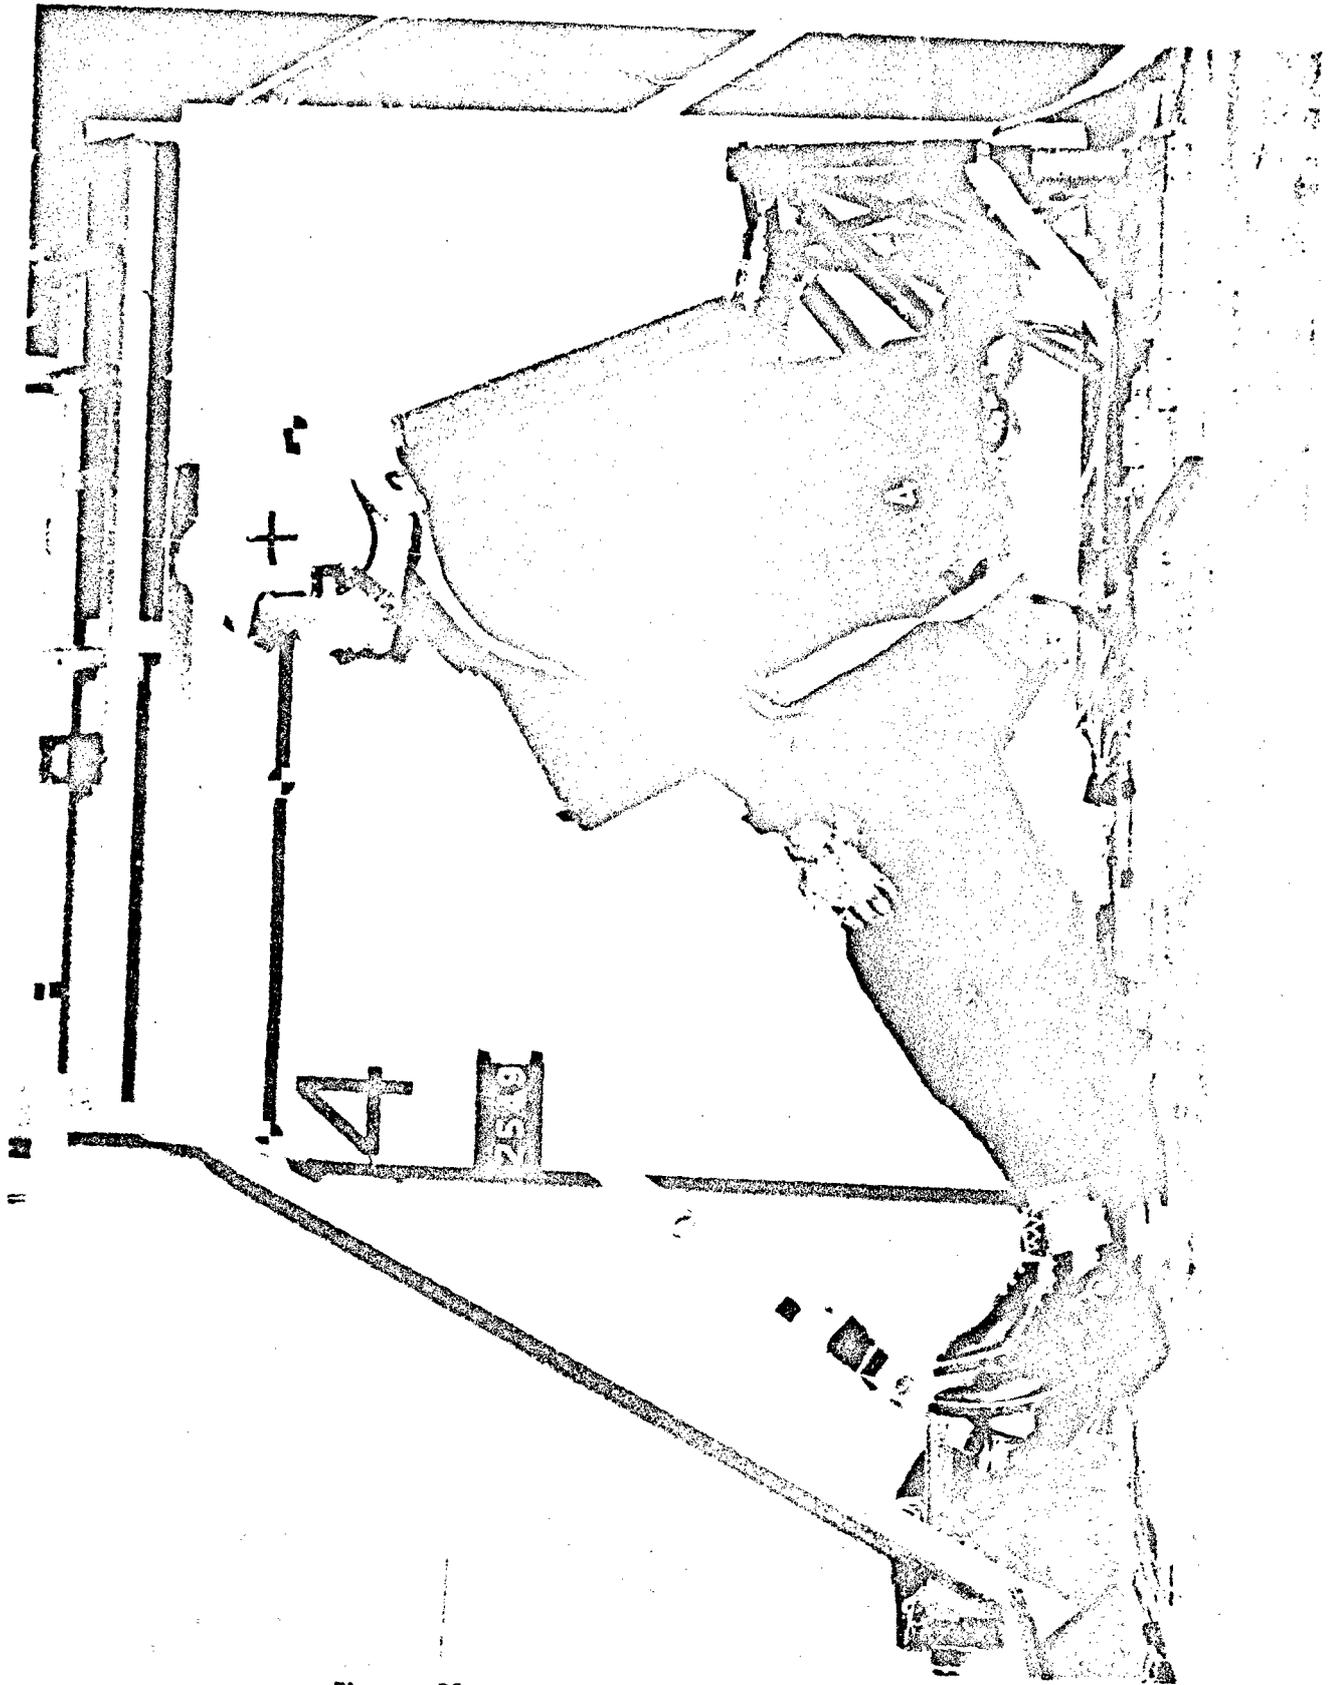
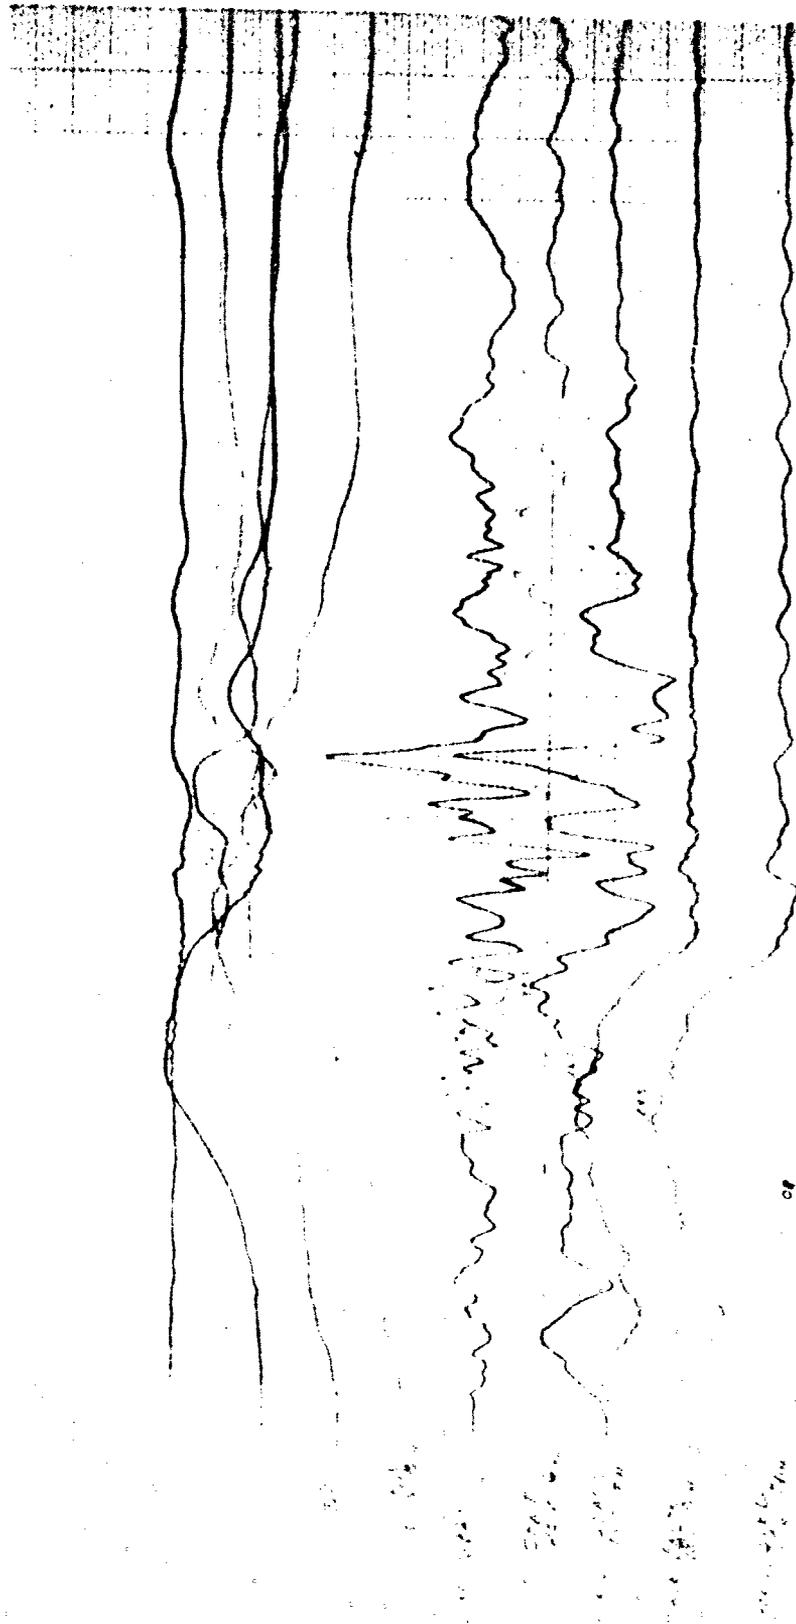
"The seat was subjected to the Test #2 condition of Table IV of MIL-S-58095(AV). The bucket was tested in the full-up position. Because of the failure of the rail mount bolts experienced in Test 3B, the coarse-threaded 1/4 inch bolts were replaced by MS-20004 allen bolts. Inspection of the system after the test event showed the seat to be intact with the dummy restrained by the harness straps. The cantilevering action of the dummy on the forward edge of the bucket plus the inertia load of the side panel assembly were sufficient to pull out some bolts retaining the seat back to the right side and rear of the seat pan. Five bolts along the right inboard side of the seat and six bolts along the bottom of the seat back pulled out of their tapped holes. However, the seat back and side remained attached. It was concluded that the seat met the design specification and performed satisfactorily, Figure 29." This was the last test conducted by NADC on this seat program.
