MARINE FOULING OF TITANIUM HEAT EXCHANGERS

Wayne L. Adamson

David W. Taylor Naval Ship Research and Development Center Annapolis, Maryland

March 1976

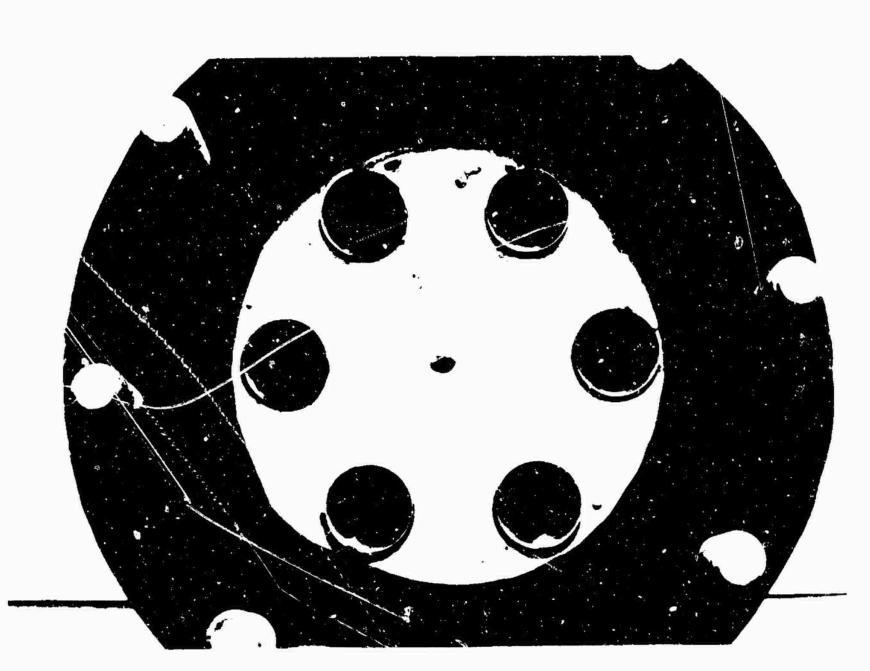
The initial runs, which were conducted at 1 and 2 ft/sec (0.3 and 0.6 m/sec) tube velocity in both heat exchangers, established the fact that marine fouling will occur in titanium heat exchangers, both inside the tubes and on the tube sheets and headers, figures 7 and 8. The species of fouling organisms were principally barnacles with some colonial hydroids. Fouling occurred on the control (No. 1) heat exchanger, whereas the No. 2 chlorinated exchanger remained void of any marine growth, figure 9. In spite of the fairly extensive buildup of marine life in the tubes, no problems were encountered in mechanical cleaning with the wire brush. Attachment did not appear to be as tenacious as might often be found with other tube materials.

Figure 7 - Barnacle Fouling of Titanium Heat Exchanger after 2 Weeks at 1 ft/sec (0.3 m/sec) Seawater Velocity
