DIAGNOSTIC SIGNIFICANCE OF MACRO- AND MICROSCOPIC FEATURES OF CATASTROPHIC GUN-TUBE FAILURES

1976

ROBERT L. HUDDLESTON

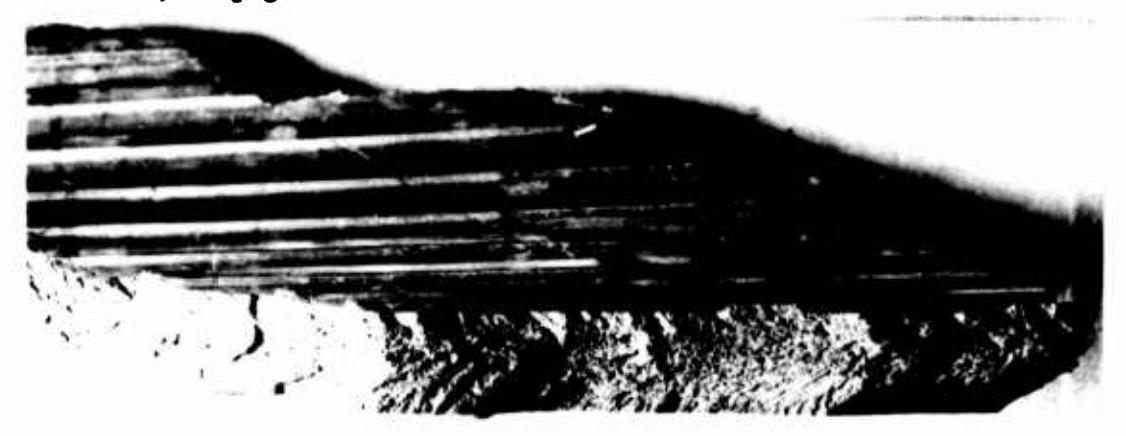
It is important to examine metal fracture surfaces before rapid corrosion sets in to conceal vital indications on the fresh, highly energetic surface. Fracture tracing can be done on mixed-mode fracture surfaces that reveal a "herringbone" or "chevron" pattern, indicating the direction of crack propagation. The chevron "V's point toward the direction of propagation when the fragments are reassembled, in jigsaw fashion.

FIG. 1 Chevron Fracture (1X)

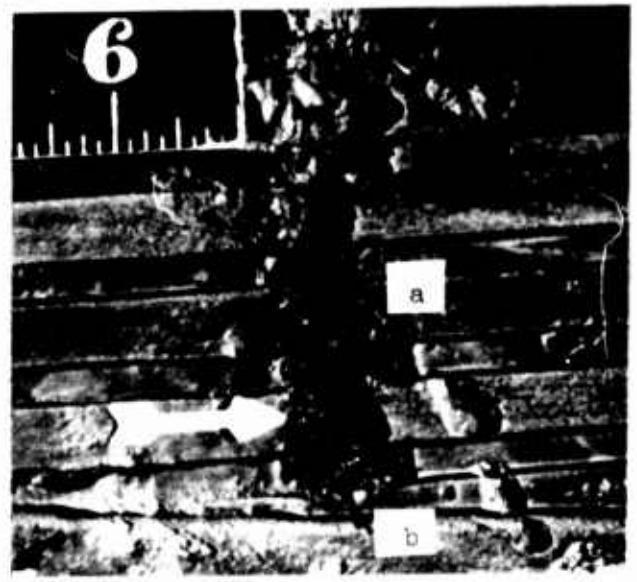
HE shell of several types have been shown to produce a circumferential ring of pits or fragment indentations corresponding to the ogive area of the shell. These pits increase the depth as the nose of the shell is approached. Apparently, the shell body, which is in close contact with the bore, does not fragment as does the

FIG. 3 Fragment Ring

unsupported ogive, fragments of which are projected into the tube at an angle, as driven by the expanding gases. HE antitank rounds (HEAT) produce an especially distinct nose fragment ring when they function in-bore.

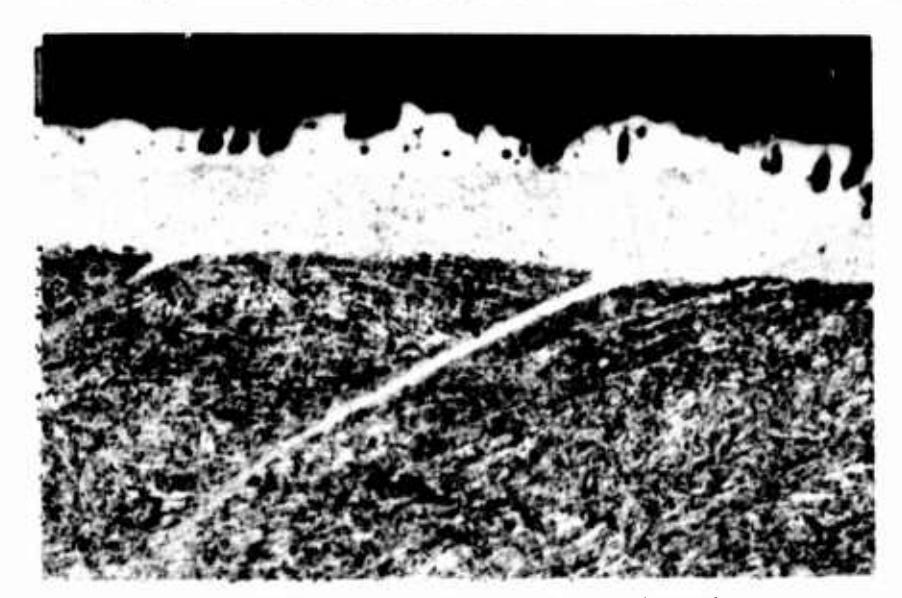
One of the more striking features produced by any order of detonation with sufficient force to rupture a tube is the martensitic streaks, which have been described as being caused by adiabatic shear (2). These indicate the presence of intense shear loading but,

FIG. 4 Adiabatic Shear (500X)

unfortunately, cannot be used to distinguish between high- and loworder detonations since they occur for both conditions. It has been thought that the direction of these "streaks" could be related to the direction of principal stress propagation, but to date they have not proved to be useful for this purpose During the breakup of a gun tube in the presence of an explosion, the shocks and reflections appear to form a virtual "tangle" and the direction of any given shear line and the direction of main stress propagation appear to be unrelated. Further observations are needed to better determine the usefulness of this observed phenomenon.

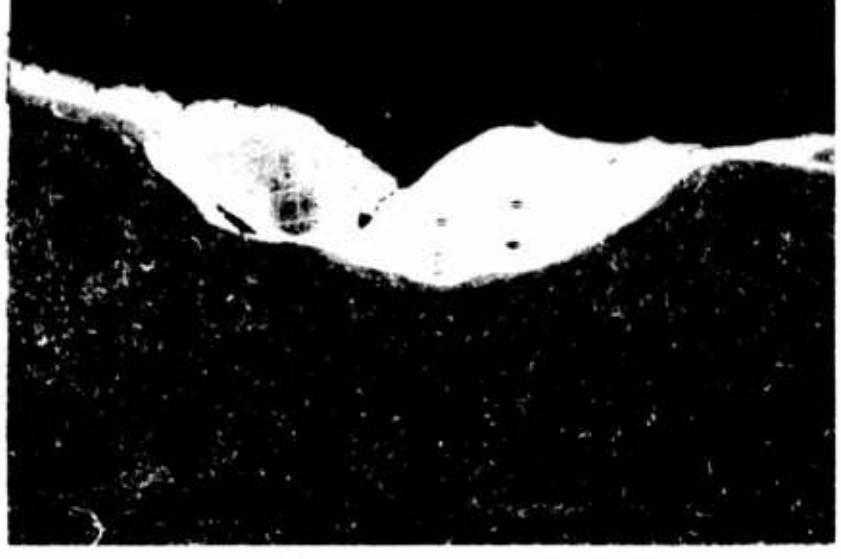
Another unusual condition has been noted on the surface of both tube and projectile fragments from in-bore prematures. A duplex white layer has been observed; this resembles the white layer seen by many examiners of worn gun tubes, believed to result from heat and the nitrogen from the propellert gases. One reference (3) reports the observation of three distinct zones: a) a subsurface tempered zone, softer than the underlying steel; b) a rehardened light etching, nearer the surface area; and c) a darker etching platelet containing layer at the surface. We have observed similar layers on tube and shell fragments and, at least in the case of the shell, the transformations resulted from the single explosion, not a large number of rounds fired over a period of time. Such transformed surface layers

FIG. 5 Layers on Shell (100X)

have not been observed on recovered shell that were fired under normal conditions and apparently are caused by the intense heat, possibly in combination with the pressure of the detonation gases. Almost all fracture surfaces of tube and shell fragments exhibit a gas-washed surface layer. This alteration of fracture surfaces, by masking
