UNITED STATES ARMY AVIATION BOARD  
Fort Rucker, Alabama

PROJECT NO. AVN 1162

EVALUATION OF RYANAV IV DOPPLER NAVIGATION  
SYSTEM

24 JUL 1962

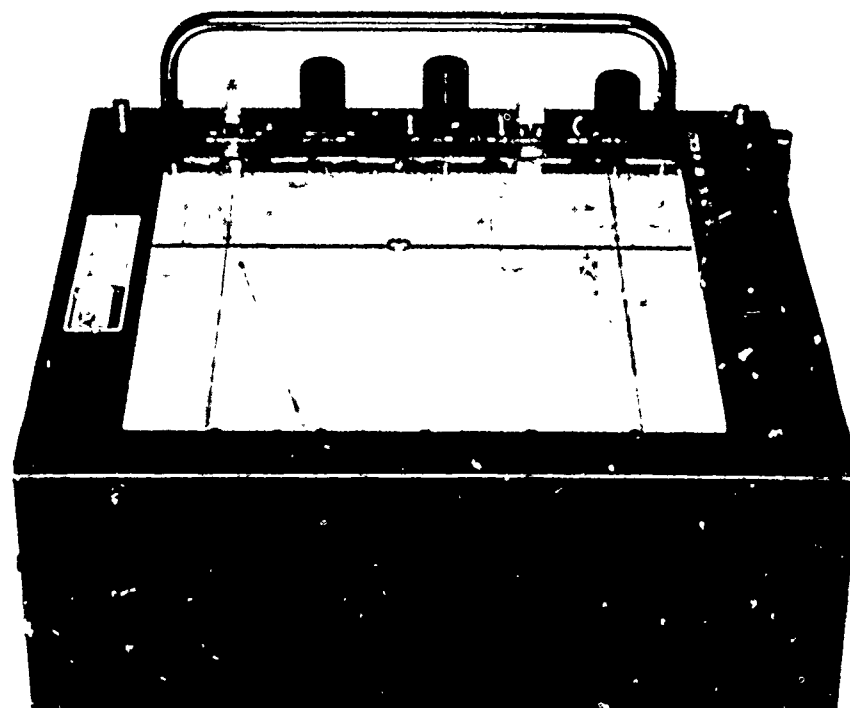
Figure 3. AFC plotting board

(2) The plotting board (see figure 3) had limited application in this configuration. Templates used in the plotting board covered 40-nautical-mile square areas for charts of 1/500,000 and 80-nautical-mile square for charts of 1/1,000,000. At an average airspeed of 140 knots on a generally straight-line mission, it was necessary to change templates every 17 minutes for the 1/500,000 charts and every 34 minutes for the 1/1,000,000 charts.

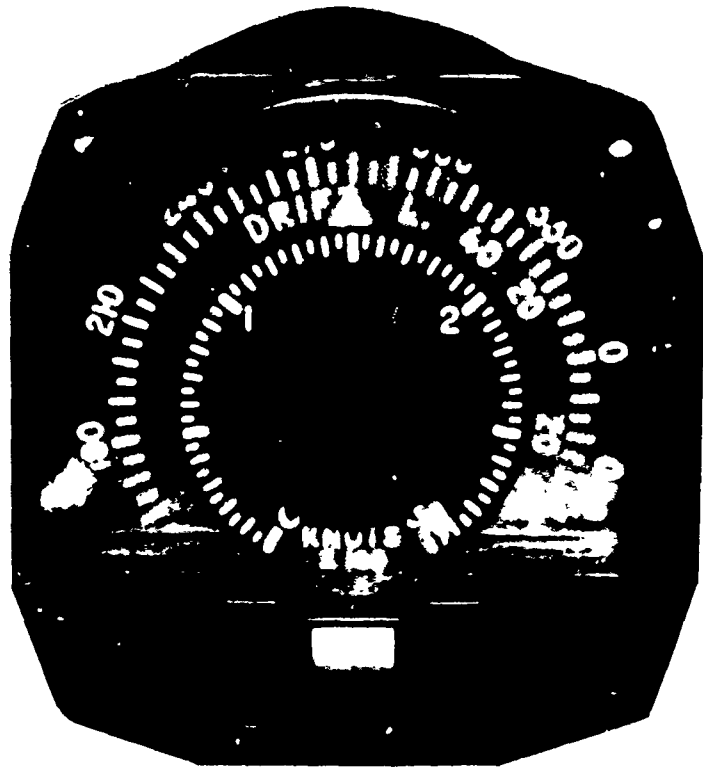
Figure 5.  
Groundspeed/  
drift-angle,  
windspeed/wind-  
direction indicator

(1) The groundspeed/drift-angle, windspeed/wind-direction indicator (figure 5) was difficult to read and differed from normal instrument presentation in that:

(a) One index served for both wind direction and drift angle, but used two sets of numbers for read-out. The wind direction was shown on a compass card with the numbers on the outside of the card; the drift angle was shown as "Left" or "Right" with the numbers nearer the center of the instruments.

(b) When switching from groundspeed/drift-angle to windspeed/wind-direction, the "knots x 100" pointer oscillated wildly for 5 to 10 seconds before stabilizing.

(c) The outside compass card of the instrument accepted and displayed instantaneous Doppler information without

damping, thus jerking and jumping at intervals of from one to five seconds in increments of five to fifteen degrees. The groundspeed and windspeed pointer varied constantly but in much smoother and smaller increments.

2. Presentation of the groundspeed/drift-angle, windspeed/wind-direction indicator is too complicated and information was displayed erratically and with oscillations.	Redesign indicator with damping incorporated taking into consideration engineering factors with regard to readability and simplicity of the instrument face.

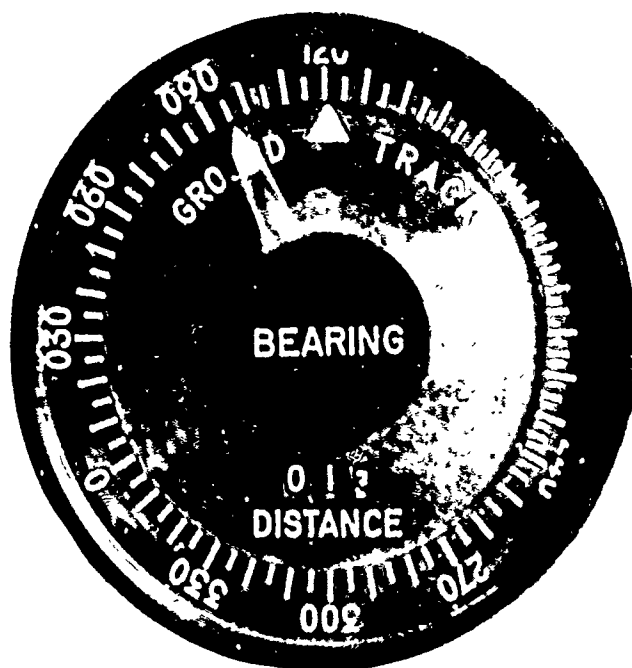
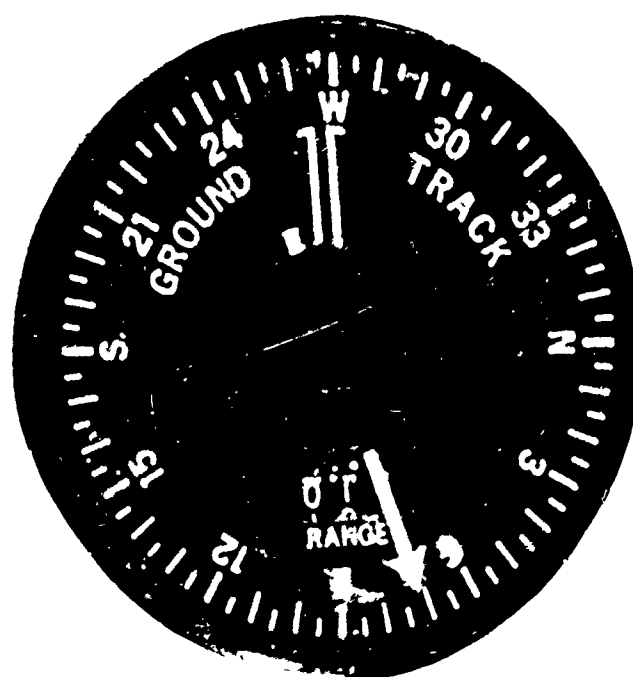
Figure 6. Original configuration of the bearing-to, ground track, and range indicator

(2) At the beginning of the test, the ground-track, bearing-to, and range indicator displayed ground track on a compass card that had the heading numbers on the outside of the card and the degree increments on the inside (figure 6). This was later reversed (figure 7), enabling easier interpretation. The numbers on the digital range read-out were too small for normal operation and were hidden by the center of the instrument when viewed at an angle from above.

3. Bearing-to, ground-track, and range indicator has numbers in the digital range read-out which are too small for normal operation and are hidden by the center of the instrument when viewed at an angle from above.	Redesign the digital readout so that the digits are large enough for normal operation, and relocate the read-out so that it is readily readable from all normal observing angles.	The manufacturer has partially corrected this by enlarging the digits. However, the digital read-out has not been relocated.

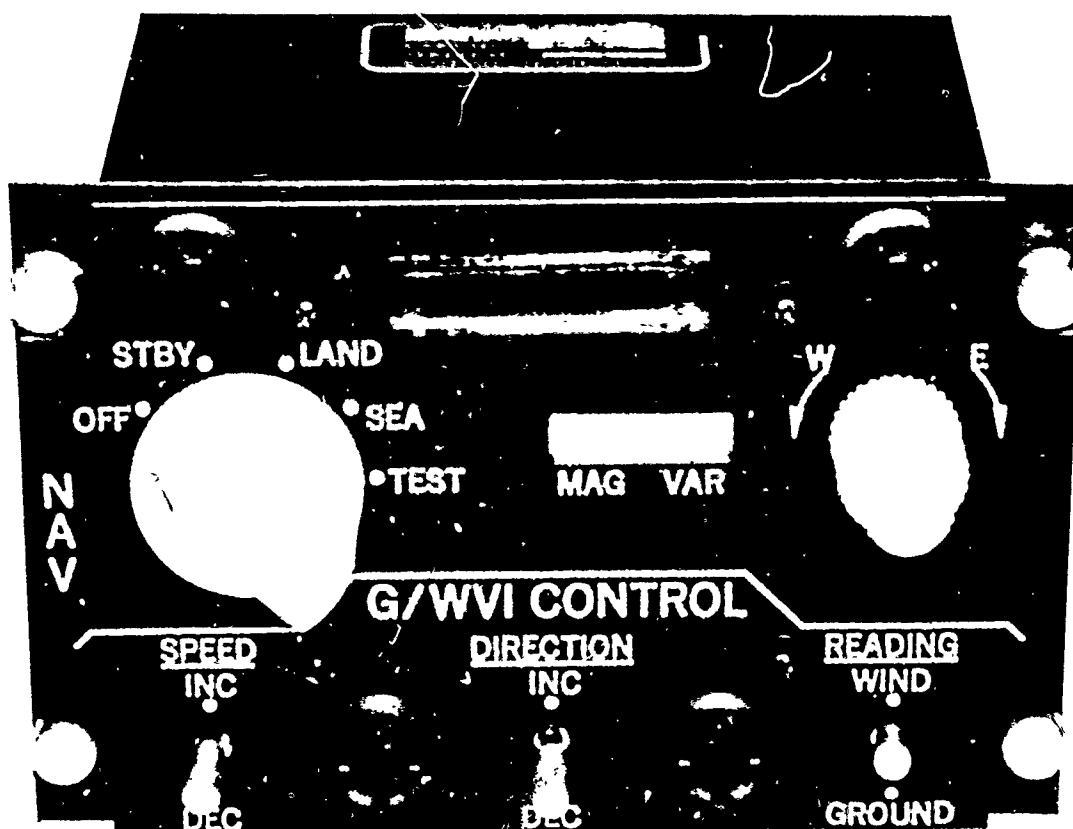
Figure 8. The G/WVI control

(1) The G/WVI control (figure 8) was easy to operate in that the switches and control knobs were readily available and lettering was easily readable. The two switches controlling wind speed and direction and the switch controlling the wind/ground reading seemed fragile. At one time one of the switches was bent, but still usable. No failures occurred during the evaluation.

<u>SHORTCOMINGS</u>	<u>SUGGESTED COR- RECTIVE ACTION</u>	<u>REMARKS</u>
The three toggle switches on the G/WVI control are too fragile.	Install more rugged switches.
