USAAMRDL-TR-76-9

• **DEVELOPMENT PROGRAM FOR FIELD-REPAIRABLE/EXPENDABLE  
MAIN ROTOR BLADES**

Kaman Aerospace Corporation  
Old Windsor Road  
Bloomfield, Conn. 06002

Final Report

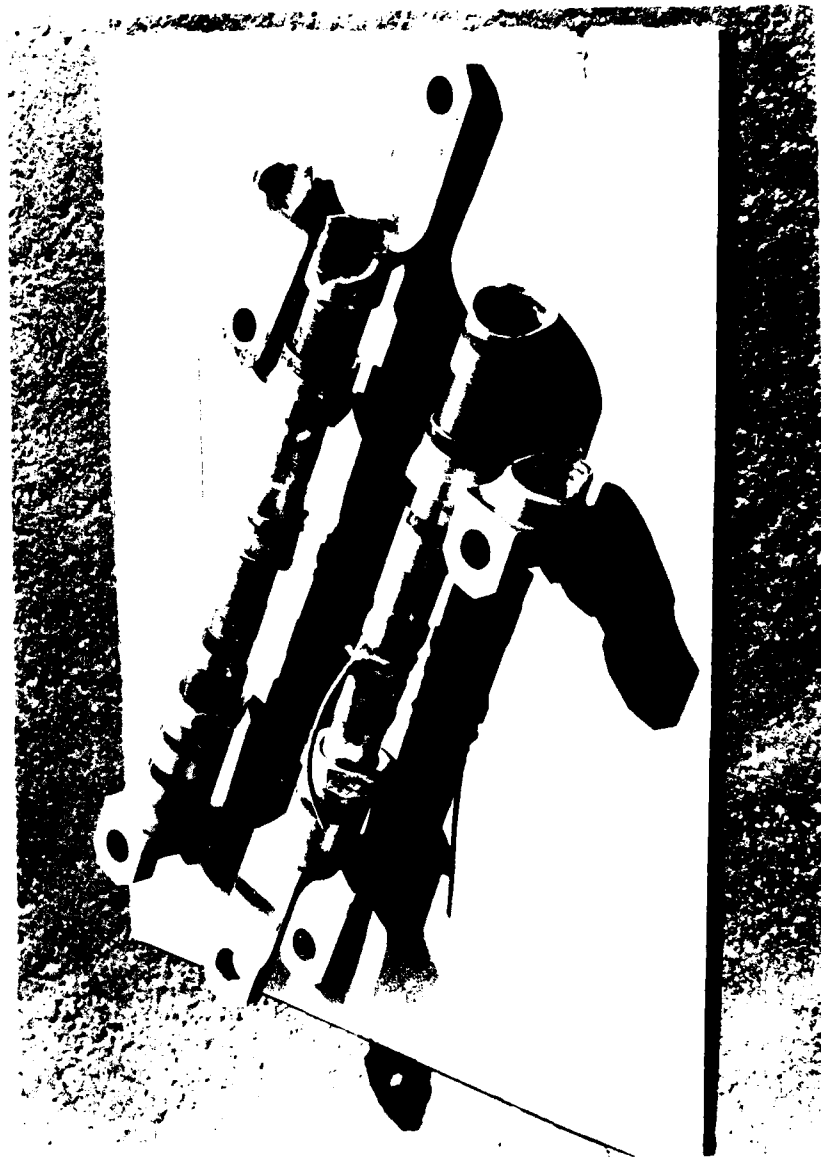
Figure 71. Typical Drag Brace Failures.
