DEPARTMENT OF THE ARMY UNITED STATES ARMY AVIATION TEST BOARD Fort Rucker, Alabama 36362

FINAL REPORT OF TEST

MILITARY POTENTIAL TEST

HELICOPTER ROTOR BLADE EROSION-PREVENTIVE KITS

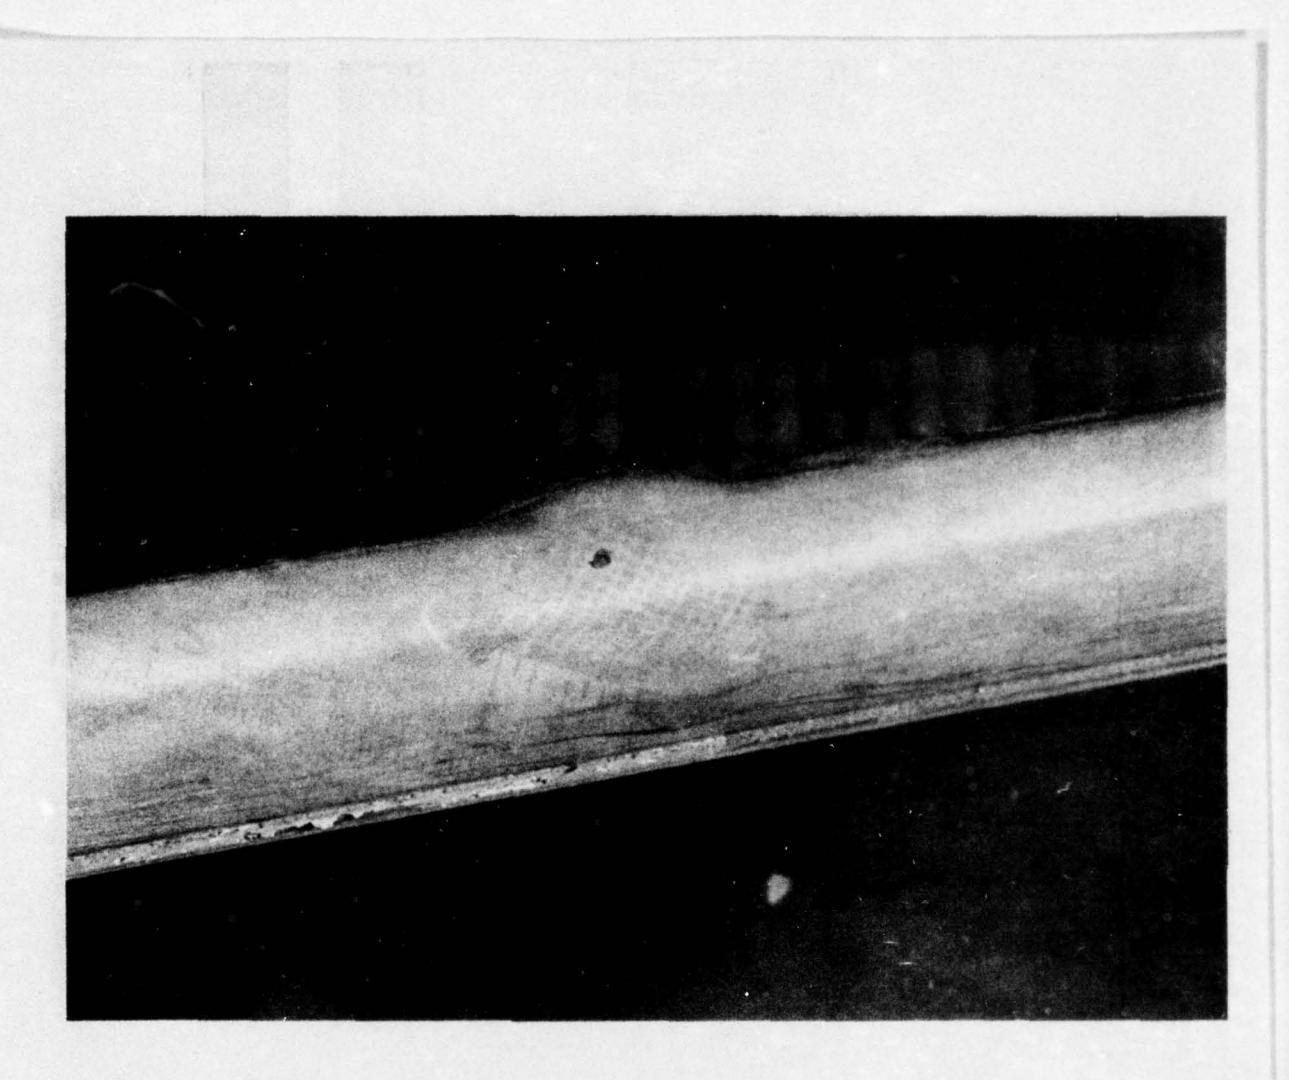
2.3.3.2. Application of the Polyurethane shoes (accomplished before the blades are installed on the helicopter) required that the rotor blades be balanced before installation on the helicopter and that they be tracked prior to flight. Application of the Estane and Neoprene shoes (accomplished while the blades are on the helicopter) required blade tracking prior to flight. Improper application resulted in vibrations and unsatisfactory flight characteristics (figure 1).

Figure 1. Improperly applied Neoprene shoe after flight

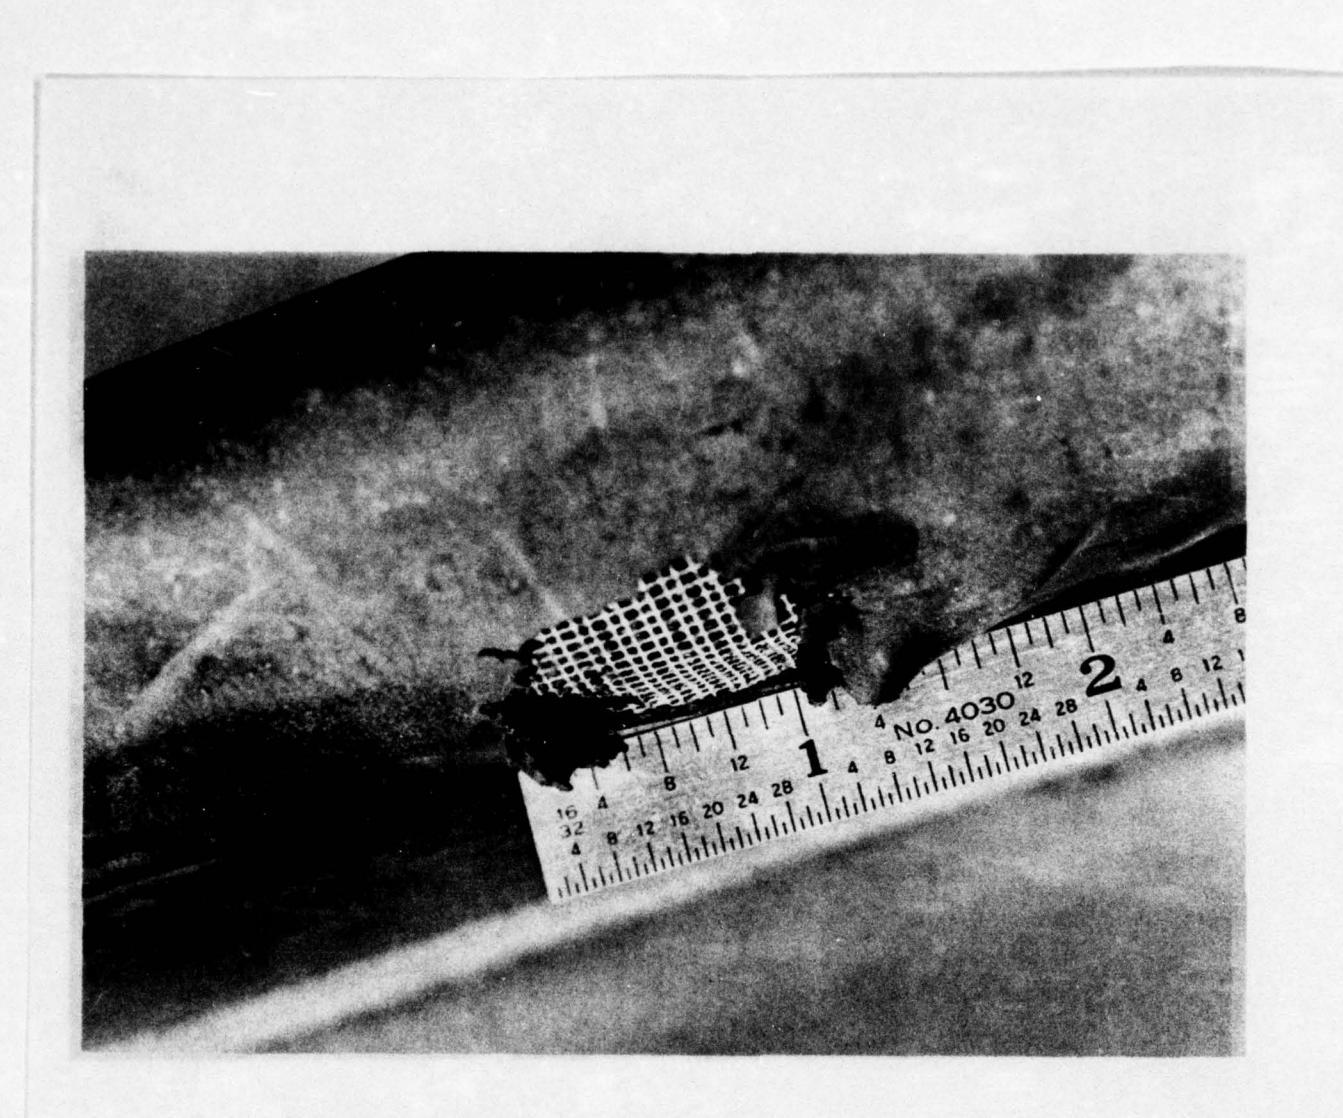
2.3.3.4. Damage such as bubbles and small separations caused moderate vibrations. Extensive damage such as loss of portions of the shoe caused severe vibrations (figure 2).

Figure 2. Estane shoe damage resulting from flight in rain.

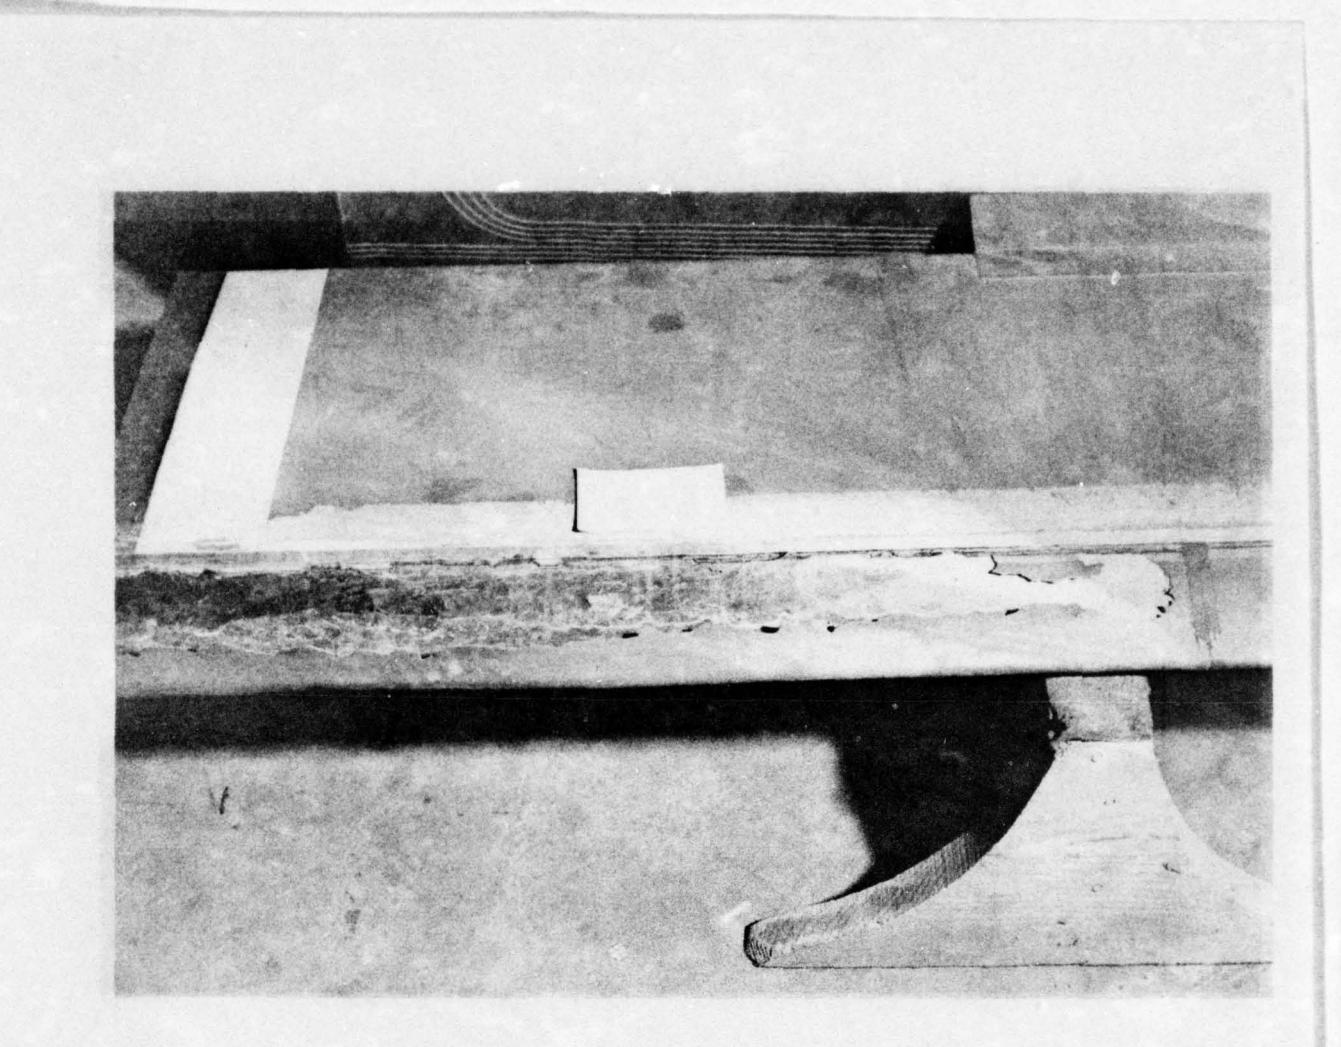
Figure 3. Polyurethane shoe damaged by flight in heavy rain.

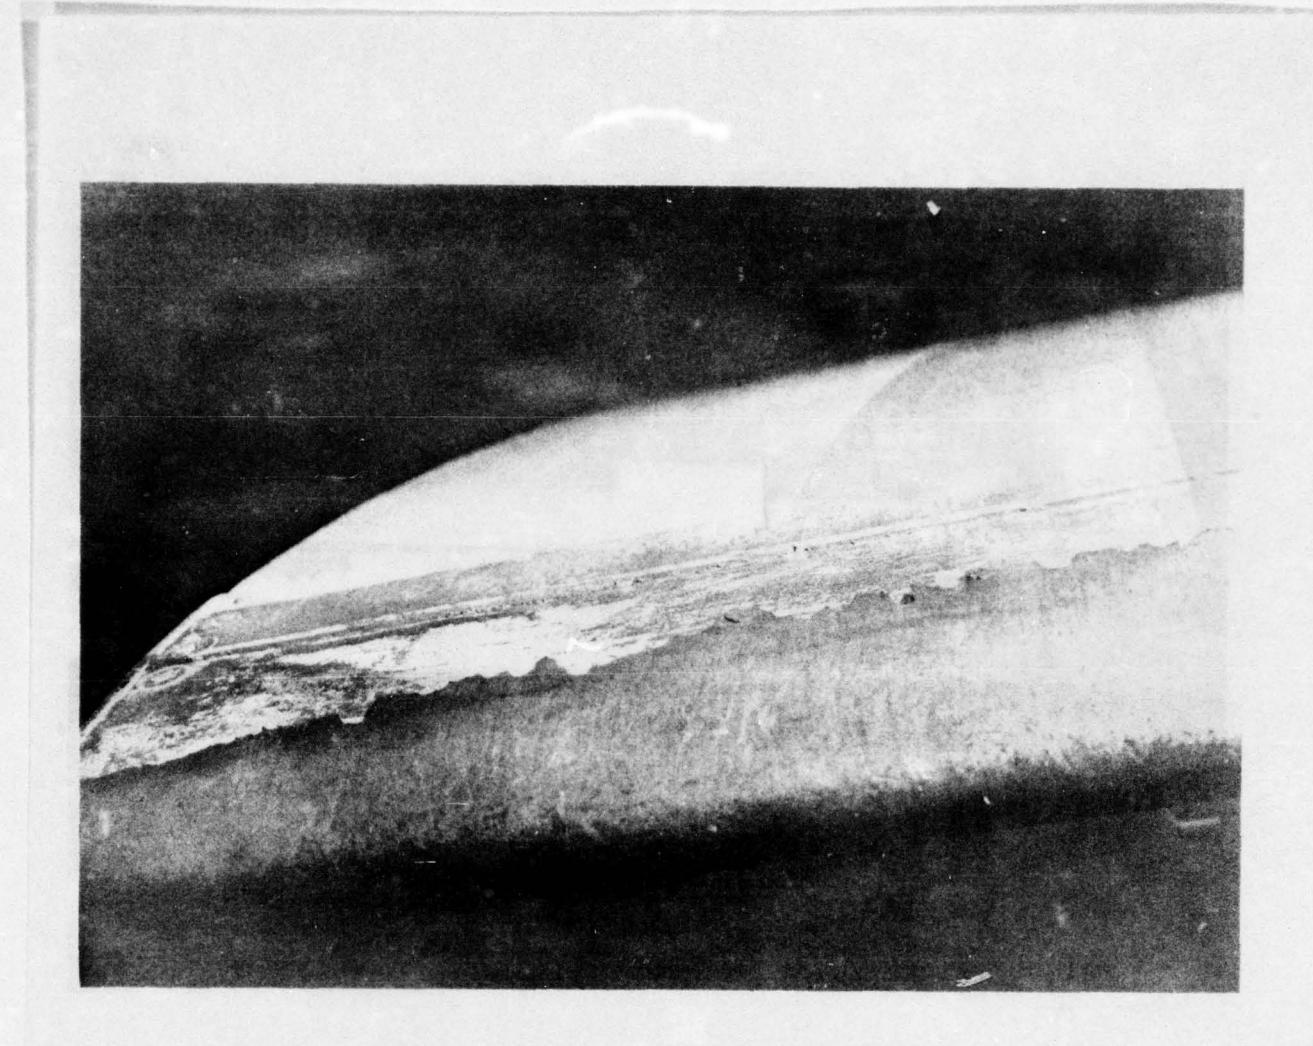
Figure 4. Neoprene shoe damaged by flight in heavy rain.

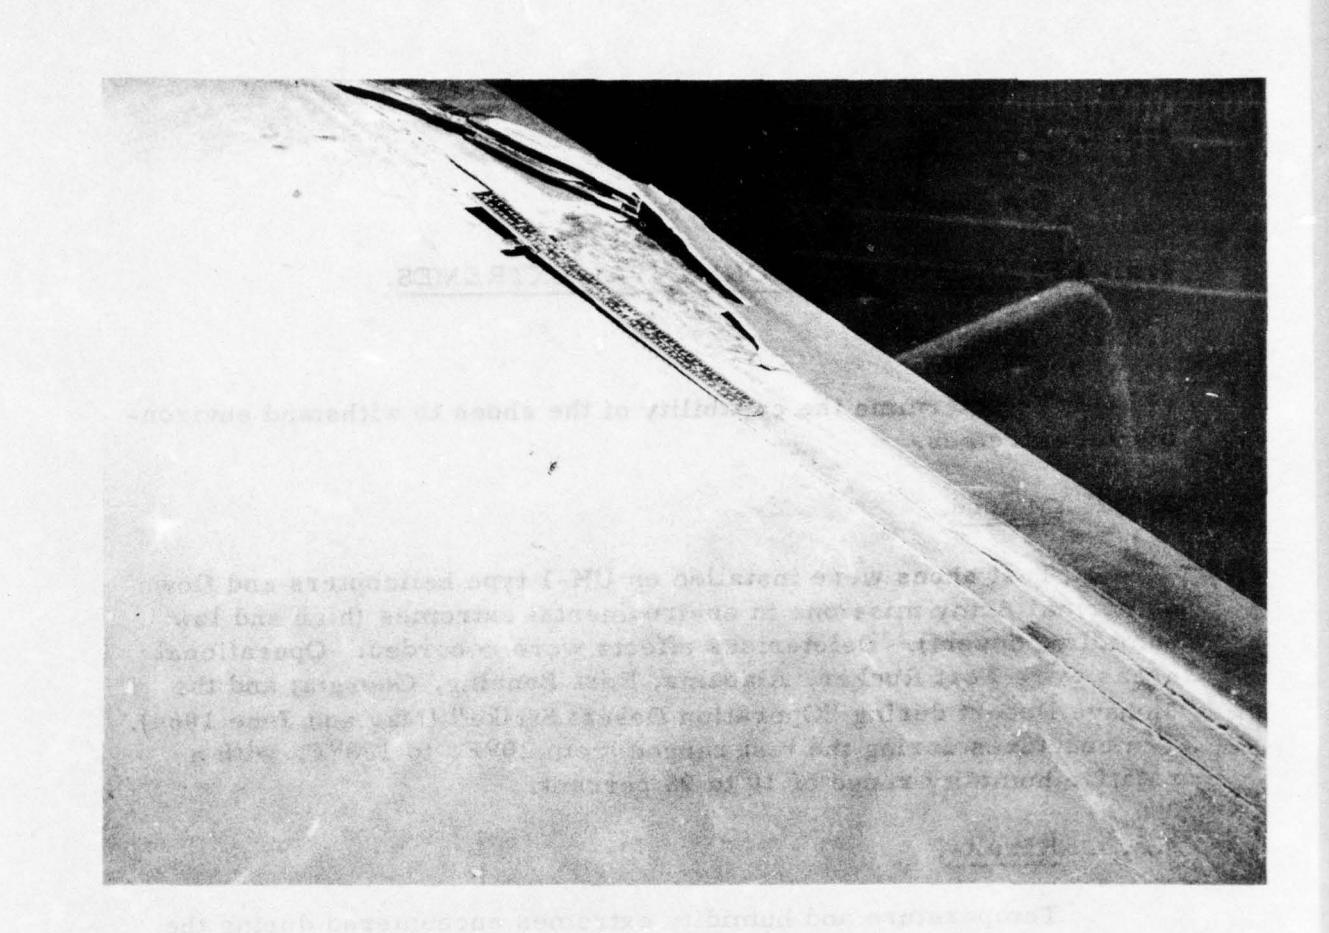
Figure 5. Polyurethane shoe with separation caused by flight in rain.

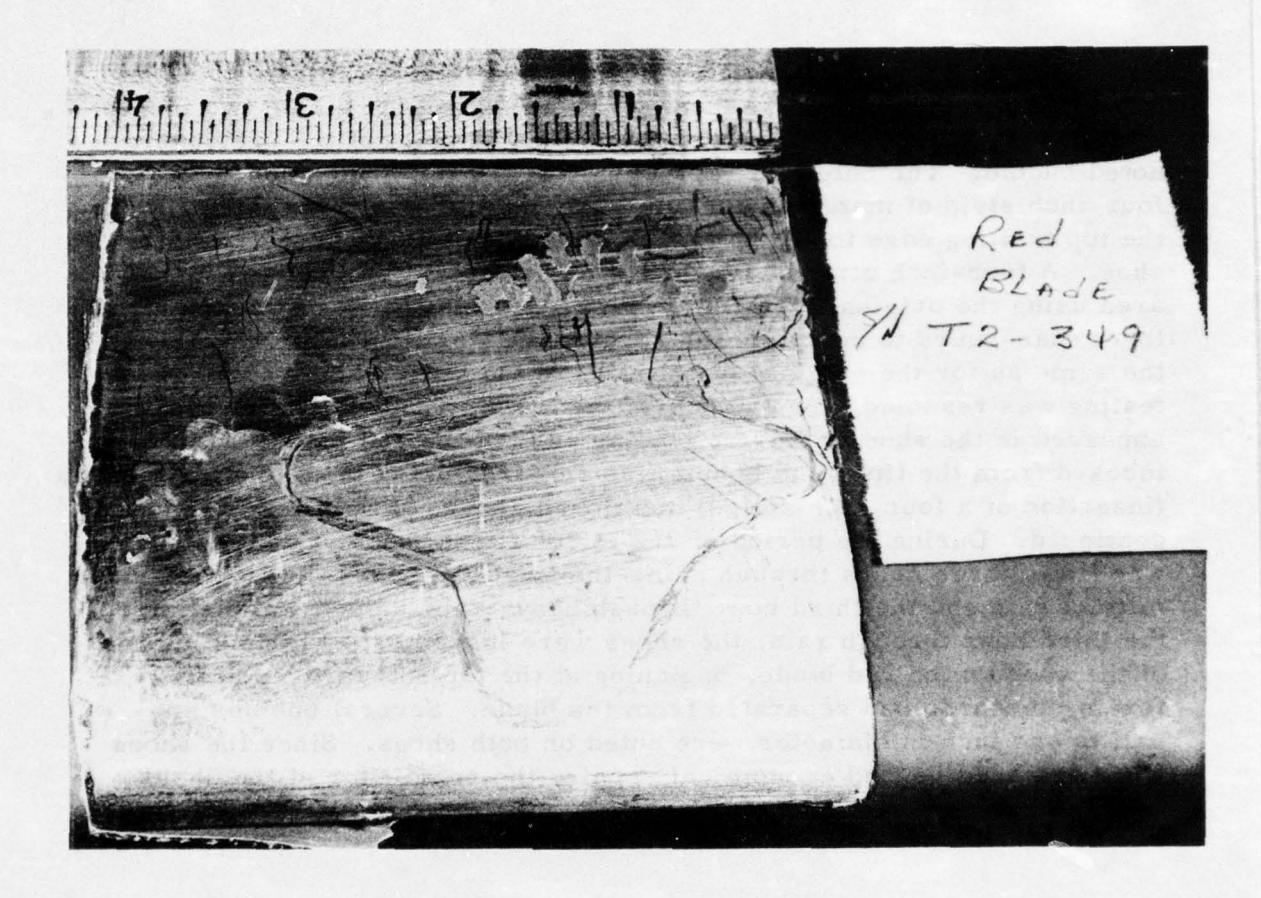
Figure 6. Polyurethane shoe with damaged portion removed to effect repair.

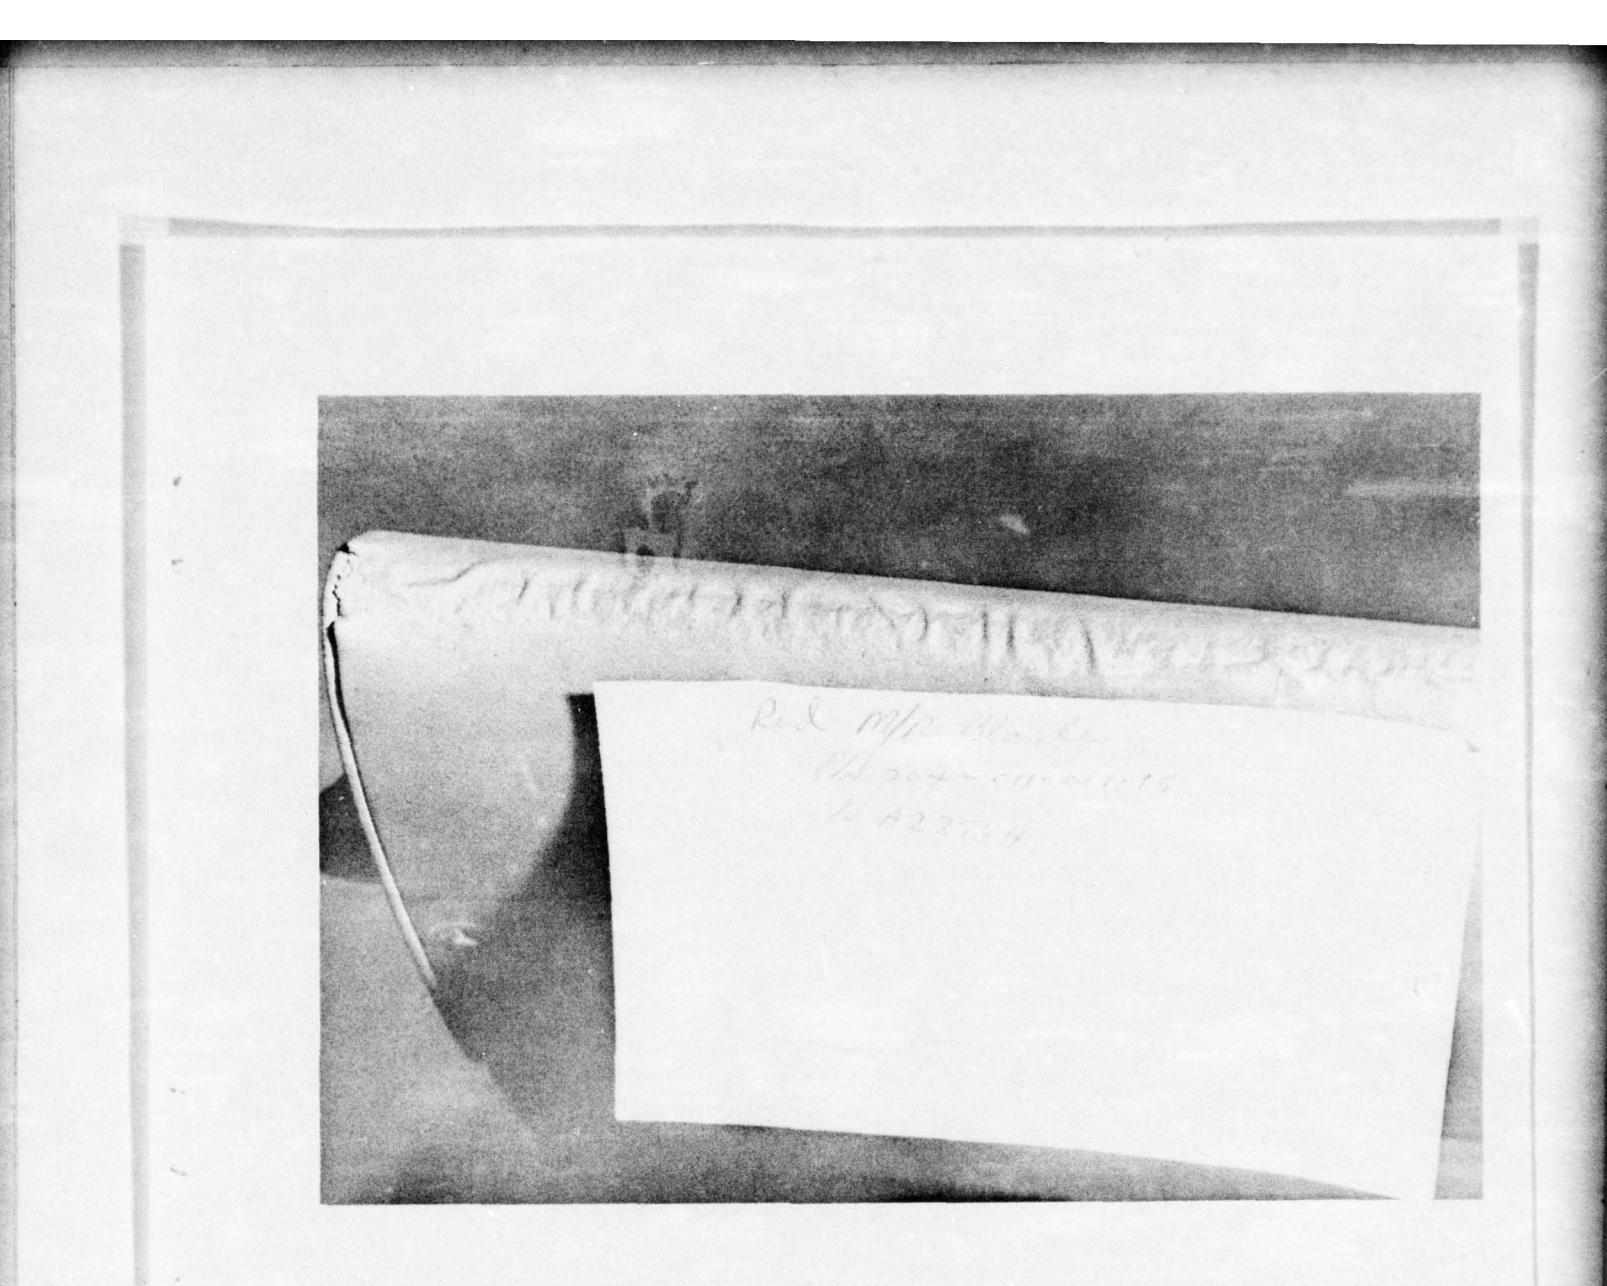
Figure 8. A helicopter with the main rotor blades installed was flown 500 hours without the erosion-protective shoes. Subsequently, two sets of shoes have been used on the same set of rotor blades, and the blades have now accumulated over 950 hours. One of these blades is pictured above.
