## DESTATOR TEST PROGRAM EVALUATION

BATTELLE COLUMBUS LABORATORIES, OHIO

8 JULY 1976

REPORT NO. CG-D-#-76

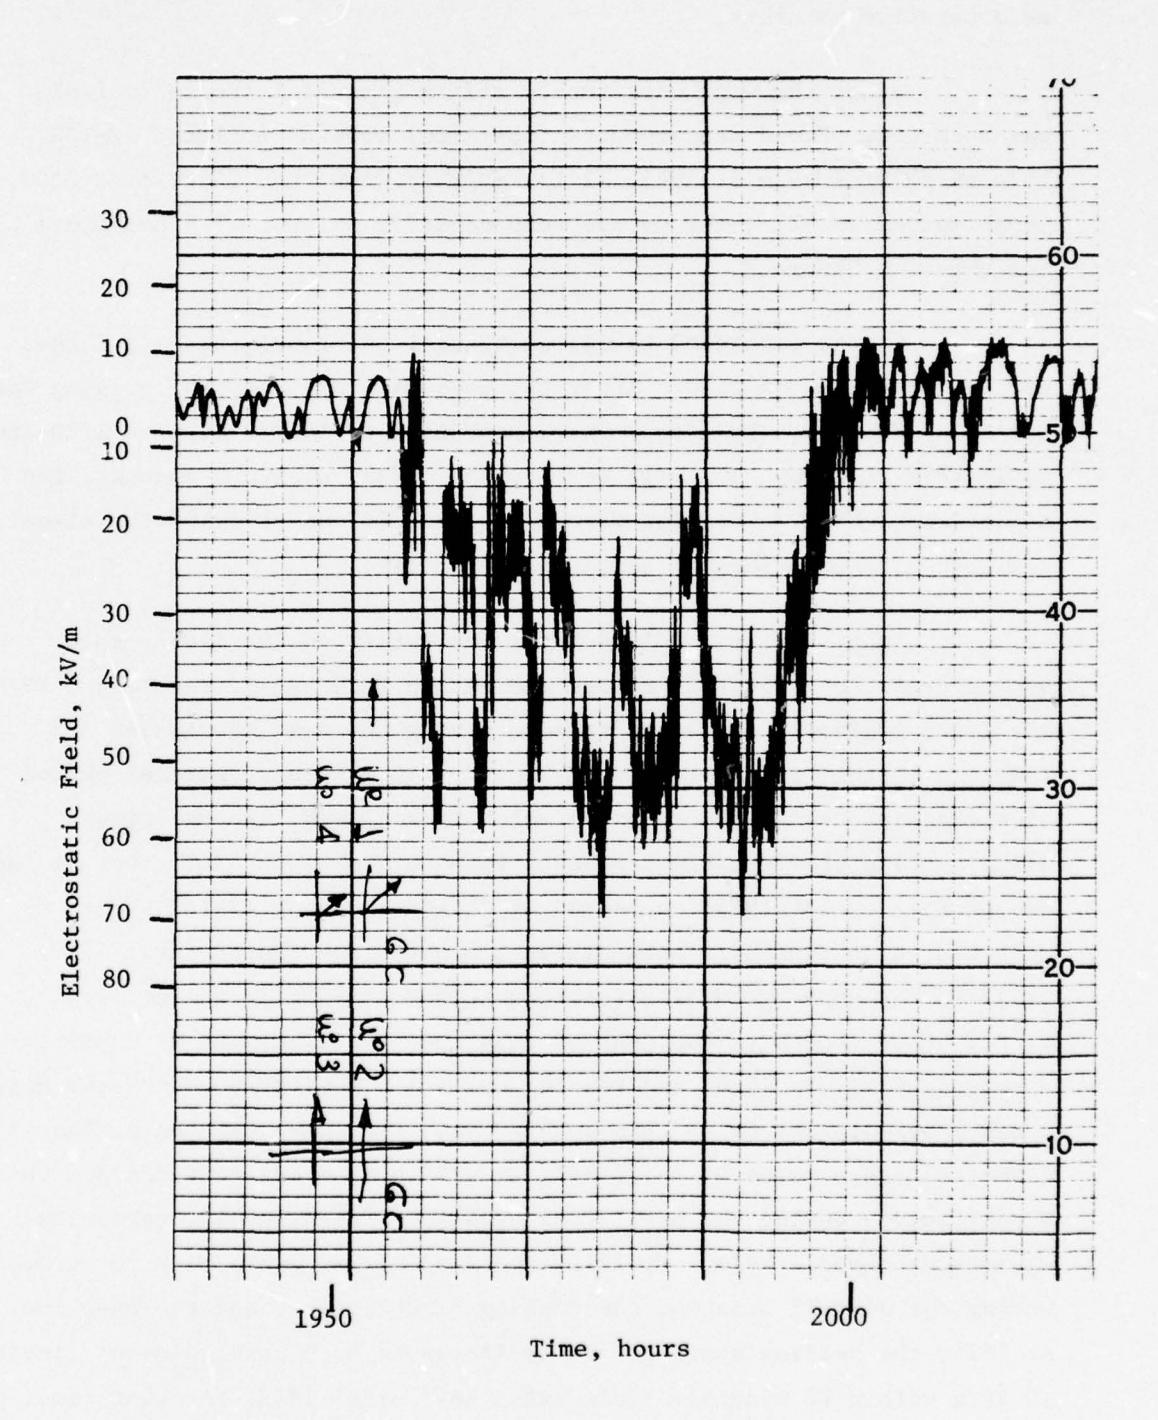
FIGURE 2. TYPICAL TRACE OF SIGNAL FROM WALL SENSOR SHOWING NEGATIVE SIGNALS SUPERIMPOSED ON POSITIVE
