USAAMRDL-TR-76-32

**OTTAWA SPRAY RIG TESTS OF AN ICE PROTECTION SYSTEM
APPLIED TO THE UH-1H HELICOPTER**

November 1976

Final Report for Period January 1976 - May 1976

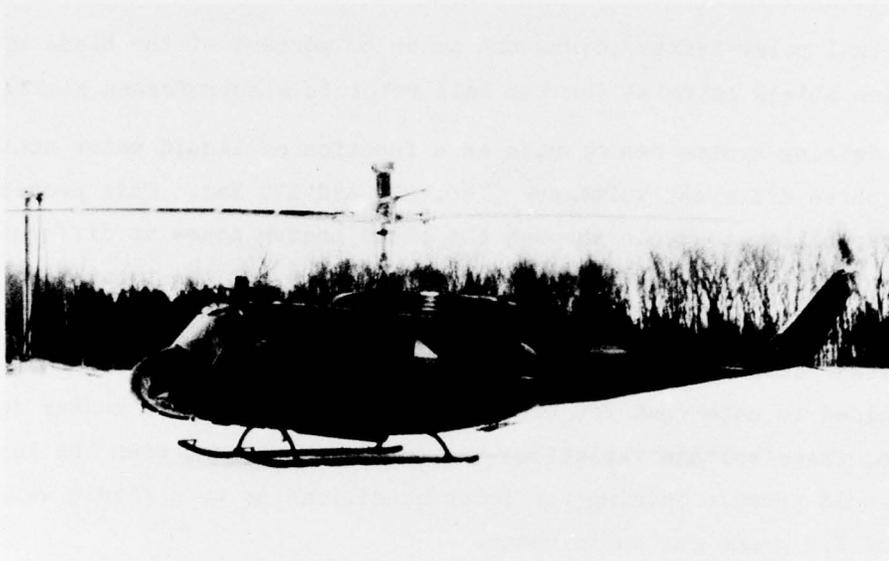
Figure 2. Test Aircraft Following a 30-Minute Run
at -10°C , 0.5 g/m^3 Spray Cloud

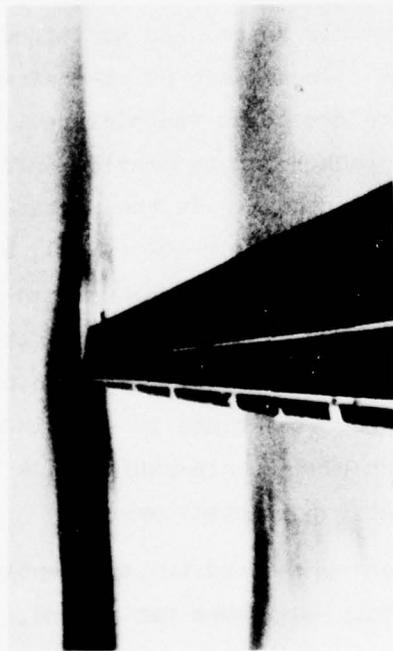
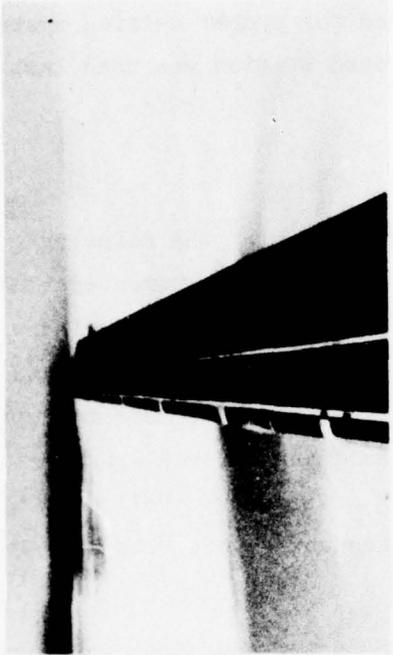
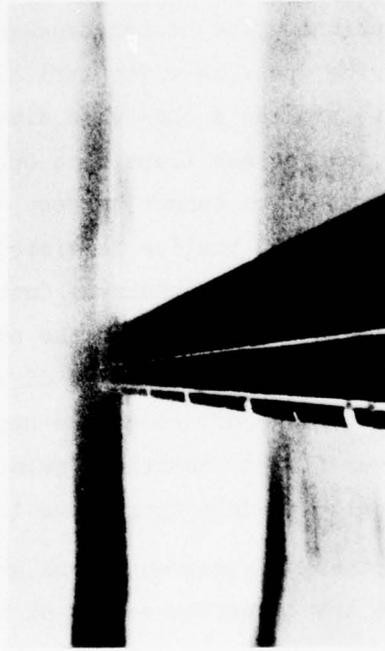
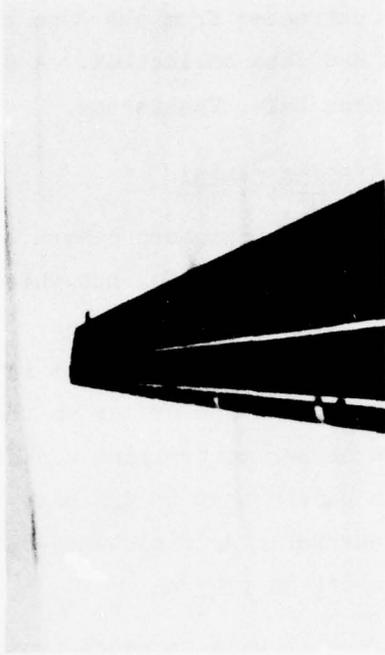
Figure 4. Blade Deicing as Photographed with Hub-Mounted 16mm Camera

a. Deicing Complete to Station 83 (Mid Zone 5)

b. Inboard Half of Zone 5 Shedding

c. Deicing Complete to Zone 6

d. Full Span Deicing Cycle Complete

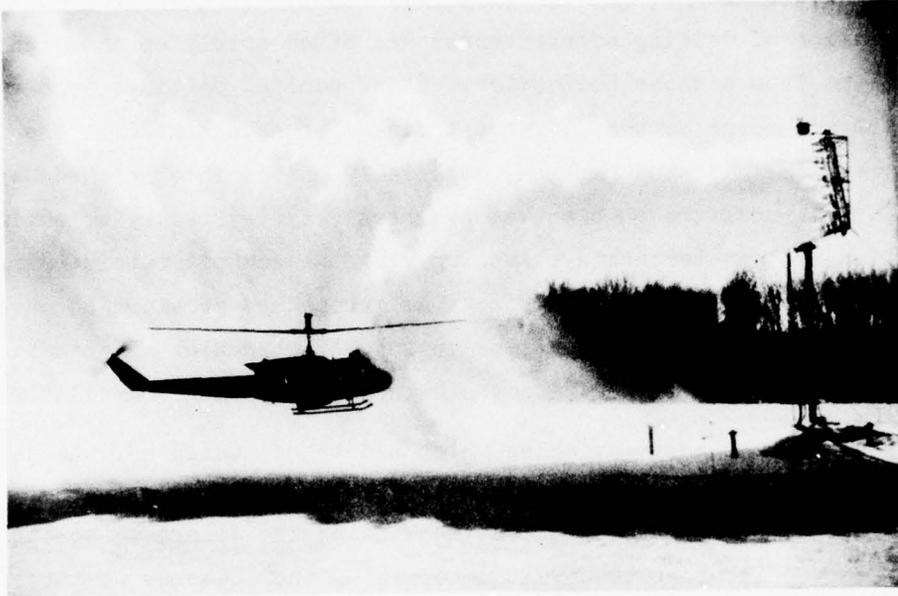
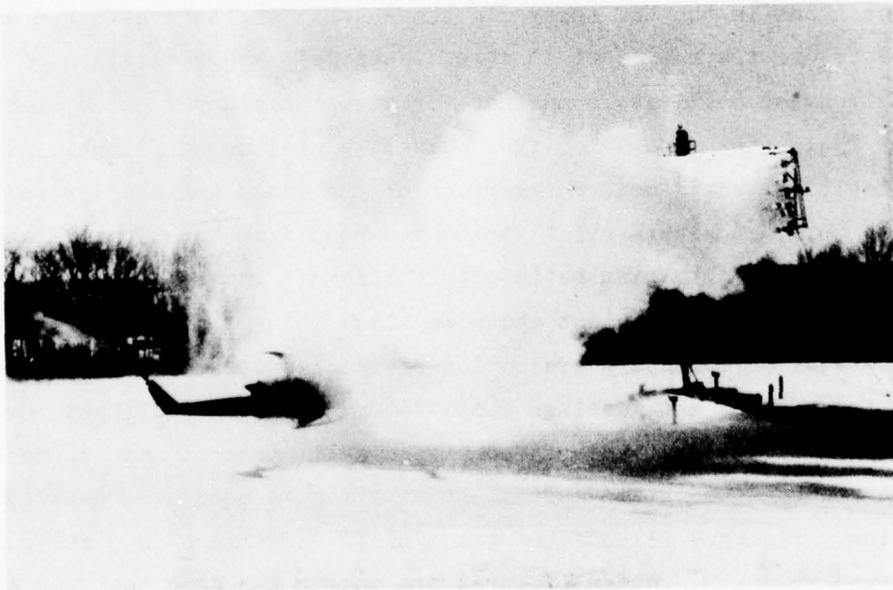
Figure 7. Spray Rig Cloud Variations with 7 mph Wind, -3.5°C , 0.8 g/m^3
LWC

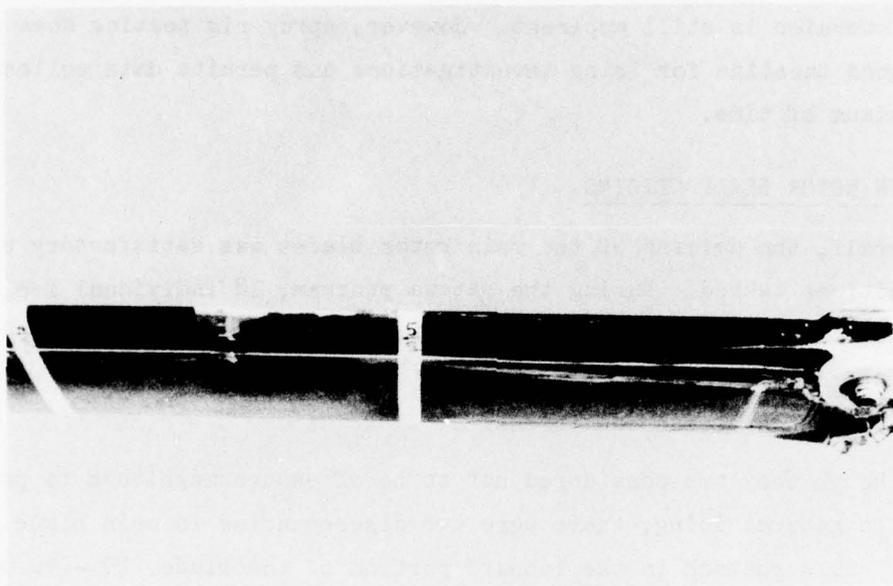
Although they are considered not to be of enough magnitude to preclude testing in natural icing, there were two discrepancies in main blade deicing: mild runback in the inboard portion of the blade (20 - 40 percent span), and residual leading-edge ice of varying magnitude in the same area. The latter and possibly both appear to be caused by the manufacturing joint in the heater and erosion shield at Station 83 (29 percent span). At this station, two design features are concluded to be responsible for the imperfect deicing. The erosion shield material thickness changes from 0.016-inch aluminum over the inboard "doubler" area of the blade to 0.030-inch steel. This difference in skin thickness results in a step in the blade surface contour that opposes the spanwise shearing action of ice separation. In addition, there is apparently a 1-inch-wide cold band (lack of adequate heater coverage) caused by the wraparound conductor that carries the C phase ac current from the upper blade surface to the lower surface. This joint is approximately the midpoint of zone 5. Figures 8 and 9 are examples of the residual ice on the blade in this area after deicing. The white appearance of the ice at the joint shows the ice has separated (or been melted by the heater) and has an air space under it but was still retained on the blade. Many times the same area would be completely or almost clear of residual ice as shown in Figures 10 and 11. It was found also that the small bumps caused by the strain gage and thermocouple installations impaired deicing. The noninstrumented blade

Figure 8. Residual Ice in Zone 5 After Attempting to Induce Runback With Three Deice Cycles at -14°C and 0.45 g/m^3 LWC

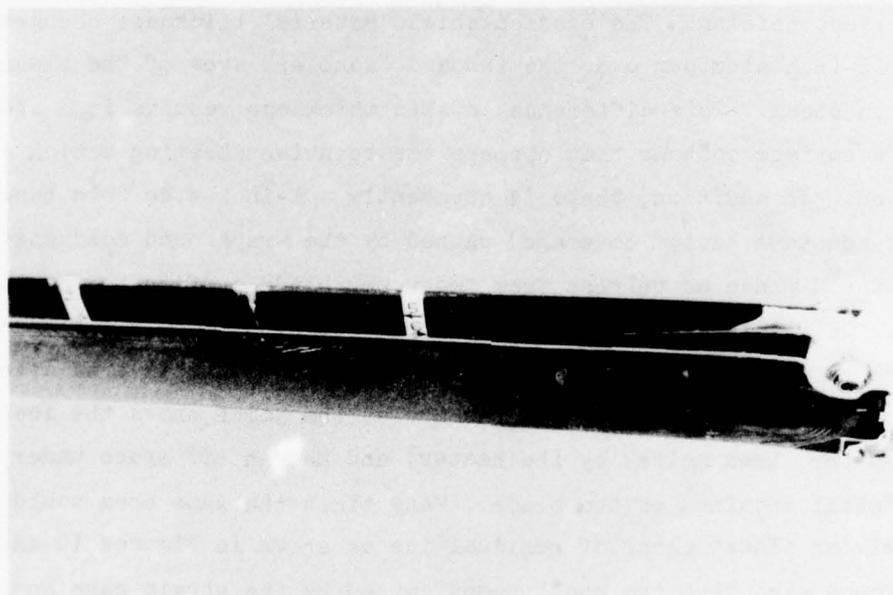
Figure 9. Residual Ice in Zone 5 at -10°C

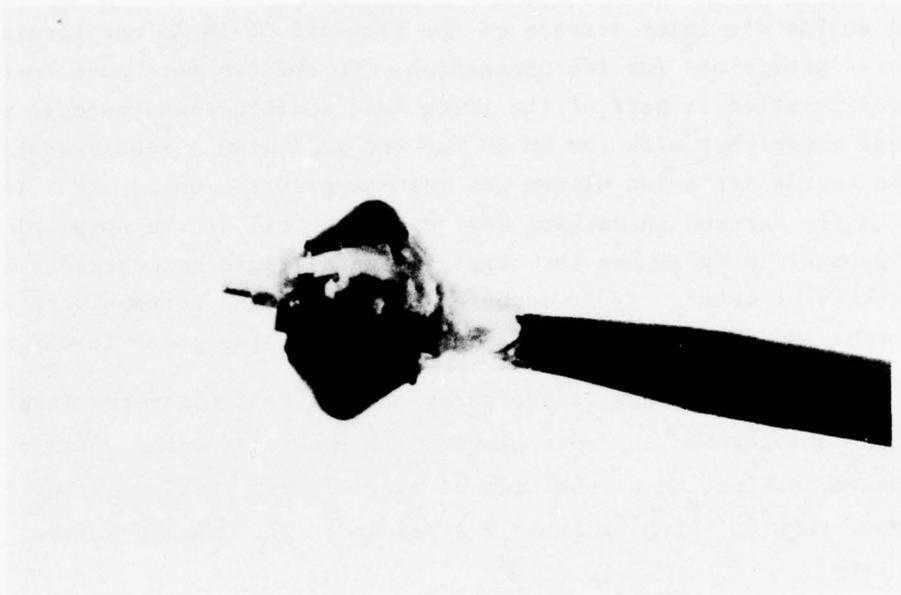
Figure 13. Typical Ice Accretion on the Unheated Portion of the Stabilizer Bar Tip Weight Installation

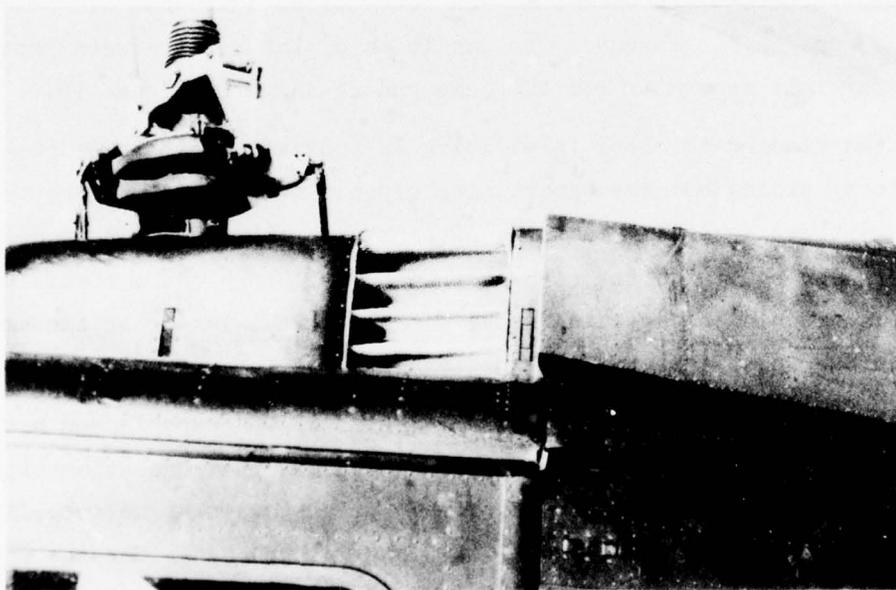
Figure 14. Engine Air Inlet Screen Condition After 30 Minutes in Cloud at -18°C and 0.35 g/m^3 LWC

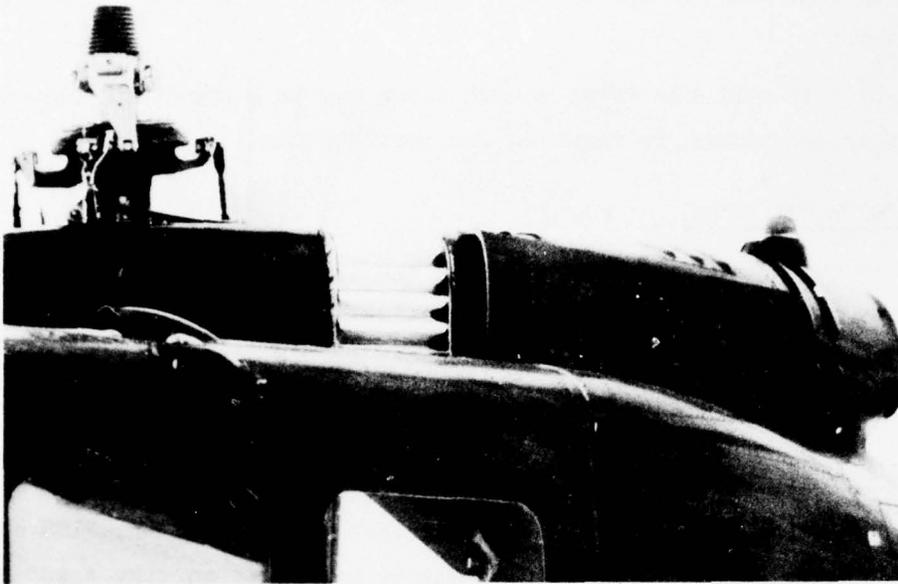
Figure 15. Engine Air Inlet Screen Condition After 5 Minutes in Cloud at -15.5°C and 0.4 g/m^3 LWC While Snowing

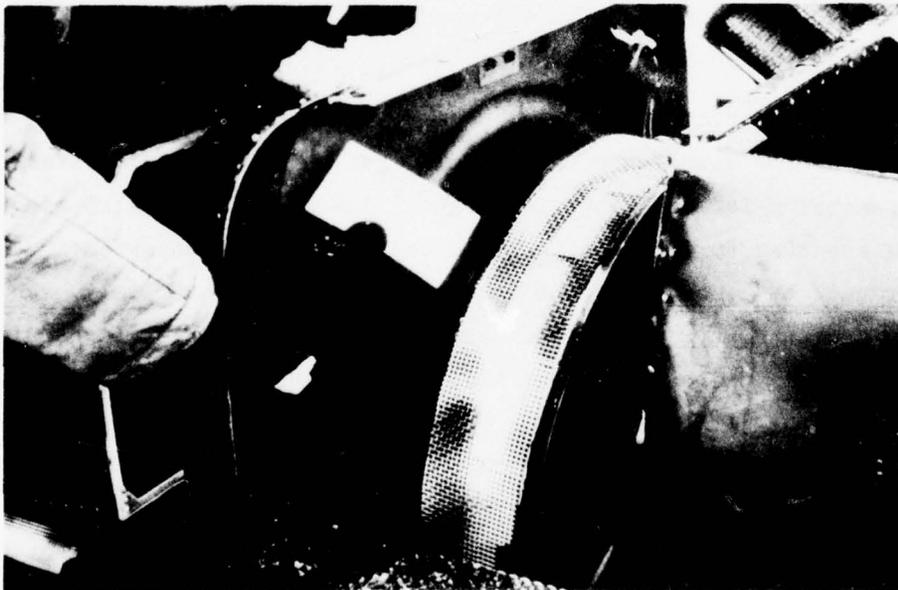
Figure 16. Engine Air Inlet Inner Particle Separator FOD Screen Icing after 5 Minutes at -15.5°C and 0.4 g/m^3 LWC While Snowing

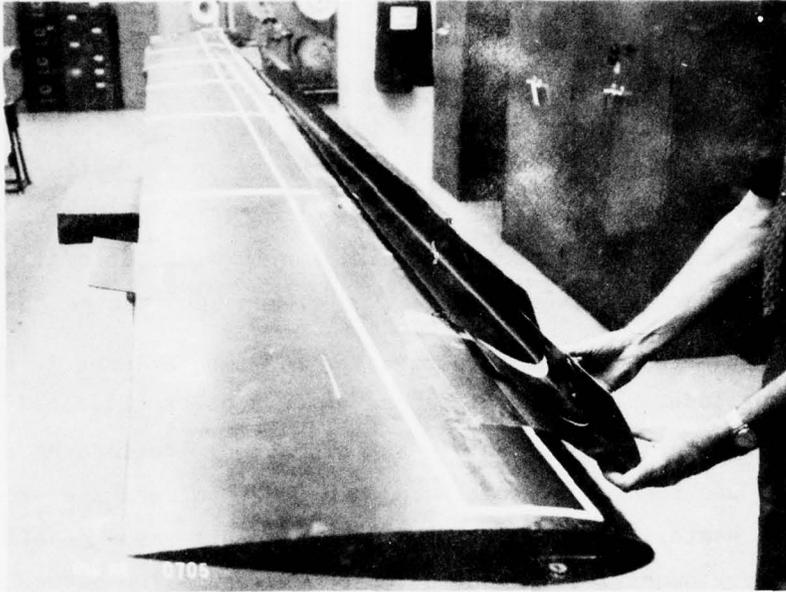
Figure 36. Blade S/N A2-25934 with Erosion Shield Removed

- There was an apparent difference in the insulating glass cloth used inboard of Station 176.6, the zone 2 and 3 boundary, from that used outboard. The cloth inboard appeared to be dry and devoid of any impregnating resin. It is not known whether all the blades were like this, as only one blade was disassembled.

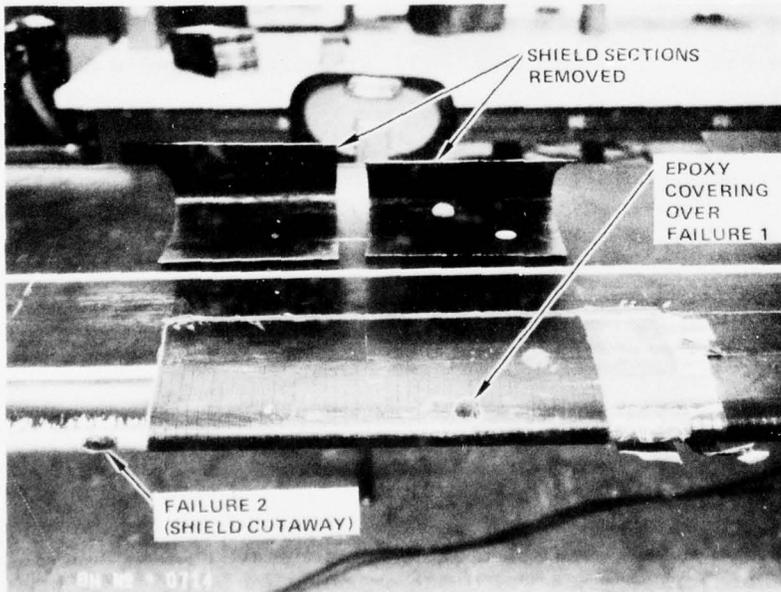
Figure 37. Under the Shield in the Area of the Outboard Failures

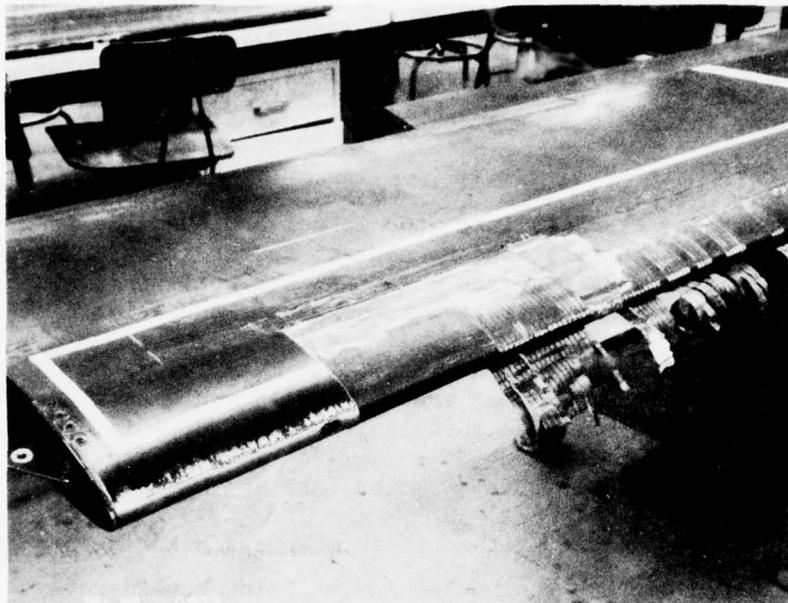
Figure 38. Heater Ribbon Peeled Back in Failure Area

- A few of the solder joints of the lead wire braids to the heater element tabs were not good solder connections and appeared to be similar to a cold joint.

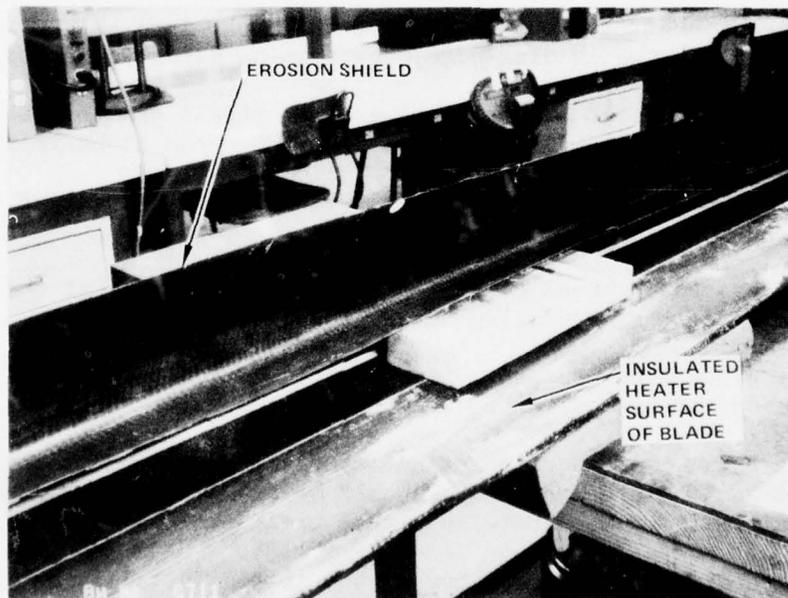
Figure 39. Zones 1 and 2 Inboard of Failure Area
