CRREL Report 77-14

Ice breakup on the Chena River 1975 and 1976

Terry T. McFadden and Charles M. Collins

June 1977

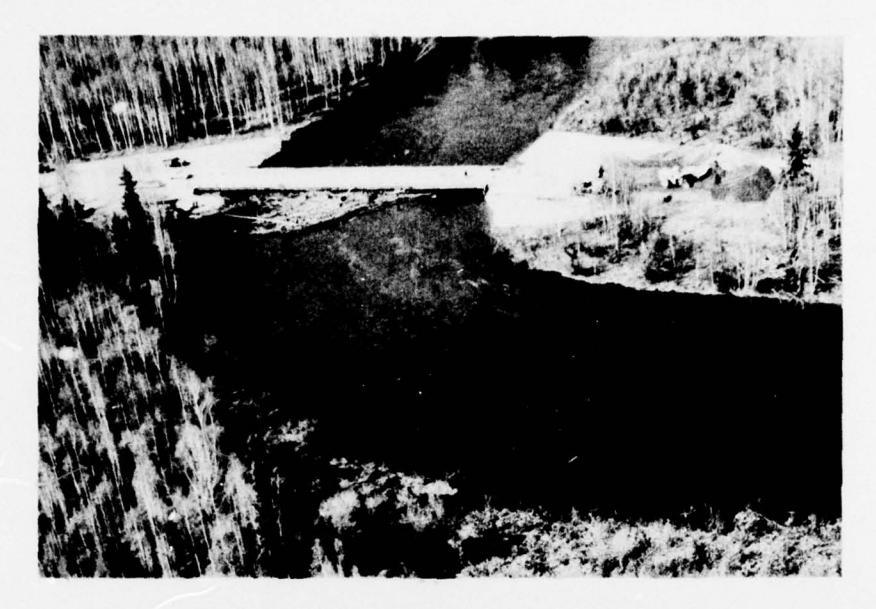
Subsequent to the melt-out of the ice, the river discharge continued to increase until it reached 16,800 ft³/s on 12 May, at the USGS Two Rivers station 40 river miles above the damsite. The discharge of the river at Fairbanks rose to 12,100 ft³/s (flood stage being 15,000 ft³/s) on 15 May (Table IV). This volume was sufficient to dislodge large quantities of debris, and the bridge at the Chena River damsite (checkpoint 8) accumulated a large number of logs (Fig. 2). Concern for the bridge mounted as both approaches washed out (Fig. 3) and debris continued to accumulate until it was feared that the bridge would be lost.

A sizeable effort was expended at the bridge to remove logs from in front of its pilings. The south approach eroded 5 m back from the bridge, although the

Figure 2. Debris accumulation behind the bridge at the damsite (12 May 1975).

bridge remained with no apparent damage when the high water subsided. Debris accumulation was also a problem at Engineer Bridge on Fort Wainwright. However, the trash racks in front of this bridge protected the bridge pilings. Figures 4 and 5 show the debris accumulation at the two bridges and the advantages of the trash tracks.

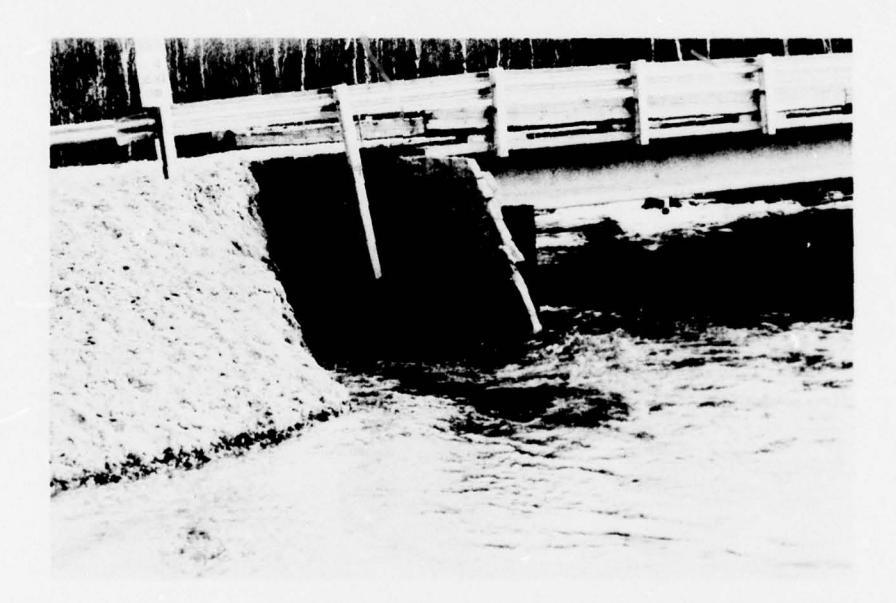
Figure 3. Early stages of damsite bridge approach washout (12 May 1975).

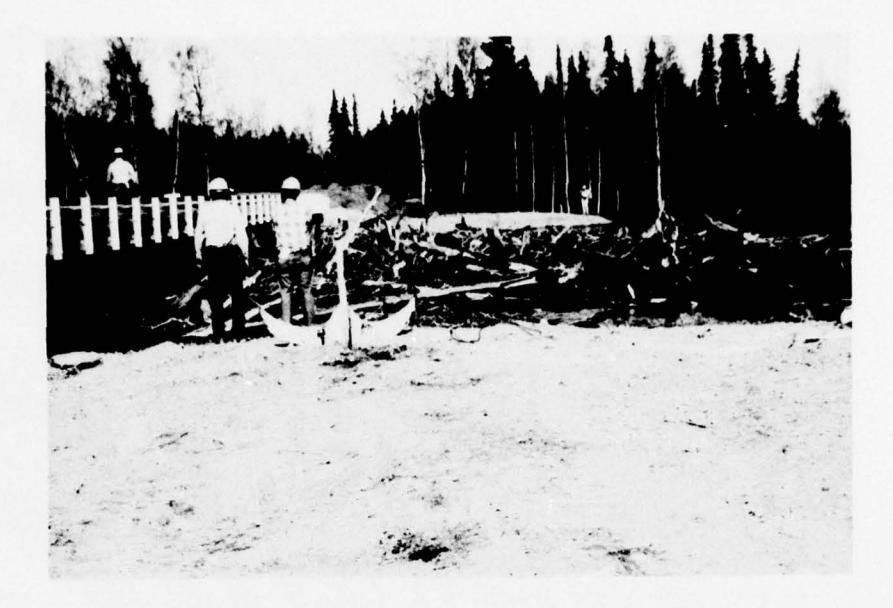
Figure 4. Debris accumulation behind bridge at damsite (12 May 1975). Note trash hook in foreground.

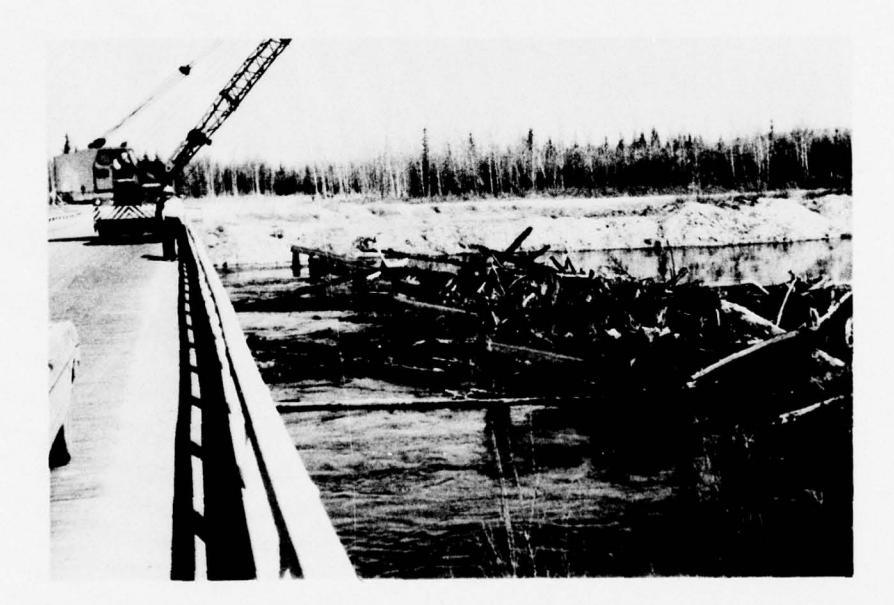
Figure 5. Debris accumulation on trash racks at Engineer Bridge, Fort Wainwright (12 May 1975). Note that debris did not accumulate against the bridge pilings.

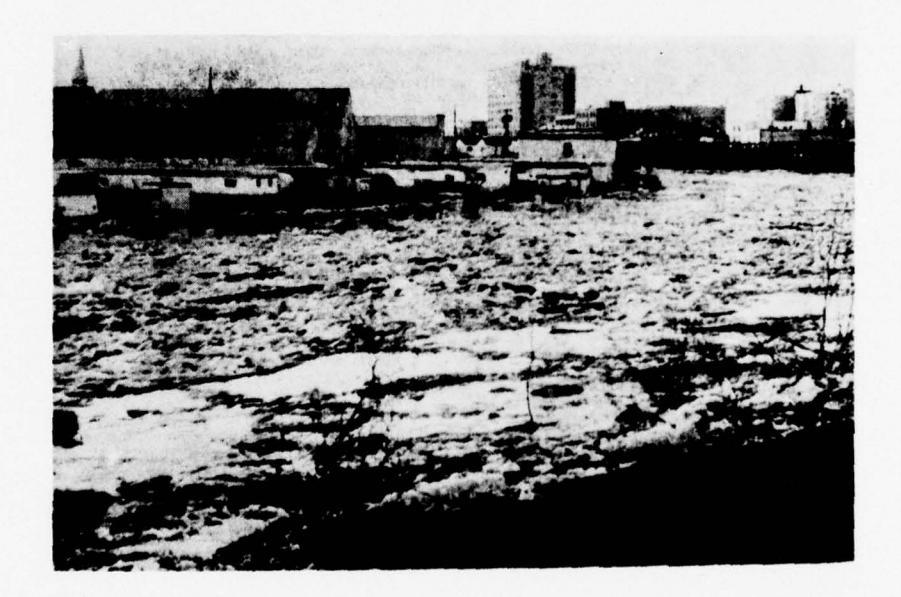
In 1960 high water and ice jams caused minor flooding at Fort Wainwright and in low-lying areas of Fairbanks. The river peaked above flood stage on 3 May at 19,900 ft³/s. Twelve Mile Village was flooded from the Tanana River and was declared a disaster area. Many parts of the Richardson Highway were under water. Figures 6-9 show parts of downtown Fairbanks and Fort Wainwright.

Figure 6. Ice and high water in downtown Fairbanks, 3 May 1960 (from Fairbanks News Miner).

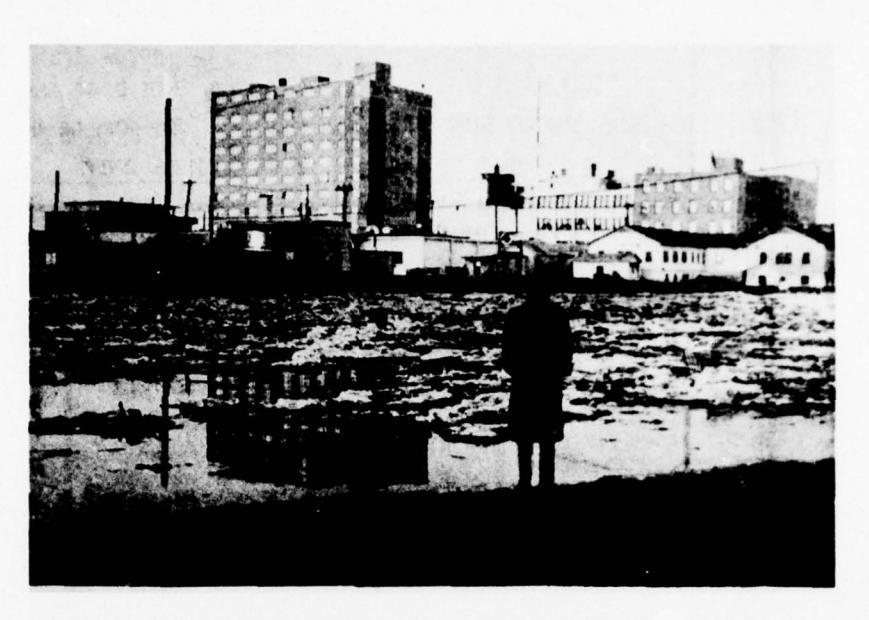
Figure 7. Ice and high water in downtown Fairbanks, 3 May 1960 (from Fairbanks News Miner).

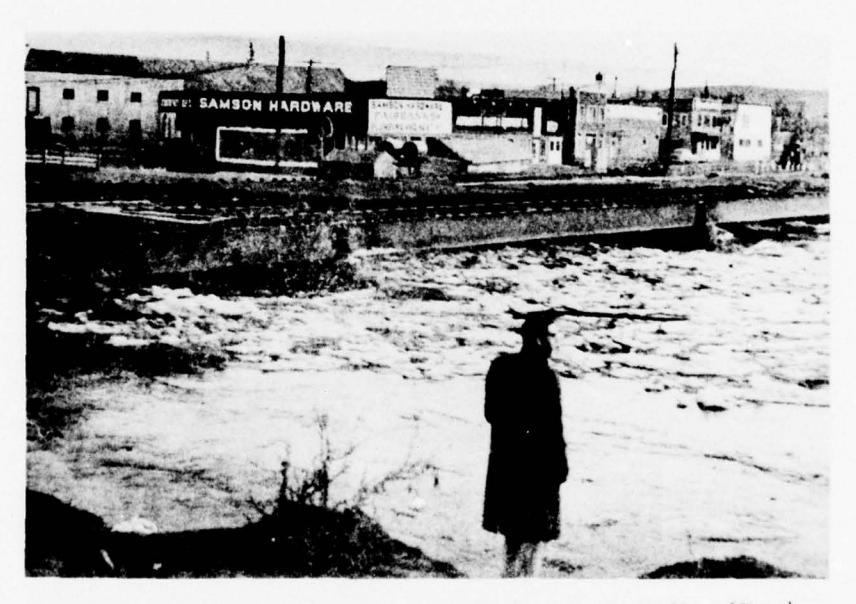
Figure 8. Cushman Street Bridge, 3 May 1960 (from Fairbanks News Miner).

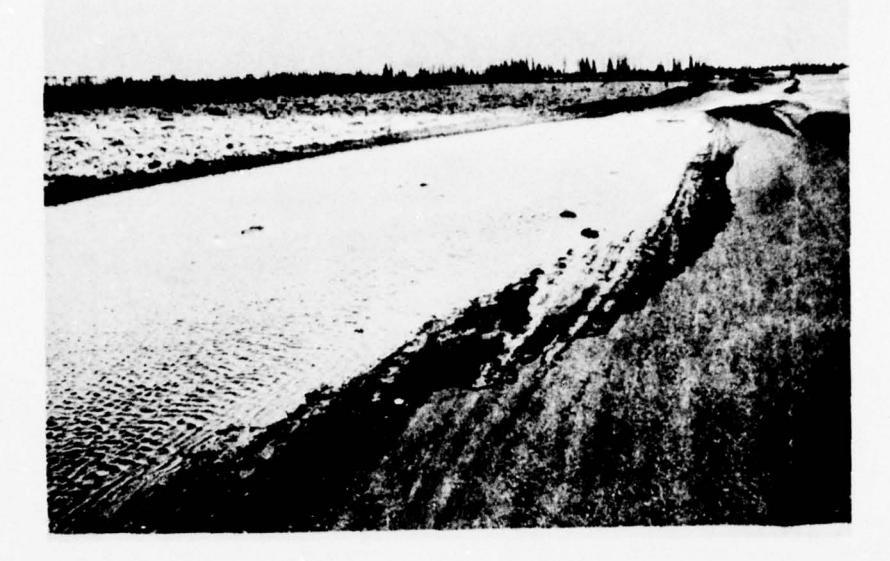
Figure 9. Water over road at eastern end of Ladd AFB runway, 3 May 1960 (from Fairbanks News Miner).

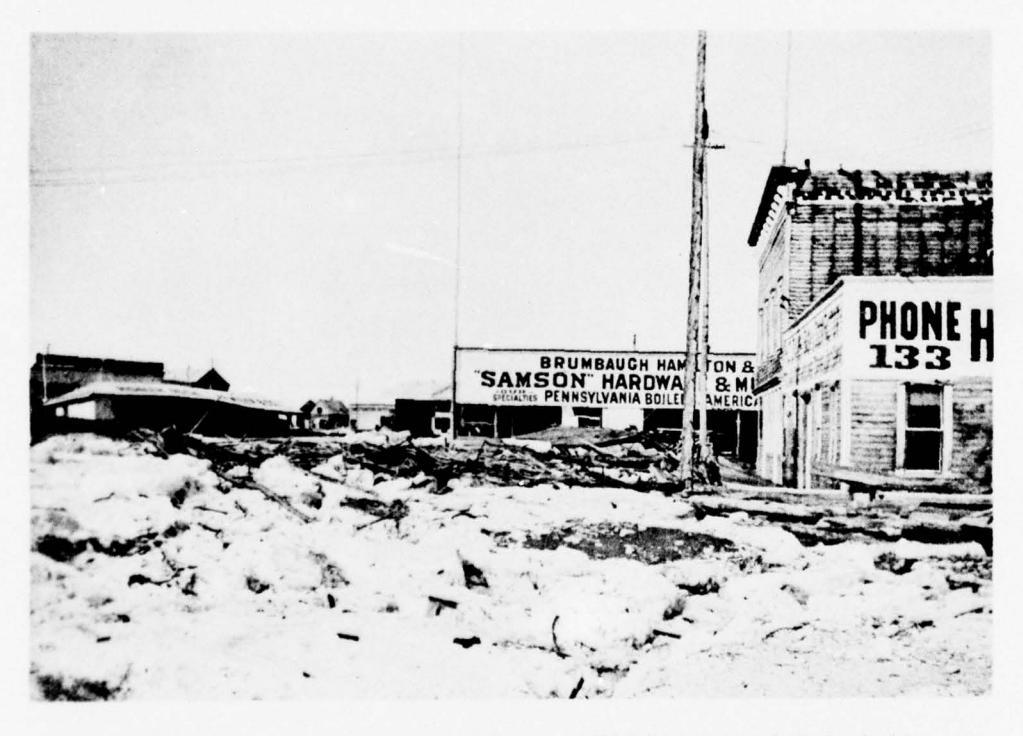
Figure 10. Fairbanks business area after breakup, circa 1915 (University of Alaska Archives, Charles Bunnell Collection).

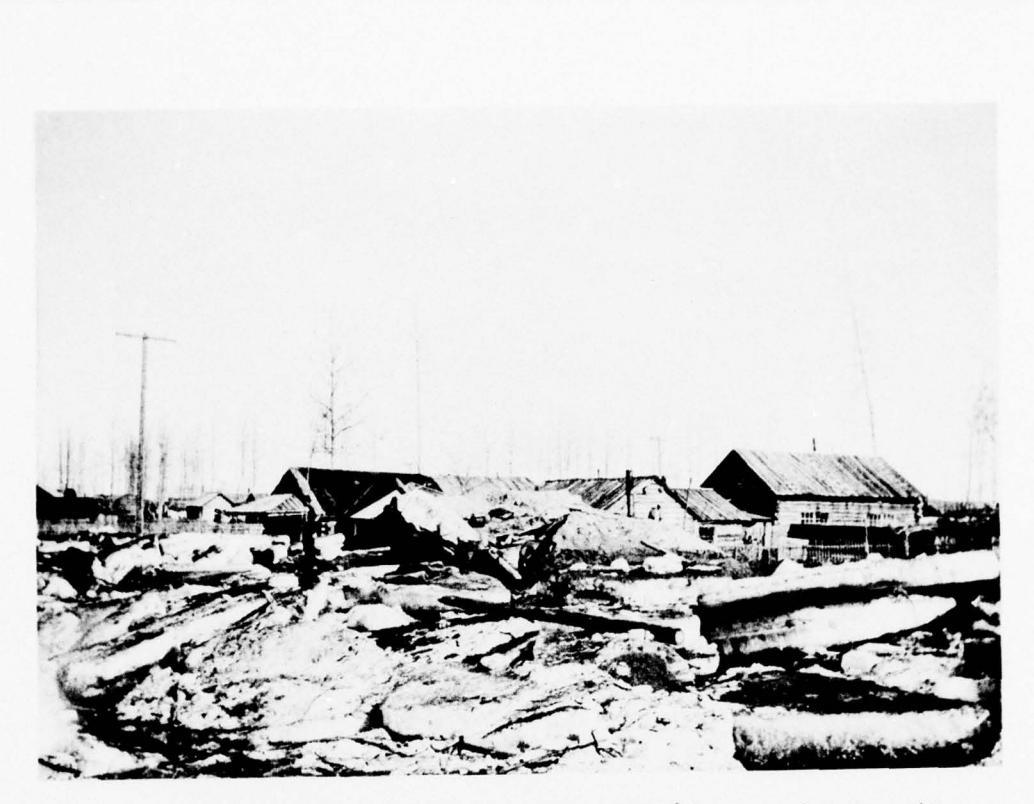
Figure 11. Grounded ice left by early day breakup, circa 1915 (University of Alaska Archives, Charles Bunnell Collection).

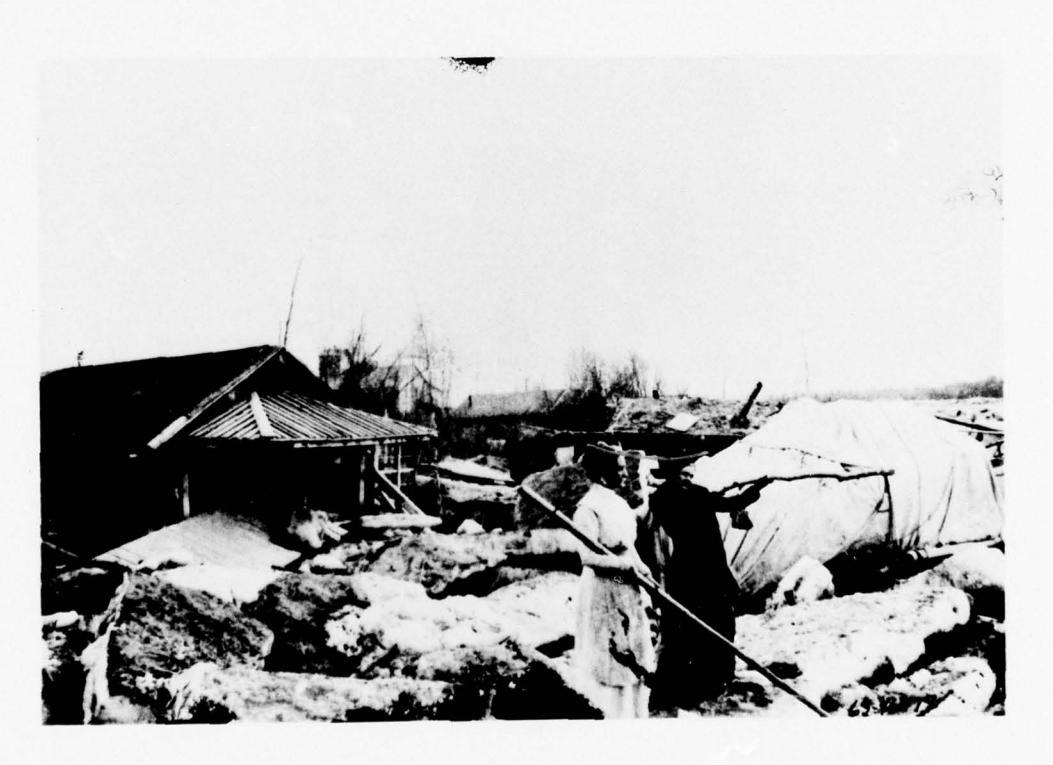
Figure 12. Ice damage from an early breakup, circa 1915 (University of Alaska Archives, Charles Bunnell Collection).

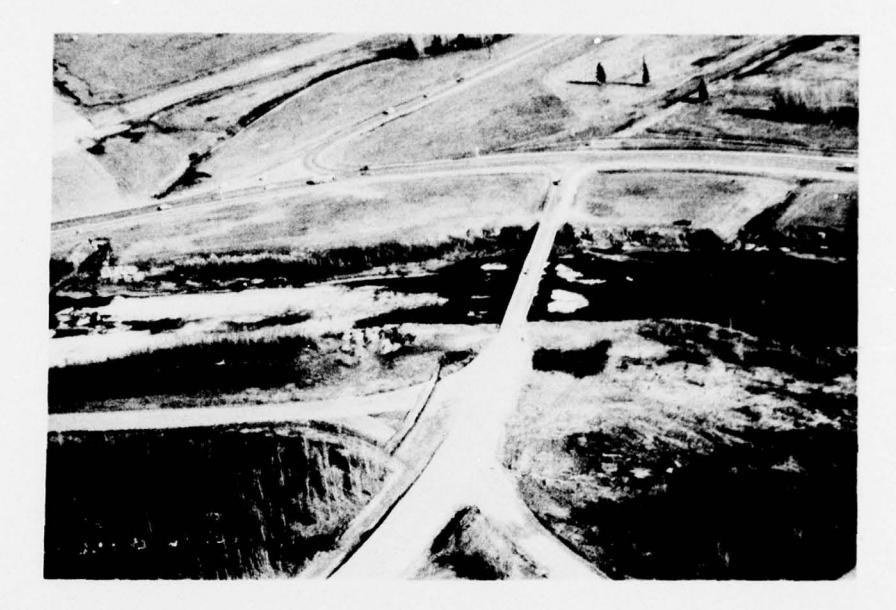
Figure A3. Checkpoint 3, 1 May 1975.

shaded area under the bridge still contained ice. By 1 May, further deterioration of the ice was noted (Fig. A3). The stage of the river had just started to rise slightly. Up to this time a sand bar below the bridge was evident, although it was a bit smaller on this date. The amount of ice below the bridge had decreased and the open water area above the bridge was considerably larger. A few small ice floes were noticed approximately 150 m upstream from the bridge as they jammed against the winter ice that had not yet moved out of this area. By 3 May, all the ice for 200 m upstream of the bridge had moved out. A few pieces of floating ice were jammed up on the trash racks. The river had continued to rise and the sand bar was almost covered. By the 5th (Fig. A4), the sand bar was completely covered as the river continued to rise. Several pieces of ice were jammed in front of the bridge on the trash racks. Two of these pieces appeared to be over 30 m long and approximately 10 to 15 m wide. No water was backed up by the ice and the jam was not causing any flooding. On 7 May the river was free of ice from its mouth to well above the bridge.

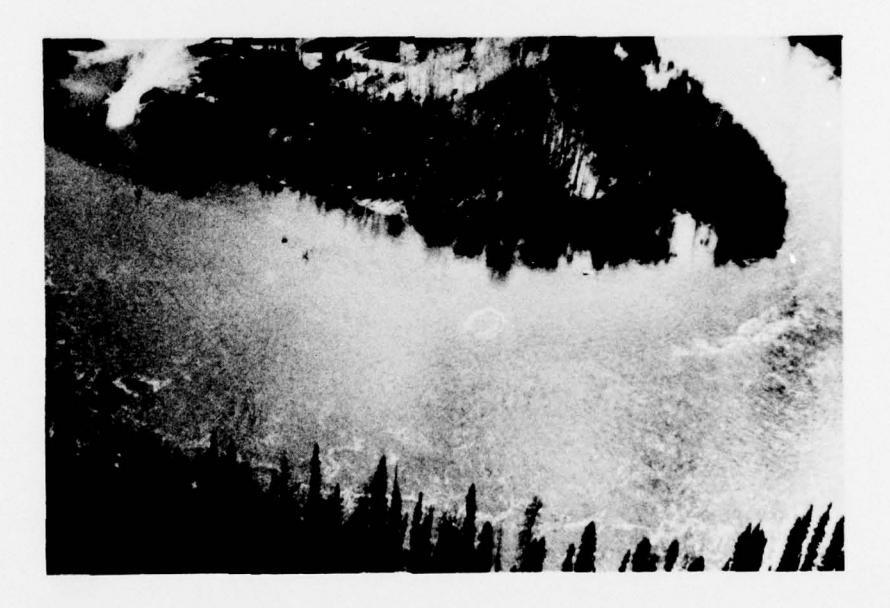
Figure A40. Checkpoint 10, 12 May 1975.

Above the damsite, minor flooding was observed along the river for several miles. At the Chena Park campground, a car parked on what is normally a dry gravel bar beside the river was submerged with only its roof remaining above water (Fig. A40).
