CORRECTIVE ACTION PROGRAM FOR BROMOCHLOROMETHANE-CONTAINING "FIRE-SAFE" DIESEL FUEL

FINAL REPORT
AFLRL No. 81

U. S. Army Fuels and Lubricants Research Laboratory
Southwest Research Institute
San Antonio, Texas

September 1976

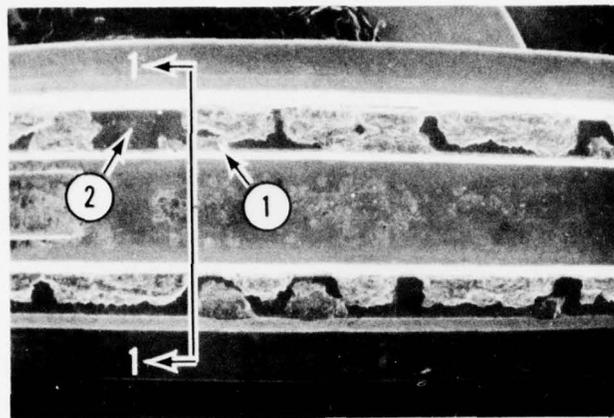
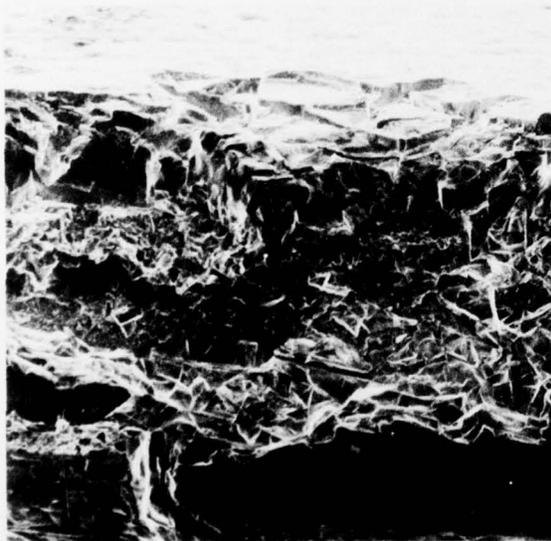
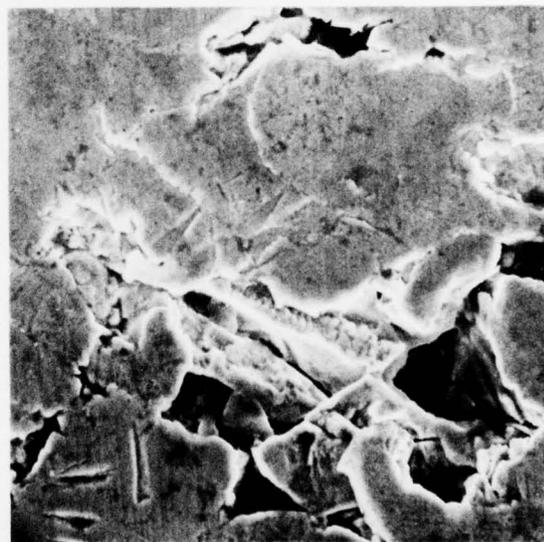
FIGURE 1. SEM MICROGRAPHS OF WEAR SURFACE OF FAILED PISTON RING FROM TCM AVDS 1790-2C ENGINE ENDURANCE TEST WITH BCM FSF

- a. No scuffing was evident on the chromium plating not yet chipped off of the piston ring (Figures 1 and 2)*.

- a. The failure of the piston ring was associated with no inherent plating defects.
- b. Failure of the piston ring provided to AFLRL occurred by intergranular cracking of the chromium plating and subsequent loss of chips of the plating. The metallographic features of the cracking are compatible with failure due to inadequate lubrication, but the possibility of stress-corrosion cracking due to a contaminant cannot be discounted.

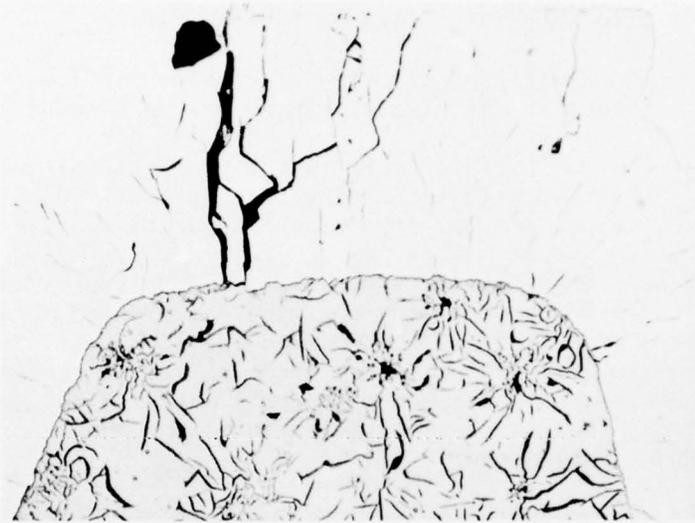
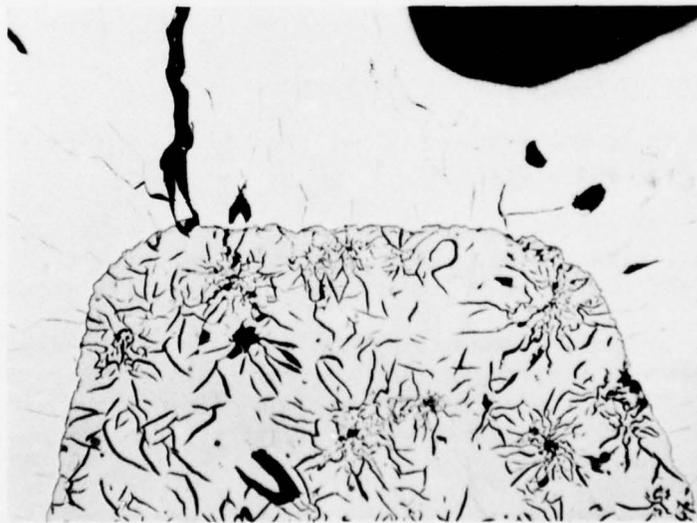
FIGURE 3. MICROGRAPHS OF SECTION THROUGH FAILED PISTON RING
Section 1-1, Figure 1(a). Unetched.

- b. There was evidence of corrosion debris in some of the intergranular cracks in both the chromium plating and in the cast iron substrate (Figures 3, 4, and 5).
- c. No significant dilution of crankcase oil with raw fuel was evident by AFLRL analysis of used oil samples (Table 1).
- d. The ratio of Cl to Br in the crankcase oil was less than in the raw fuel, indicating that much of the halogen content of the oil stemmed from blowby products--not raw fuel (Table I).

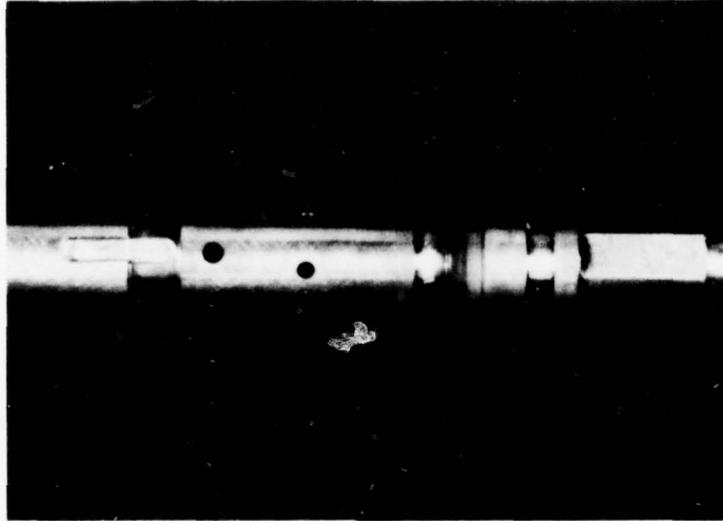
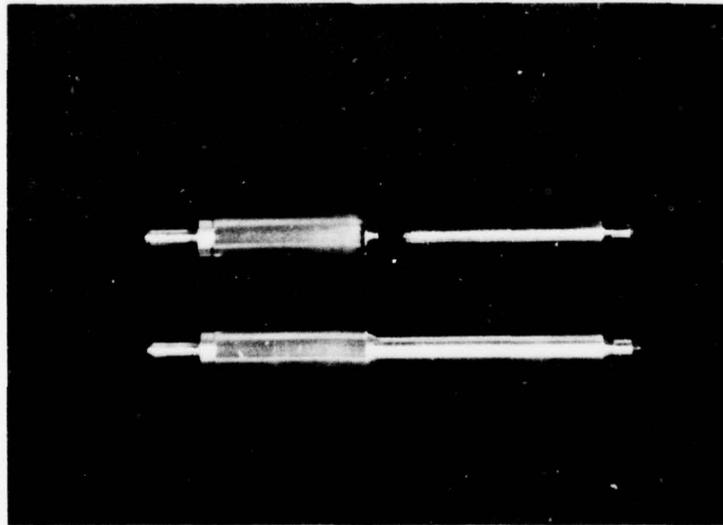
The surface topography of these parts was also examined in the scanning electron microscope (SEM). In the case of the pintle [Figure 6(b)], no evidence of attack of the surface was apparent in the dark zone and the microscopic features indicated the presence of a loose deposit, Figure 7(a). Distinctly different topographic features were noted between the dark zone and clean surface on the plunger as shown in Figures 7(b) and 7(c). Within the dark zone the surface was rough and pitted, suggestive of corrosive attack.

The dark area on the pintle was found to be acetone soluble, and SwRI metallurgists saw no evidence of corrosion [Figure 6(b)]. As in the case of the previously discussed engine parts, significant quantities of chlorine were present in dark zone on the pintle (see Table 4).

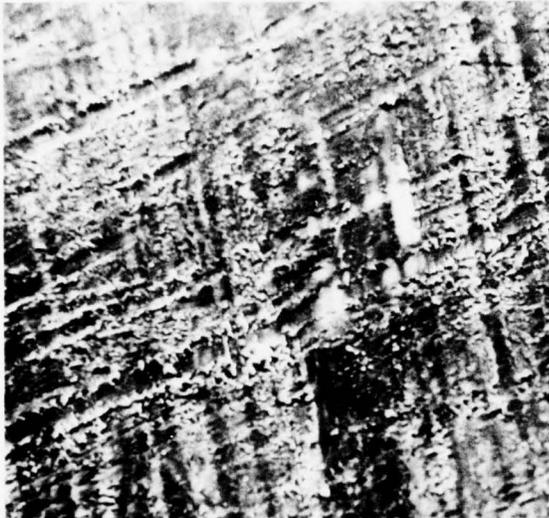
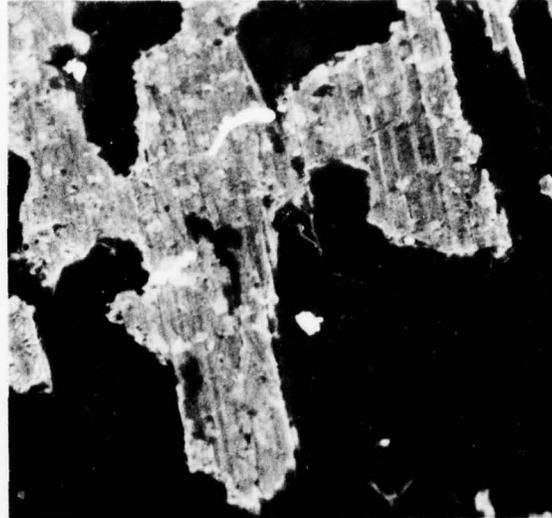
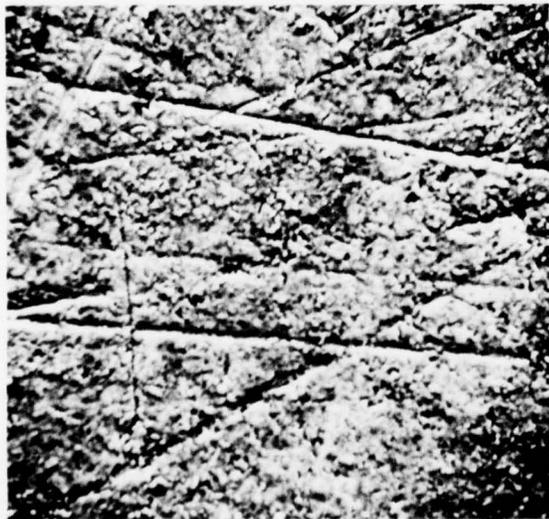
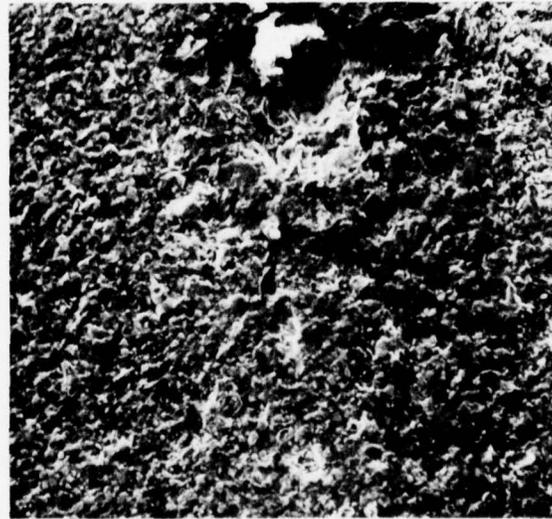
A longitudinal metallographic section was taken through the dark zone of the plunger. Examination of this section revealed definite pitting of the surface within the dark zone, while the surface profile at the clean zone was extremely flat and smooth (see Figure 8). These metallographic features together with the fine-scale topography observed in the SEM examination are definite evidence that the dark band on the plunger is the result of corrosive attack. It should be noted that both sulfur and chlorine were present in significant amounts within this zone of the plunger. Either of these elements could cause corrosive attack of the plunger."

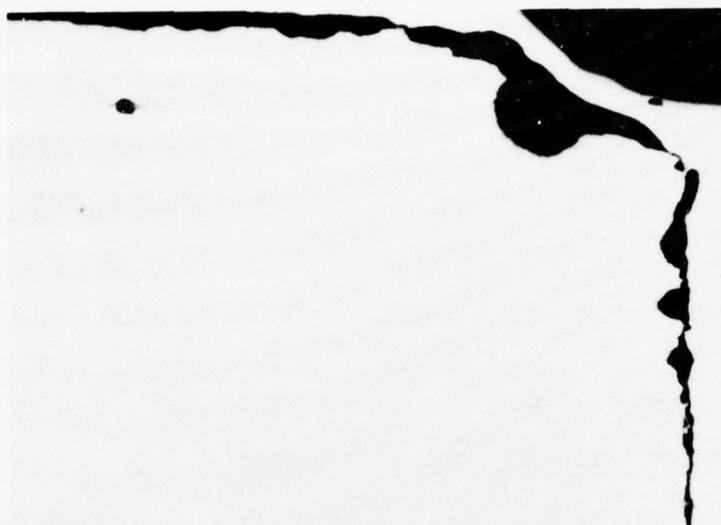
FIGURE 8. MICROGRAPH OF SECTION THROUGH INJECTOR PLUNGER. Unetched.

- e. The dark band on the injector pump plunger definitely resulted from corrosive attack.

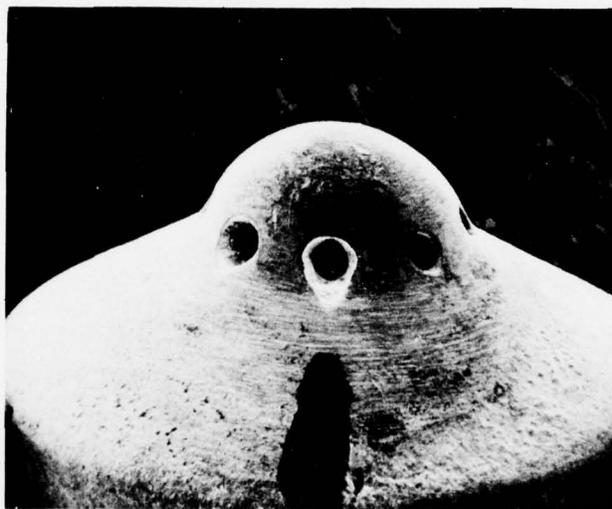
FIGURE 9. FAILED INJECTOR TIP (CENTER HOLE IN MICROGRAPH DESIGNATED AS NO. 1) FROM AVDS 1790-2C ENGINE ENDURANCE TEST WITH BCM FSF

- d. The mechanism of enlargement of the injector tip holes was not definitely identified, but it is most likely that the metal loss occurred as the result of corrosion rather than by erosion, possibly during engine shut-down periods.

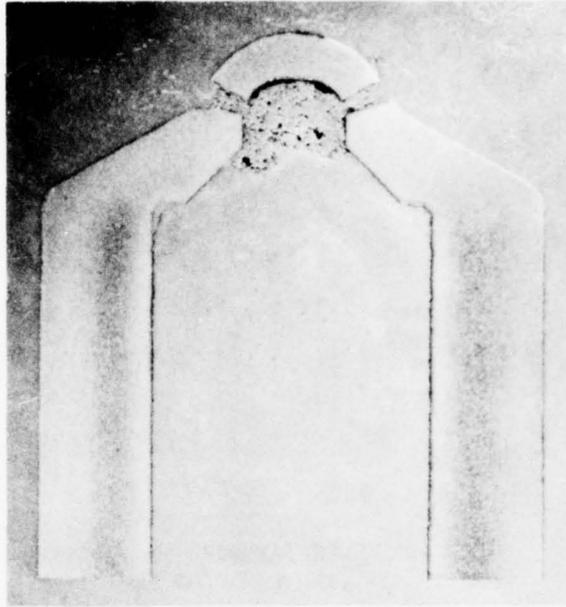
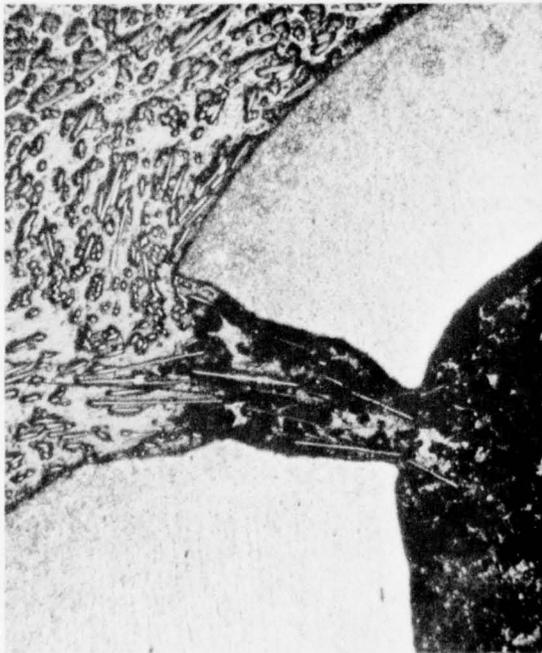
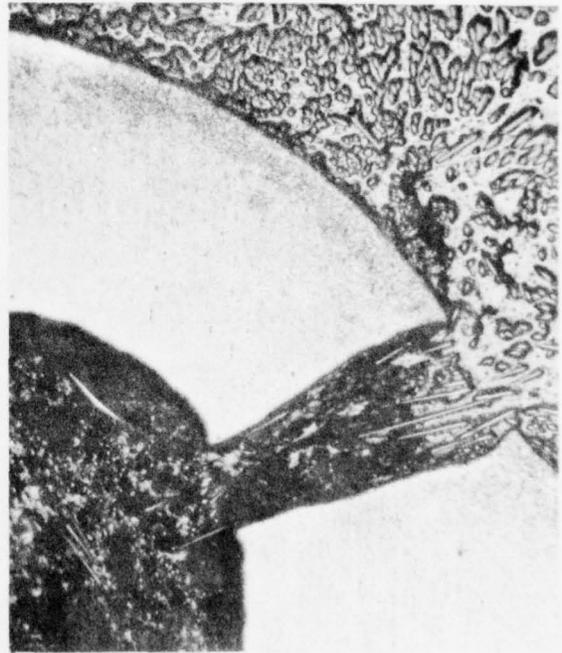
FIGURE 11. SECTIONED SPECIMEN REVEALING CROSS-SECTIONS OF LARGEST AND SMALLEST HOLE IN FAILED AVDS 1790-2C INJECTOR NOZZLE

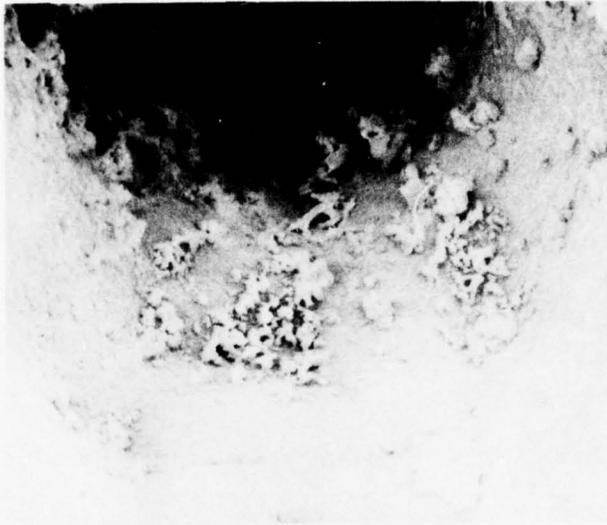
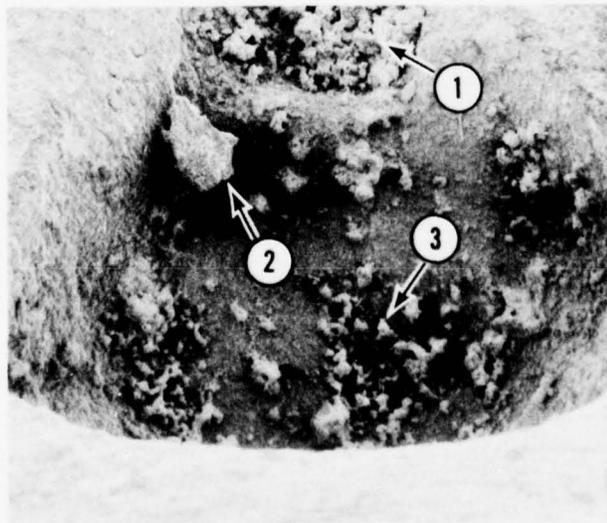
FIGURE 12. AREAS OF SEM MICROPROBE EXAMINATION
FAILED INJECTOR TIP, Hole No. 1.

Location ^a	Peak/Background ^b	
	Cl	Br
Area 1	469/52	Not detected
Area 2	283/48	Not detected
Area 3	42/10	Not detected
Conical Surface	500/85	1350/1200

Notes:
^aSee Figure 12 for location of areas examined.
^bCounts in 30 sec., $i = 0.2 \times 10^{-7}$ amps.

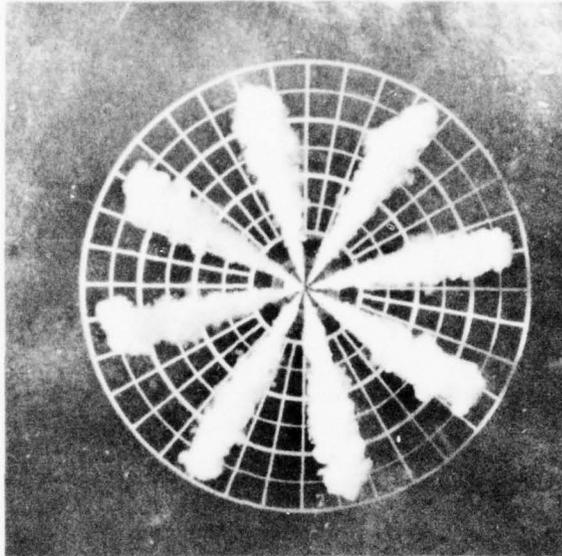
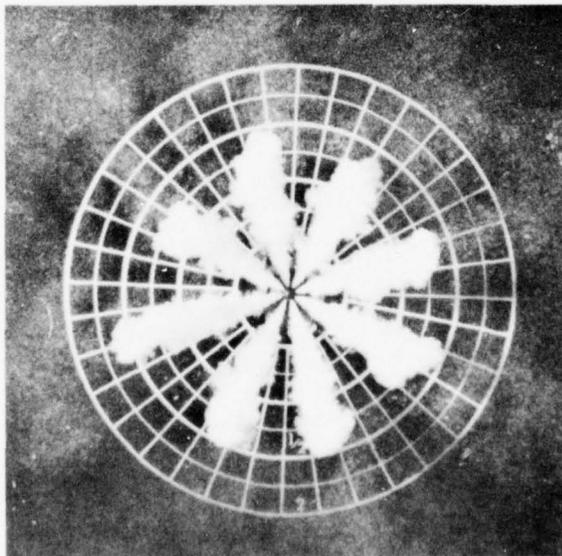
FIGURE 13. NEAT DIESEL FUEL SPRAY PATTERNS FOR NOZZLES
FROM AVDS 1790-2C ENGINE

Rather than only attributing the previously-mentioned excessive smoke emissions to overfueling because of nozzle hole enlargement, an alternate explanation could lie in the influences of the nonuniform nozzle injector tip hole enlargement on spray density and distribution. Figure 13 illustrates changes that occurred in the spray patterns* of a typical nozzle from the AVDS 1790-2C engine FSF endurance test after about 30 hours exposure to BCM FSF (with overnight shutdowns). These reveal substantial decreases in spray penetration with attendant increases in spray-droplet

(New)
7.5° After SOI
26.5° Duration
1200 RPM

(Used 145 hr with Diesel Fuel + BCM)
7.5° After SOI
21.5° Duration
1200 RPM

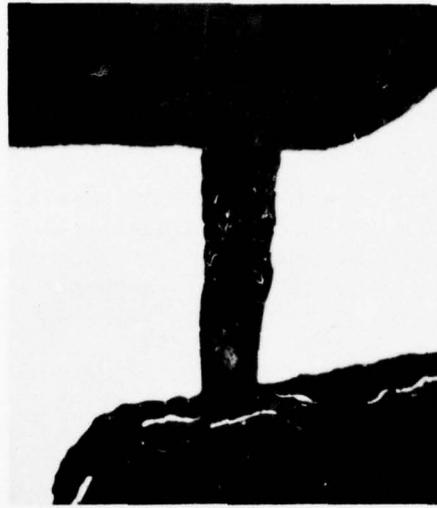
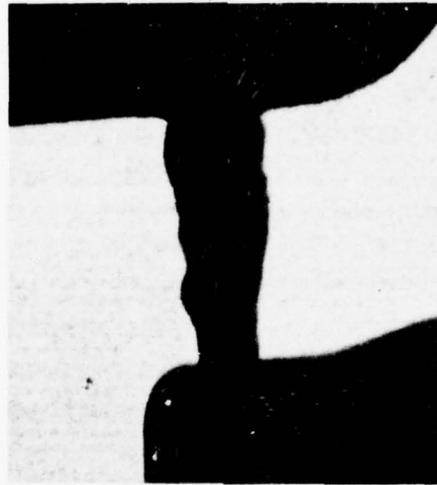
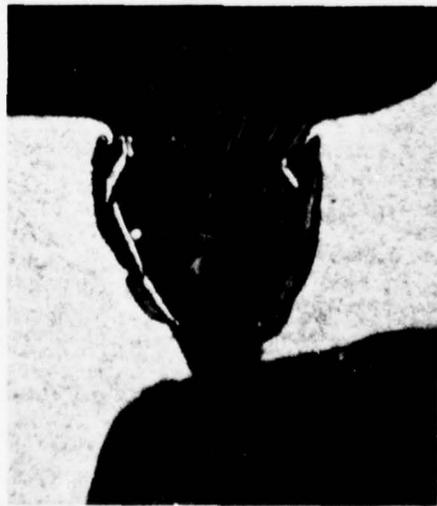
FIGURE 16. SECTION THROUGH LARGEST HOLE IN V6-155 ENGINE FUEL INJECTOR NOZZLE AFTER 80 HOURS OPERATION

After the test, the engine was disassembled and inspected, with the following effects noted: (1) substantial reduction in injector tip hole enlargement, (2) increased cylinder liner wear, (3) increased piston ring end-gap change (approximately 0.030 inch), and (4) extreme blackening of all engine parts below the ring belt. The black color seemed to be caused by a thin layer of lacquer-like carbonaceous substance containing bromine and iron in

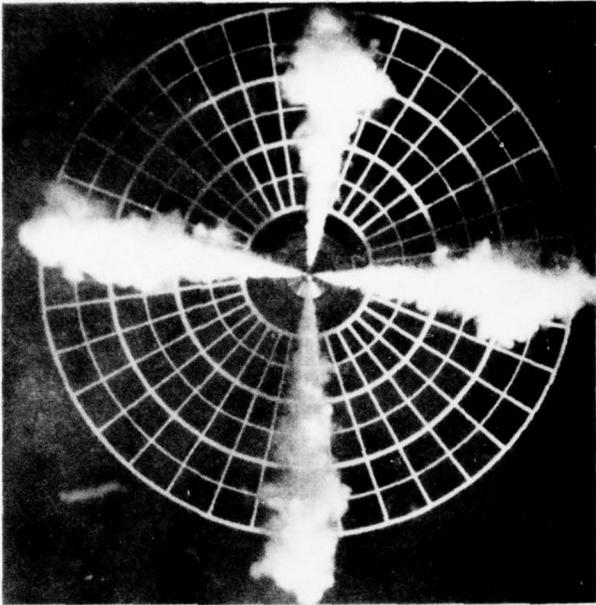
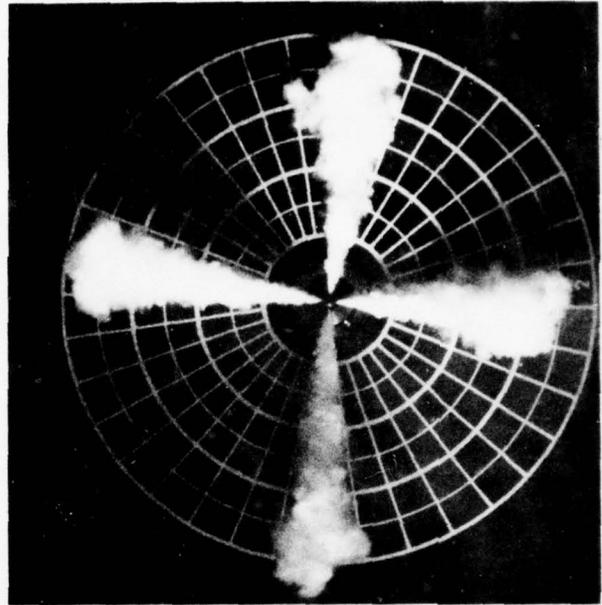
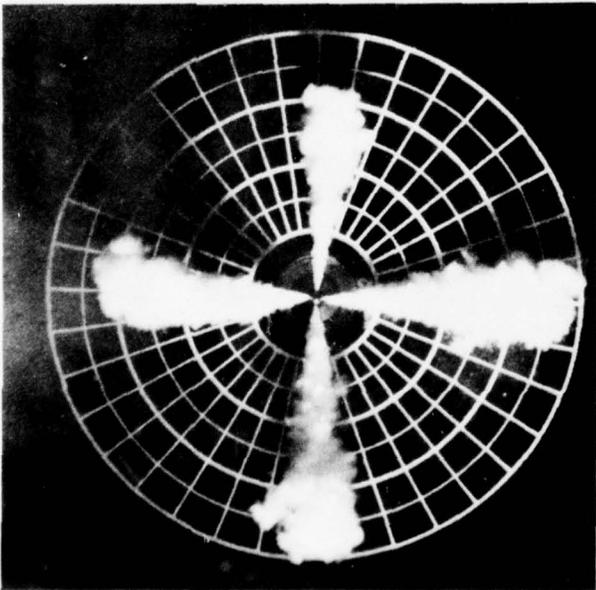
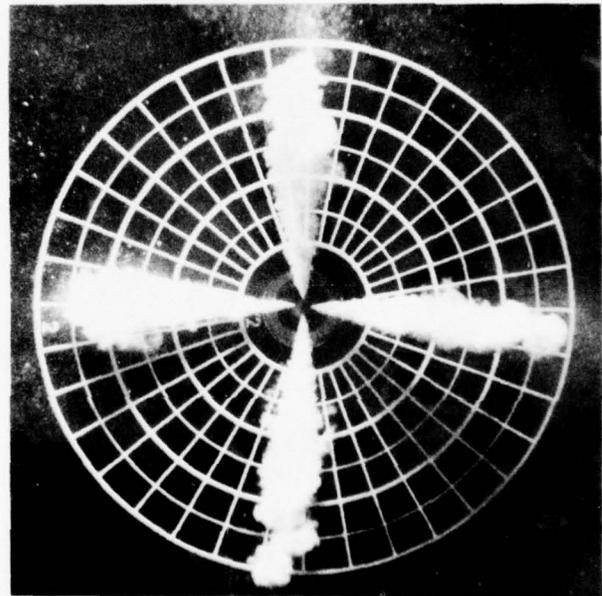
FIGURE 18. SPRAY PATTERNS FOR A NEW NOZZLE AND NOZZLES USED WITH NEAT DF-2 PLUS BCM, AND DR-2 PLUS CHO

120 HOURS - BASE FUEL

60 HOURS - BCM FSF

80 HOURS - BCM FSF + CHO
