Report No. FAA-RD-77-13

FULL-SCALE AIRCRAFT CRASH TESTS OF MODIFIED JET FUEL

Robert H. Ahlers

JULY 1977

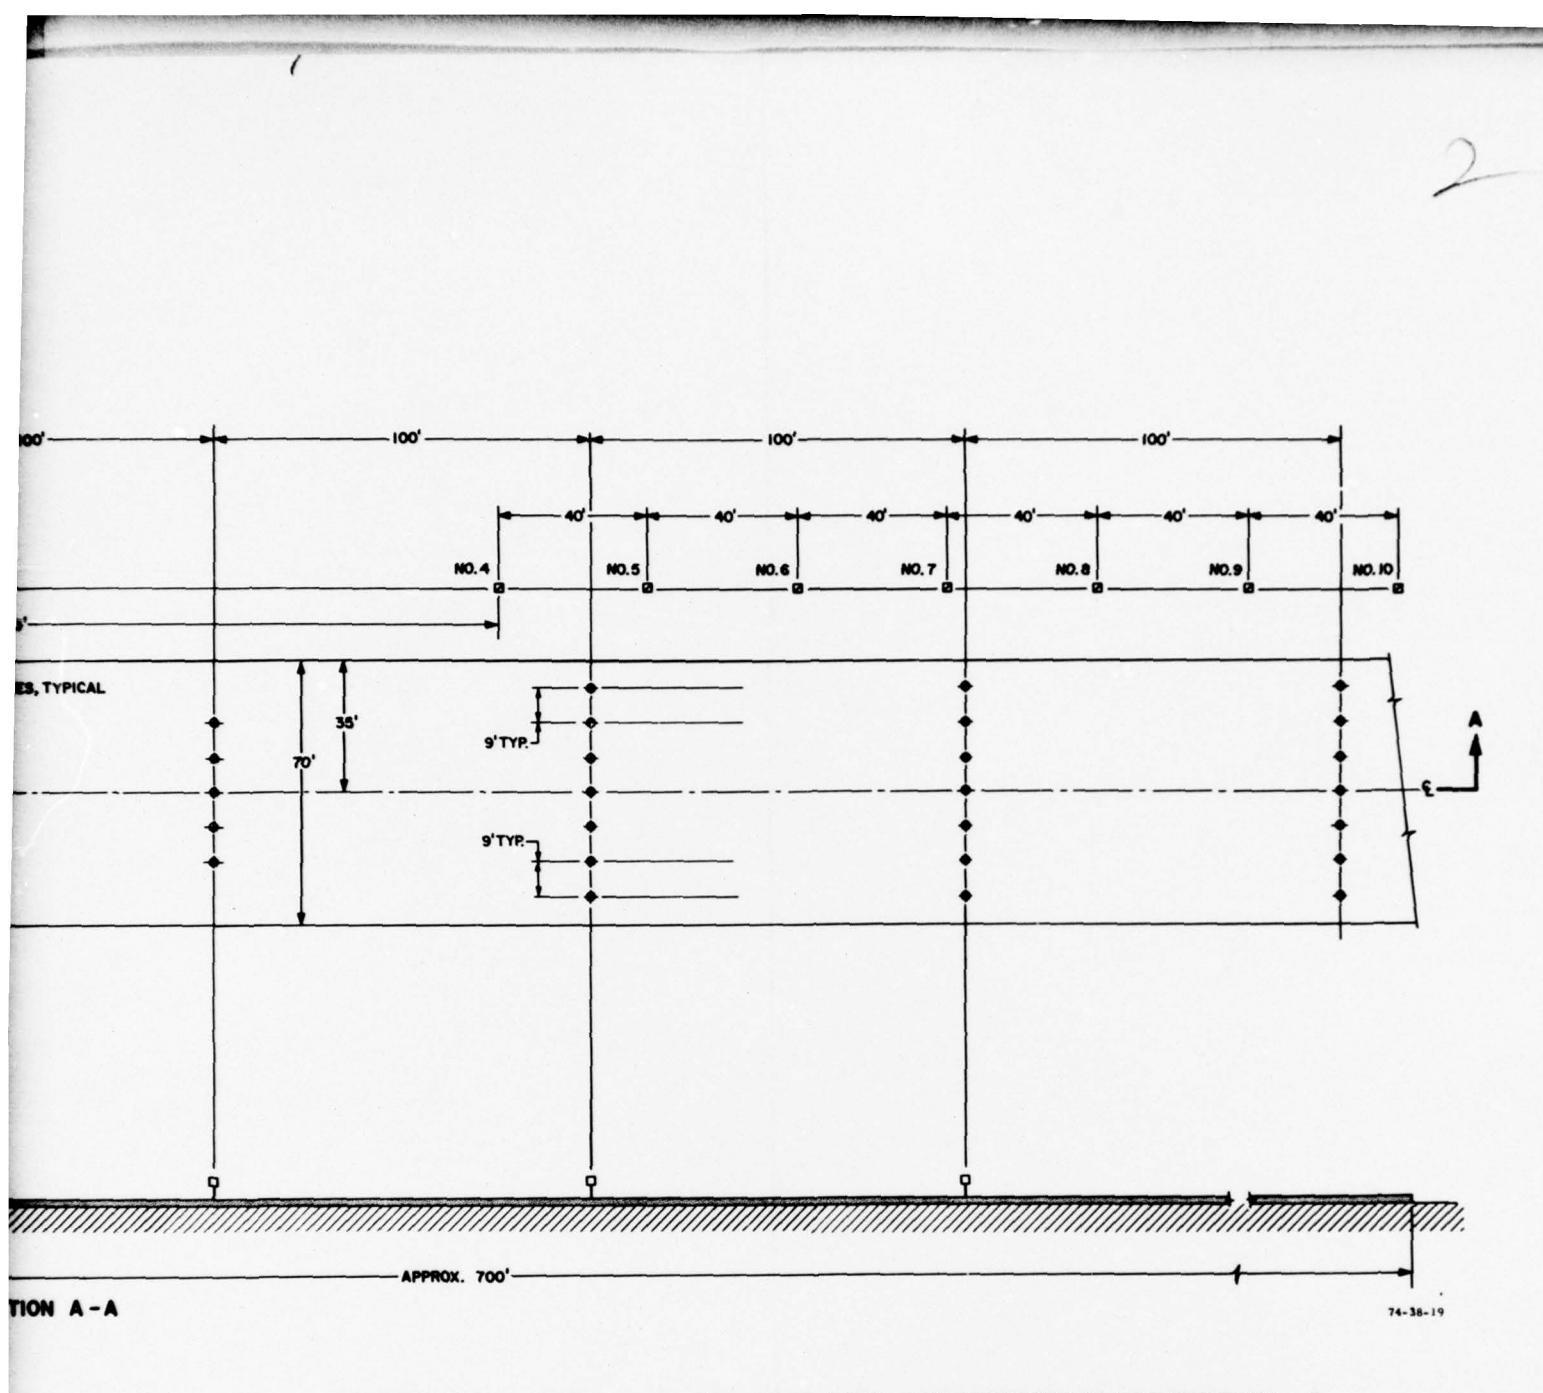
FIGURE 17. SKETCH OF TEST SITE AREA CONFIGUREATION FOR TEST NO. 4

Beyond the propane torches were 30 ignition sources suspended from l-inch-diameter steel poles, as shown in figure 19. Figure 17 shows the location of these ignition sources along the crash site area.

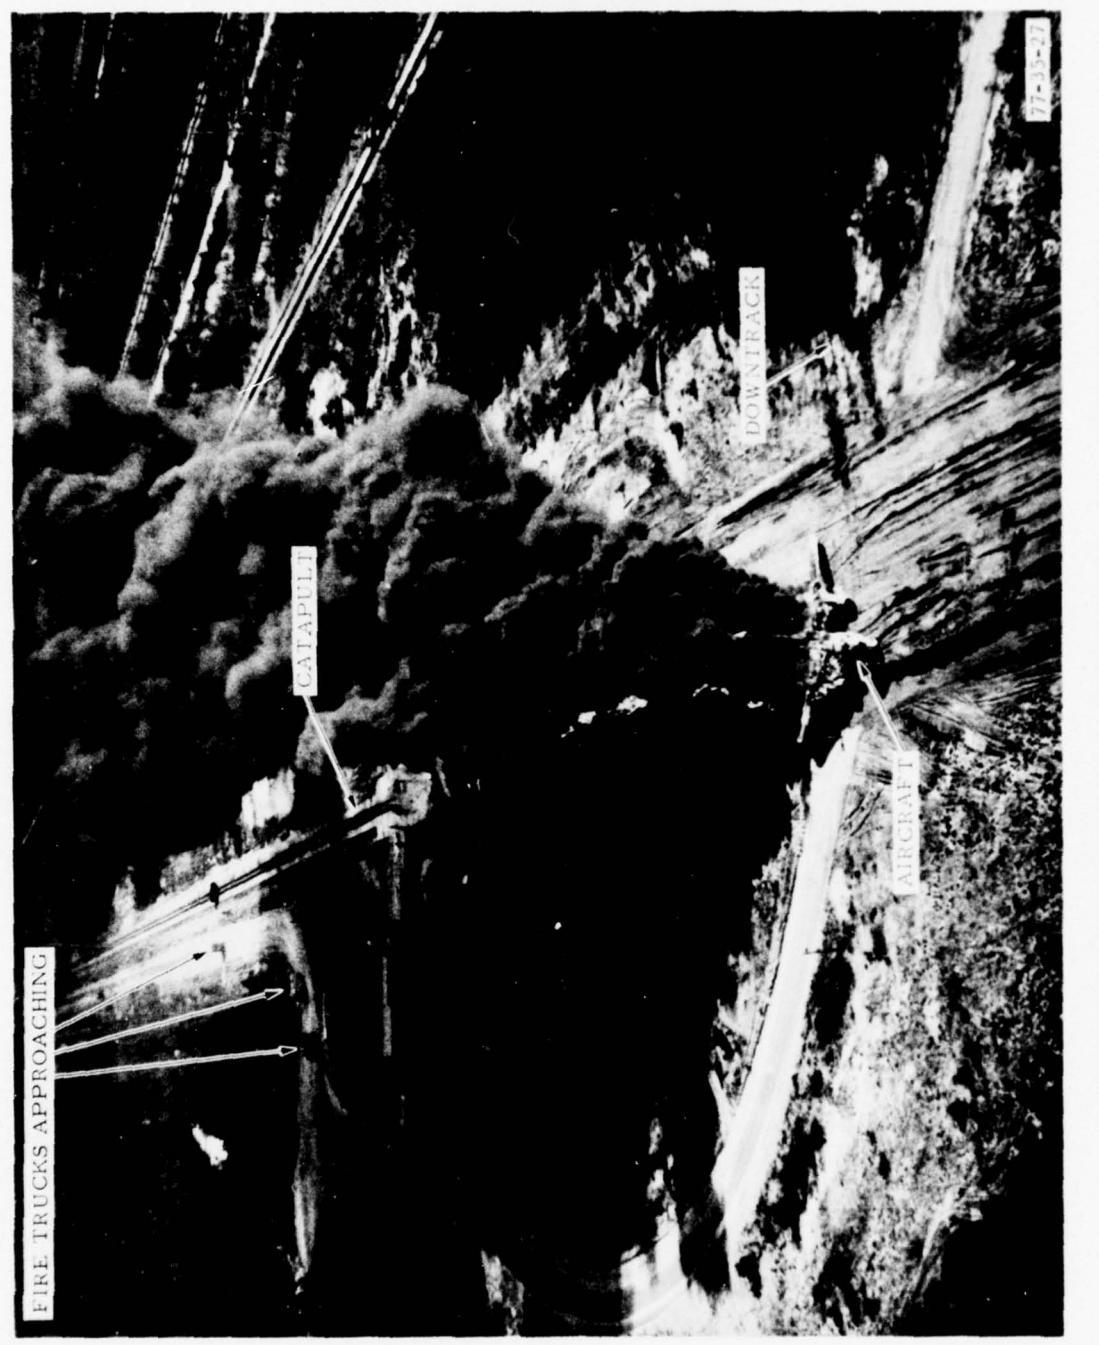
FIGURE 27. RESULTING FIRES FROM SPILLED FUEL DURING TEST NO. 4

The engines on the airplane were started on JP-4-type fuel and switched over to run on the modified fuel in the wing tanks. The airplane was accelerated to an impact speed of 102.4 knots by the jet car, and the airplane came to rest 600 feet downtrack. There was considerable fire in the test site area, and the airplane itself was on fire from the forward wing roots aft, to the tail (figure 27).

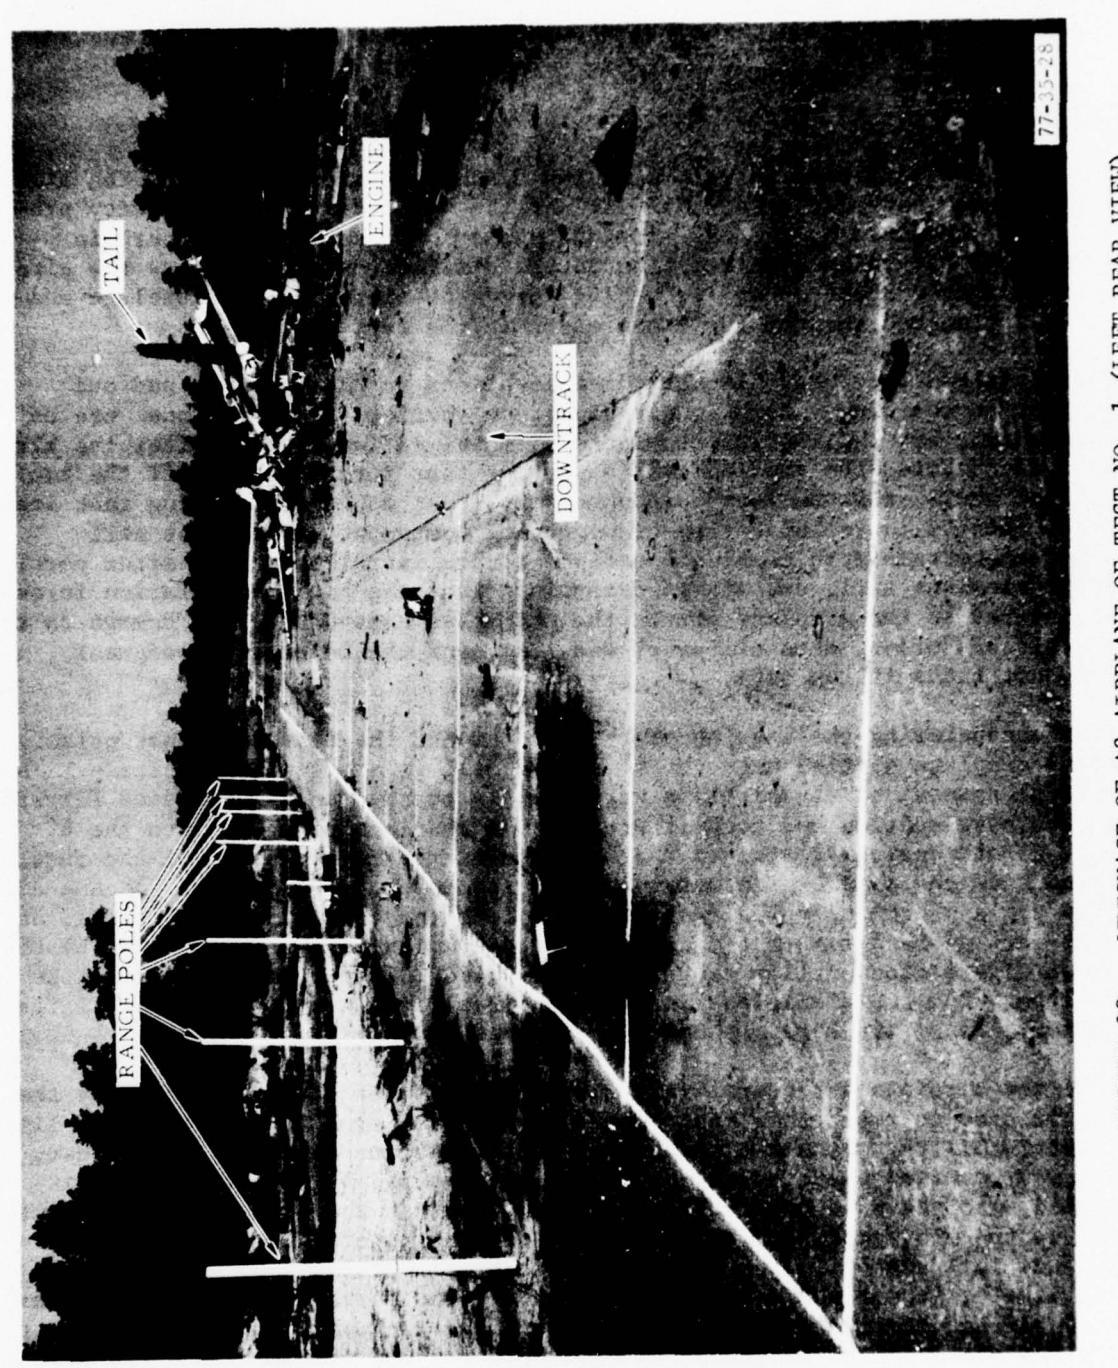
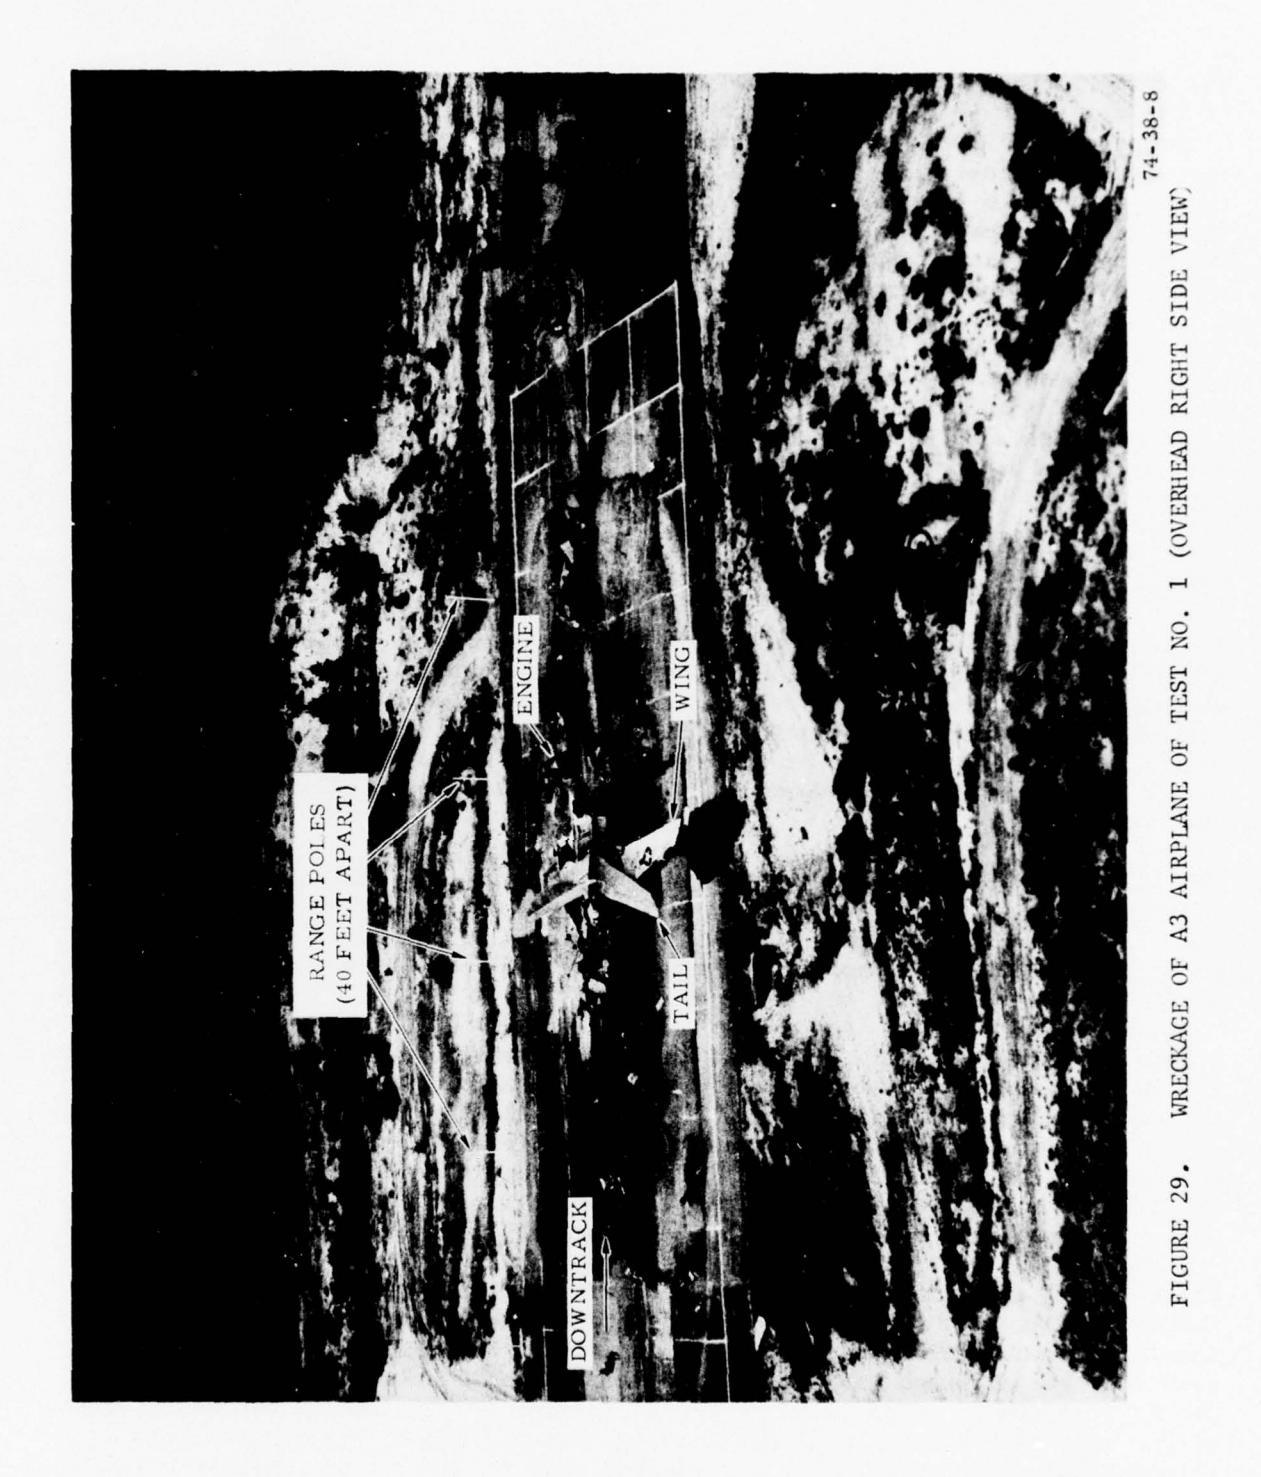
After encountering the landing gear obstacles and the four telephone poles, the A3 airplane settled onto the 6° sloped hill in a nose-down attitude. The vertical descent of the airplane was abruptly changed as it proceeded forward, and the nose section and cockpit area of the fuselage ploughed into the 6° slope. Both engines contacted the 6° slope as the forward part of the fuselage failed, and the port engine was torn from its mount. The airplane became airborne for approximately 190 feet after it left the crest of the 6° slope, and as it settled back toward the ground, the port wing contacted the edge of the 2-foot-high earthen pillow that was constructed 200 feet downtrack from the 6° slope. The whole airplane folded upon itself and came to rest in a large compact pile of wreckage, as shown in figures 28 and 29.

Since the airplane structural integrity had been completely destroyed by the time it came to rest, this test could not be considered to be within the limits of survivability. From the high-speed motion picture coverage of the test, it was determined that the impact forces encountered by the airplane as it settled onto the 6° sloped hill were so severe that they caused vital structures, such as the wing roots and engine-pod attachment points, to fail. As the airplane left the 6° slope, it appeared to be structurally sound, but more than likely, it was not. The movement of all the parts, wings, fuselage, and tail, through the air at the same velocity made it appear intact, but when the airplane settled back to ground level, there was not enough structural strength left to hold the various parts in their relative positions, and the airplane came to rest in a heap.
