### ER-7867-F

# ULTRASONIC INSPECTION OF CERAMICS CONTAINING SMALL FLAWS

TRW Inc. Cleveland, Oh. 44117

**Final Technical Report**

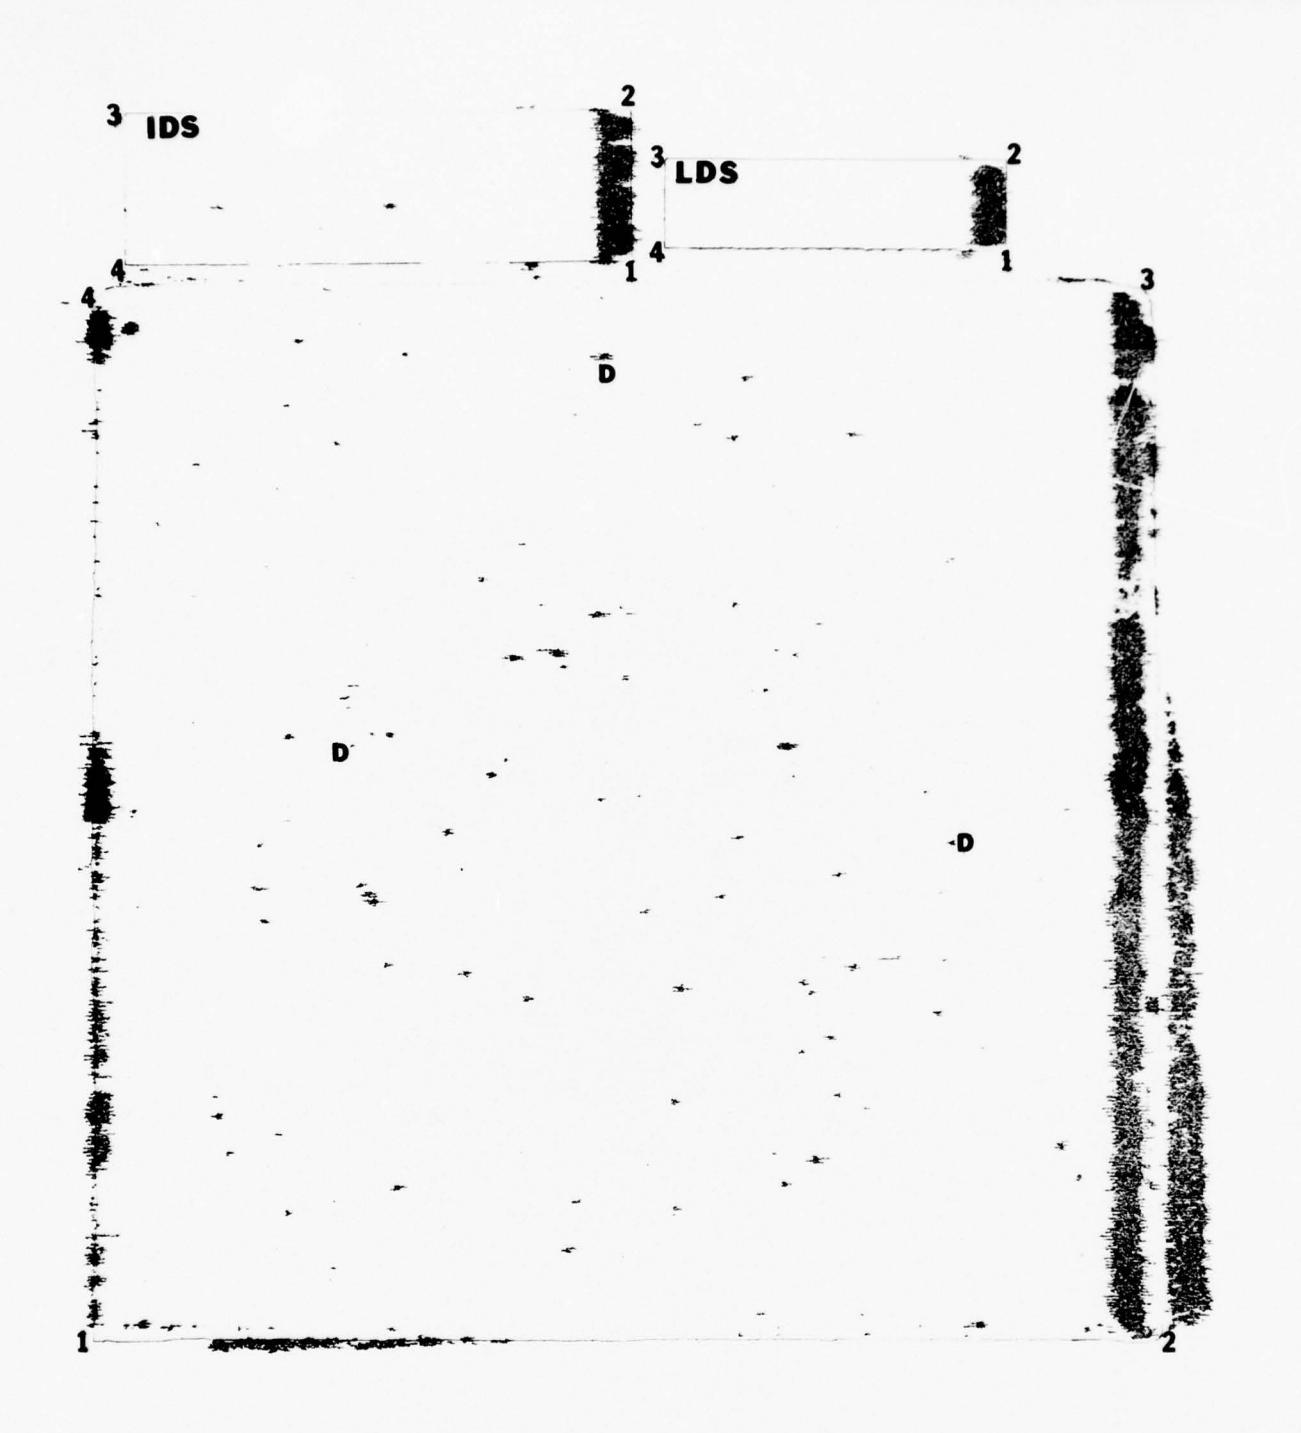
Figure 7. C-scan Recording of 45 MHz, 11° Ultrasonic Shear Wave Inspection of Ceralloy 147A after Machining.

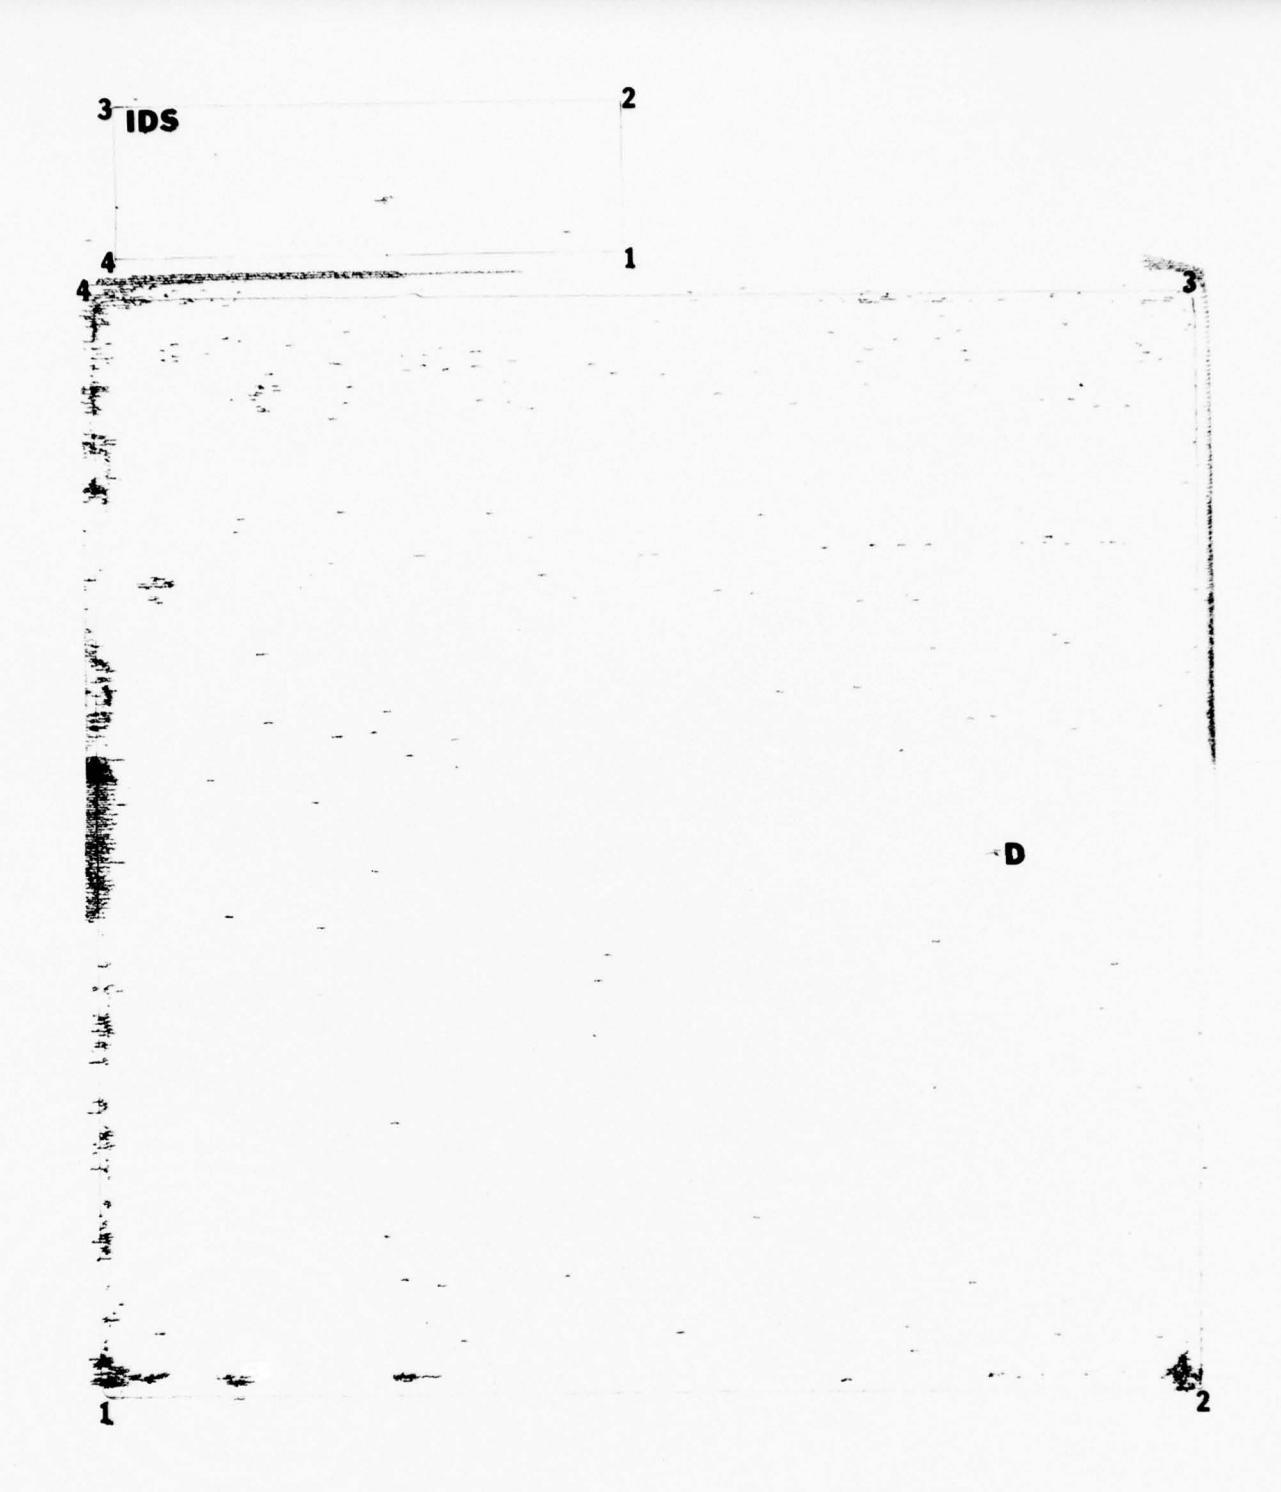
Figure 9. C-scan Recording of 45 MHz Longitudinal Wave Inspection of NC-132 After Machining.

The billet of NC-132 was also relatively free of defects. In addition to one small defect detected by longitudinal wave inspection (labelled D in Figure 9), a number of mostly small defects were detected by the shear wave technique (Figures 17 and 18). These two figures show C-scan recordings for shear wave inspections made at two orientations 90° apart. The indications labelled D appear in both figures. Subsequent measurements of defect depths revealed most of these indications to be the result of residual surface pits that were too deep to remove by surface machining. In contrast, the billet of Ceralloy 147A was found to have a large number of defects scattered throughout the part (Figure 14). Because of the large number of scans and the large number of defects in each scan, it is difficult to present an overall recording of the inspection results on this billet which would clearly distinguish the circumstances under which each defect is detected. However, Figures 19 and 20 summarize the

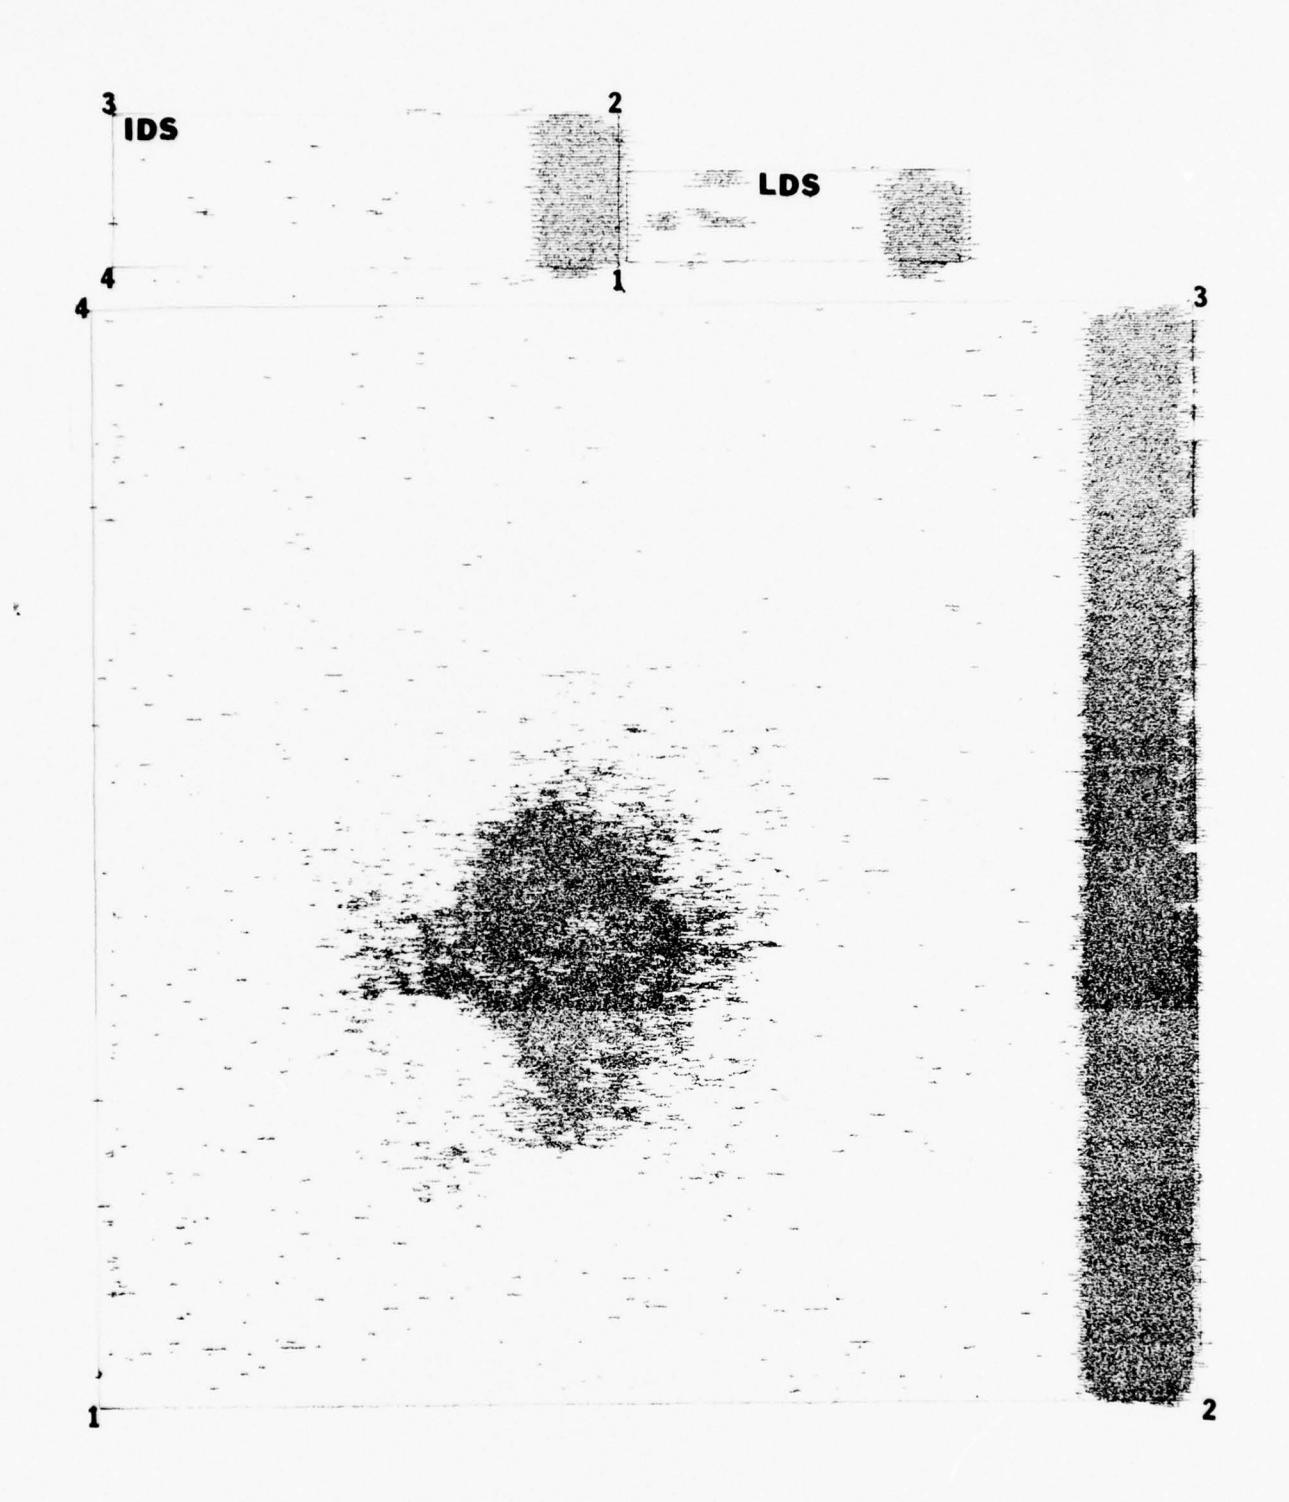
Figure 12. C-scan Recording of 45 MHz, 11° Shear Wave Inspection of NC-203A Before Machining.

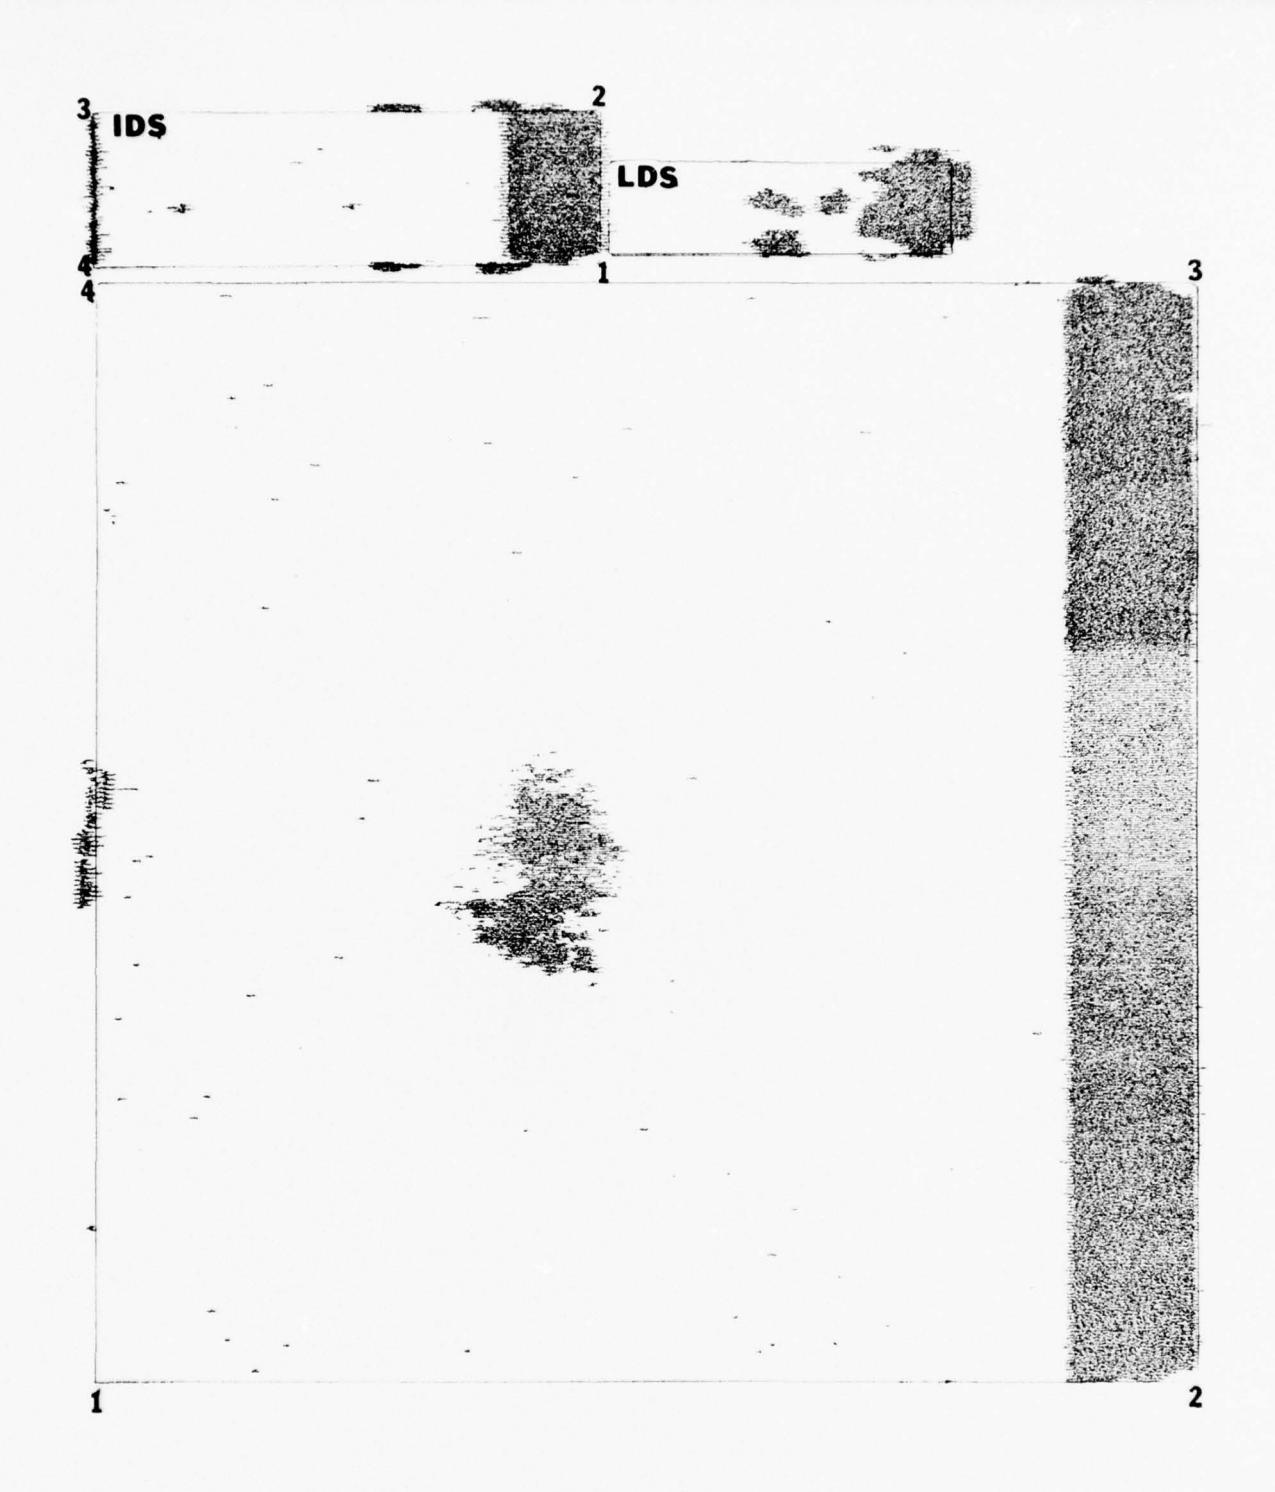
Figure 13. C-scan Recording of 45 MHz, 11° Shear Wave Inspection of NC-203A After Machining.

The Ceralloy 146A, which was inspected in the previous program using longitudinal waves and found to have only a few small defects, was not found to have any additional defects by shear wave inspection. The billets of NC-203A were also found to be relatively free of defects, except for the area of visible surface porosity near the center. This area was detected both by shear wave inspection from either side (Figures 13 and 15) and by longitudinal wave inspection from the same side (Figure 16). The A-scan display observed during the inspection shown in Figure 16 revealed that this defective area is not confined to the surface but extends somewhat into the material.

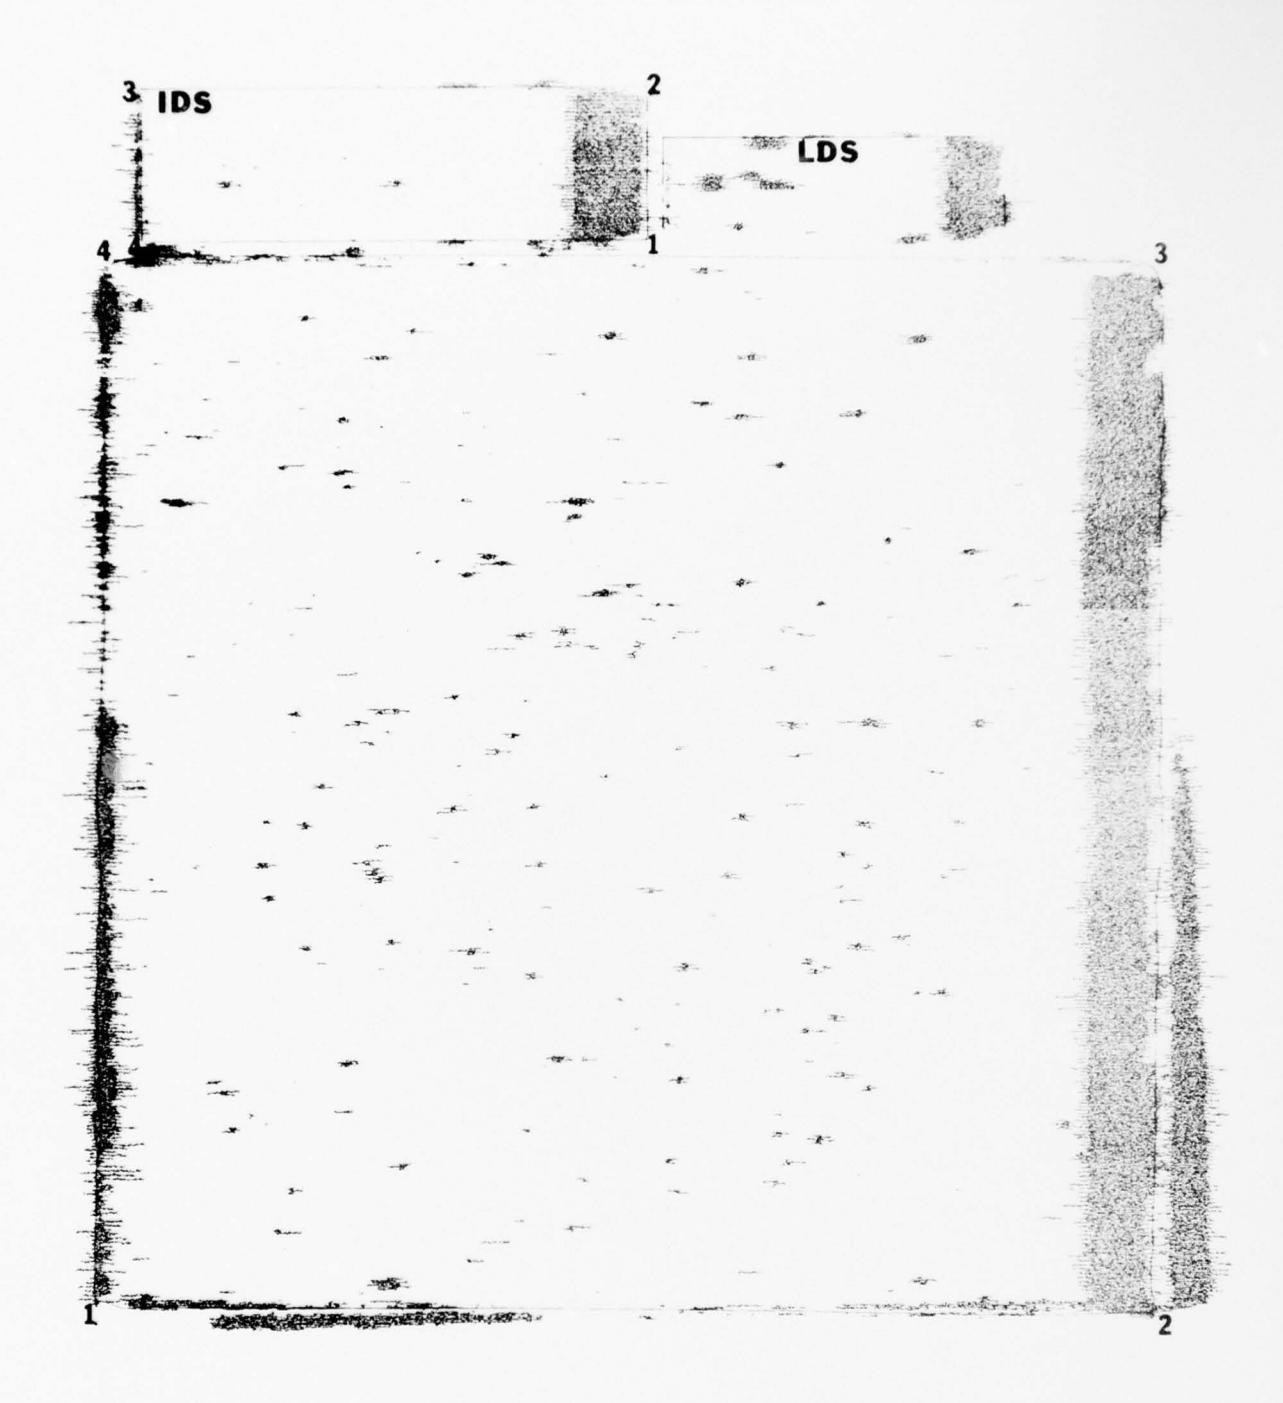
Figure 7 shows the IDS, LDS and billet of Ceralloy 147A inspected using the single gate width shear wave technique. Figure 14 shows the same scan made with the double gate width technique. In Figure 14 the deadband along the right hand edge of each part is twice as large as in Figure 7, the holes in the LDS are seen, the indications from the seeded defects in the IDS are larger and there are many more indications in the Ceralloy 147A. It was concluded from these scans that the double gate width technique offers improved sensitivity and reduces the probability of failing to detect a large defect (such as the holes in the LDS) due to unfavorable orientation.

Figure 14. C-scan Recording of 45 MHz, 11° Shear Wave Inspection of Ceralloy 147A, After Machining Using Longer Defect Gate.

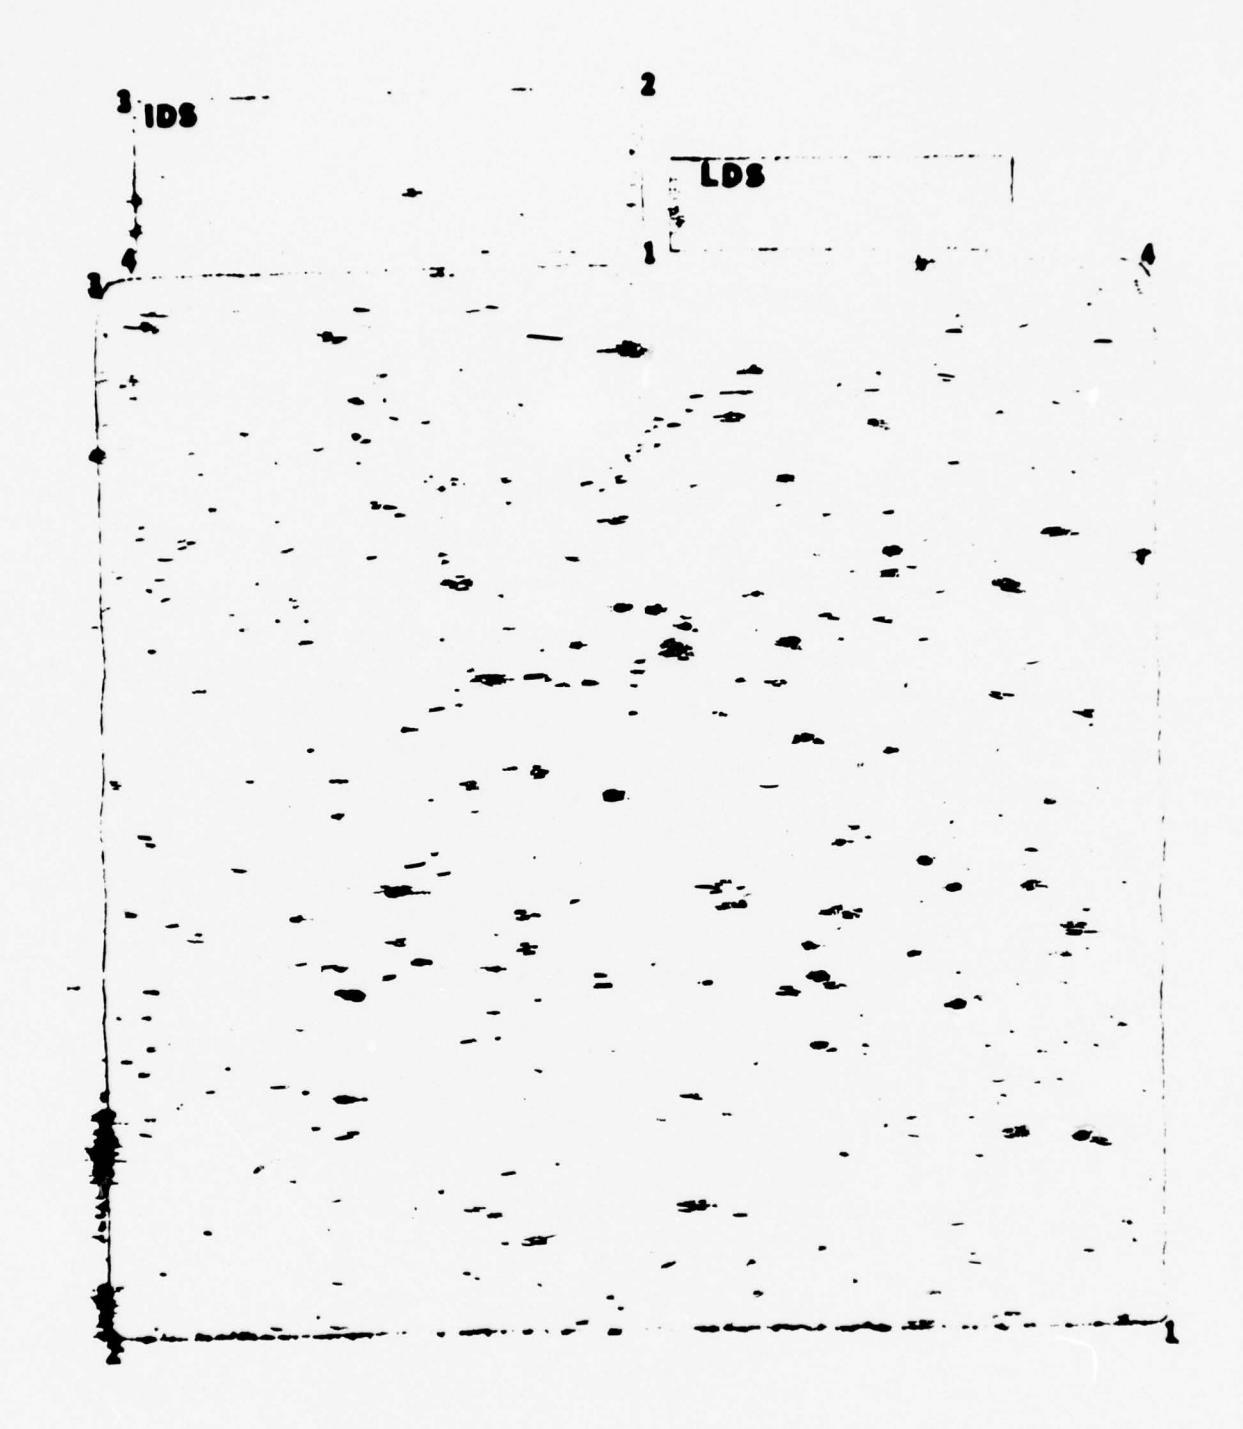
Figure 19. Composite C-scan Recording of Three 45 MHZ Longitudinal Wave Inspections of the Billet of Ceralloy 147A.

results of the longitudinal and shear wave inspections, respectively. Each figure was made by making a transparency from one C-scan recording and then laying that over the other C-scan recordings and tracing any new indications. Figure 19, therefore, is a composite of the three longitudinal wave inspections made at three different focal planes, while Figure 20 is a composite of the four shear wave inspections made at two orientations at each of two focal planes. In Figure 20 it should be noted that a number of cases exist where indications form a + or L shape. These are caused by defects that are detected from two different orientations 90° apart. The exact relationship between the two indications depends on the depth of the defect and on whether it was detected by the beam going down or up or both. By overlapping the two transparencies from which these figures were made the defects were identified that were only detected by shear wave inspection.

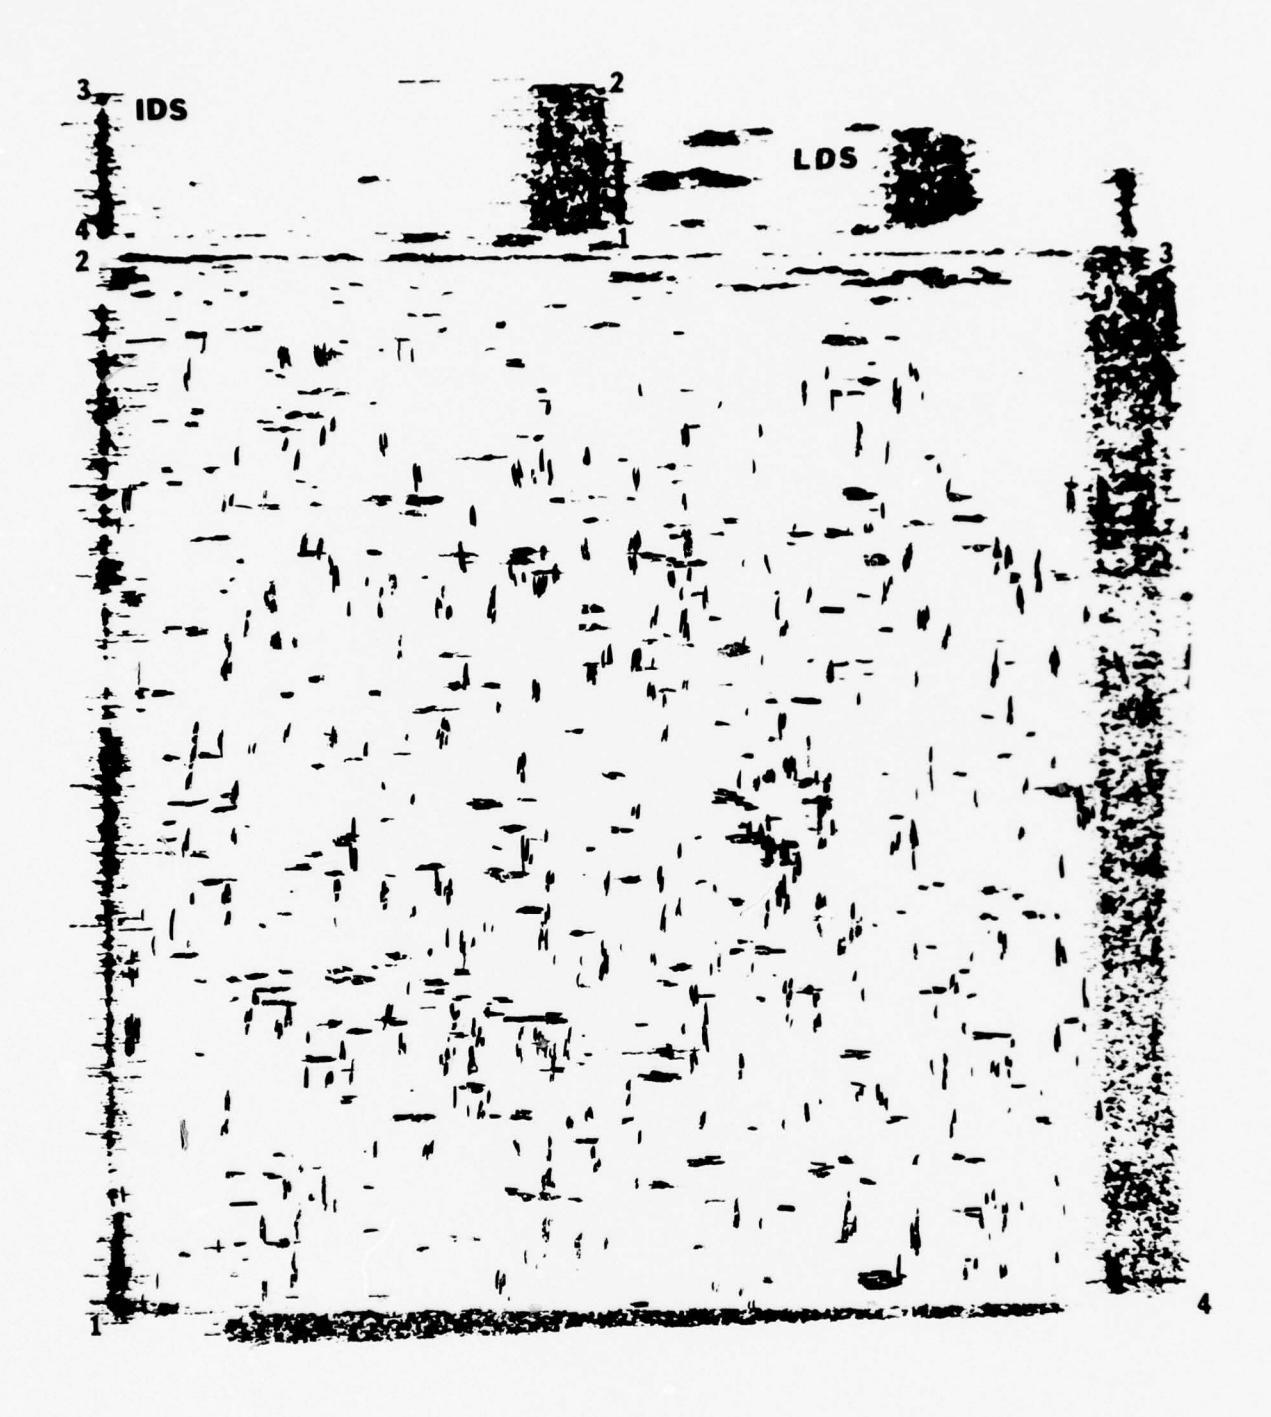
Figure 20. Composite C-scan Recording of Four 45 MHz, 11° Shear Wave Inspections of the Billet of Ceralloy 147A.

- The shear wave technique is capable of detecting substantially more defects than the longitudinal wave techniques, i.e., a large number of defects can only be detected by the shear wave technique;
- A small number of defects were only detected by the longitudinal wave technique (it is natural to assume that these defects lie in an unfavorable plane to shear waves, i.e., in a plane parallel to the billet surfaces);
- A large number of defects were only detected by one of the two inspections made 90° apart (showing the sensitivity of inspection beam orientation to defect orientation);
- 4. Some defects are only detected from one side of the billet (defects near a billet surface are outside of the focal plane of the transducer when that surface is up).

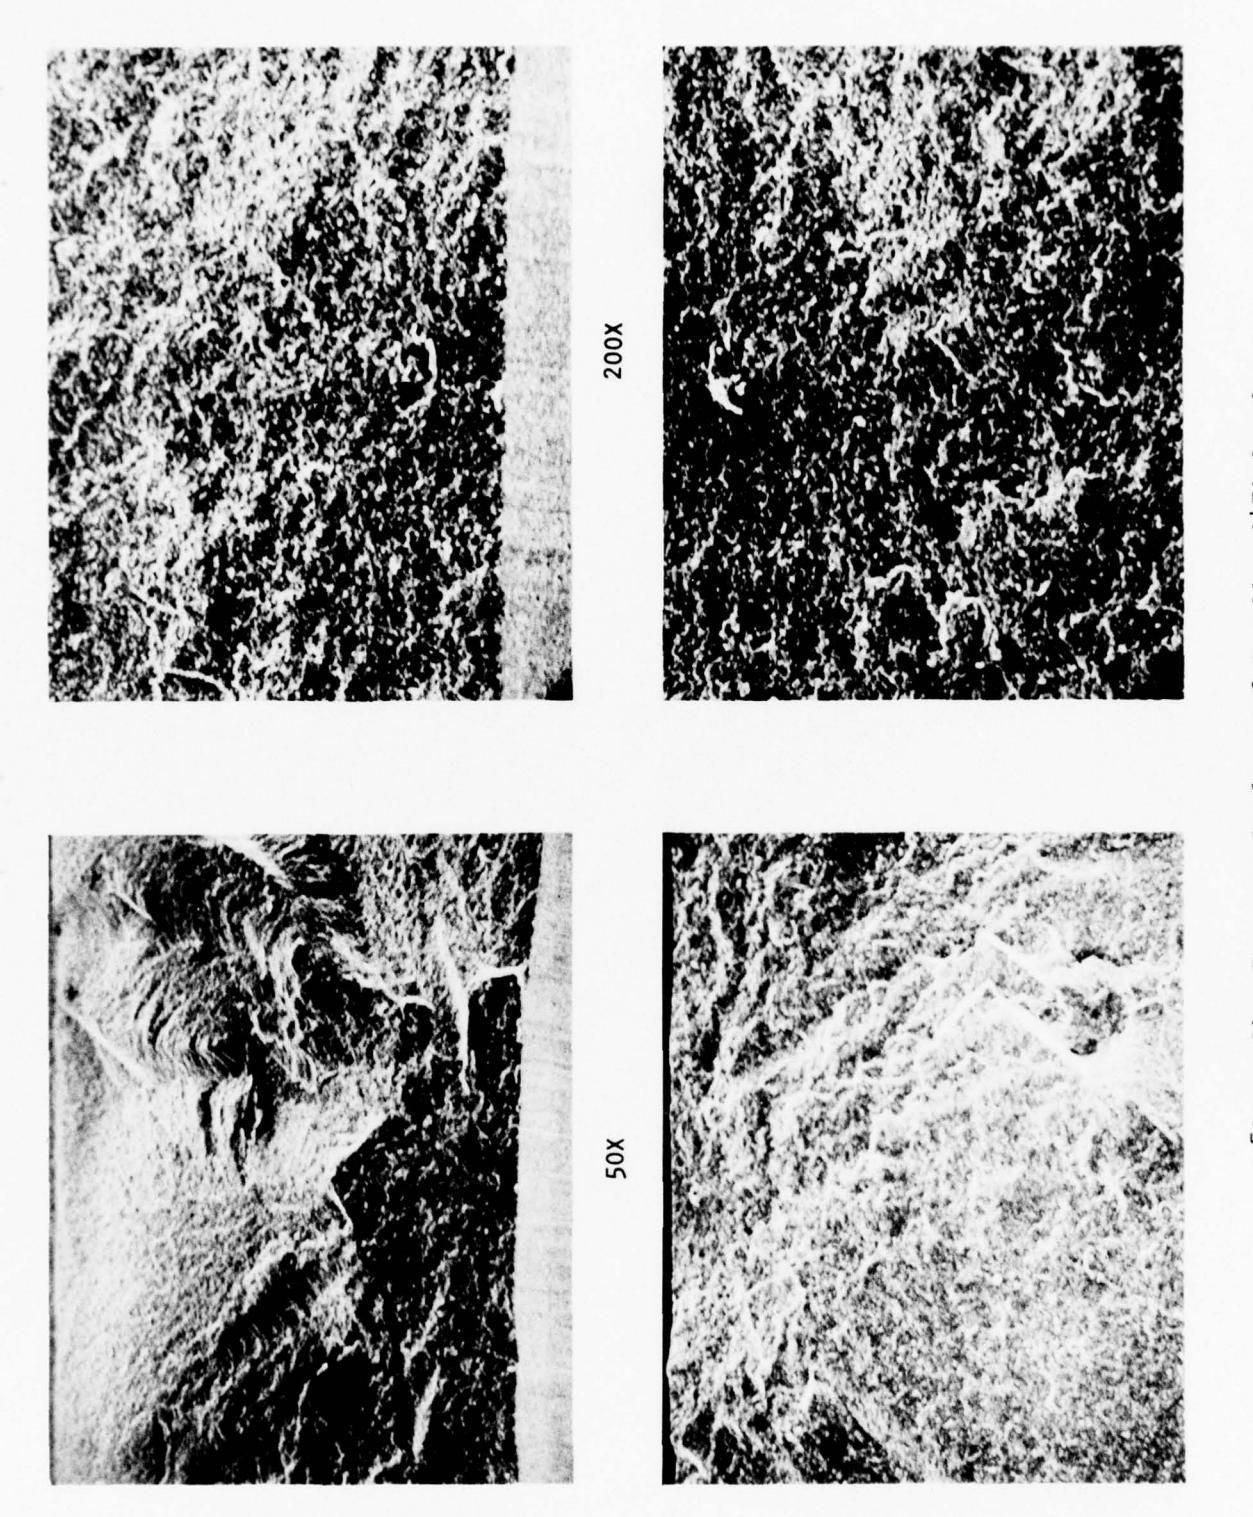
Figure 31. Fracture Surfaces of Ceralloy 147A Specimen 7 Showing Fracture Initiation Site.

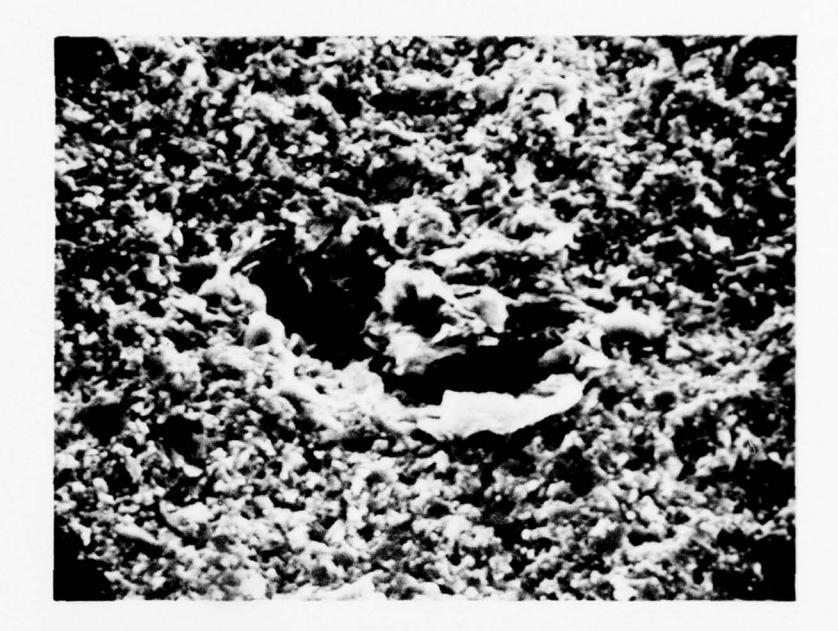
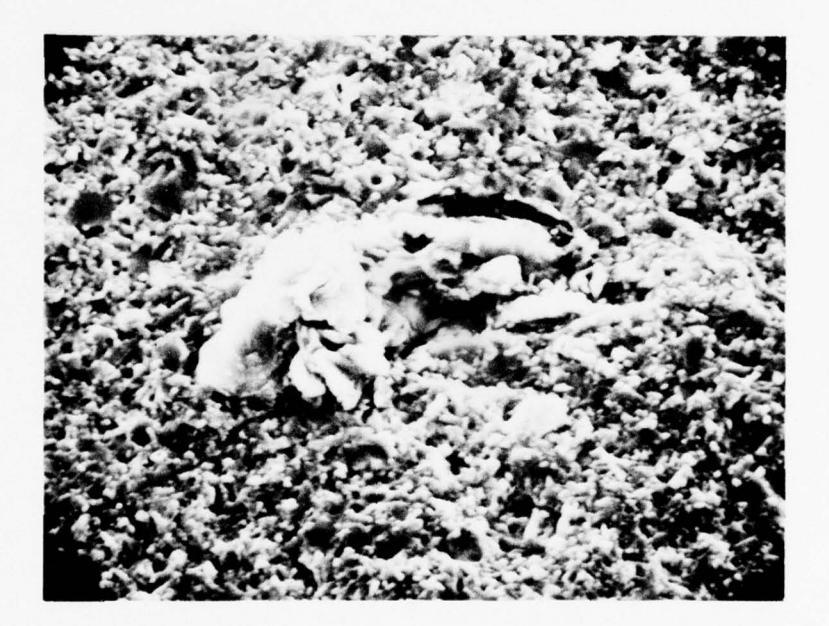
Figure 32. Fracture Initiation Site in Specimen 7 at High Magnification.

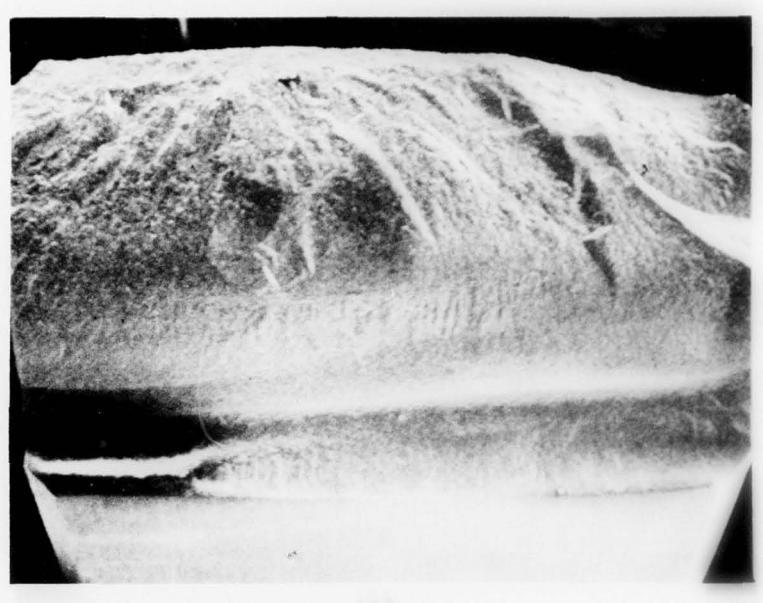
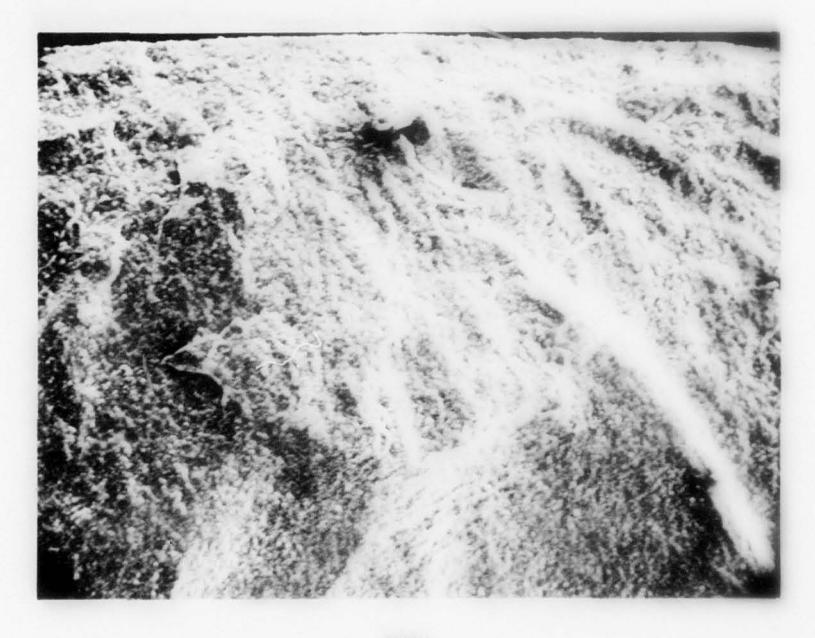
Figure 34. Fracture Surface of Ceralloy 147A Specimen 13.

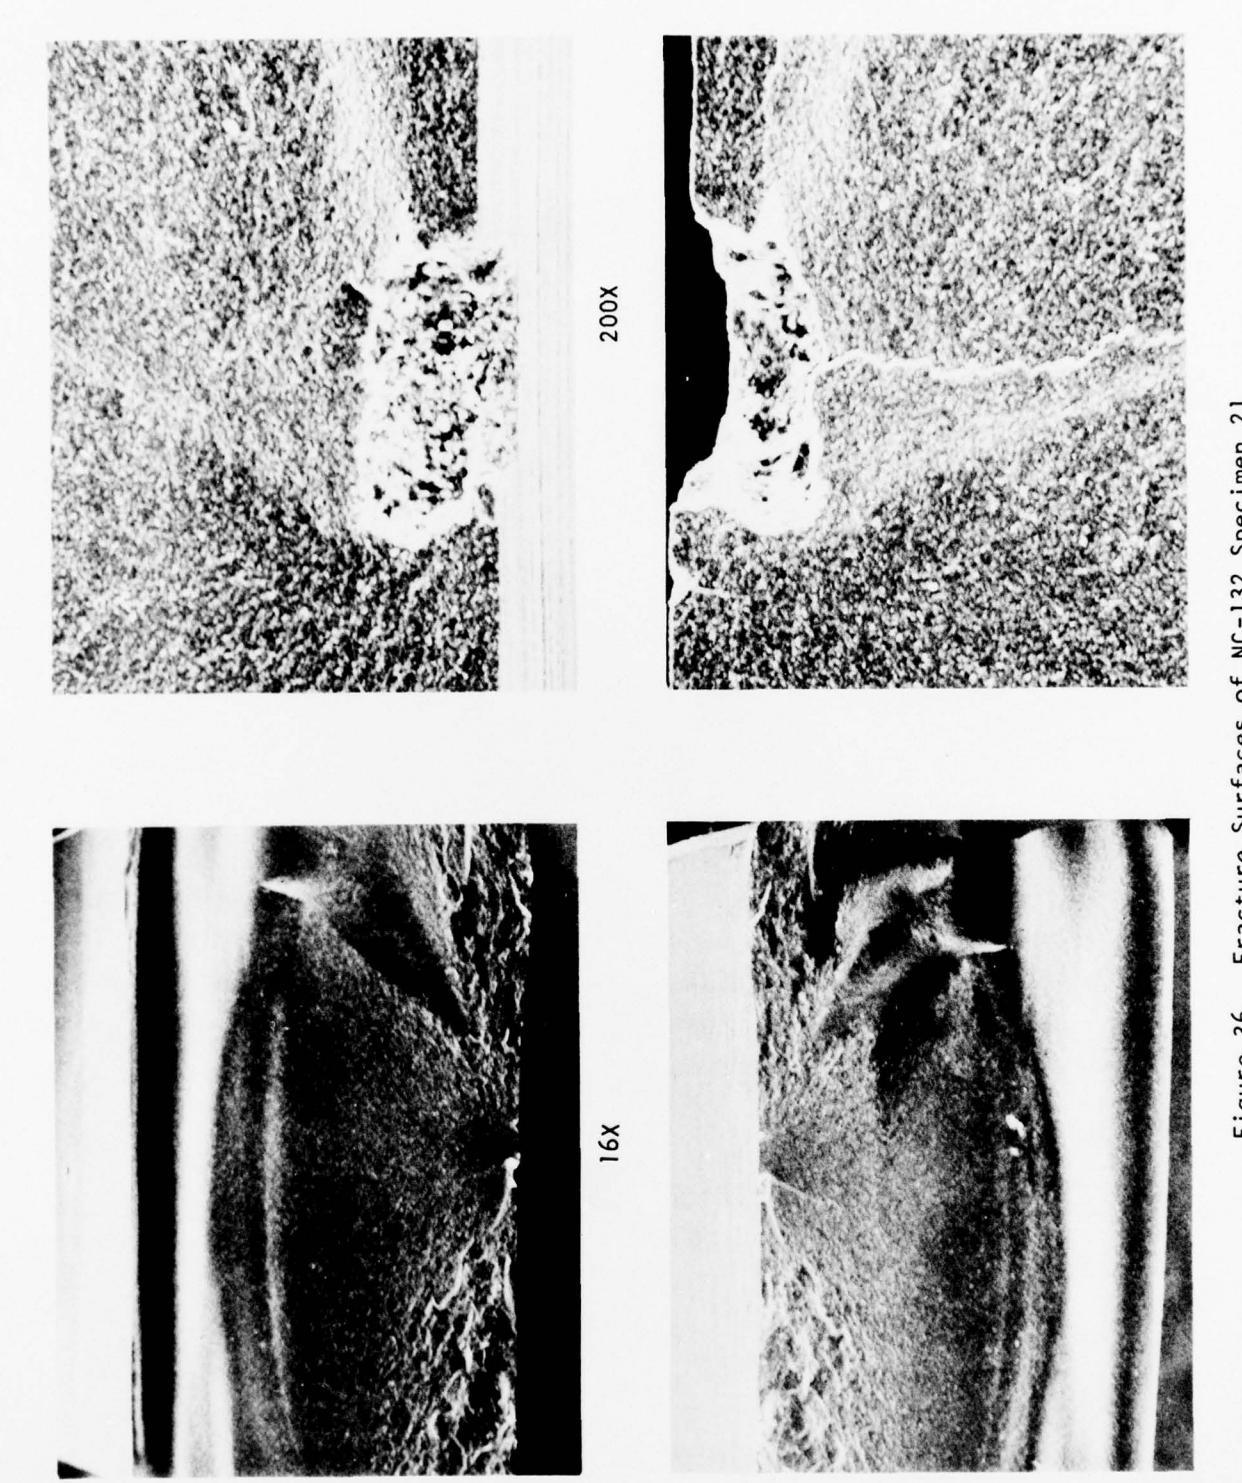
Only specimen 21 of the four specimens of NC-132 tested broke through an ultrasonically detected defect. This defect was a surface pit of hemispherical shape that penetrated about  $100\mu$ m. Since all of the defects in these specimens were in the same plane, the ultrasonic pulse heights should give a good indication of the relative defect sizes. The data in Table IV shows that specimen 21 had by far the largest signal. Therefore, the defects in the other specimens must have been much smaller, or at least shallower. than  $100\mu$ m. The defect in specimen 24 which caused failure was a  $30\mu$ m deep, sharp defect which apparently had a higher stress concentration factor than the surface pit detected ultrasonically. This data indicates that it is important to develop the capability to detect sharp, small surface defects, such as the one in specimen 24, which apparently are too shallow to be detected by the shear wave technique. The results for these specimens are summarized in Table V.

Figure 36. Fracture Surfaces of NC-132 Specimen 21 Showing Fracture Initiation Site.
