FOURTH QUARTERLY REPORT ON  
MANUFACTURING METHODS AND ENGINEERING  
FOR TFT ADDRESSED DISPLAY

February 7, 1977 to May 7, 1977

Prepared by D. H. Davies, W. L. Rogers,  
F. C. Luo, S. D. Burkholder, M. Green

CONTRACT DAAB07-76-C-0027

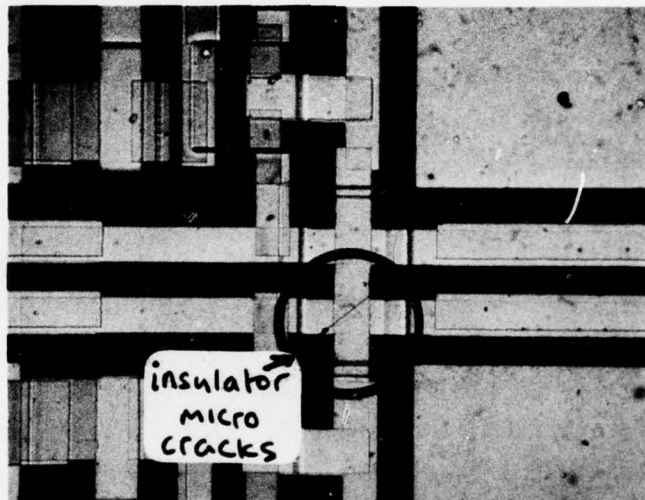
Fig (1) Insulator microcracks

2.2.1 Insulator cracks are a minor but not insignificant problem.

Fig (1) is typical. They cause shorts if they occur between metal deposits in crossover regions. Their cause is as yet not fully pinned down but appears to be related to substrate moisture absorption. The rapid desorption of water when the hot  $\text{Al}_2\text{O}_3$  nucleates and forms causes a stress condition that strains the film. Either immediately, or possibly during anneal, the cracking occurs. The major question: why is this virtually never observed in the X-Y displays? Several differences are present in the processes viz;

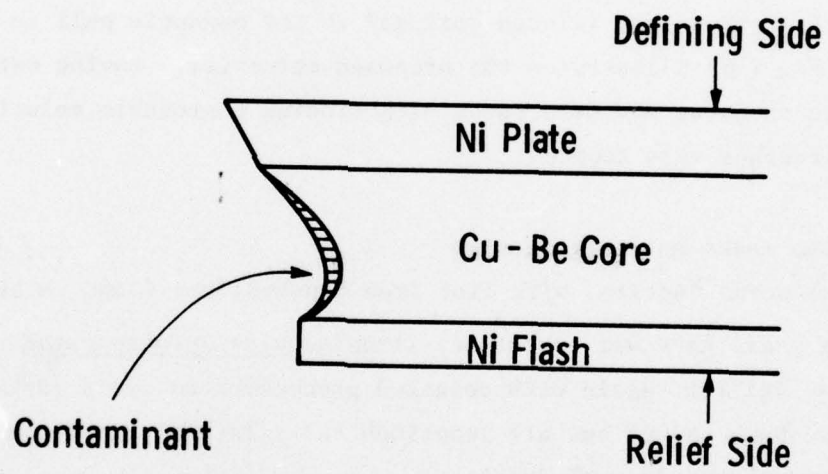
Fig. 4 - Cross section of aperture mask showing lamination groove

and therefore quite delicate. Hence they are not given a physical scrub action. This could be a cause; to establish it we examined a so-called clean  $\text{Al}_2\text{O}_3$  mask in detail at ultra high magnification. It became obvious that the grooves in the multiple film laminates are contaminated, see Fig ( 4).

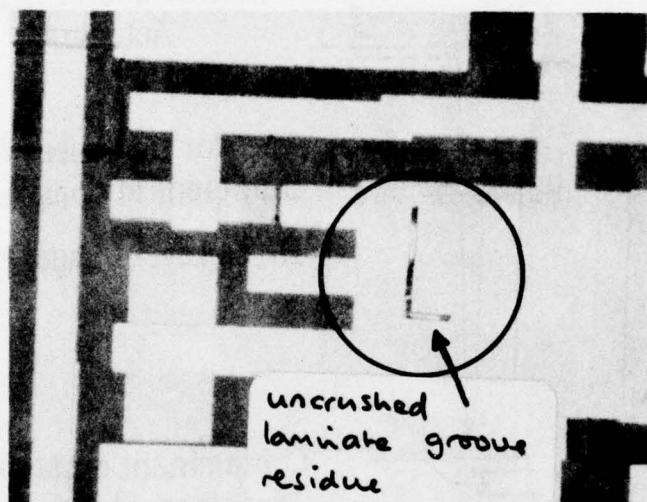
Fig (5) Dislodged contaminant material

Placing glass in contact with the mask transfers this contaminant. Indeed in some cases the entire shaped groove is dislodged, and can be seen on the glass, unbroken as shown in Fig ( 5). In most cases however the material is quickly mashed to a microparticulate form that is typical of the observed contaminant. Tests indicate that the dislodging of the material occurs when the pneumatic actuator pushes down vigorously (against the release springs) in the magnetic pull up jig action. Fig ( 6) illustrates the proposed mechanism. Having established a probable cause we now were faced with finding a probable solution. Three approaches were adopted:

- Clean the masks more rigorously.

A physical scrub action, with lint free brushes, was found to be possible providing great care was exercised; likewise heavily attenuated ultrasonics was utilized again with detailed procedures to avoid mask damage. These have been useful but are laborious and relatively dangerous procedures as regards mask damage.

The mask supplier fabricated a mask set for us made completely from kovar. This avoids any lamination and should make the mask easier to clean. In addition the kovar mask would be more magnetic, and have better thermal properties. Although the masks were of sufficient tolerance precision, it was found that they were too stiff to operate in the magnetic pull up jig. They did not "conform" sufficiently. An order has been now placed for less stiff masks.

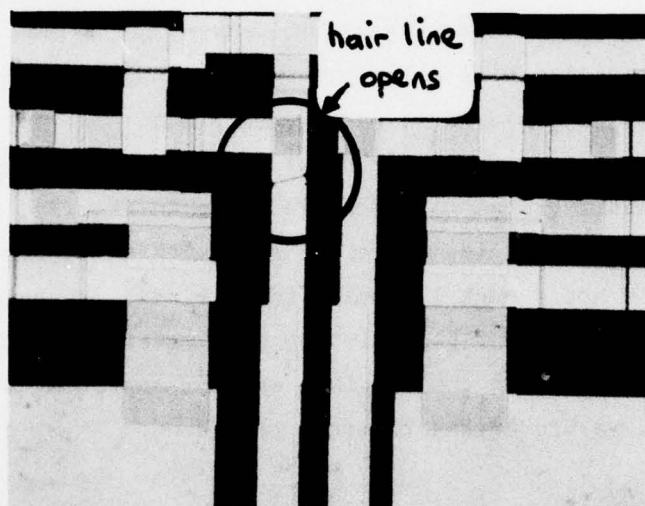
Fig (8) Hair line opens in busbars

One category of opens is "hair lines", Fig ( 8 ) illustrates this phenomena which occurs rarely but sufficiently often to cause problems. Fine opens ( $\sim 0.2 \mu\text{m}$  in width) cut across circuit segments almost always in metal films although it is likely that they are most visible in metals and much less so in the transparent insulators. These lines characteristically cut busbars and are not found in adjacent pads but then can be seen in other adjacent segments.

This is characteristic of mask contamination once again. The segments broken correspond to the pattern segments on the same mask.

Lint is a possible contender but we are familiar with lint and related fibers and they are not so thin or smooth in appearance. Fine glass hair line defects are likely although the selective nature of the problem is hard to explain on that basis. An alternate glass substrate with much improved surface texture has been recommended by

The most likely possibility, given the shape and appearance of this fine line, is a fine trace of DUCO<sup>(R)</sup> cement that has contaminated a mask. This is consistent with the evidence. DUCO is not used in the X-Y system and this problem is not found in the X-Y system. DUCO is almost impossible to see on the mask when it is this fine. DUCO burns out clean during anneal to give a clear line as is found. The DUCO is used as a back up adhesive to ensure the substrate does not fall off. Another technique, with double stick kapton tape is now being evaluated. This also will allow the insitu glass prebake that we are trying in order to avoid glass water adsorption.

Corning; this is low alkali as is the present glass. We have ordered this glass, however it is a long shot.

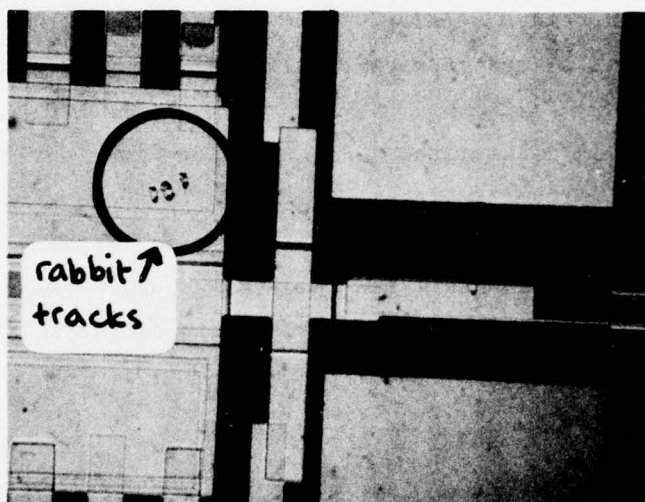
Fig (9) Rabbit tracks

A minor additional source of occasional opens (and sometimes shorts) is "rabbit tracks". These are shown in Fig (9), although this is an extreme example. The effect is a scratching of the films in small localized areas much like tiny foot prints. We believe that these are caused by abrasion of the films by mask metal asperities. The mask asperities are either in the original mask or appear as a result of mask clearing, we are trying to track this down.

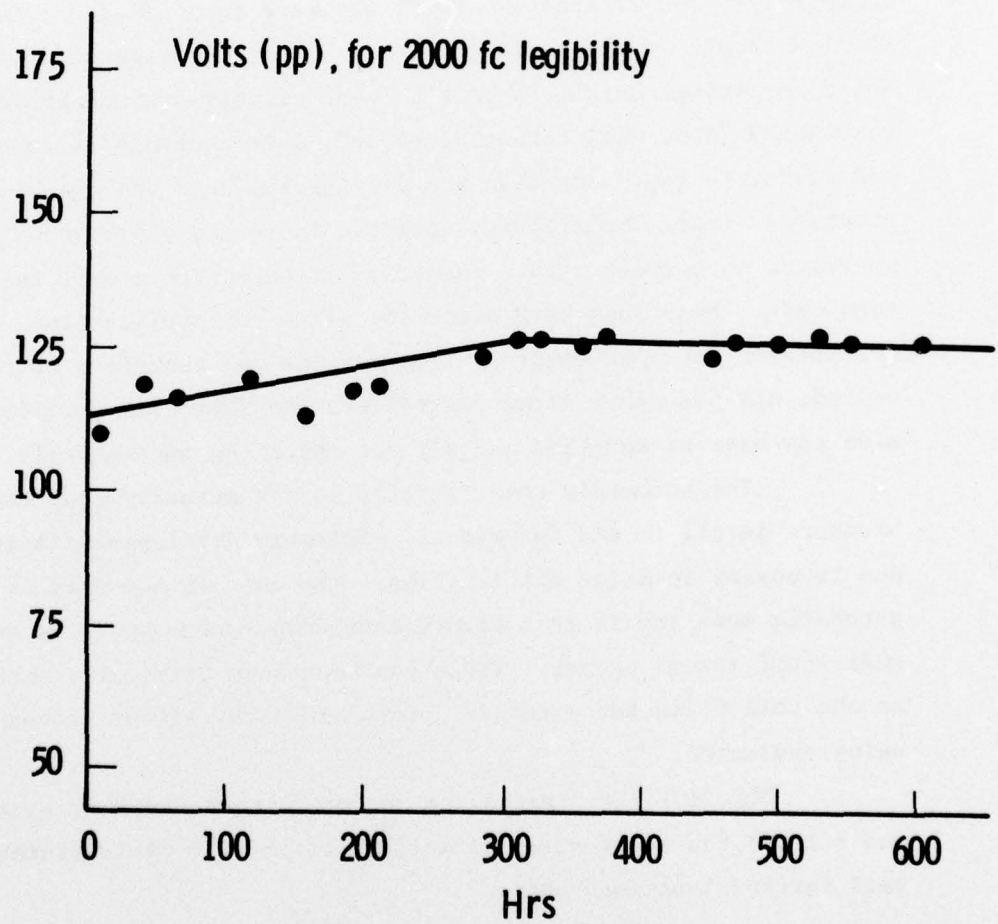
Fig. 12 - Constant brightness life test, 600 hrs  
at 2000 fc legibility level

A 600 hrs life test has been set up and run under conditions identical to that required by SCS 501, except that for this initial run the display was maintained at room temperature. The entire panel is exercised (every element), the gates are scanned and the sources held at constant voltage. The EL voltage was set at a value to give 2000 fc legibility. The panel was set at 50 mins ON 10 mins OFF. Bias settings, defect counts, brightness and power dissipation were measured before and after the test. The results are shown in the attached Fig (12). Initial dissipated power - all elements on, 853 MW. Final dissipated power - all elements on 980 MW, within specifications.

No ON elements turned off and only ~2 off elements turned on. A few (~7) new shorts appeared.
