ANALYSIS OF PROPELLANT STORAGE TANKS AFTER FOUR YEARS HYDRAZINE STORAGE

FINAL REPORT - MAY 1976 - APRIL 1977

BELL AEROSPACE TEXTRON DIVISION OF TEXTRON, INC. P. O. BOX ONE BUFFALO, NEW YORK 14240

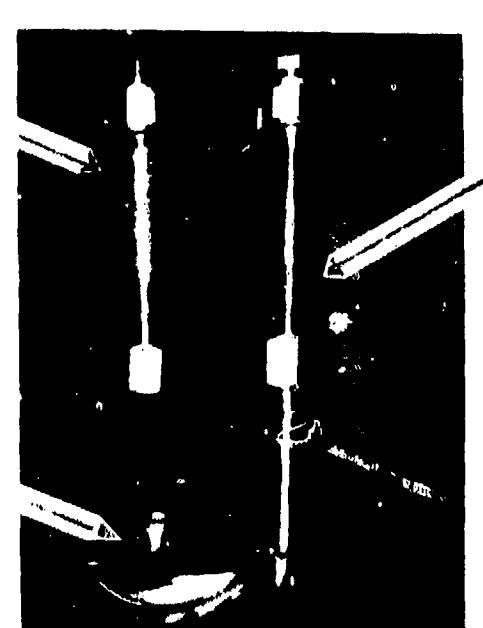
a) View of outlet tube components received from tank S/N 5 compared with unsectioned components of tank S/N 1 illustrating segment missing from original shipment Typical components of Tank S/N 1 showing lengths and arrangement.

b) Tube extension from corroded outlet fitting showing slight surface etching but no significant corrosive attack. Etched regions are indicated by black arrows, unetched areas by white arrows.

- c) Overall view of outlet fitting showing etched area and pit at bottom.

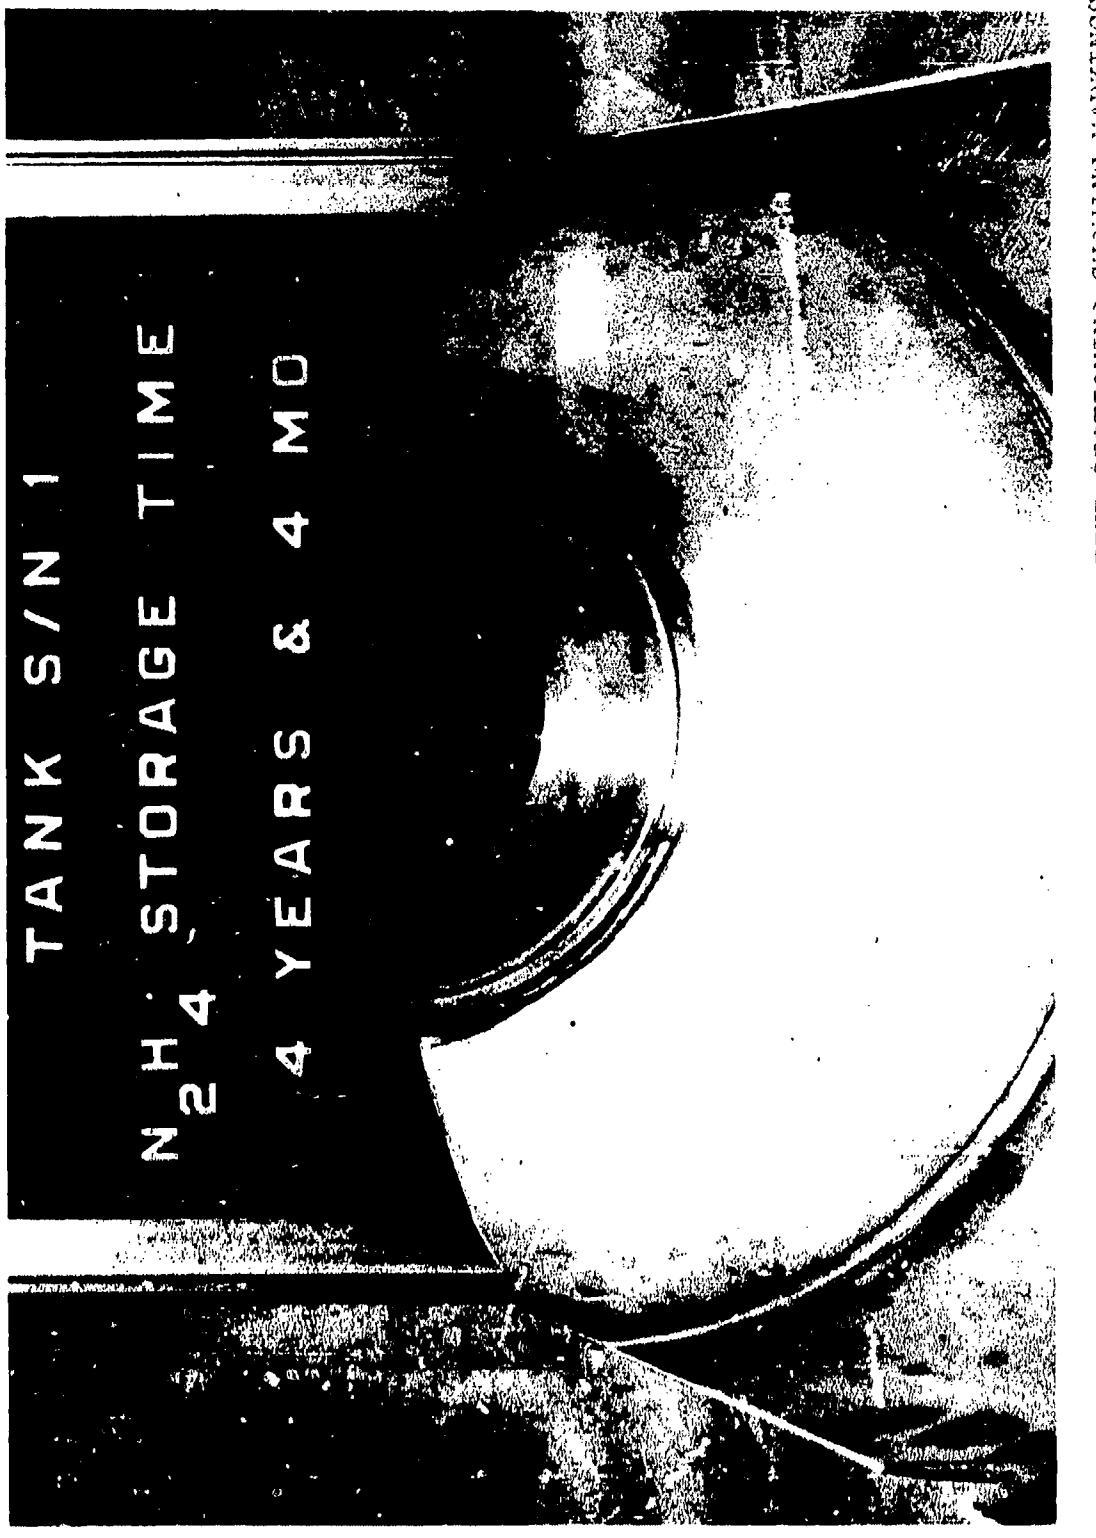
TANK S/N 1 IN THE AS-RECEIVED CONDITION AFTER SECTIONING SHOWING MARKINGS SIMILAR TO WATERLINES. THEIR PRESENCE IN THE FLANGE AREA MAY BE A RESULT OF POSITIONING AFTER REMOVAL FROM THE STORAGE RACKS. FIGURE 12.

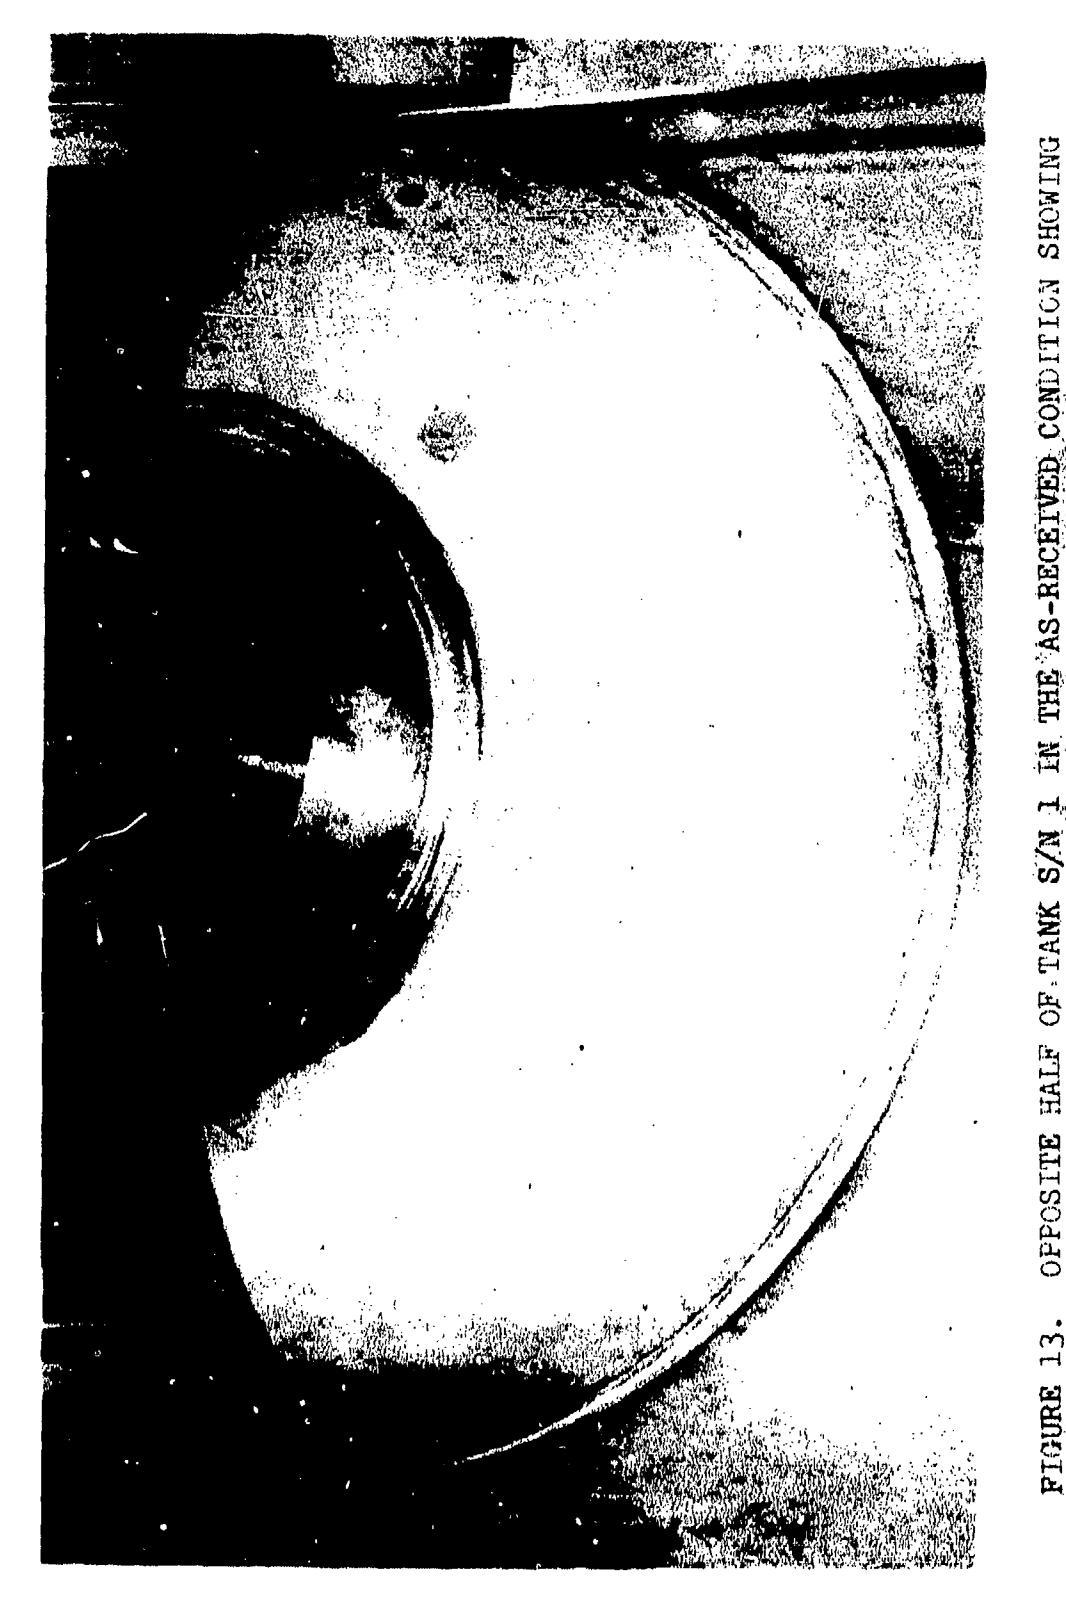
OFPOSITE HALF OF TANK S/N 1 IN THE AS-RECEIVED CONDITION SHOWING THE SAME TYPE OF MARKINGS AS SHOWN IN FIGURE 12. THESE PHOTO-MACROGRAPHS SUBSTANTIATE THE OVERALL INTERIOR CONDITION OF THIS TANK. NO EVIDENCE OF CORROSIVE ATTACK WAS OBSERVED IN EITHER HALF OF THIS TANK ON A MACROSCOPIC EASIS.

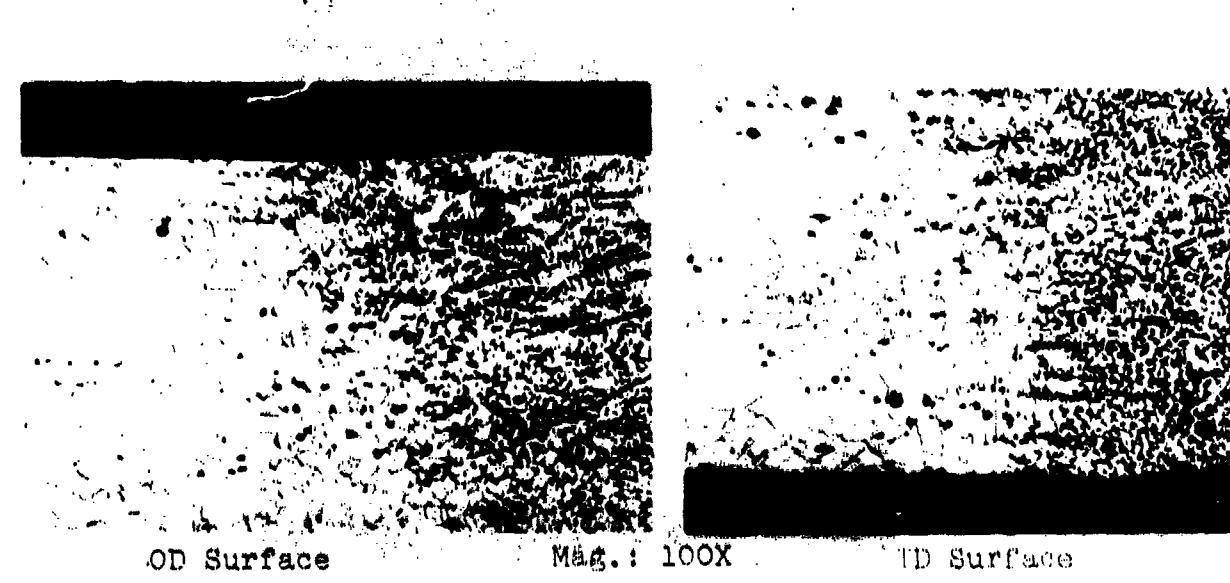
FIGURE 25. SURFACE CROSS SECTIONS SHOWING ABSENCE OF ANY SURFACE ATTACK IN TANK AND TUBE WELDS FROM S/N 1.

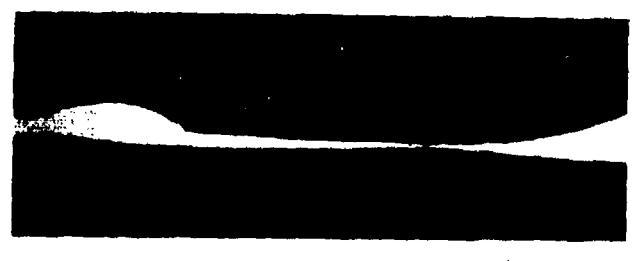
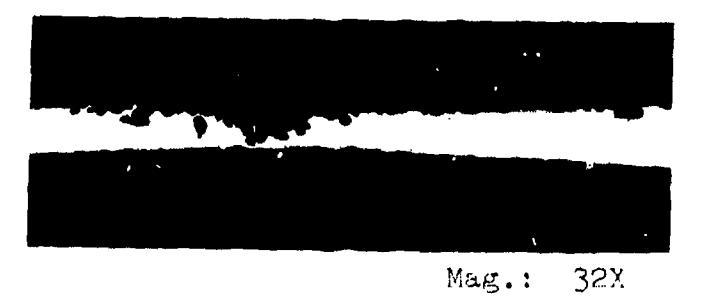
a) Interior surface at location of corroded exterior of outpet fitting. Note crack-like discontinuity.

b) Cross section of outlet fitting showing extreme thinning from machining plus corrosion

c) View of corroded region showing extensive corrosion on exterior surface

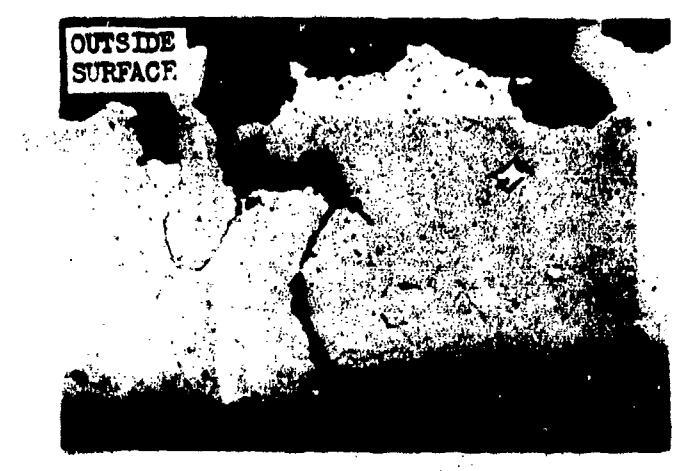
Mag: 500X d) Detail view at leakage or complete penetration site.

c) Detail view of area where attack is proceeding along ferrite to martensite phase boundary.

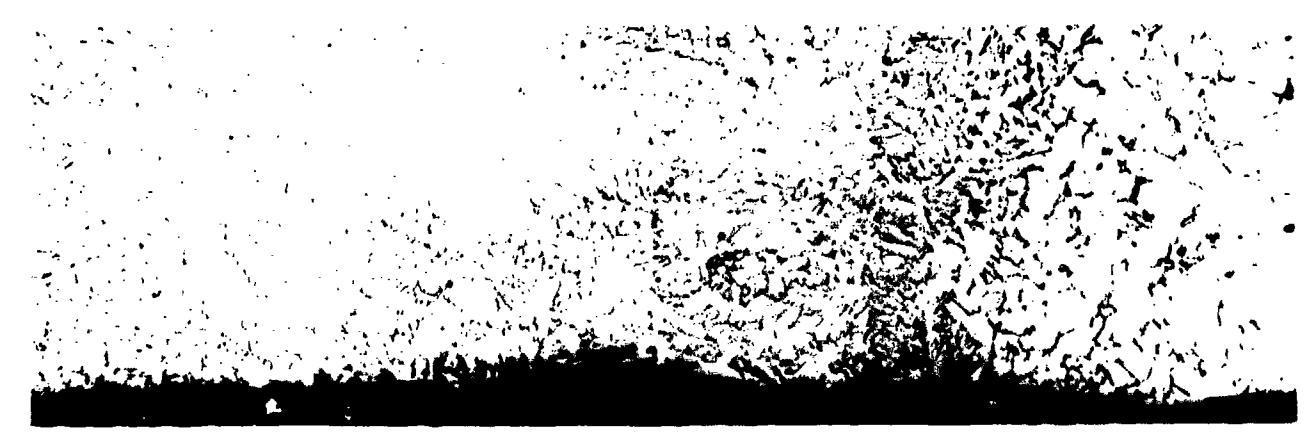
a) Overall view of continent tube showing deposite on wold and tube suggesting cullles had dried in norizontal position

b) Closeup view showing deposit crusted on surface of weld

d) Microstructure t weld underbead surface illustrating shallow corrosion observed

FIGURE 39. VIEWS OF DEPOSIT FOUND IN TUBE AT FLANGE END OF TANK S/N 5 AND CROSS SECTIONS OF UNDERLYING WELD. METALLURGICAL LABORATORY MET NO. 76-79016

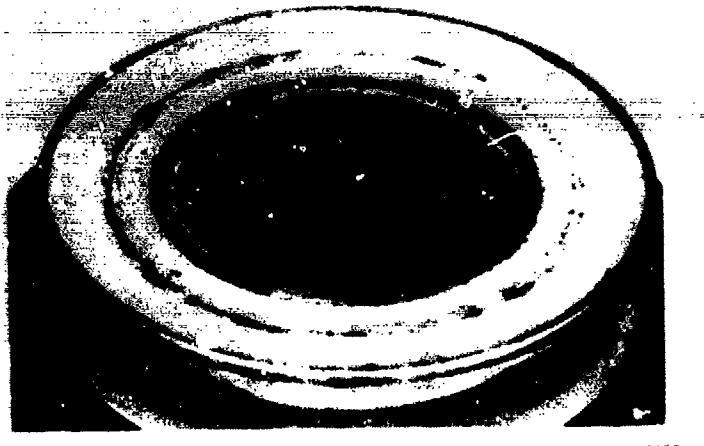
a) Overall view of RPL fitting sealing member showing deposits on inner surface in vapor phase.

b) Deposits on surface of sealing member after sectioning.

c) Close-up view of deposit color is reddish brown to dark brown with occasional lighter brown streaks.

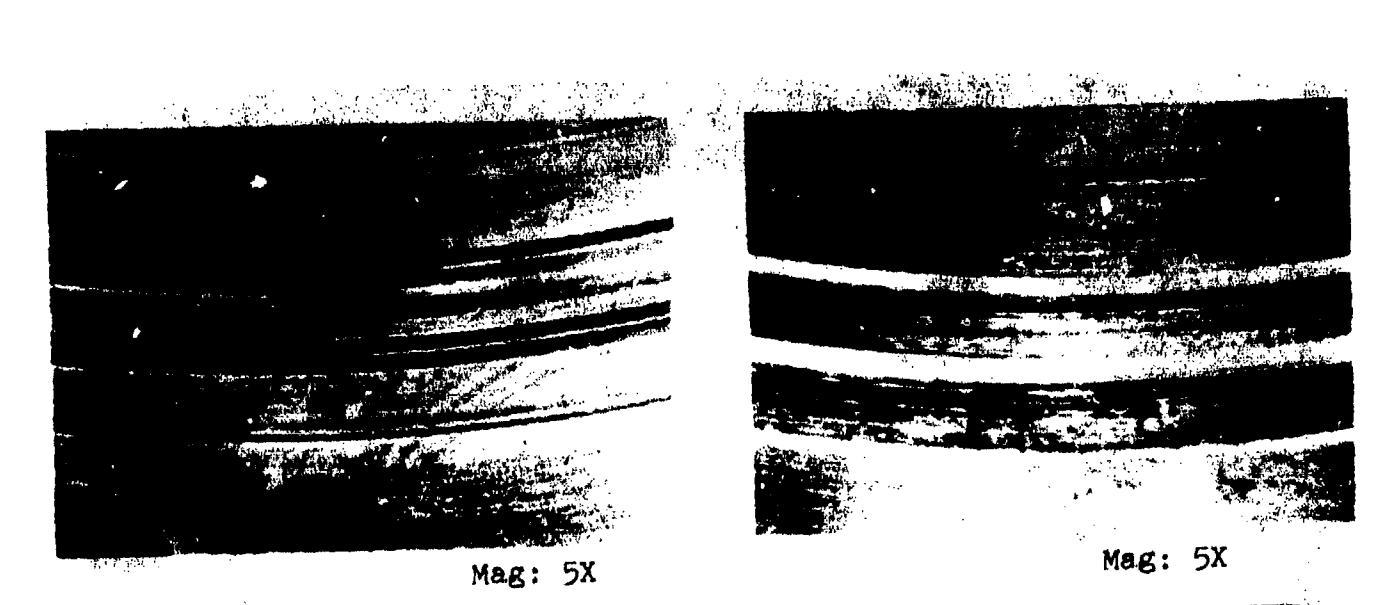
FIGURE 48. DETAIL VIEWS OF SEALING GROOVE AND RIDGES IN FLANGE COVER. SLIGHT ROUGHNESS OR RIPPLING SHOWN AT RIGHT WOULD NOT AFFECT SEALING.

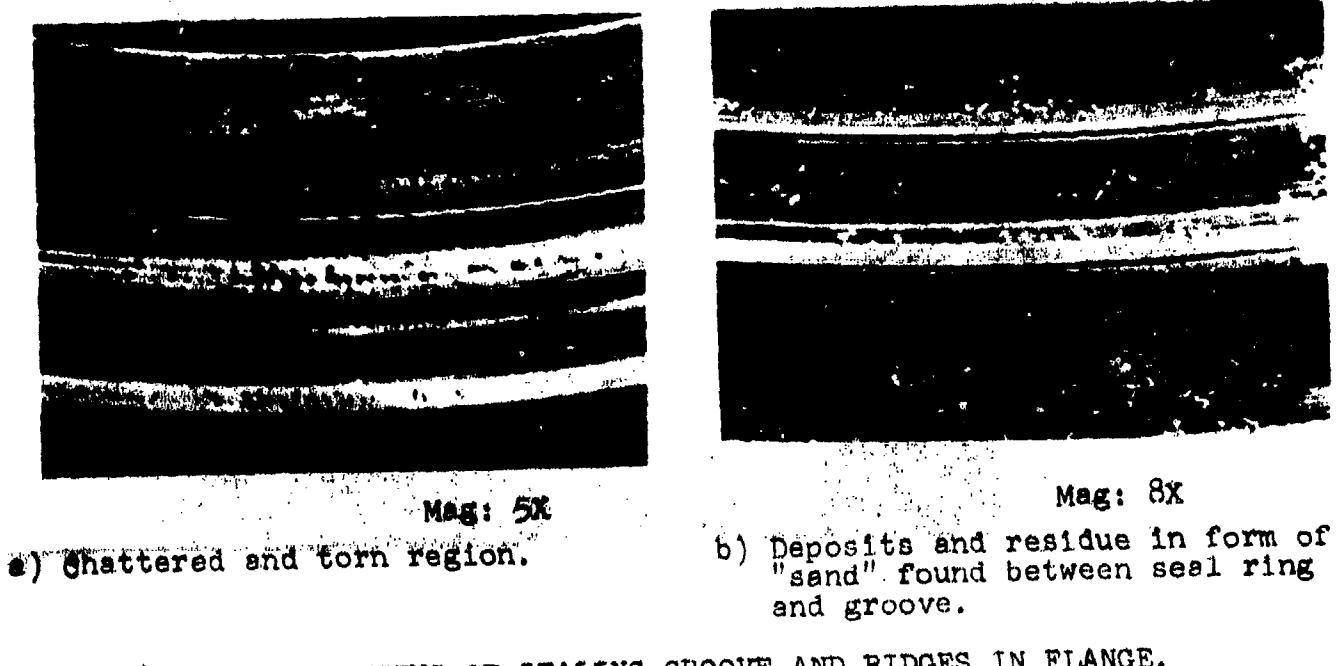
FIGURE 49. DETAIL VIEWS OF SEALING GROOVE AND RIDGES IN FLANGE. SMEARED AND TORN SUNFACE ON RIDGE IS MOST CRITICAL TO SEALING CAPABILITY.

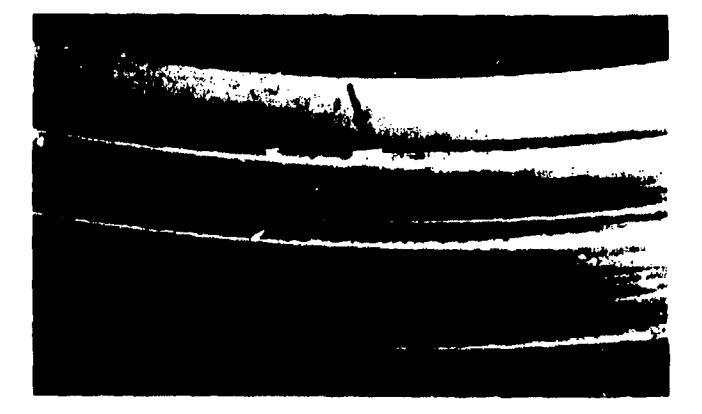
c) Scaling ring in region of chattered surface of flange. Note that aluminum formed around torn out ridge.

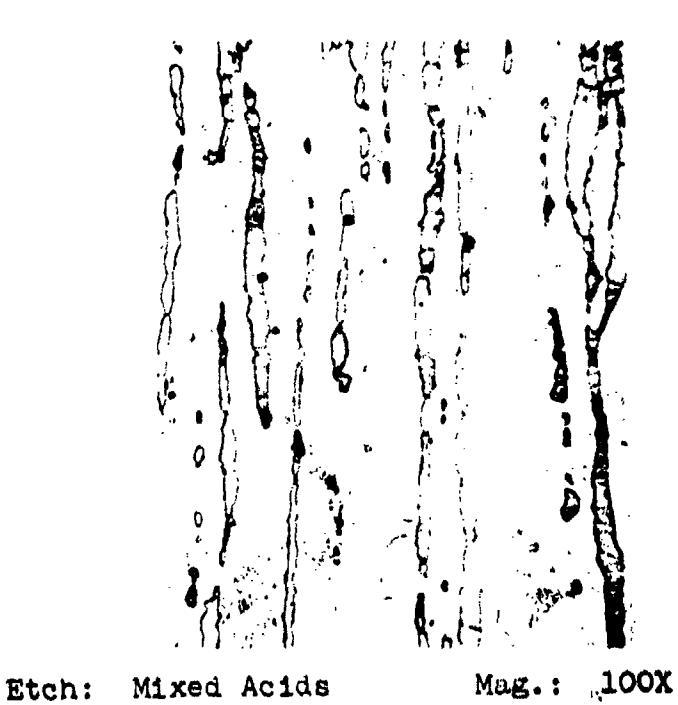
a) Cross section through sealing ring groove where some chattering occurred. Ridge at arrow was slightly torn. No material anomaly is visible to explain chattering and tearing.

b) Microstructure showing very elongated ferrite stringers in a matrix of transformed martensite.

FIGURE 51. MICROSTRUCTURE AND GRAIN ORIENTATION IN FLANGE UNDER SEAL RING GROOVE OF TANK S/N 3.
