Most Project - 2 **RÉPORT 257** PROBLEM NEL 4G1 0 WORK STATUS: 1 JUNE 1951 REPORT APPROVED: 6 JULY 1951 AD A 051401 1 9 Final rept. for period final report: Variable Ship Speed and Usable Life Tests of Nylon-Coated, Surface-Vessel, Bathythermograph Hoisting Cable L B. STARK ENGINEERING SERVICES DIVISION 18 181 1Jun 51 7180796 NAVY ELECTRONICS LABORATORY, SAN DIEGO, CALIFORNIA DISTRIBUTION STATEMENT A Approved for public released 253550 6 Distribution Unlimited

Buships problem NEL 4G1: Test nylon-coated, surface-vessel, bathythermograph hoisting cable considered for use in sonar work. This final report covers the conclusion of the variable ship speed tests and the usable life tests of the cable (recommended in NEL Report 177), and correlates the entire testing program.  $\chi 95018$

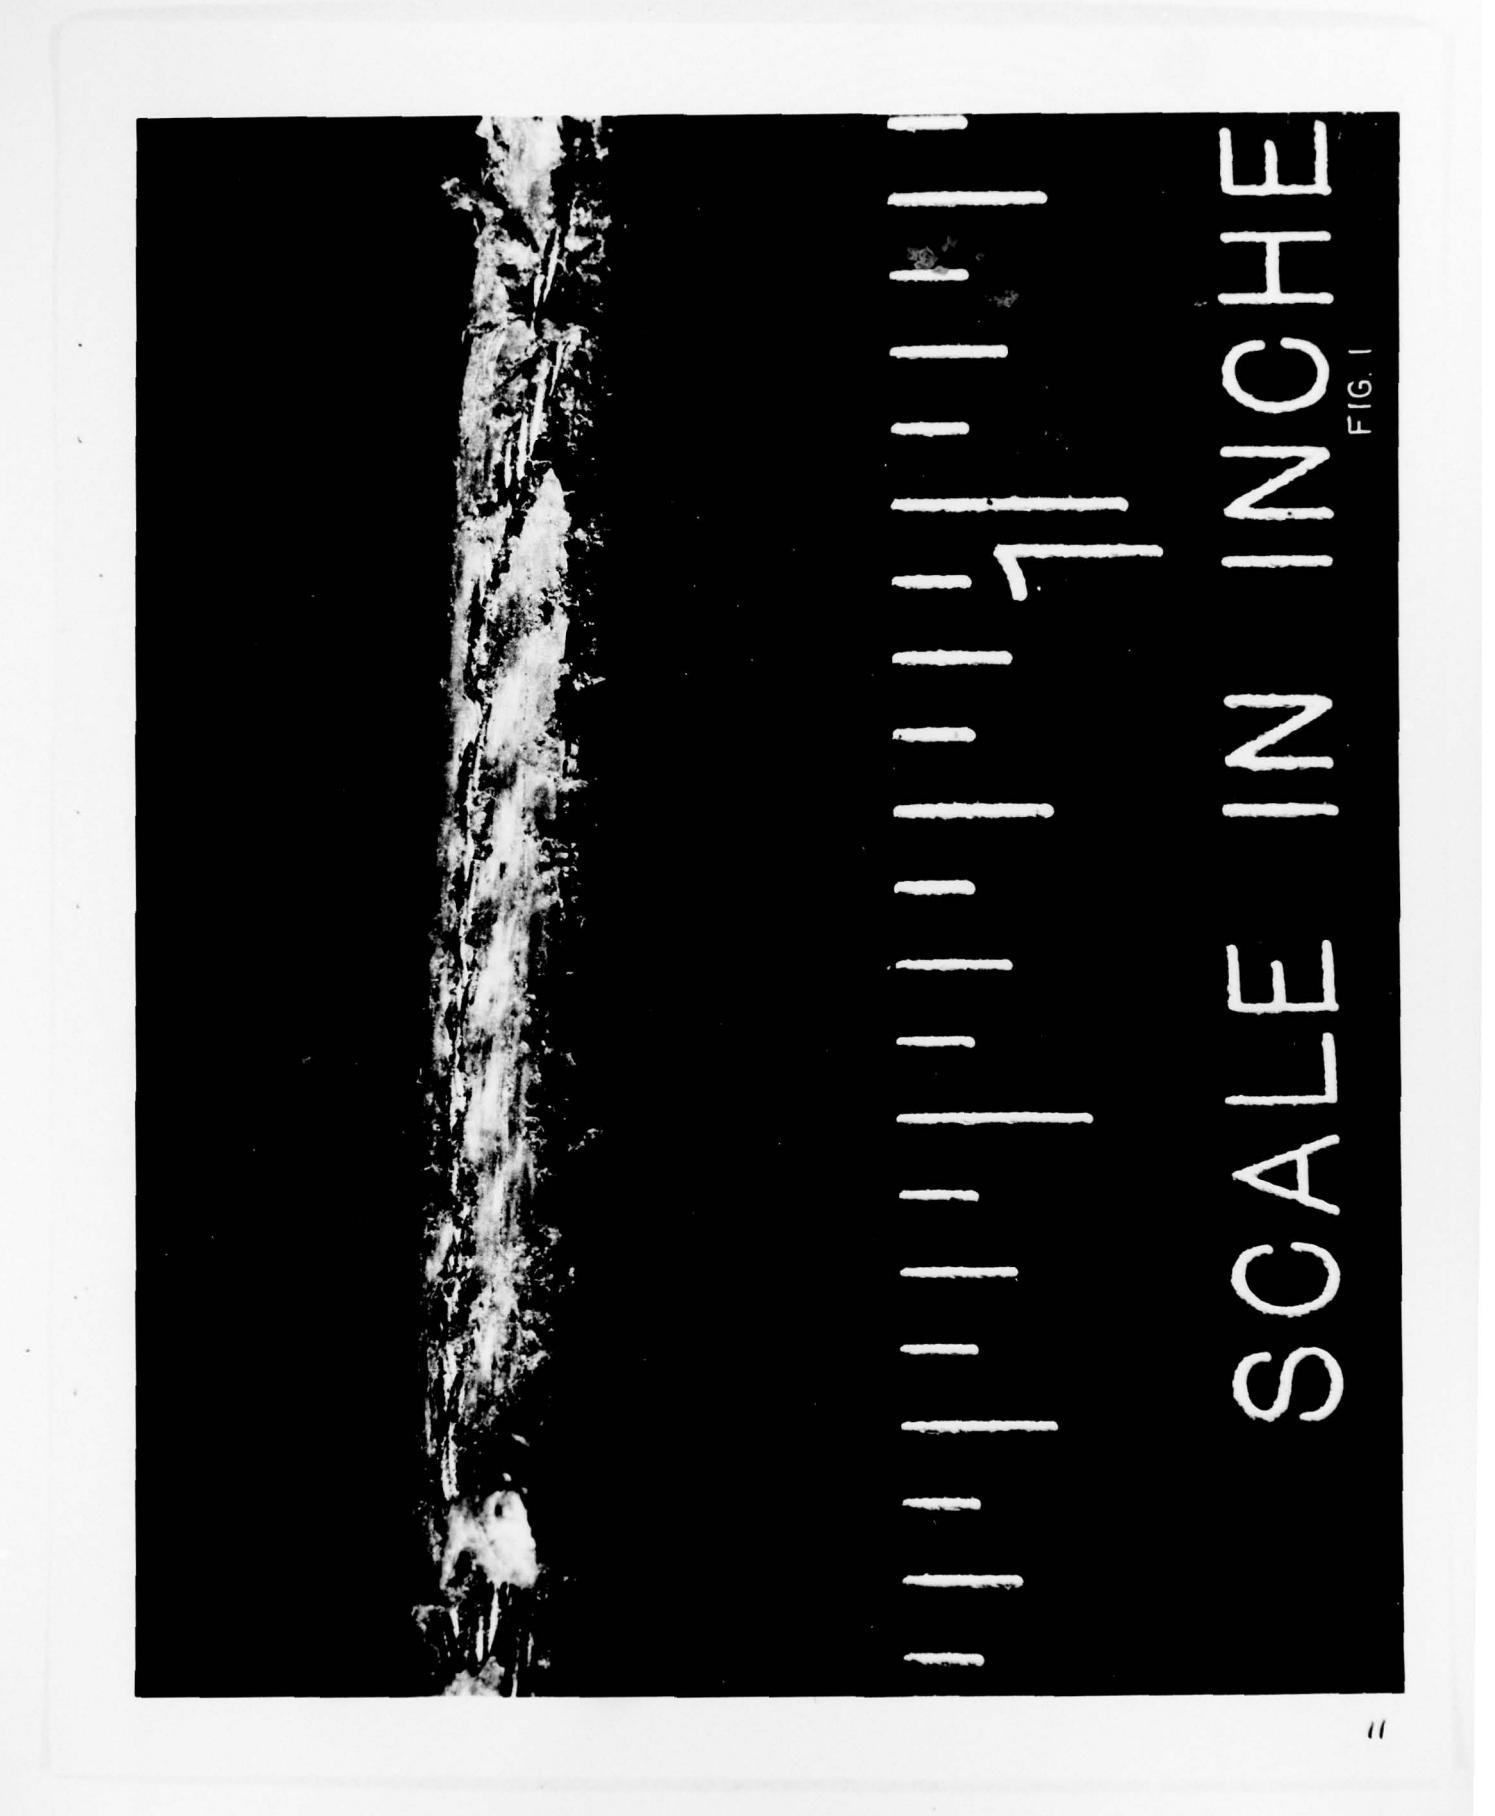
2 FIG. 2 SCALE 13

The detailed cable failures are illustrated in figures 1 through 22. Figure 1 is a typical example of a severe tear in the 1/64-in. thick coating of Cable 3. Extreme fraying and distortion is evident at the torn coating edges. The coating failure shown in figure 2 shows the effect of severe abrasion in a section of Cable 3 within 20 feet of the bathythermograph end of the cable. The abrasion caused a longitudinal tear in the 1/64-in. nylon coating as well as secondary spiral cuts and peeling along the edges of the tear.

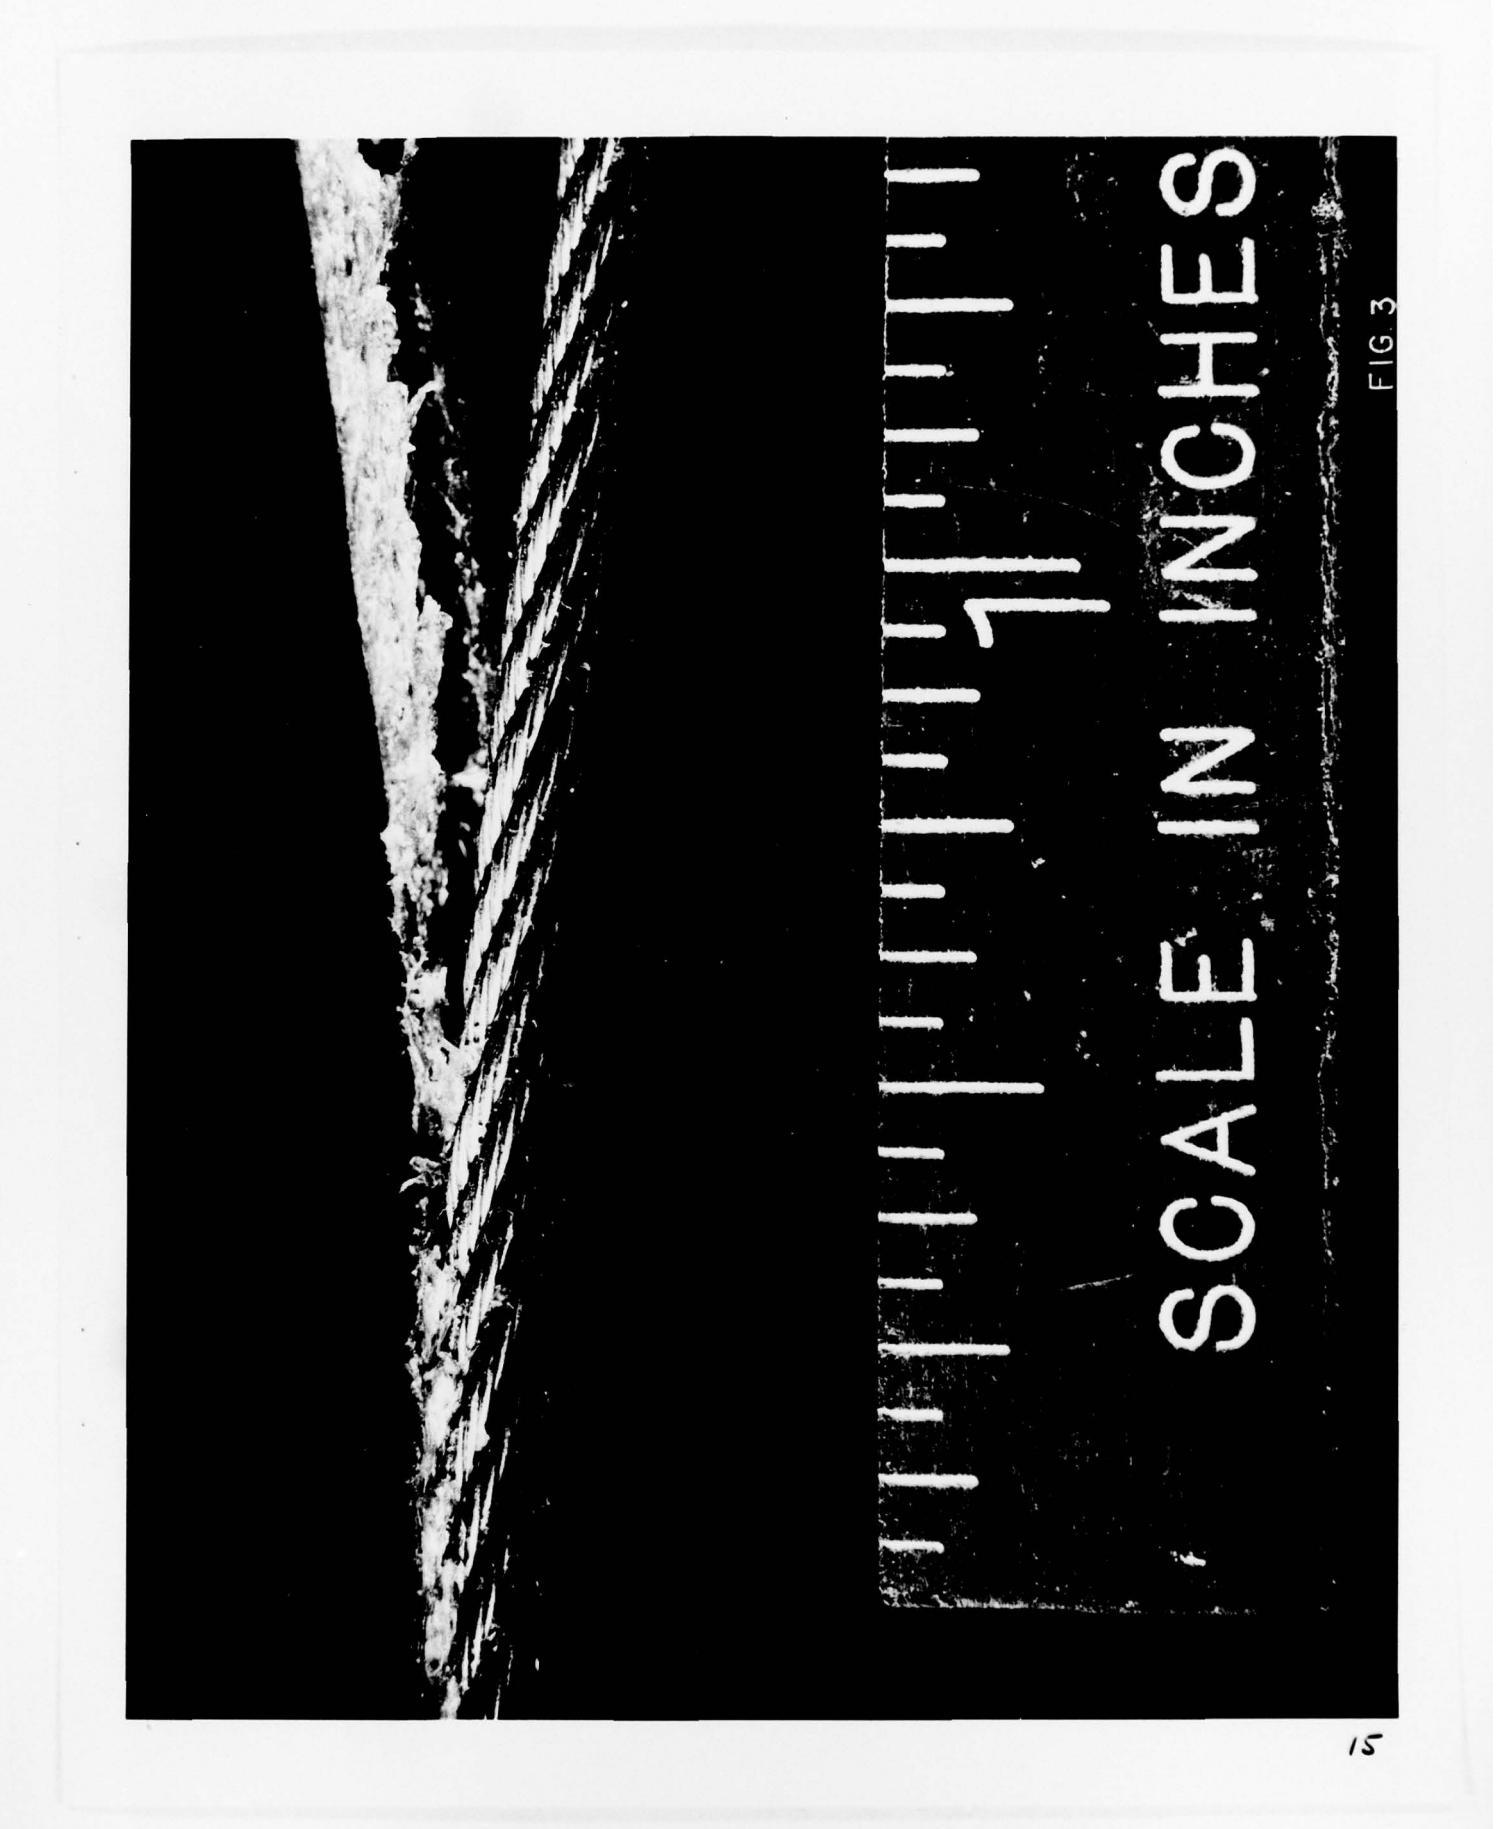
It is important to note the type of coating failure in figure 3, since this type of coating separation occurred in both cables. In this failure the nylon coating split and then pulled completely away from the wire core. This particular peeled area was in Gable 3, approximately 10 feet from the bathythermograph end. The 20-foot section closest to the end of the cable and containing this failure was severed from the cable after 764 lowerings. Figures 4 and 5 are illustrative of severe abrasion most likely due to edge rubbing on the sheave. These damage areas were both in the same 20-foot section of Cable 3 that contained the

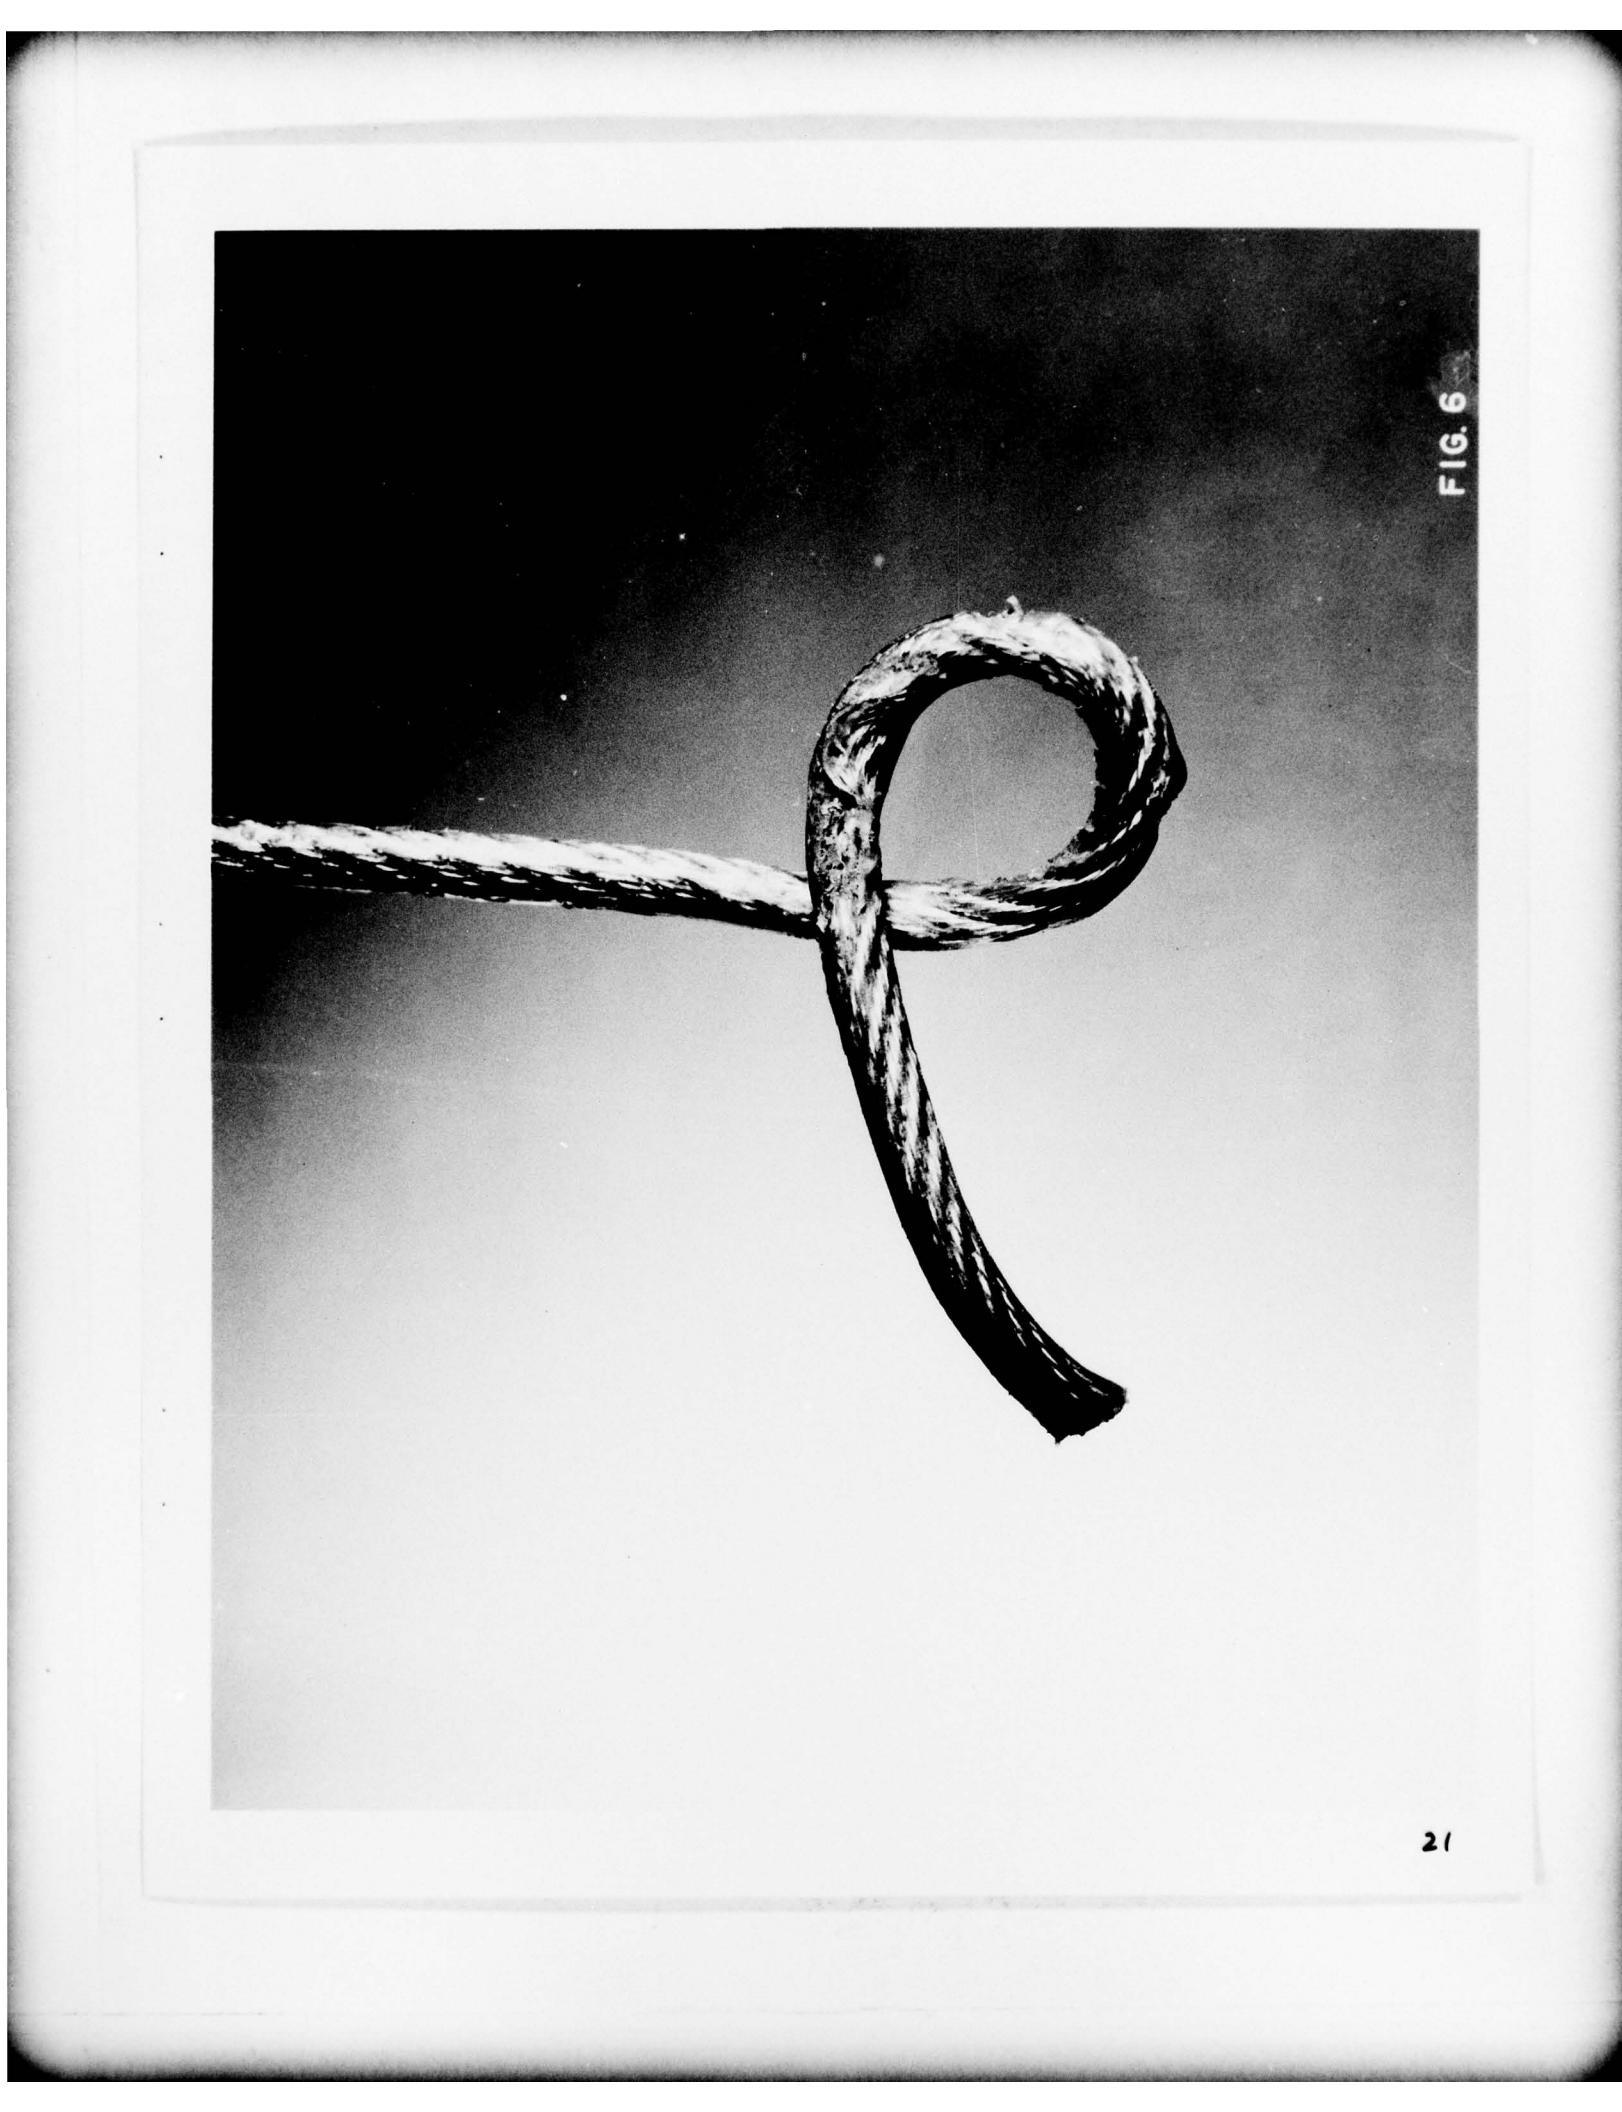
The cable section that appears in figure 6 shows the coating failure resulting at the point where the cable is attached to the bathythermograph shackle. Localized cuts and peeling of the 1/64-in. coating of Cable 3 are typical of the failures caused by this type of cable juncture. The severe longitudinal distortion leading to a transverse "pile-up" of the 1/64-in. nylon coating is shown in different stages of severity in figures 7 and 8. This type of failure occurred at numerous points where small kinks were found in Cable 3. It is quite noticeable that knifelike transverse cracks resulted in the coating, penetrating to the wire core and creating areas where localized corrosive attack would be accelerated.

(5) Danco Sealer No. 4 (manufactured by the Danielson Manufacturing Company, Danielson, Connecticut), or equivalent, should be used on all cable terminations. If such a sealer had been available during this testing program, it is most probable that the fraying of the coating near cable terminations and subsequent wire-core corrosion could have been prevented.

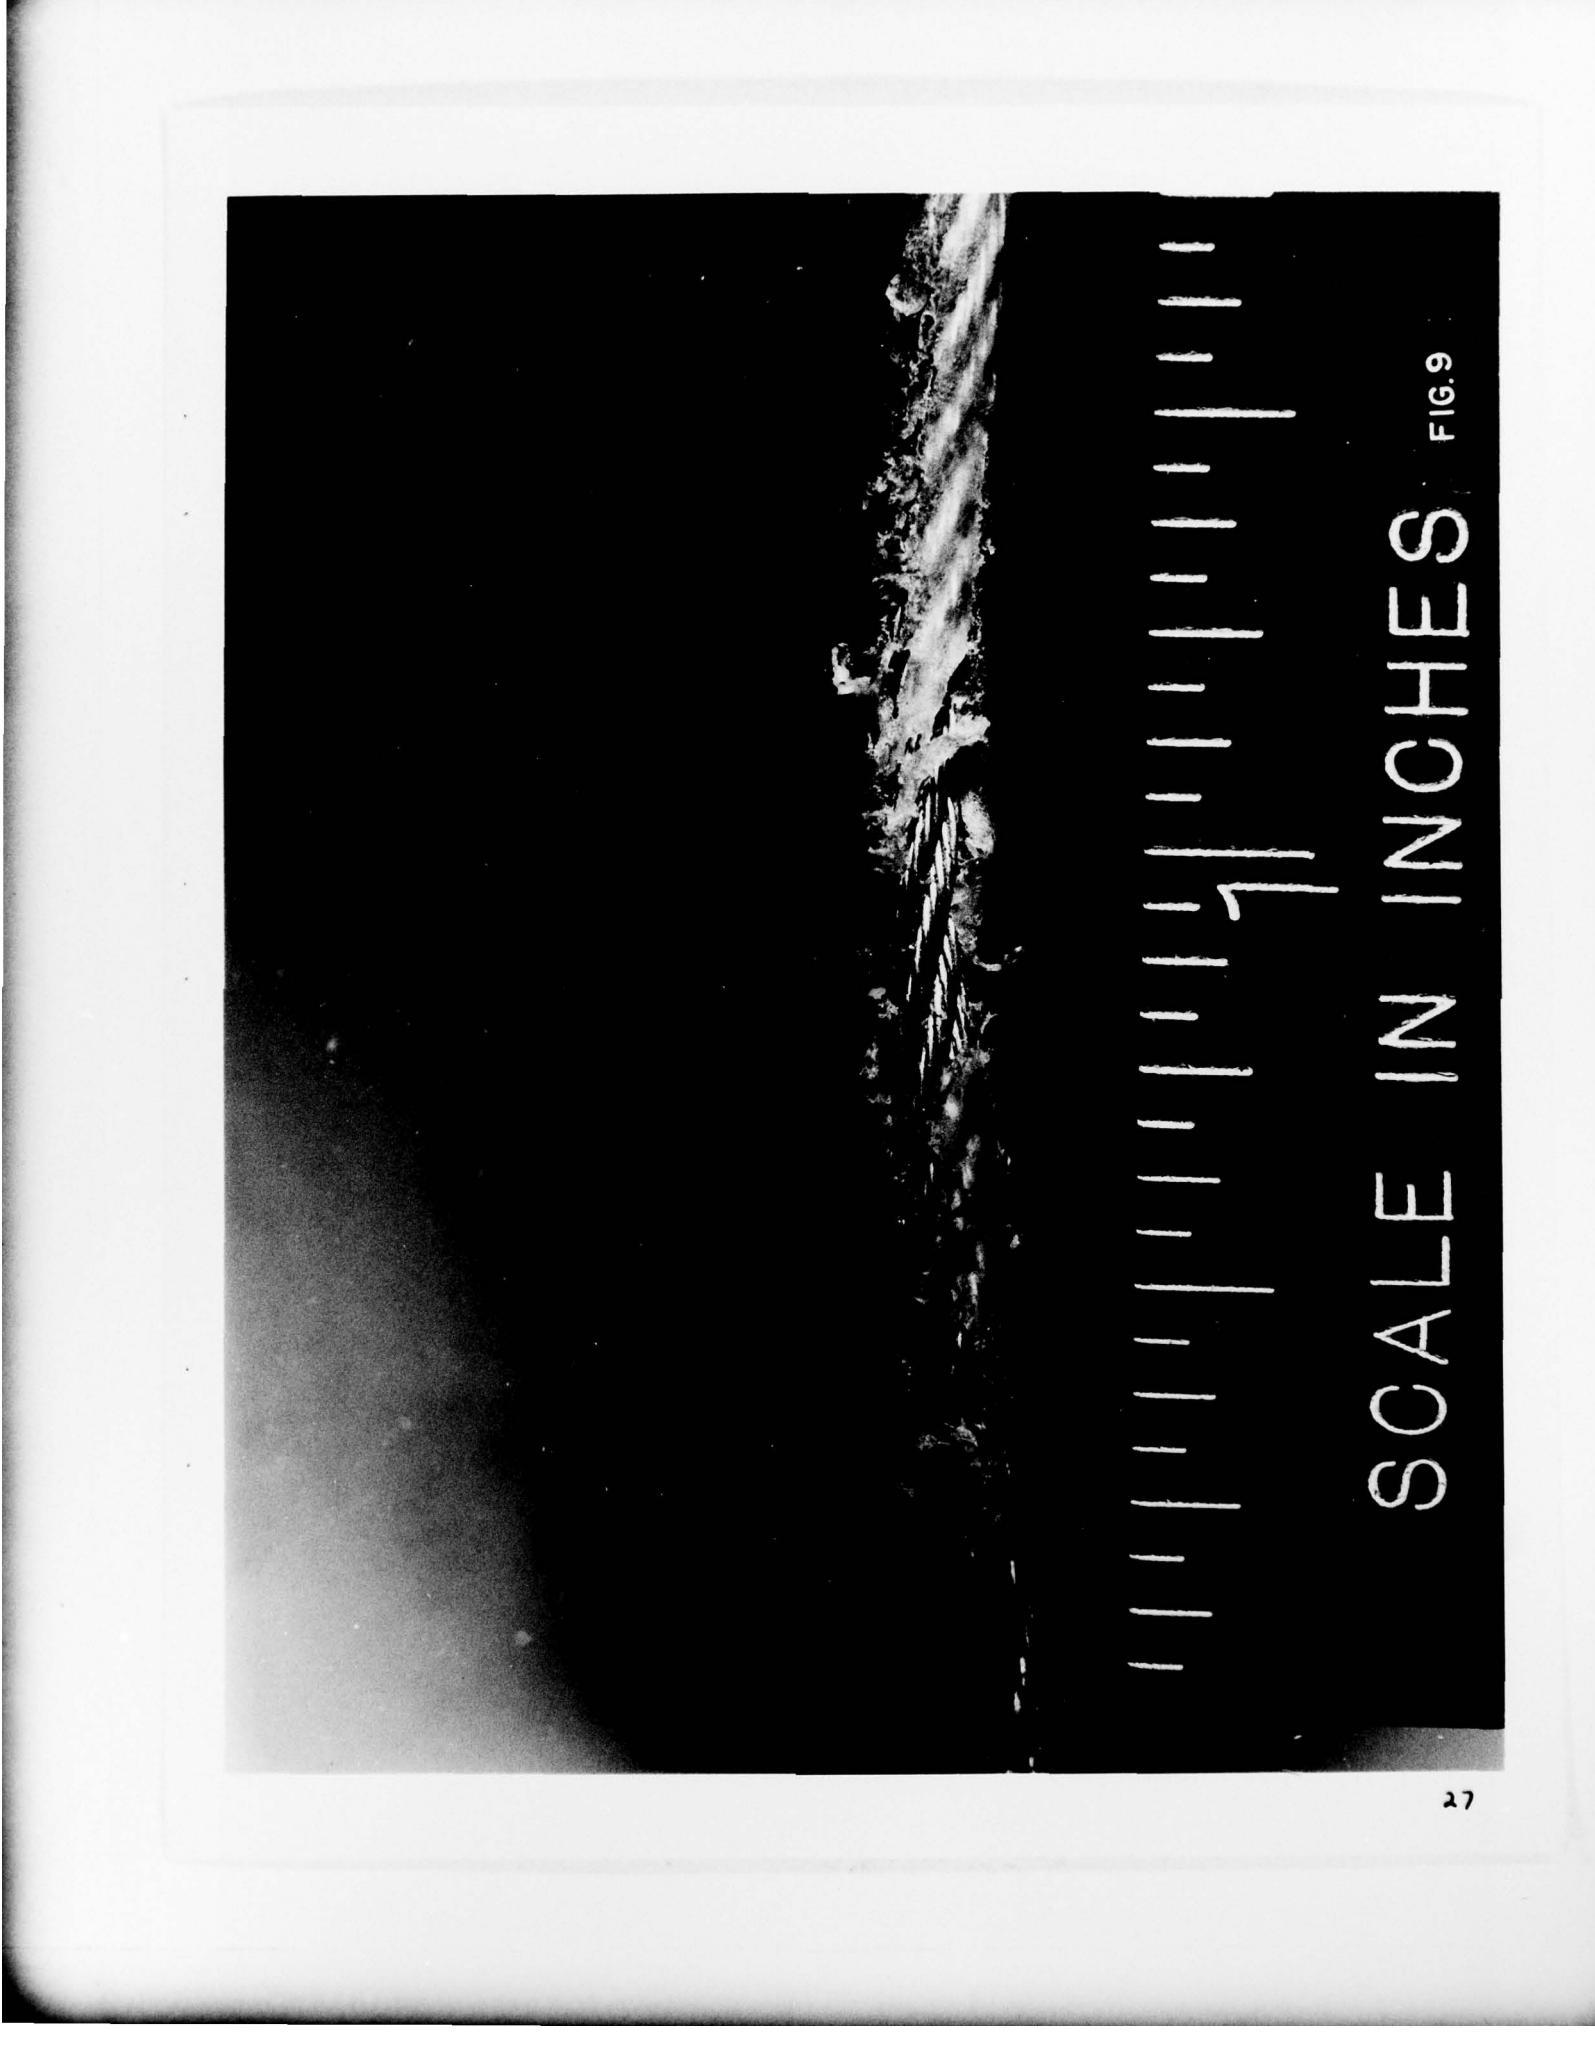
The severely torn and frayed coating section shown in figure 9 is indicative of failure conditions consisting primarily of abrasion (most probably on the sheave sides) and torsion. The spiral tears appearing in the center of the photograph are characteristic of this condition. The failure sections illustrated by figures 10 and 11 are quite distinct from the previous failures shown. These failures occurred in the 1/64-in, nylon coating of Cable 3 and are solely transverse cracks, a large number of them being of sufficient severity to cut down to the wire core. The primary cause of this type of failure is a severe kink. This indicates that kinking of the severity shown is very damaging to such thin nylon coatings and leads to cracks which would cause subsequent peeling and splitting off of the coating from the wire core.

(3) In order to utilize to a fuller extent the desirable properties of nylon-coated bathythermograph lowering cables, an investigation of sheave materials should be authorized and carried out, in order to find methods to lower abrasive damage to the nylon coatings that occur through sheave contact factors. The feasibility of using molded, or molded and finish-machined, nylon sheaves should be determined as an integral part of such an investigation.

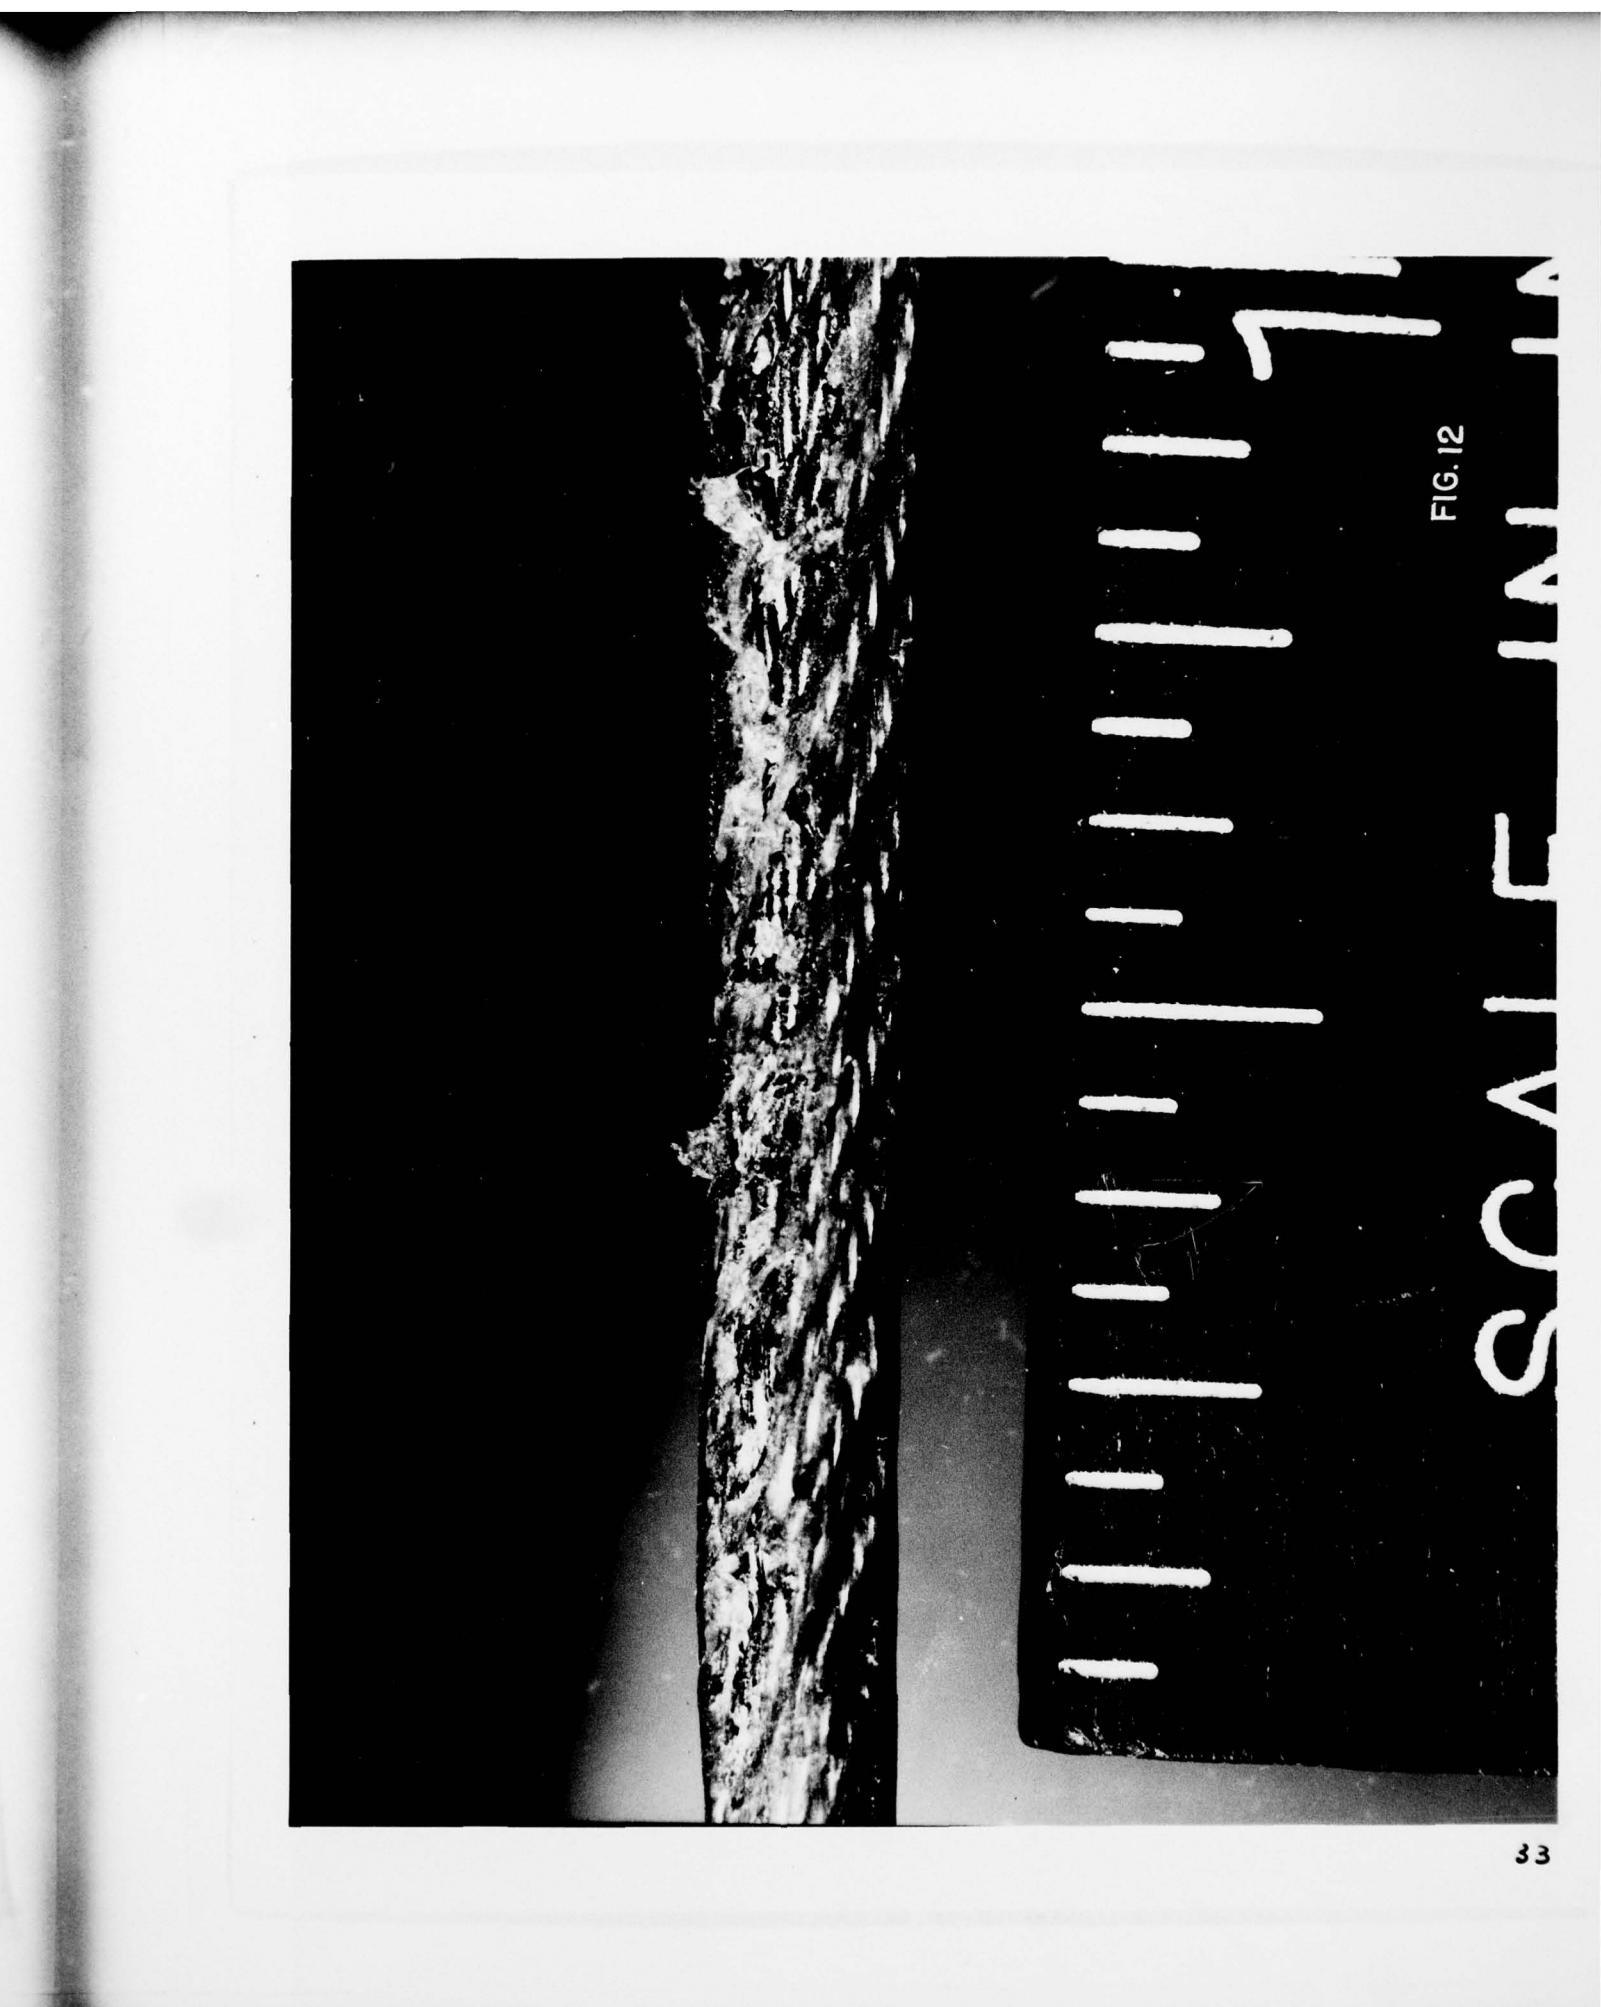
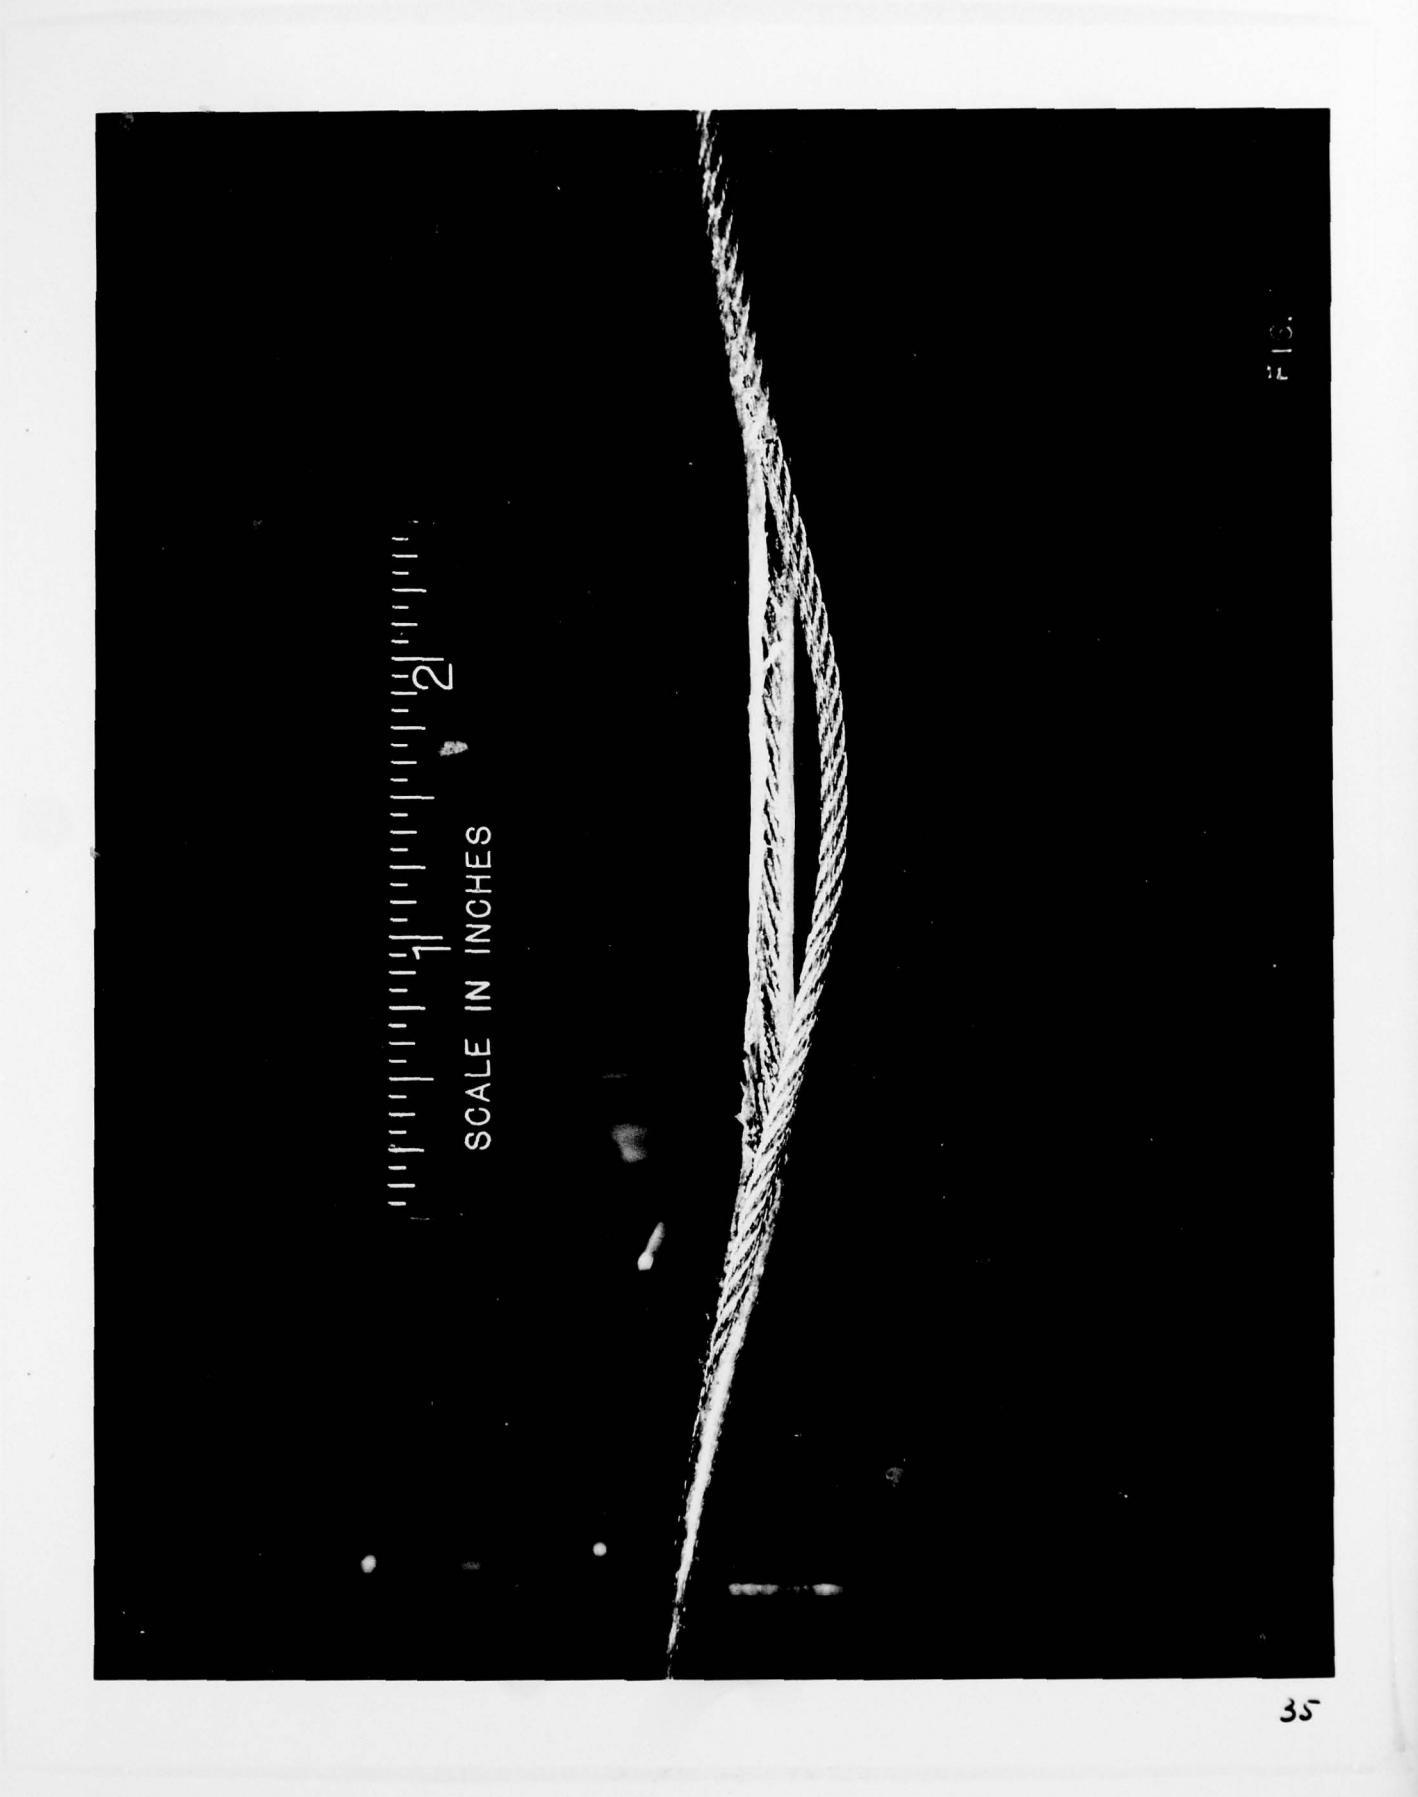
Figures 12 and 13 show the initial stage and final result of a coating failure that resulted in full separation of the coating from the wire core. The area shown was approximately 175 feet from the bathythermograph end of Cable 3. The longitudinal split of figure 12 turns into a continuous break and leads to the complete pull-away of the nylon coating and the full exposure of the wire core, as shown in figure 13. A considerable section of the wire core is exposed, making it more susceptible to corrosive attack than other sections of the wire core.
