Most Project - 2 **RÉPORT 257** PROBLEM NEL 4G1 0 WORK STATUS: 1 JUNE 1951 REPORT APPROVED: 6 JULY 1951 AD A 051401 1 9 Final rept. for period final report: Variable Ship Speed and Usable Life Tests of Nylon-Coated, Surface-Vessel, Bathythermograph Hoisting Cable L B. STARK ENGINEERING SERVICES DIVISION 18 181 1Jun 51 7180796 NAVY ELECTRONICS LABORATORY, SAN DIEGO, CALIFORNIA DISTRIBUTION STATEMENT A Approved for public released 253550 6 Distribution Unlimited

Buships problem NEL 4G1: Test nylon-coated, surface-vessel, bathythermograph hoisting cable considered for use in sonar work. This final report covers the conclusion of the variable ship speed tests and the usable life tests of the cable (recommended in NEL Report 177), and correlates the entire testing program.  $\chi 95018$

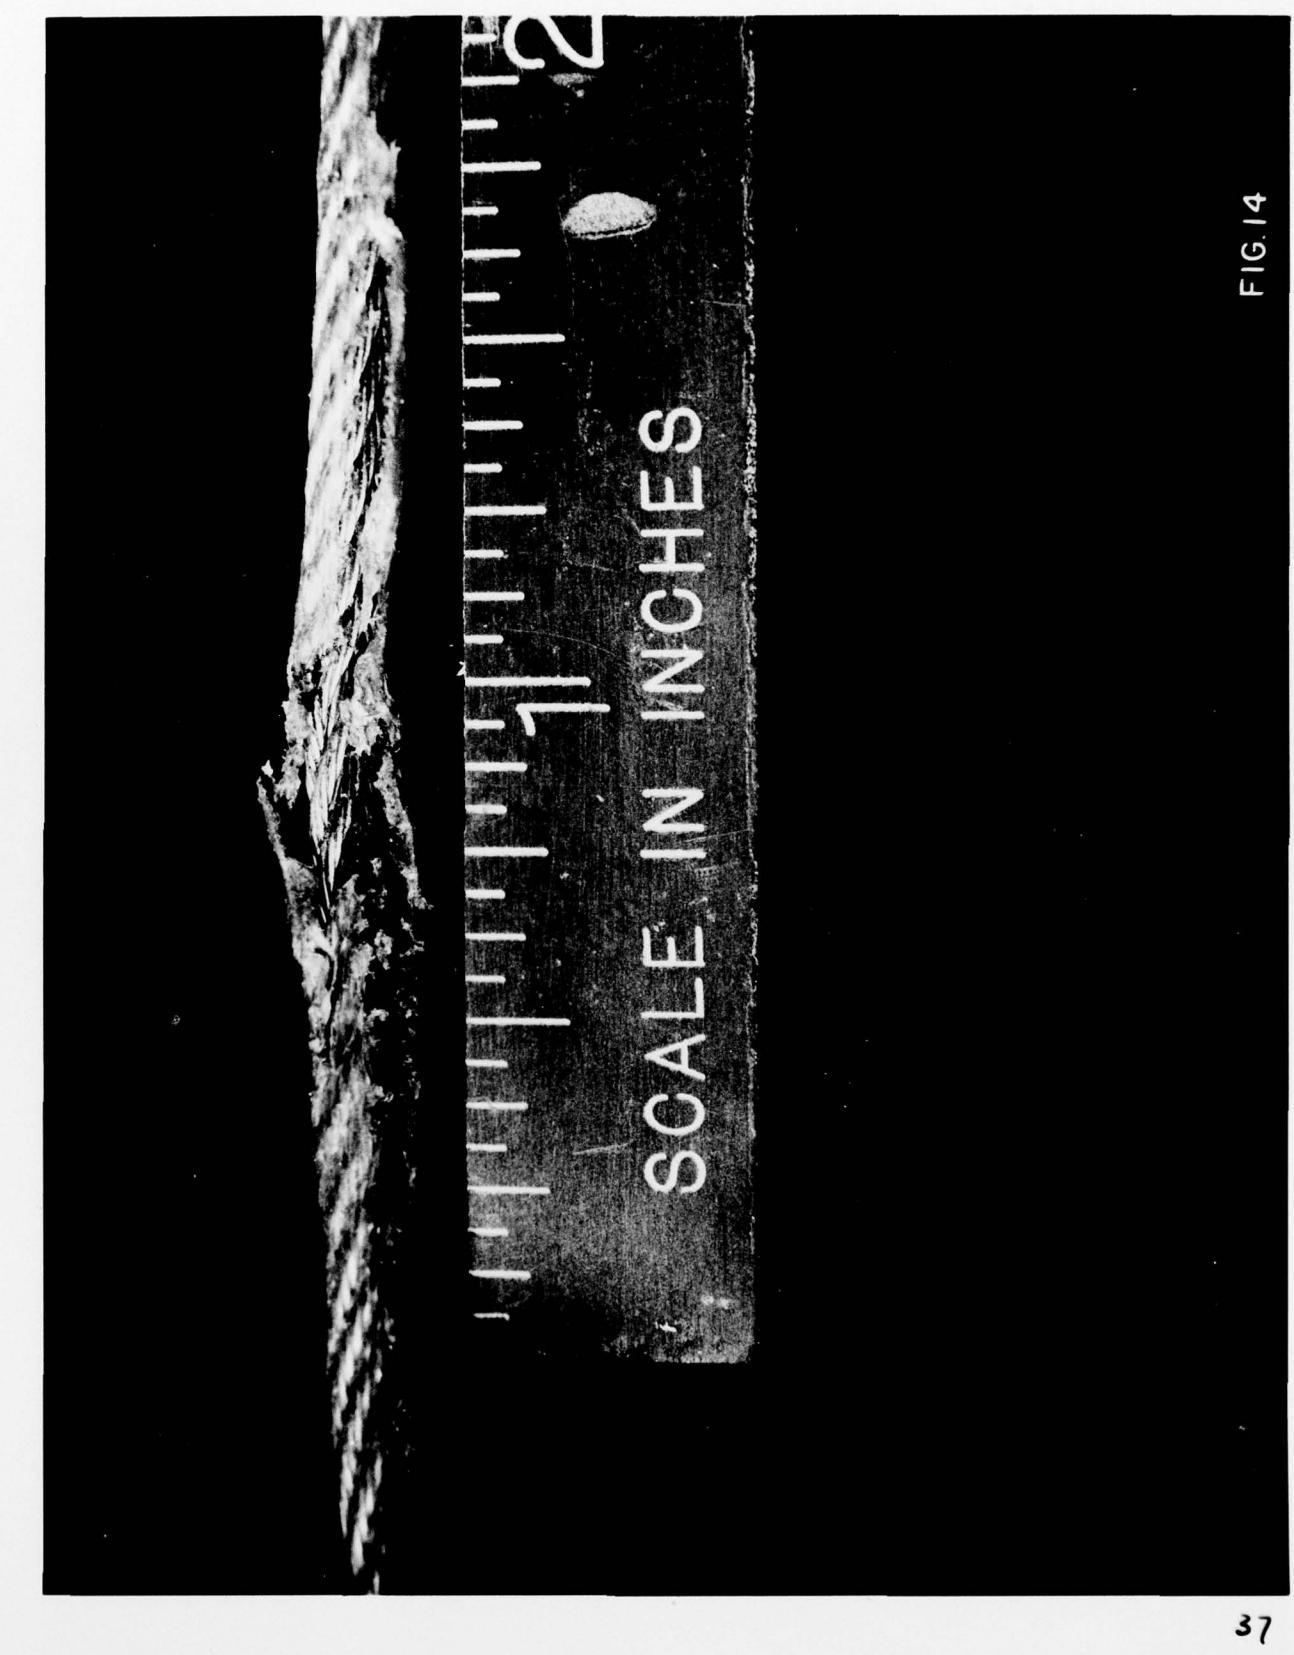
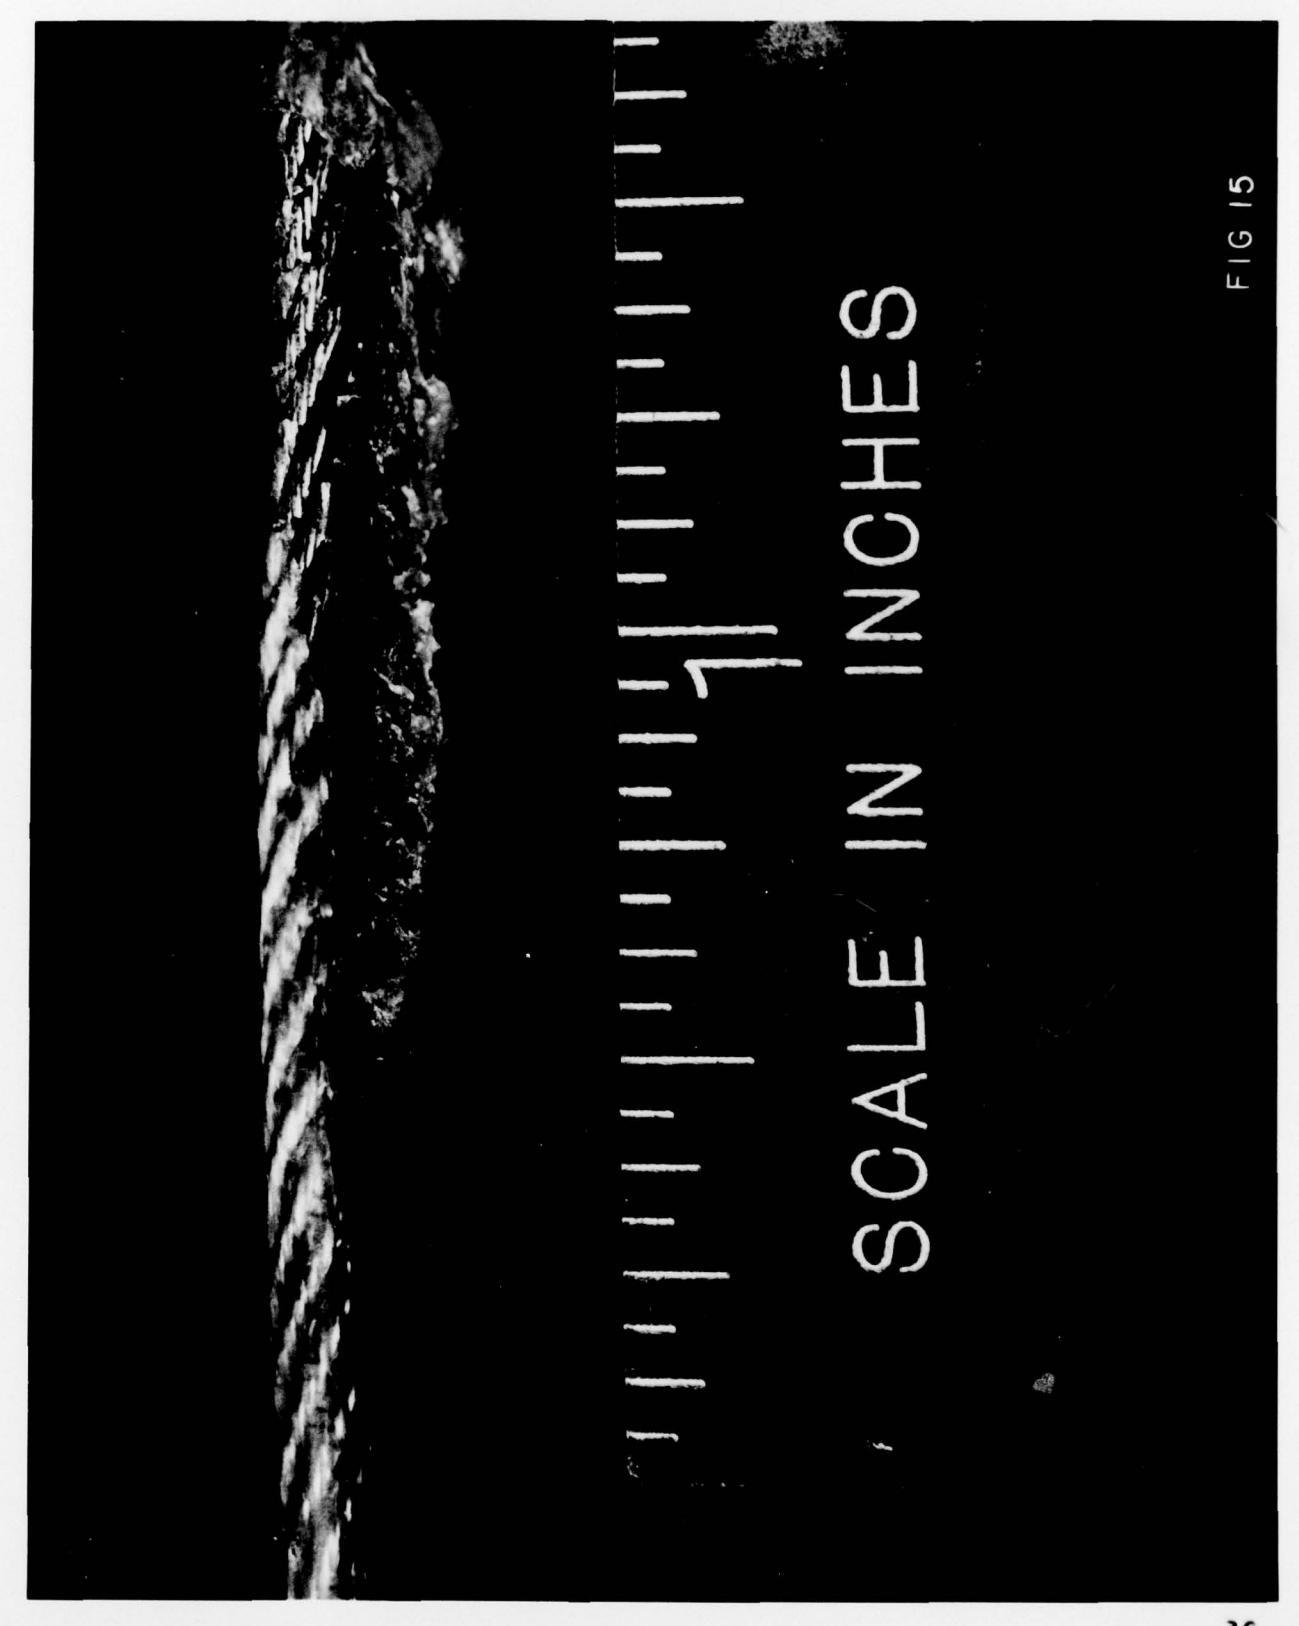
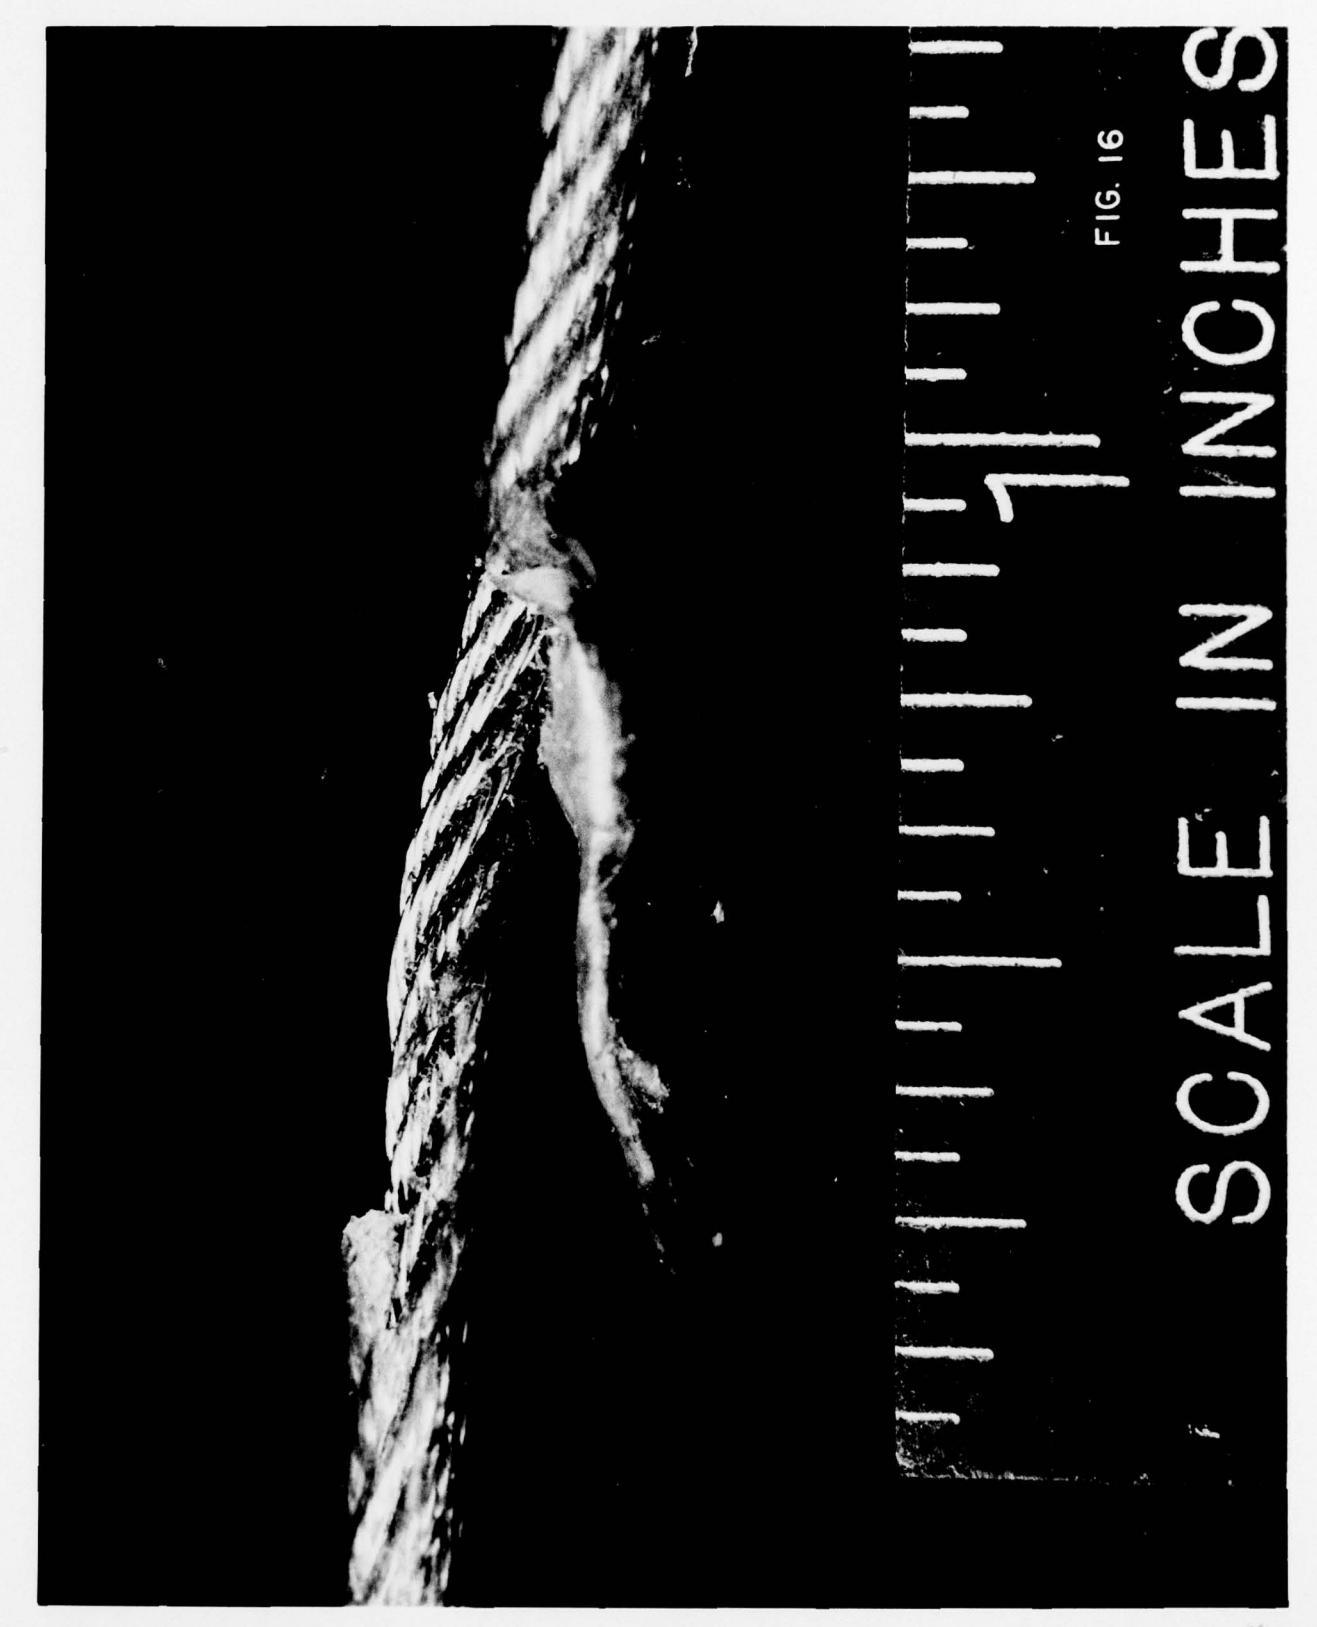
Starting with figure 14, a group of coating failures of the types encountered in the 1/32-in. nylon coating of Cable 2 shows the marked difference between the failures that occur in the 1/32-in. nylon coating as compared to the 1/64-in. nylon coating of Cable 3. The failures shown in

figures 14, 15, and 16 are examples of the progressive stages of coating failure leading to the peeling of the 1/32-in. nylon coating from the wire core. Figure 14 illustrates an early stage of failure, where a longitudinal tear in the coating has occurred and one edge of the torn coating has started to peel from the wire core. Figures 15 and 16 show the intermediate peeling of the torn coating and, finally, the complete peeling of the coating from the wire core. This leads to a full discontinuity in the cable surface; the cable is damaged more severely as it passes through the guide sheave in this condition. Normally, a cable section with this surface condition must be cut out of the cable proper after a very small number of lowerings if it is desired to maintain the cable in service.

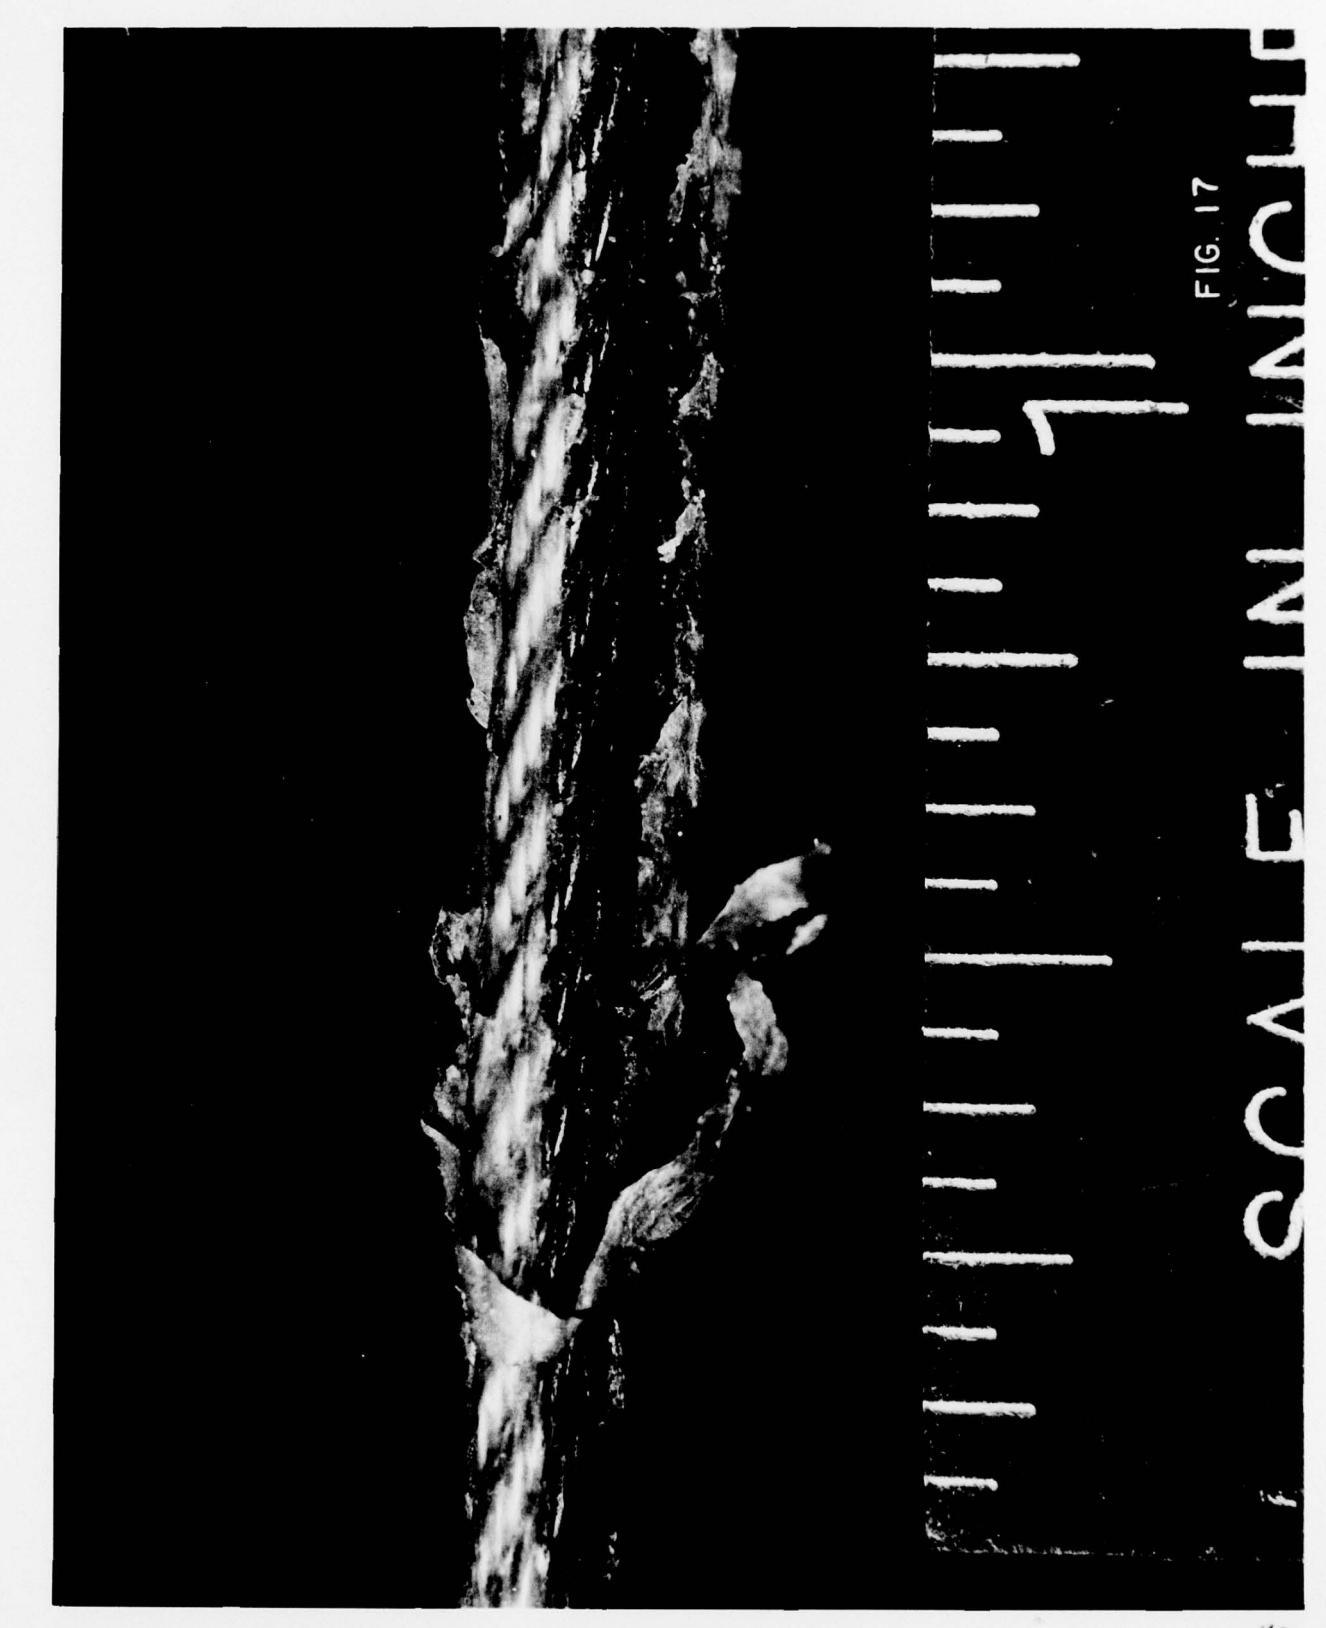
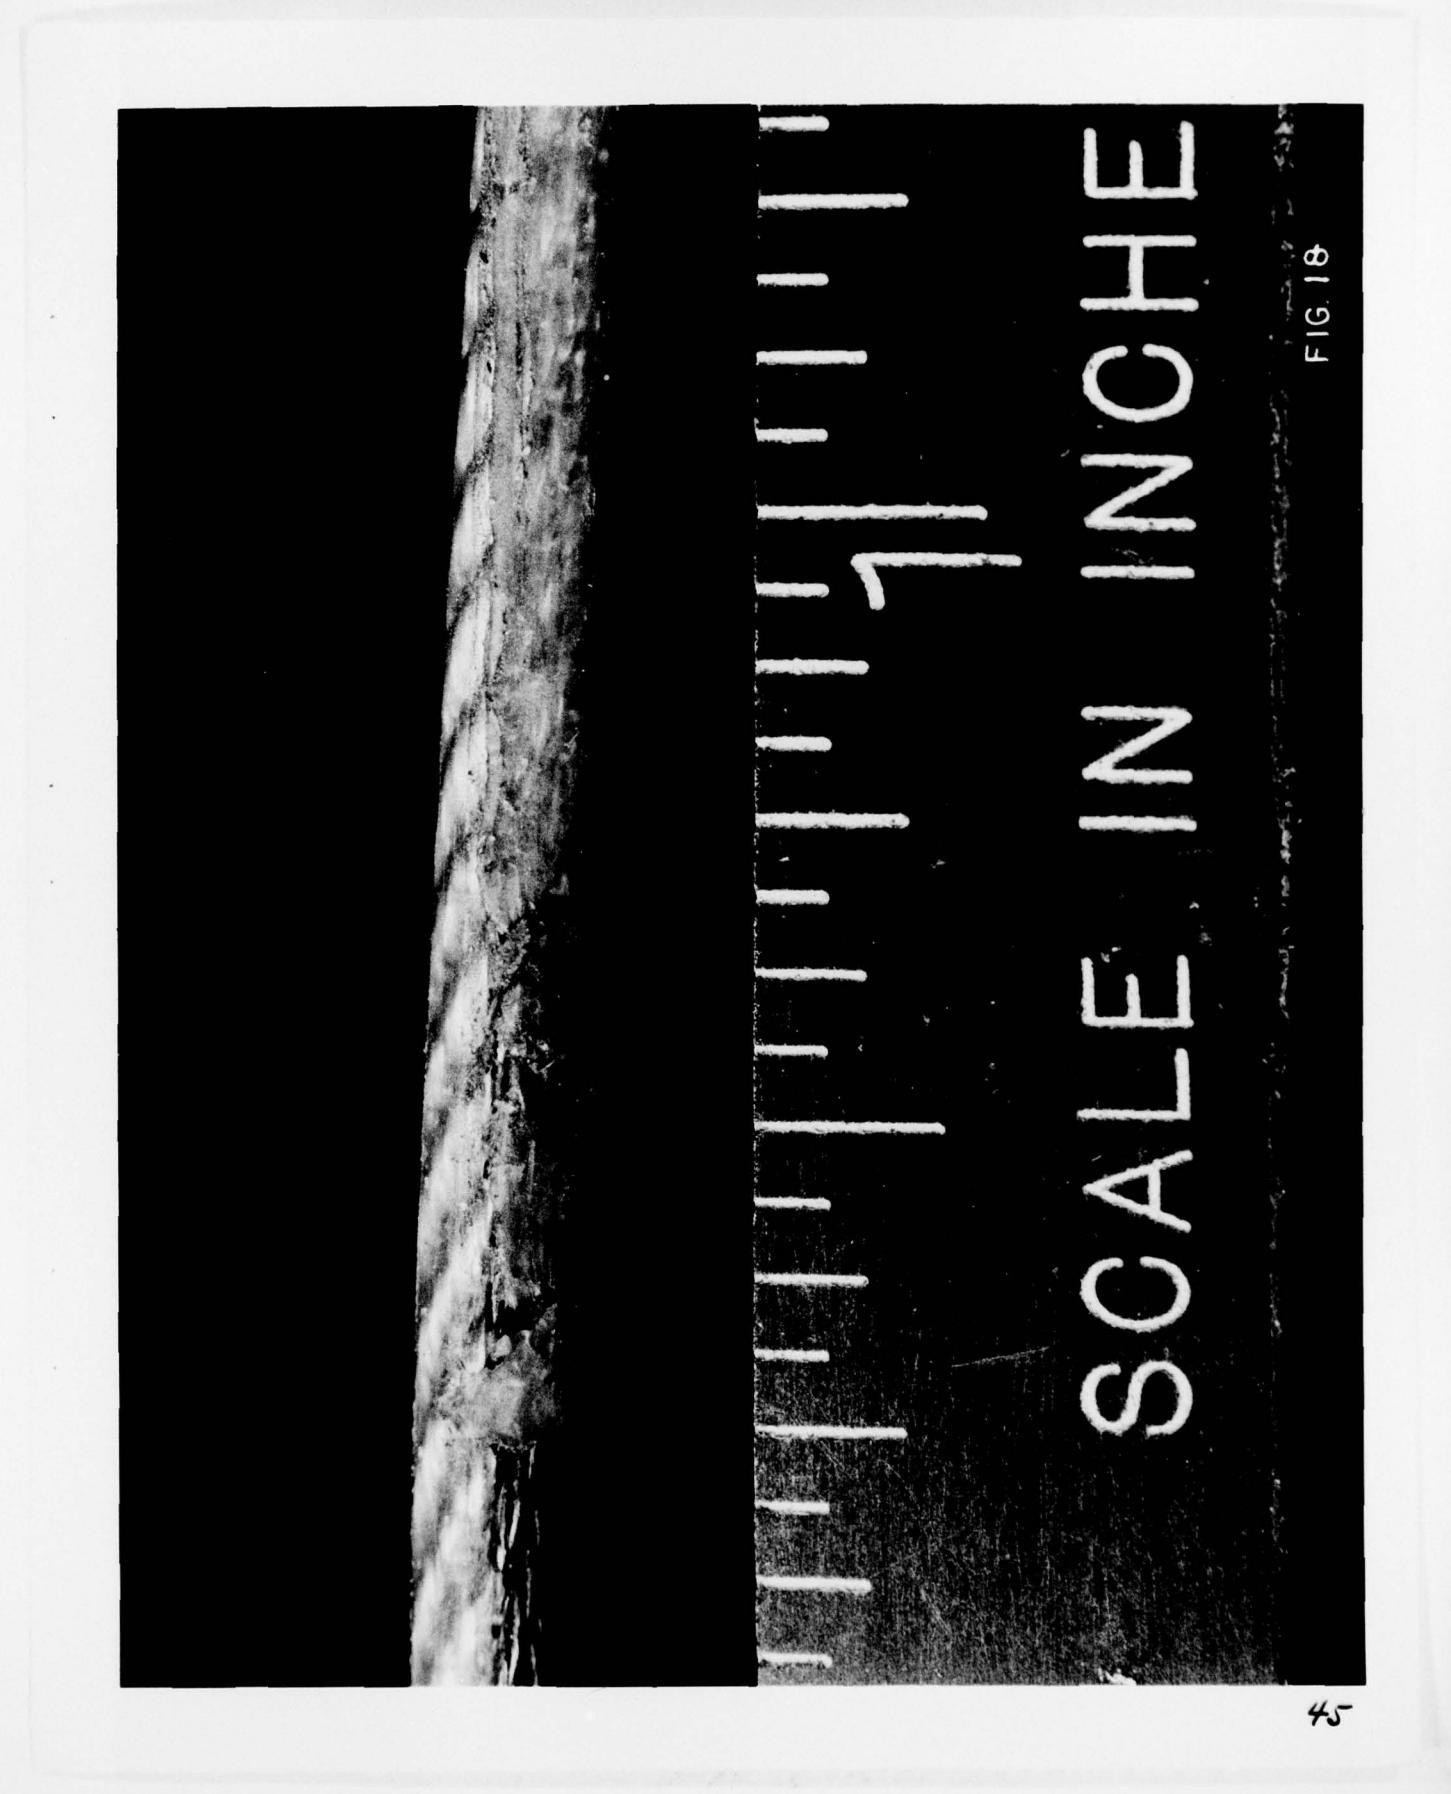
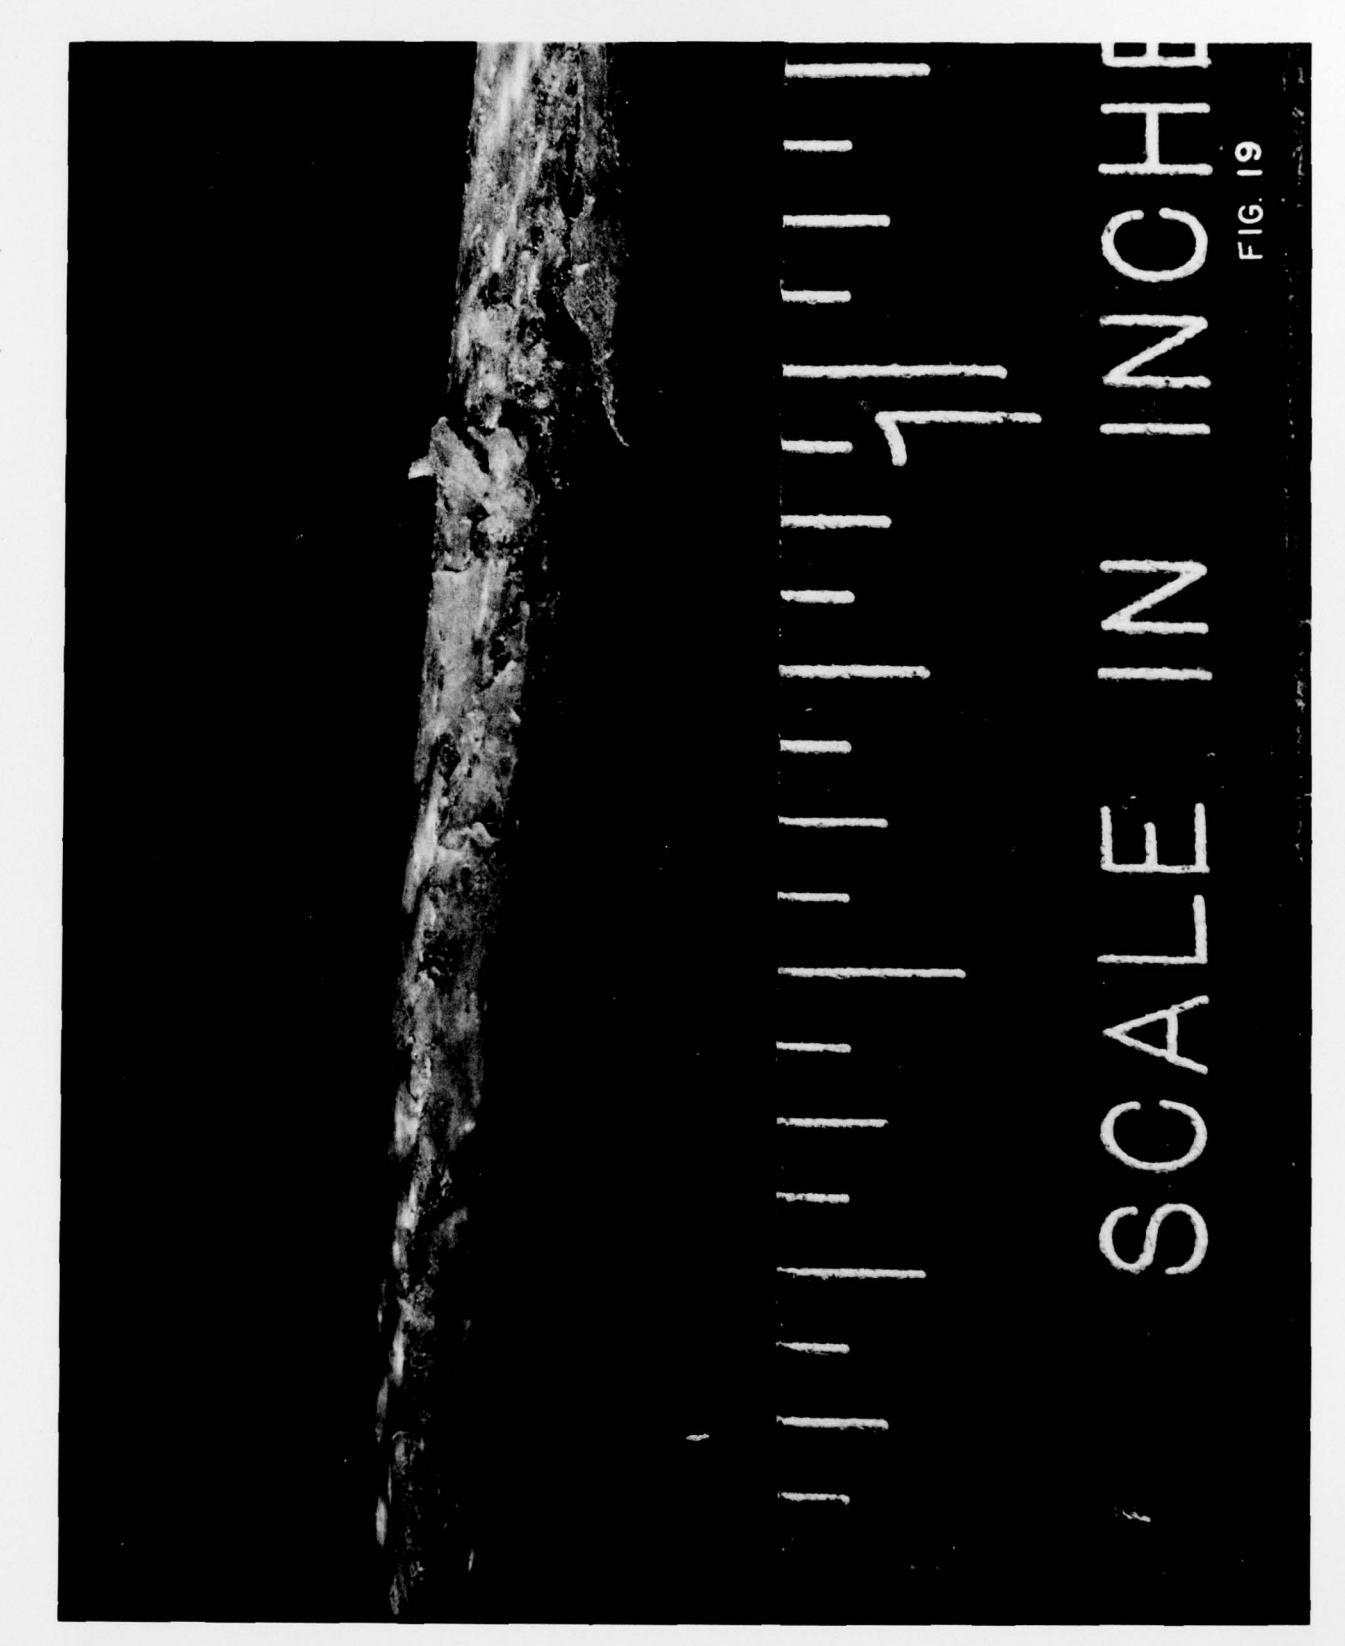
Types of coating failures restricted to a small area are shown in figures 17, 18, and 19; in most cases these failures did not lead to further damage which impaired the use of the cable. The fibrous peeling indicated in figure 17 appears to have been caused by localized abrasion and, in practically all cases, the fibrous peeling tore away from the remainder of the coating without further serious coating damage. Figure 18 shows a small, sharp transverse cut of a type which did not usually cause the coating to peel. Figure 19 is representative of a localized tear, most examples of which did not extend over 3/8 in. in length and often did not reach the wire core. All of the coating failures shown in figures 17, 18, and 19 are indicative of the generally higher durability of the 1/32-in. nylon coating as compared to the 1/64-in. coating shown in figures 1 through 13. These less severe failures occurred approximately 180 feet from the bathythermograph end of Cable 2.

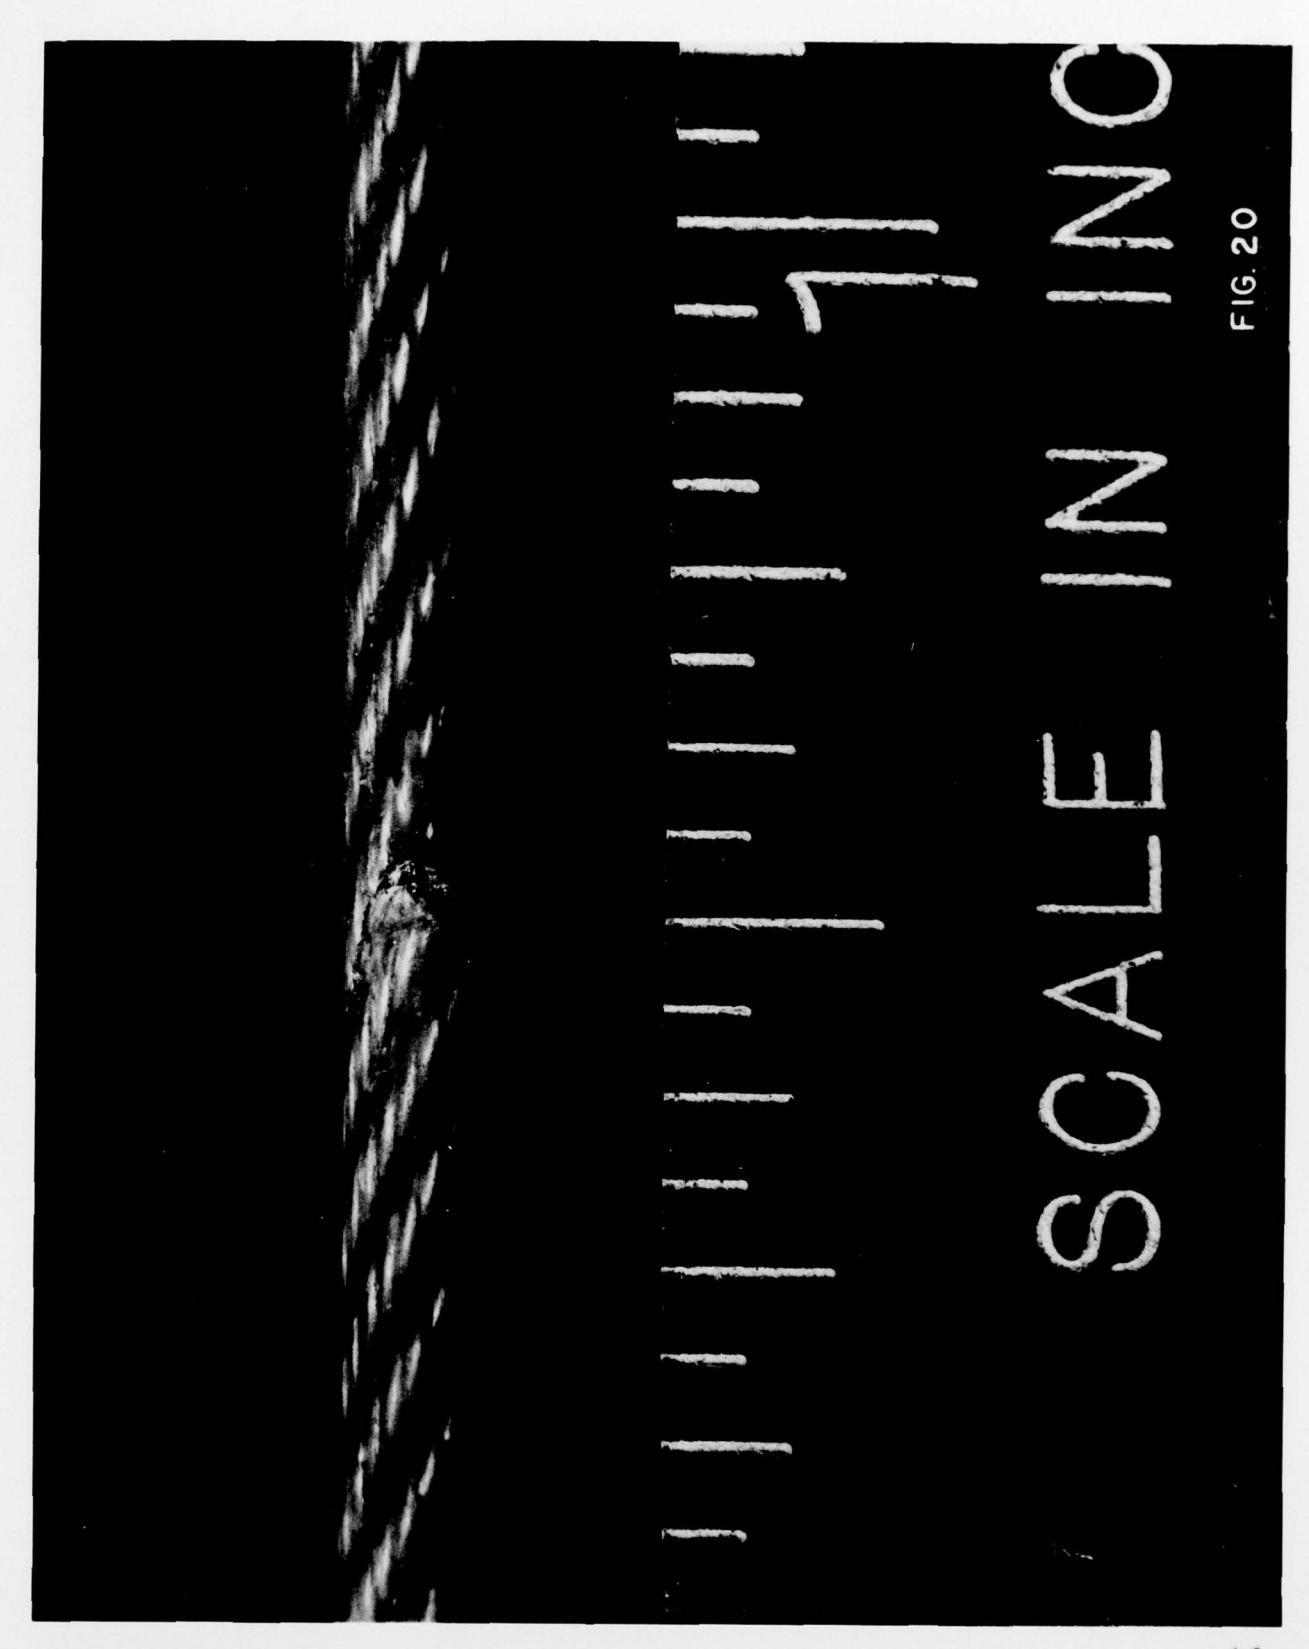
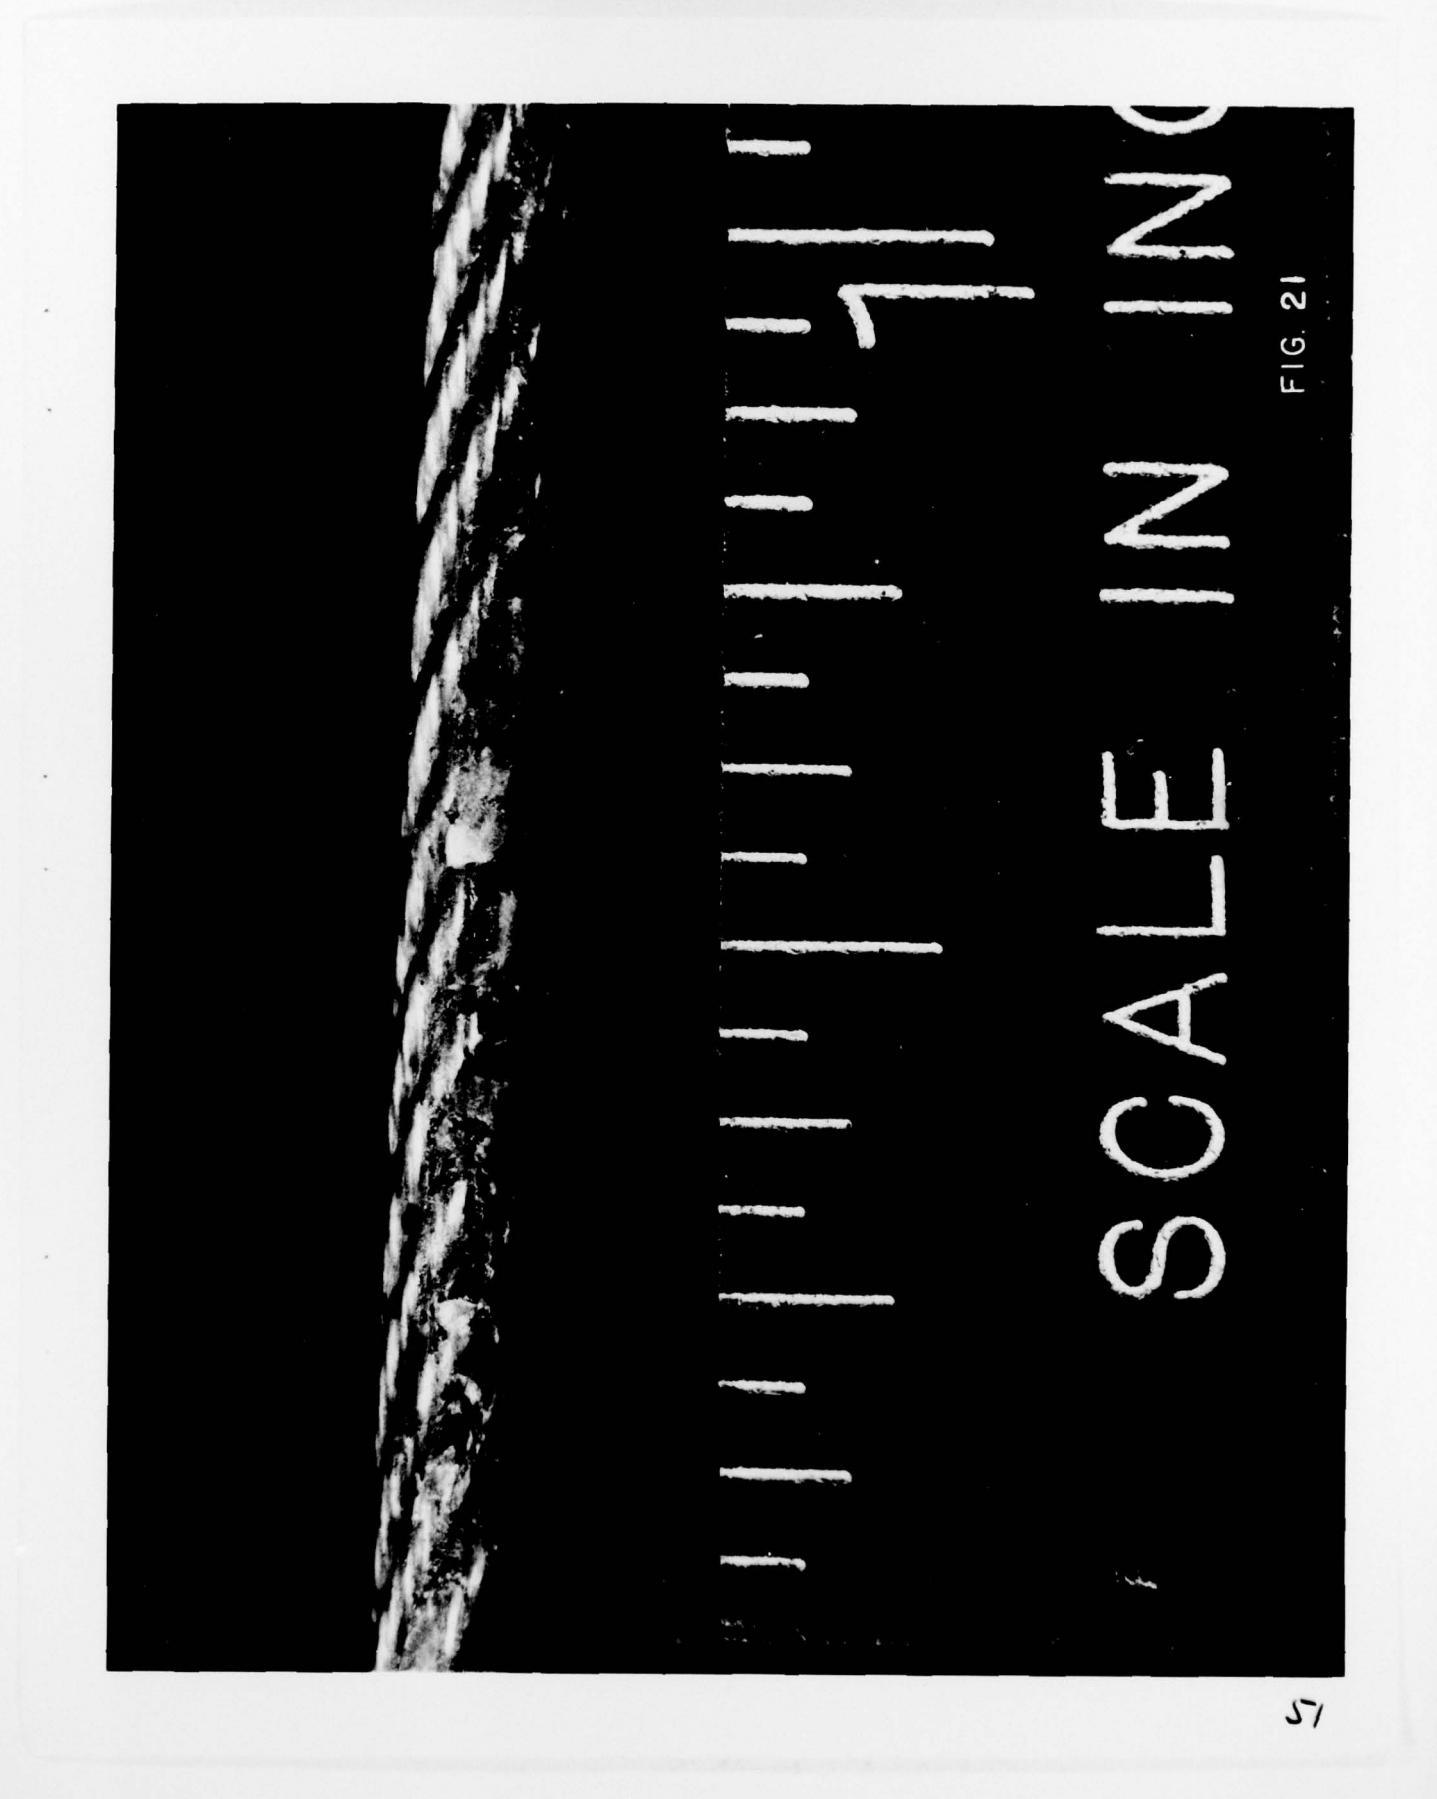
Figures 20, 21, and 22 are examples of miscellaneous failures that occurred occasionally in Cable 2 from 150 to 190 feet from the bathythermograph. The small surface cut shown in figure 20 occurred frequently, indicating that the nylon coating is quite susceptible to surface nicks by any sharp object. It is nevertheless important to note that surface cuts of this type did not usually lead to progressive coating failures or peeling of the coating from the wire core. Figure 21 shows a type of surface abrasion failure of the 1/32-in. nylon coating, which generally consisted of the intermittent tearing out of chunks in the surface layer of short sections (1/2 to 1 in.) of the nylon coating. Although these abrasions do not add materially to severe coating failures, cumulatively they tended to roughen intermittently the cable coating surface over fairly large linear distances (50 to 100 feet) in the areas closer to the bathythermograph

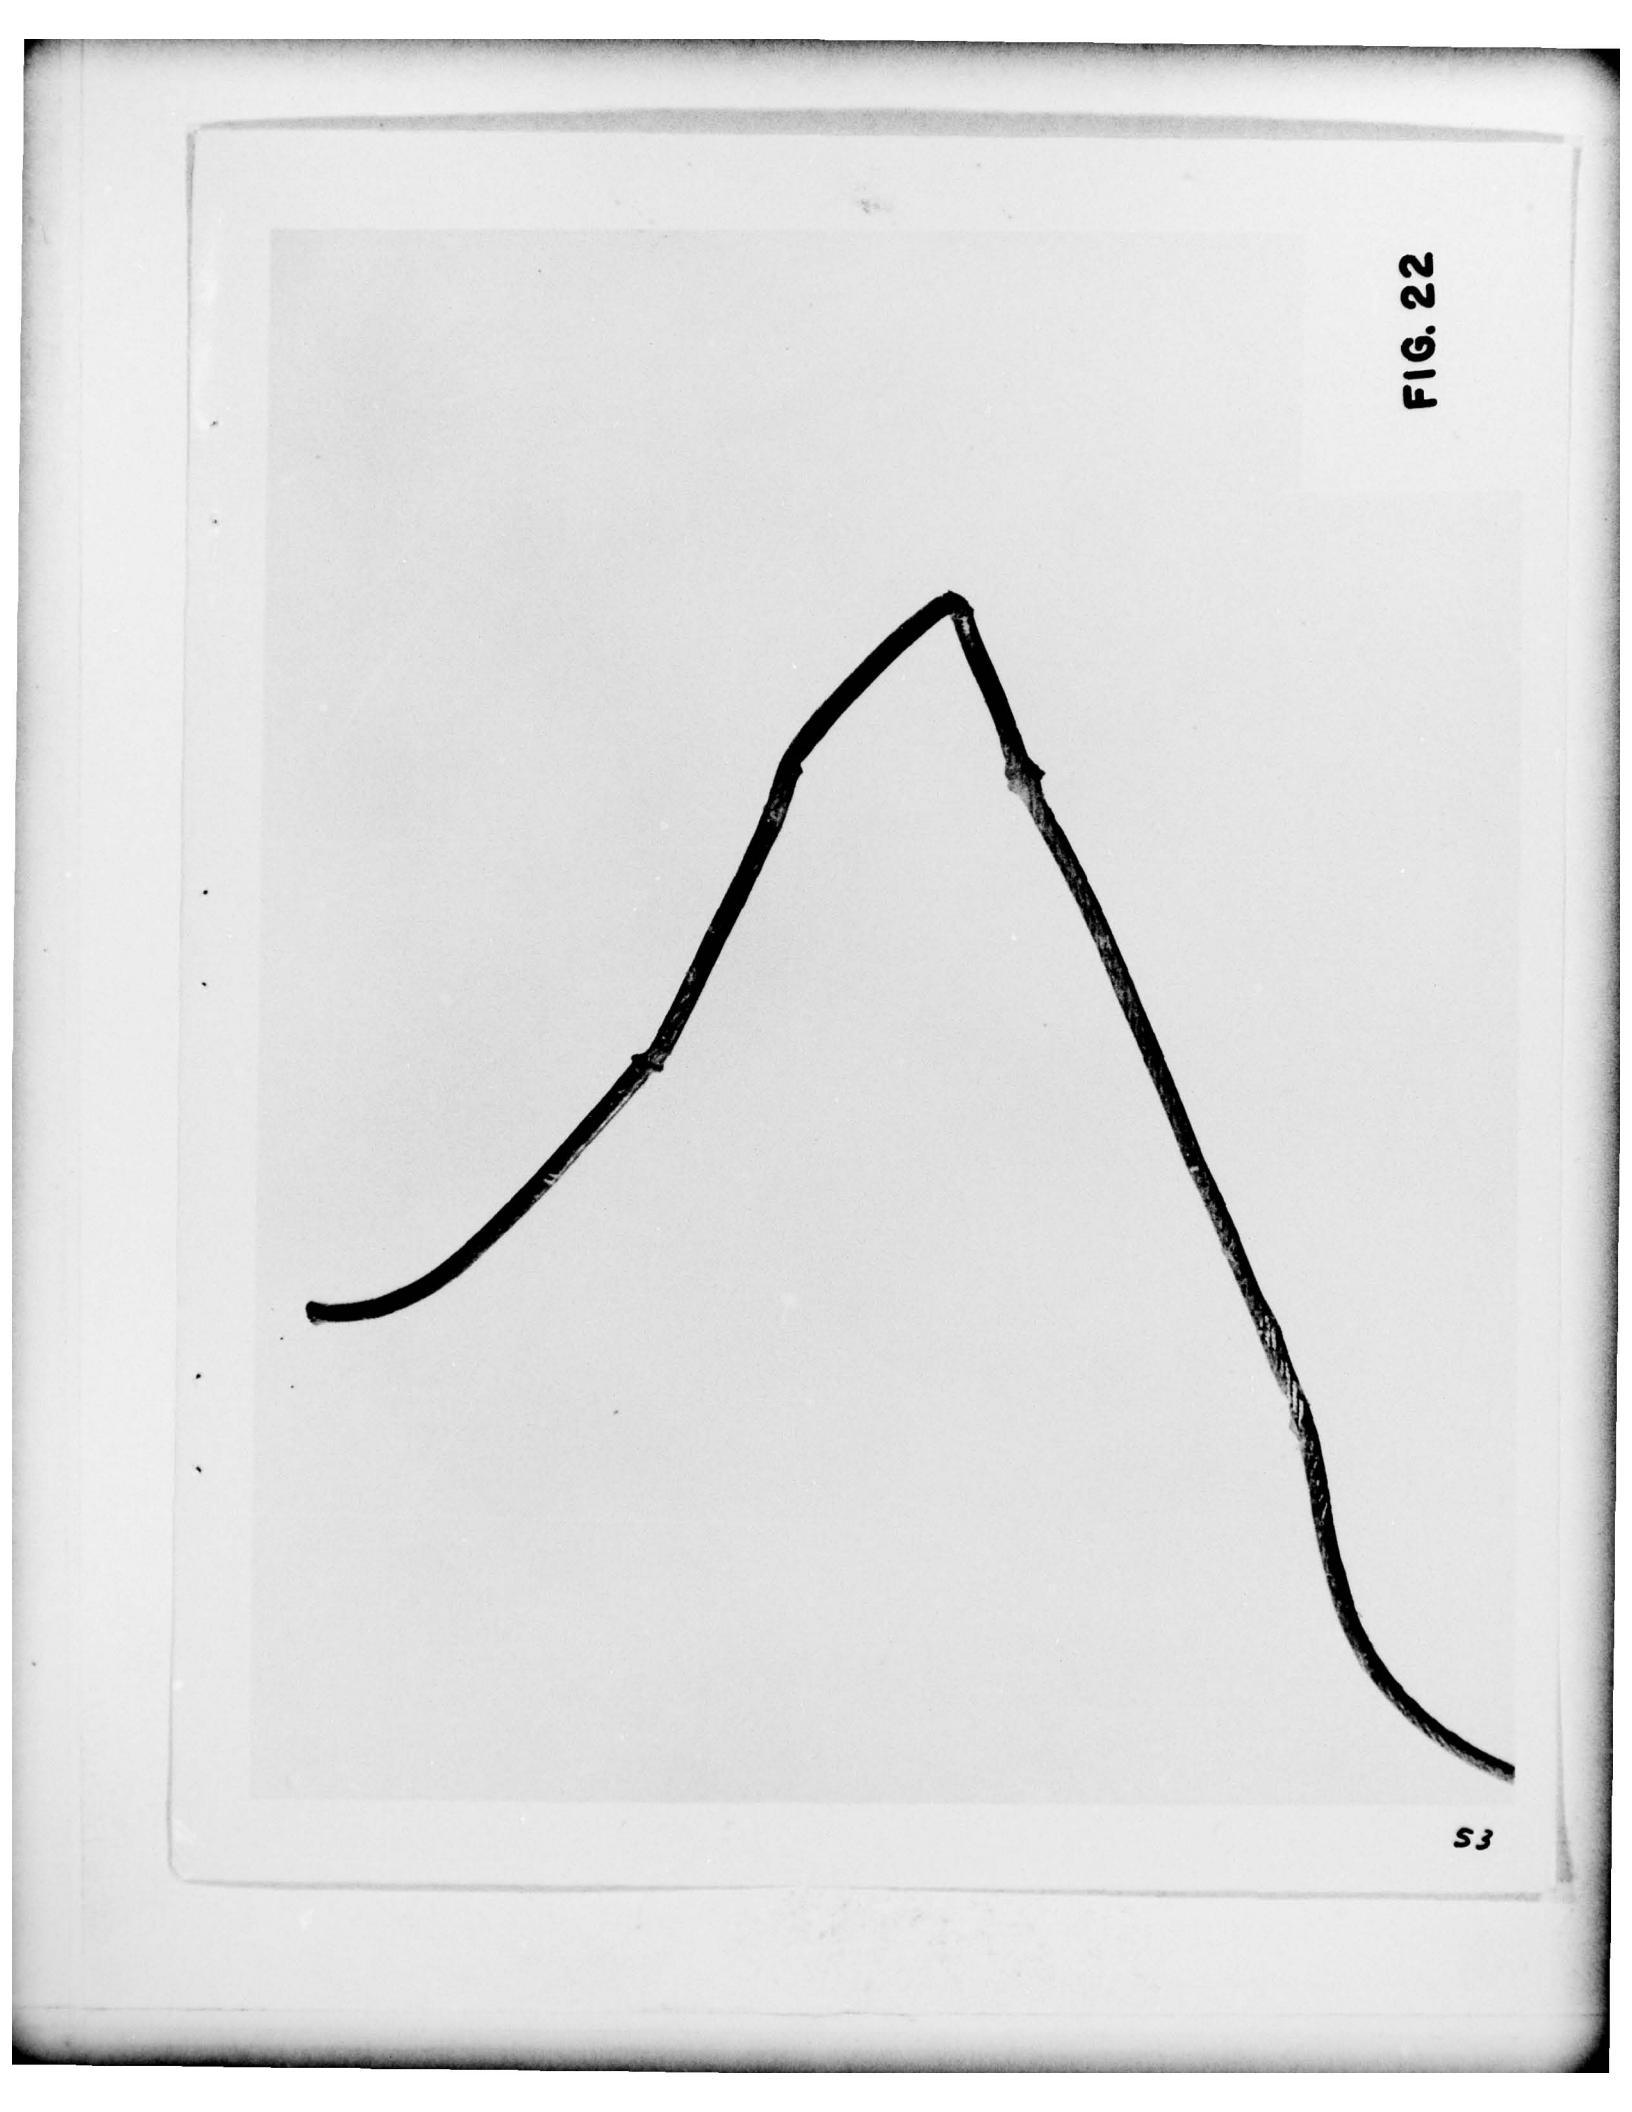
end. The results of moderate to sharp kinks over short lineal distances on Cable 2 are well illustrated by the coating failures shown in figure 22. It is evident that some transverse "pile-up" of the nylon coating results from the severe longitudinal strains caused by the kinks. In general, these transverse points of coating distortion are not nearly as severe in the 1/32-in. nylon coating of Cable 2 (figure 22) as the similar kinking damage in the 1/64-in. nylon coating of Cable 3 (figures 10 and 11).
