FINAL REPORT

AN/SPS-57 RADAR IMPROVEMENT PROGRAM, PHASE II

February 1977

Prepared for U.S. COAST GUARD 400 7TH STREET, N.W. WASHINGTON, D. C. 20590 under Contract DOT-CG-52488-A

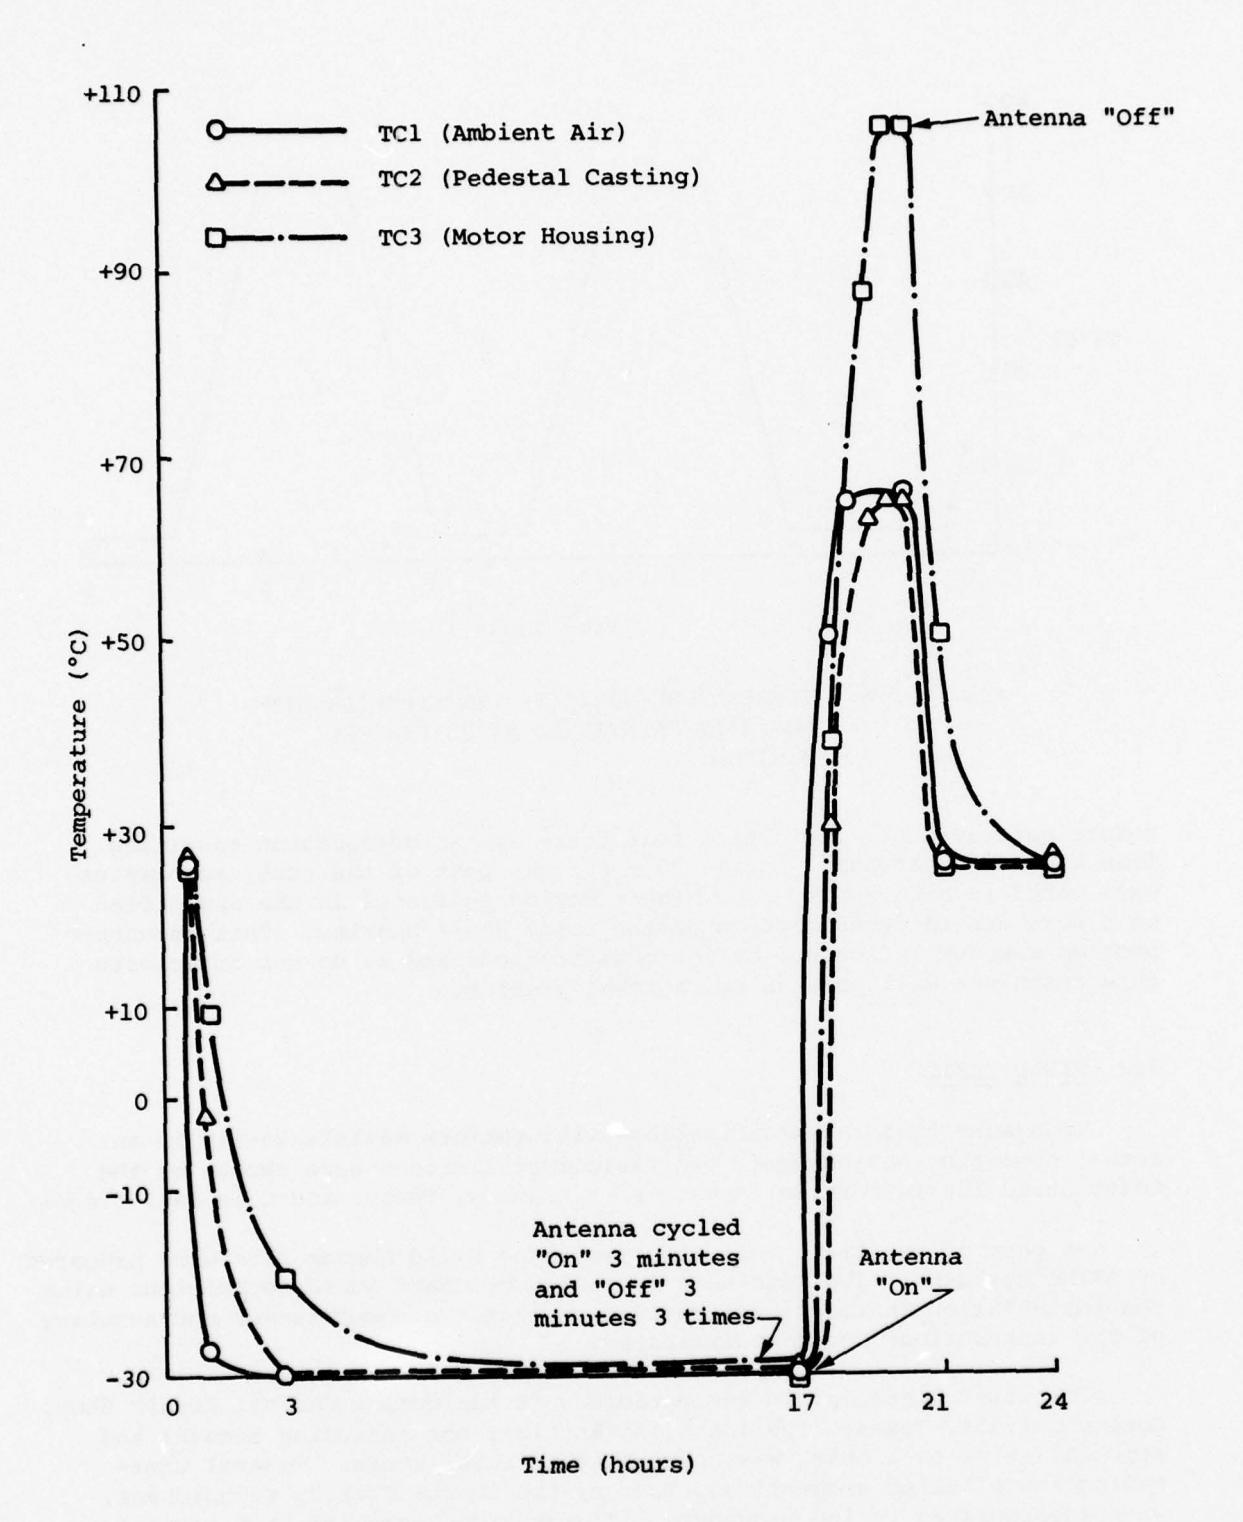
Figure 3-5. LOW/HIGH TEMPERATURE TEST

The modified antenna was subjected to various temperatures to verify that there was no degradation in operation at the temperature extremes. The temperature profile shown in Figure 3-5 was used for this test, with rotator operating as indicated but without r-f excitation or other power applied to the antenna position indicator components.
