ACCESSION for E.E.S. Report C-3599-A(1) ATIS White Section ) NS-623-071 000 Butt Section D BWARNOUNCED D U. S. NAVAL ENGINEERING EXPERIMENT STATION JUSTIFICATION. Annapolis, Maryland 27. DISTRIBUTIOR / AVAILABILITY CODES VENGRX STA . C. 3599-A AVAIL. and/or SPECIAL bist. 25 Mar 49 TEST OF PHILIPS MODEL 1/4D EXTERNAL COMBUSTION ENGINE 100501 toublie: Alan R. Schrader Small Diesel Engine Branch קות תחק Internal Combustion Engine Laboratory 16 1978 Approved to Submitted by W. F. Joschim W. D. Legge Captain, USN Superintendent Director I. C. E. Laboratory

A Model 1/4D Philips external combustion engine was delivered 18 May 1943 under Contract NObs-34195 for test. Wariable load tests were conducted and attempts were made to obtain endurance runs. The test operation was generally unsatisfactory due to numerous casualties and to the inadequate delivery capacities of the gasoline nozzle and air compressor. The test of the first engine was discontinued after 86 hours operation. A replacement engine embodying numerous modifications was subsequently furnished for test. It was operated a total of 79 hours. Test operation again was generally unsatisfactory due to numerous minor casualties and

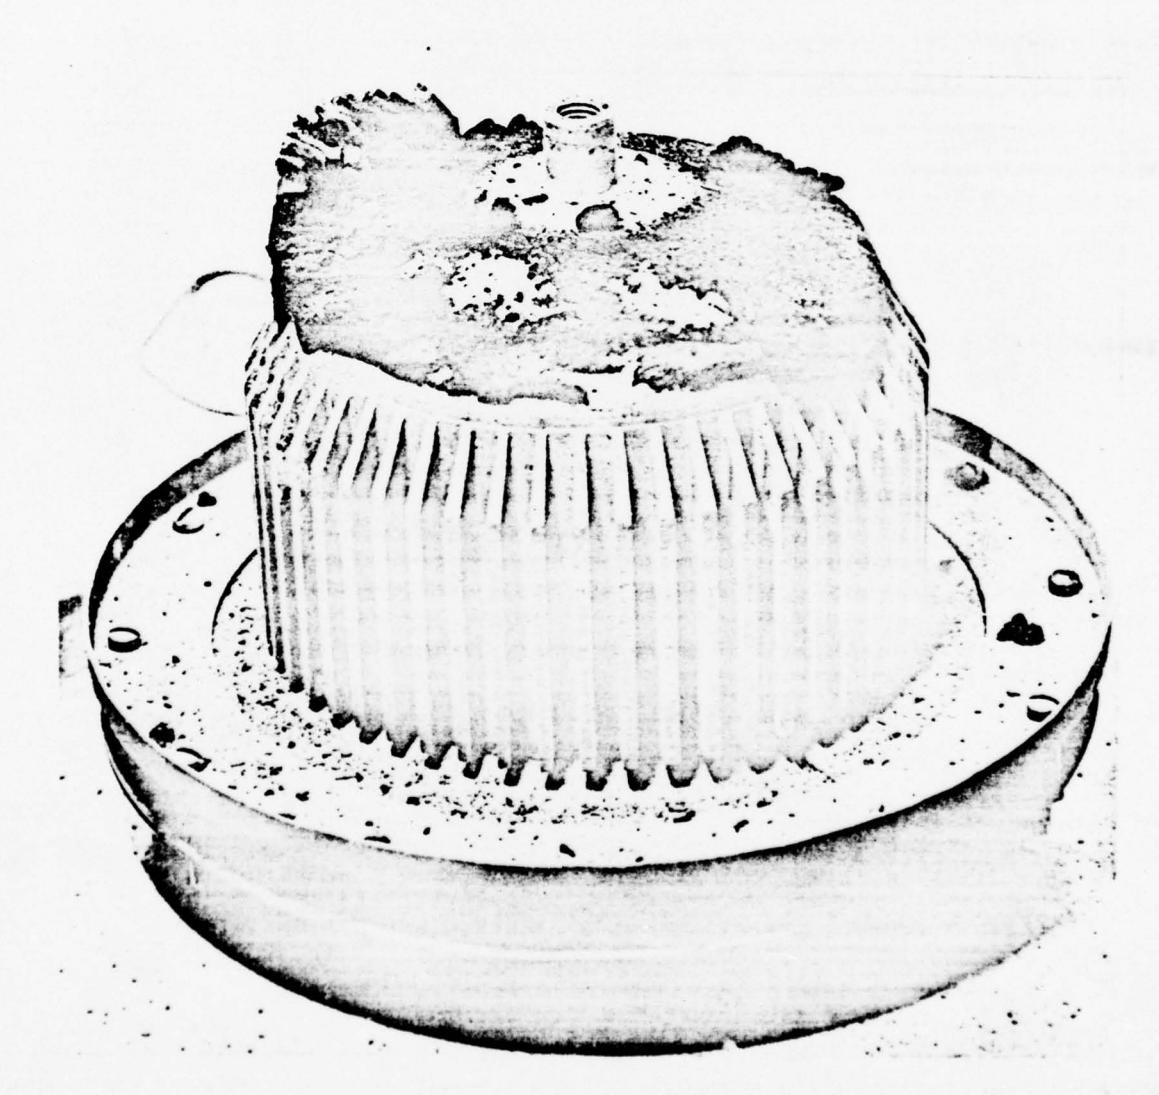
PLATE 6

- (c) Throughout the test, the engine was usually difficult to start, requiring from two to ten trials.
- (d) On two occasions, heavy carbon deposits were found on the heater head, Plate 6, causing interference with combustion.

26. It is considered probable that the observed carbon deposits on the heater head were caused by minor combustion derangements. The deposits occurred at irregular intervals and on some occasions they followed observed combustion irregularities. It is considered that the range of acceptable combustion conditions is too narrow and that the combustion is excessively sensitive to various factors such as burner nozzle pressure, partial plugging of fuel or air nozzles, and variation of the fuel nozzle suction lift.

## CARBON FORMATION ON HEATER HEAD, ORIGINAL ENGINE 4-1/2 HOURS OPERATION SINCE CLEANING

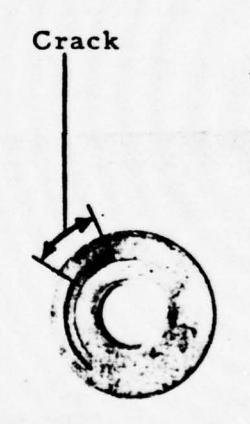
- (e) Compressor difficulties included: cracking of two suction valve discs, Plate 7; sticking of the compressor piston; fouling of the discharge valve with carbon deposits; loosening of the suction valve neoprene seat; and breakage of the compressor crankshaft by failure of the brazed joint of the two-piece shaft, Plate 8.

30. The compressor suction valve discs that cracked during the test of the original engine, Plate 7, were made of steel. Suction valve discs of beryllium copper were later furnished by the contractor. There were no failures of the new type valve discs, either in the original or replacement engines.

# COMPRESSOR SUCTION VALVE, ORIGINAL ENGINE 59 HOURS OPERATION

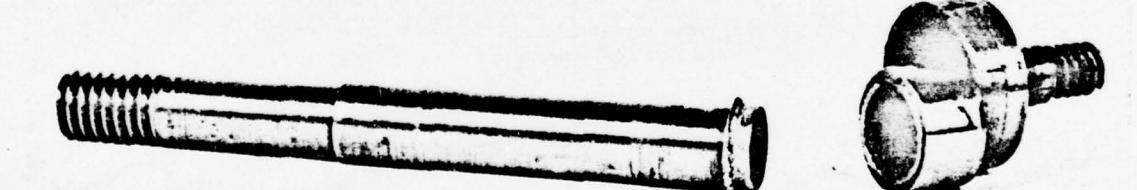
29. The breakage of the compressor crankshaft, Plate 8, was caused by the compressor piston striking the head during operation as a result of insufficient adjusted clearance. A weak brazed, two-piece construction of the crankshaft contributed to the failure. The crankshaft was later replaced by a one-piece shaft of increased strength.

# BROKEN COMPRESSOR CRANKSHAFT, ORIGINAL ENGINE

## 61 HOURS OPERATION

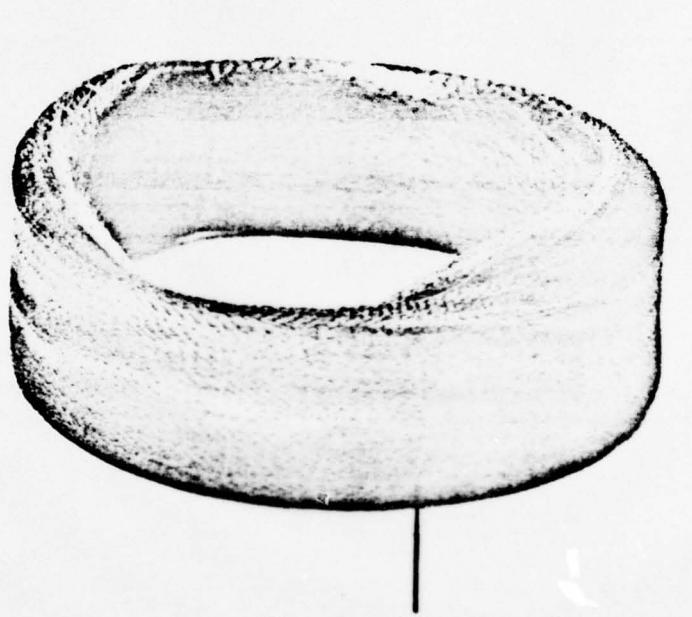
- (i) In the inspection of the engine, incident to the replacement of the heater head, black and white deposits were found on the metal wire of the regenerator, Plate 9. The results of a chemical analysis of the deposits indicated that they contained oil and corrosion or wear products of steel and copper materials in the engine, Appendix III.

33. The analysis of deposits found on the regenerator of the original engine after 81 hours operation, Plate 9 and Appendix III, suggests that corrosion and/or wear products of iron or steel and copper formed part of the material. Analysis of crankcase lubricating oil removed from the engines, Plates 10 and 17, show extraordinarily high ash content for a straight mineral oil, 0.14 to 0.45 percent, indicating the presence of unusual amounts of wear products.

# REGENERATOR, ORIGINAL ENGINE 81 HOURS OPERATION

Discolored by Deposits

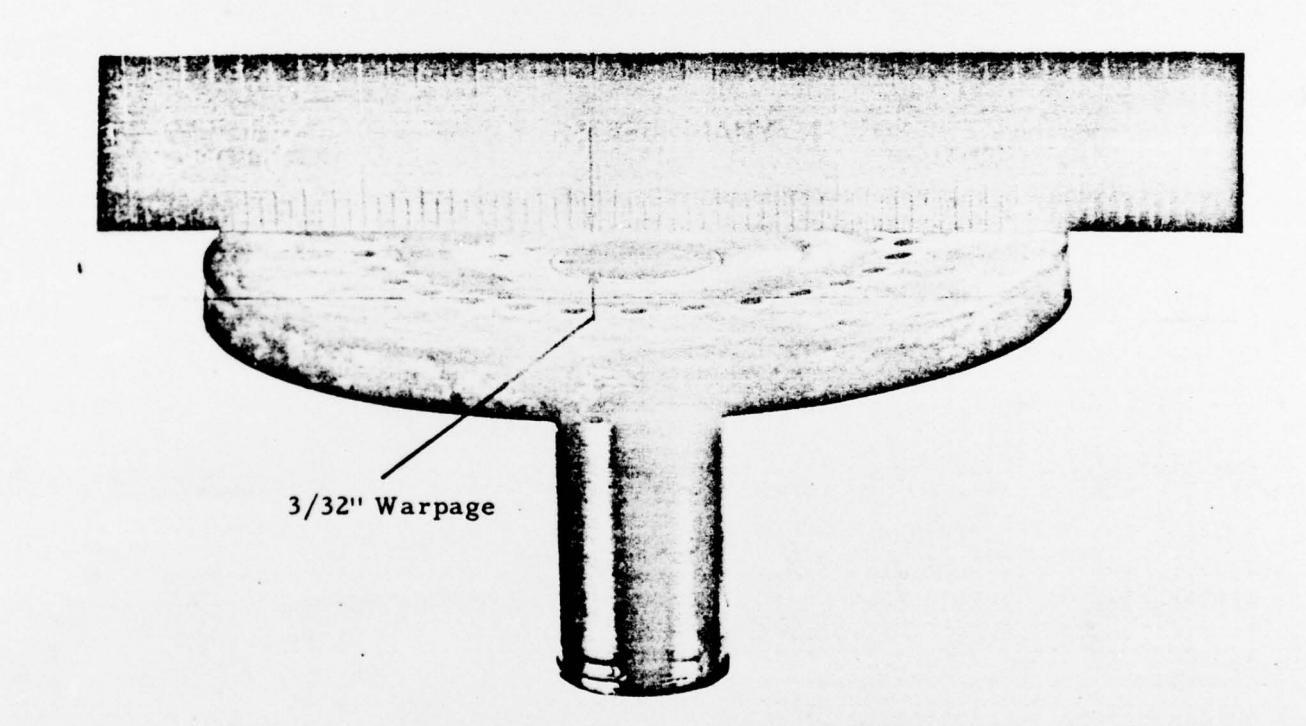
- (e) After 12 hours operation of the engine, deformation of the burner grate occurred, Plate 16, resulting in improper combustion. The part was replaced by a re-designed part having a tapered section; there was no further similar difficulty during the remainder of the test operation.

38. The deformation of the burner grate of the replacement engine after 12 hours operation, Plate 16, was caused by the inadequate design of this part. The grate was supported only at its center and it operated at substantially red heat. The replacement grate had a thicker section at its center with the section tapering toward the periphery. This grate appeared to perform satisfactorily, without visible distortion, during the remaining 67 hours operation.

## BURNER GRATE - REPLACEMENT ENGINE 12 HOURS OPERATION

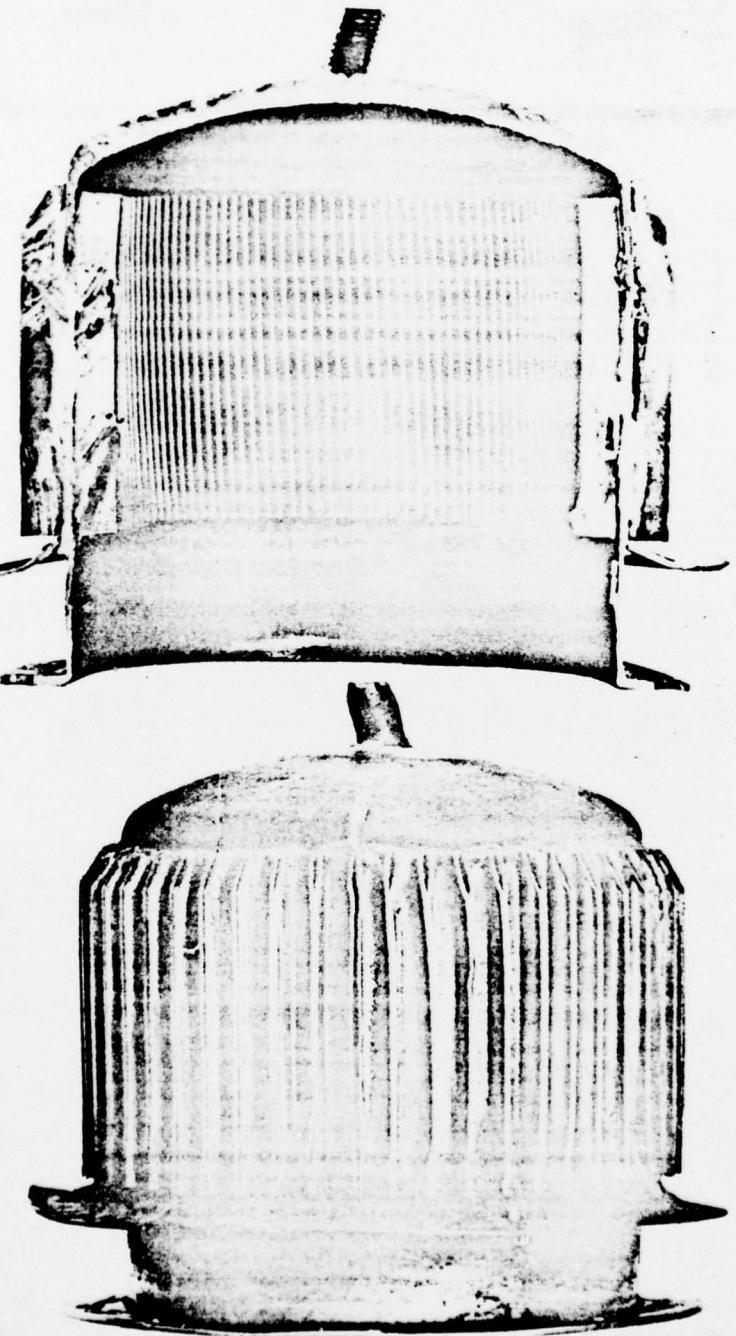
- (h) Cracking of the heater head occurred after 77 hours operation, resulting in a loss of air pressure. The results of a metallurgical examination of the failed part are given in Appendix II.

3. The photographs shown on page 3 illustrate the appearance of the head as received. A photomacrograph (X7) of a polished and etched section through the failure is shown on page 4. Details of construction are clearly evident, and the main crack was found to be surrounded by secondary cracks. Subsequent sectioning and dismantling revealed the crack to be about 1-1/4" long, extending to within 5/16" of either end of the fins.

METALLURGICAL EXAMINATION OF CRACKED HEATER HEAD OF ORIGINAL ENGINE

8. Reference (a) requested recommendations as to means of prevention of this type of failure. Obviously, if the cracks formed during fabrication of the shell, these should be located with a hydrostatic test or other non-destructive means. It is understood that the manufacturer plans to make future heater heads by machining the outer fins and shell from a single piece of Type 310 steel. This approach is a wise one, because the possibility of damage from liquid brazing alloy is eliminated in service. Furthermore, the use of a single piece should add strength to the shell itself. Certainly some means of strengthening the shell should be devised, without impairing heat transfer, so that stresses leading to creep failure will be reduced.

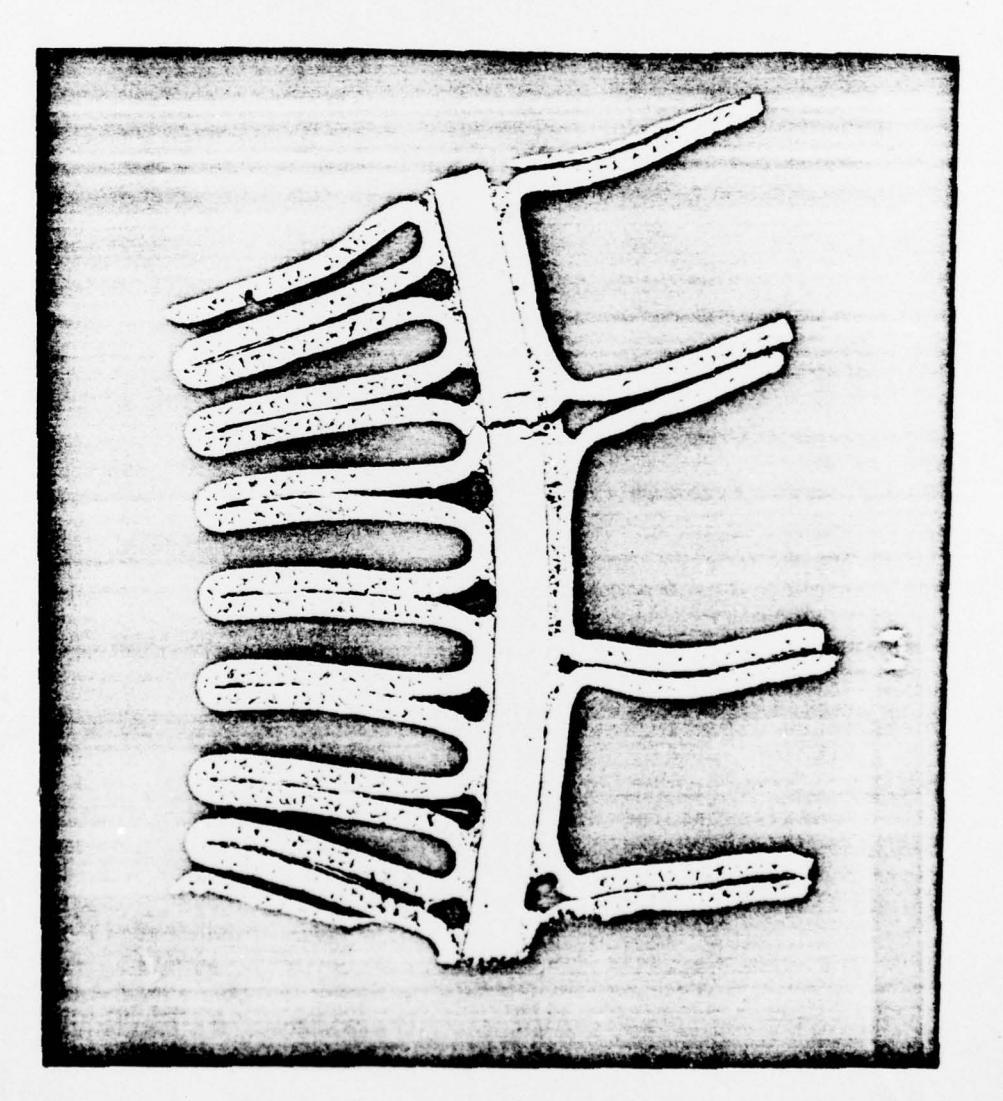
Page 4 Appendix II

## METALLURGICAL EXAMINATION OF CRACKED HEATER HEAD, ORIGINAL ENGINE

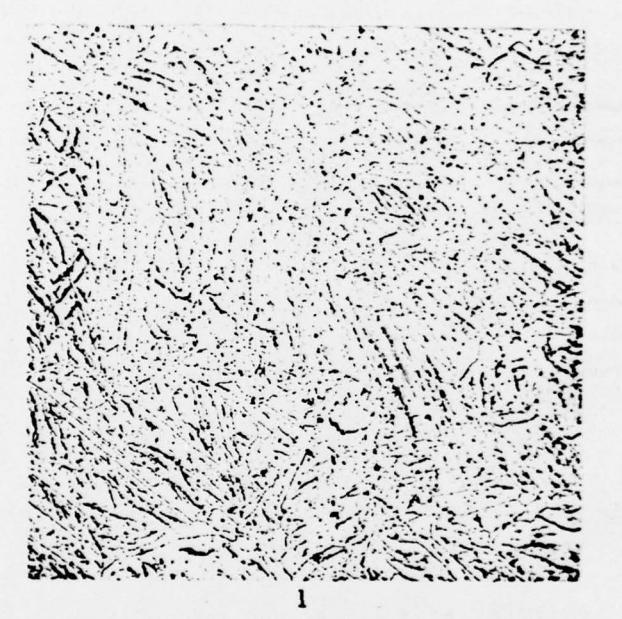
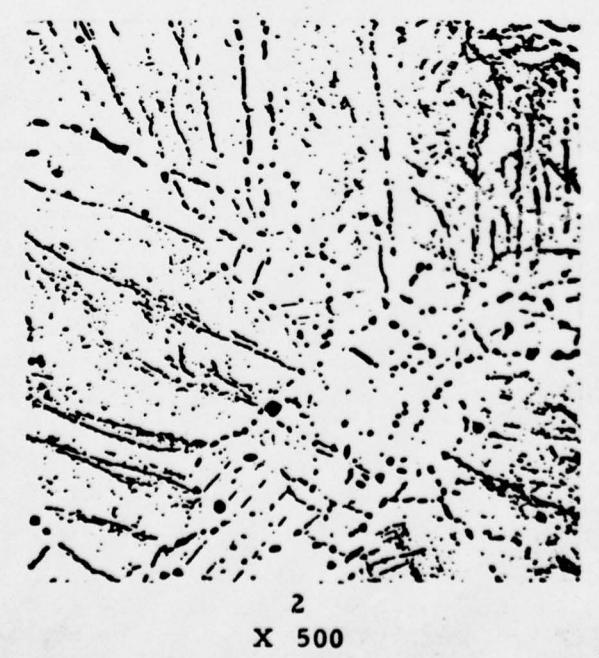
Page 5 Appendix II

4. The microstructure of the stainless shell is shown on page 5. The structure consisted of coarse grained austenite containing many twins. Carbides were precipitated at the grain boundaries and twin planes. The structure is not unusual for this type of material. The bond between the shell and fins was found to be strong.

# METALLURGICAL EXAMINATION OF CRACKED HEATER HEAD, ORIGINAL ENGINE

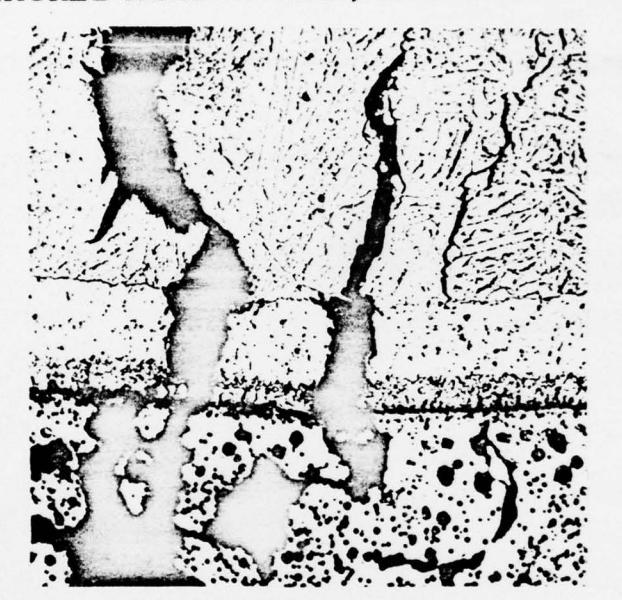
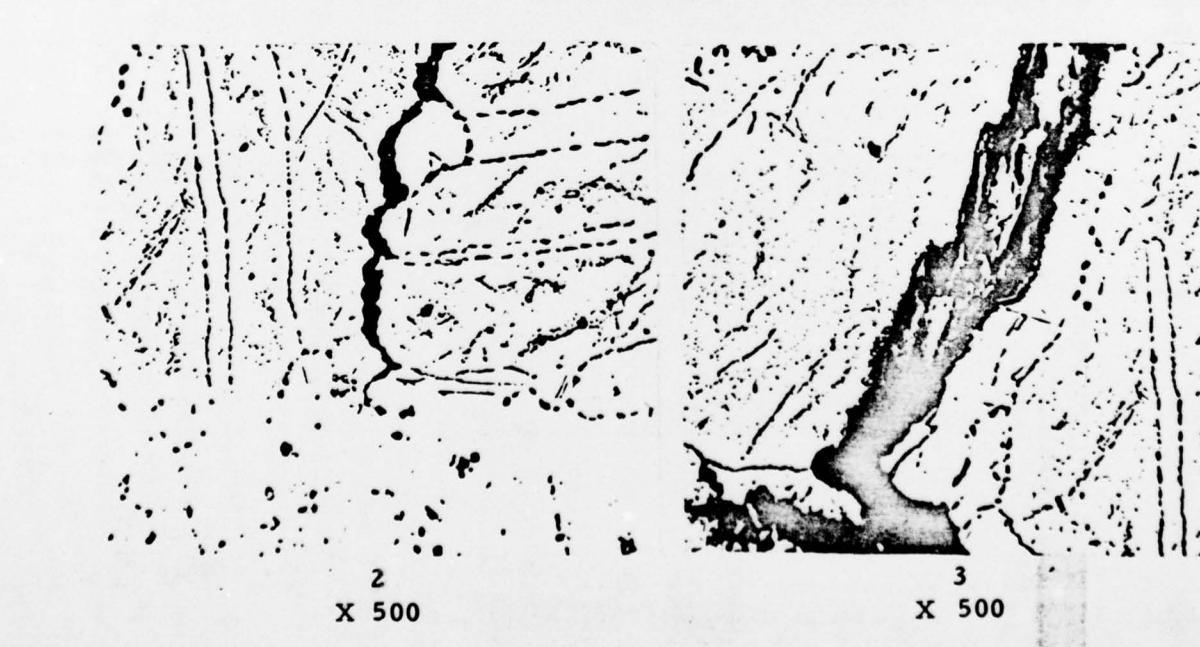
Page 6 Appendix II

6. Photomicrographs taken in the cracked areas are shown on Page 6. All of the cracks followed intergranular paths and contained foreign matter which may be oxides of steel or penetration of brazing alloy oxides. However, for the reason stated in the previous paragraph, if the foreign matter is brazing alloy residue, it is believed that the penetration did not occur until after the crack had formed. The photomicrographs seem particularly interesting since the three cracks illustrated show the life history in the crack development. It is especially noteworthy that the cracks start in the steel shell, then subsequently open up through the brazing alloy and bronze fins to produce a leak.

7. The intergranular nature of the attack and the complete lack of ductility around the rupture would indicate that creep at elevated temperatures was the cause of the failure. The development of an intergranular crack then could be accelerated by the presence of liquid brazing compound. The possibility of a crack formed during fabrication of the shell, even before service, should also be considered, particularly since reference (b) states "X-ray examination of three shells as machined, before brazing the fins in place, located a vertical crack about 5/16"

# METALLURGICAL EXAMINATION OF CRACKED HEATER HEAD, ORIGINAL ENGINE
