APPENDICES A THROUGH BB - Individual Accident Investigation Reports

CAPSIZING/SWAMPING ACCIDENT INVESTIGATIONS FOR 1976 SEASON

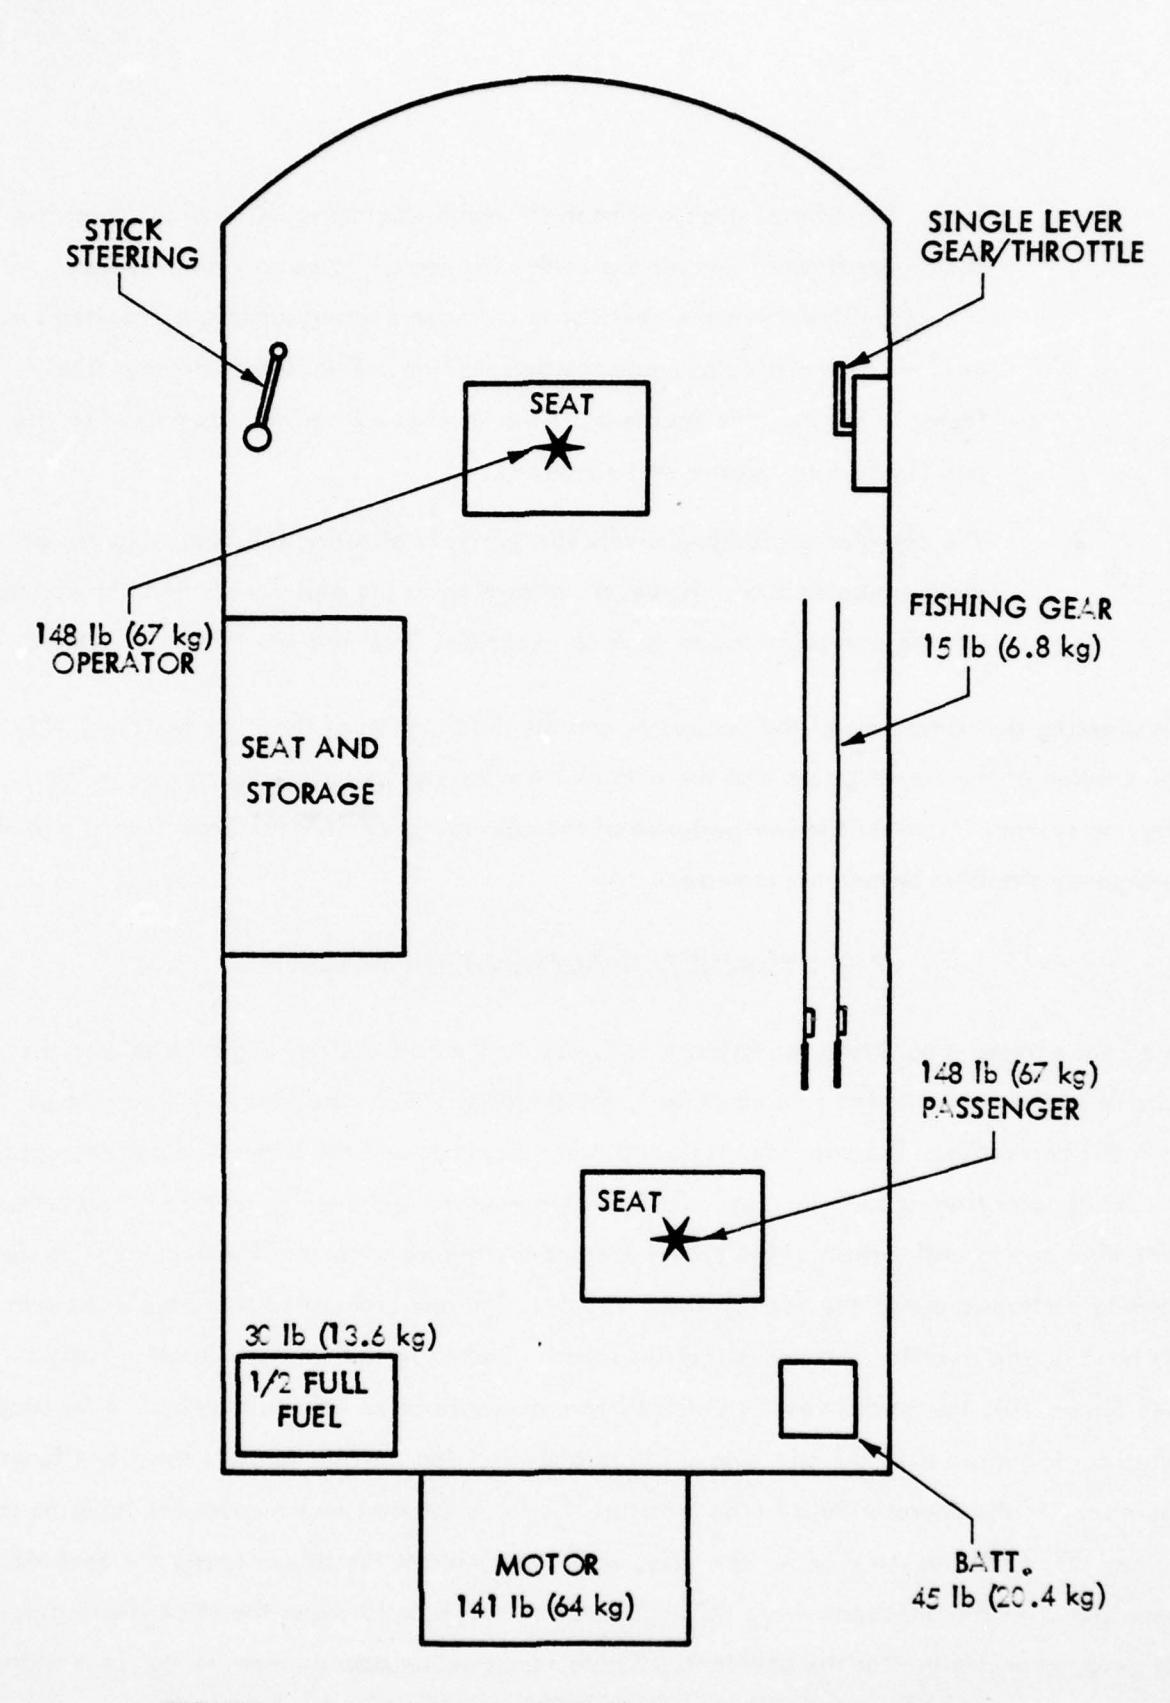
FIGURE 1. BOAT LOAD DISTRIBUTION AT TIME OF ACCIDENT

The boat entered a hard turn to starboard and, due to the hull design, began to skid to the outside of the turn. As the turn continued, the skidding action caused the keel to ride up over the bow wake. The boat then rolled to port (tripped), and the port chine dug in, causing the skidding motion to abruptly stop. Sufficient momentum had been generated in the turn, so that when the lateral motion of the boat was stopped, the momentum of the occupants caused them to be thrown out of the boat on the port side. The operator stated that he always kept his hand on the throttle when traveling full speed. Seated in the normal operating position (see Figure 10), the normal reaction of the operator would be to hold to the throttle for support when being thrown over the port side. The throttle position for full speed is down and forward; therefore, if the operator held to the throttle, the force exerted would cause the lever to come up and aft, reducing the engine rpm. This would account for the slower speed the boat was traveling after the occupants were thrown overboard. Figure 10 shows the stick steering position for zero motor angle after the accident. Figure 11 shows the approximate normal zero motor angle position prior to the accident.

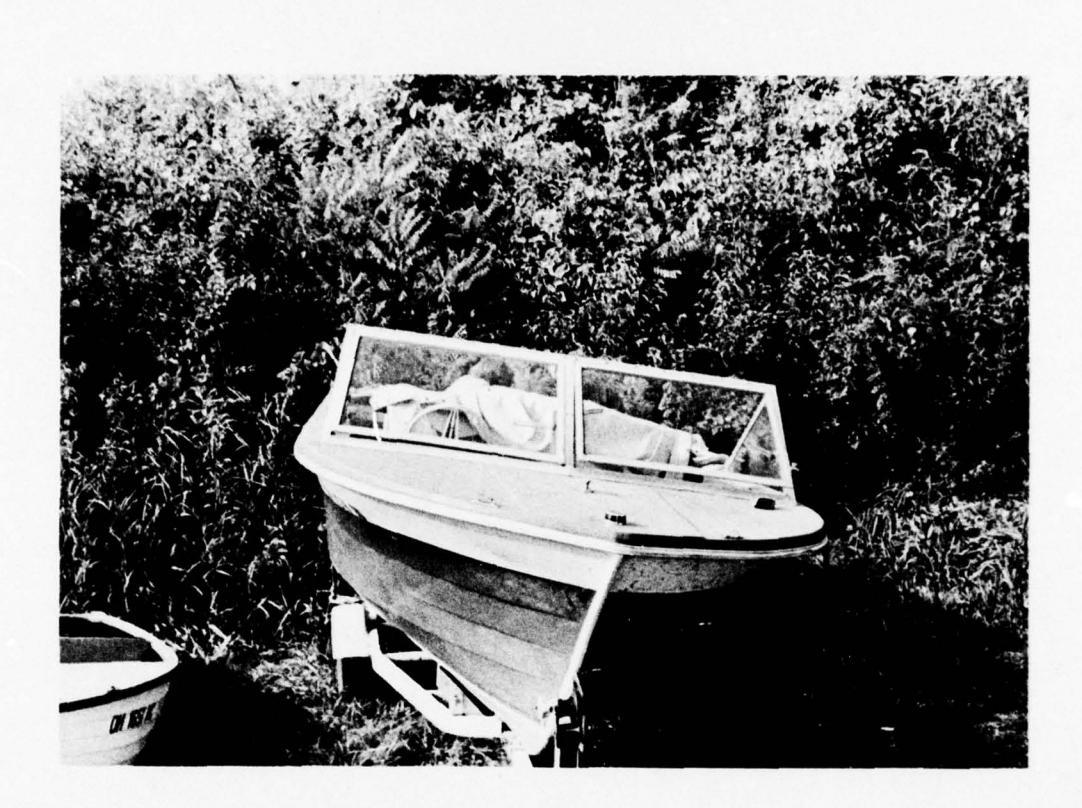
FIGURE 3. FRONT VIEW OF INVOLVED BOAT

The boat was anchored by the port stern cleat. As can be seen in the loading diagram (Figure 1), the aft port side of the boat had a rather large concentration of weight. This would cause the boat to heel to port and trim aft. The operator's daughter said that there was a little water in the boat when they left the dock. With the boat trimmed aft and heeled to port, this water would also add to the heel/trim by flowing into that corner. This excess trim and heel alone might have been enough to reduce the freeboard at the port aft corner enough to allow water to flow over the transom into the motor well. The boat being anchored by the aft port cleat in two to three ft (0.6 - 0.9 m) waves would almost certainly allow water, as each wave hit the transom, to flow into the motor well. The location of the three control cable cutouts was such that the lower edge of each cutout was at the same vertical height as the transom. The absence of rubber boots on the cutouts permitted water coming over the transom to easily pass through the cutouts into the interior of the boat. The double bottom, which apparently had no flotation material and possibly could have leaked through the water sump at the transom, could have partially filled with water before the level reached the cockpit sole. Even if it did not fill with water, the attitude of the boat permitted an accumulation of a large amount of water before the passenger in the starboard aft seat noticed the water almost over her feet. If the boat were heeled to port as indicated by the weight distribution, then the water level at the port side would have been even greater. The accident may have been avoided if the engine would have run and allowed the boat to be headed into the waves. As it was though, the engine would not run, and bailing operations could not keep up with the inflow of water. By this time freeboard aft was reduced sufficiently to allow each wave to break over the transom and into the interior of the boat. The heeling moment caused by all the occupants exiting from the same side of the boat initiated a rolling motion which was amplified by the free surface effect of the water in the boat, causing the boat to capsize and come to rest in an inverted, bow high attitude.

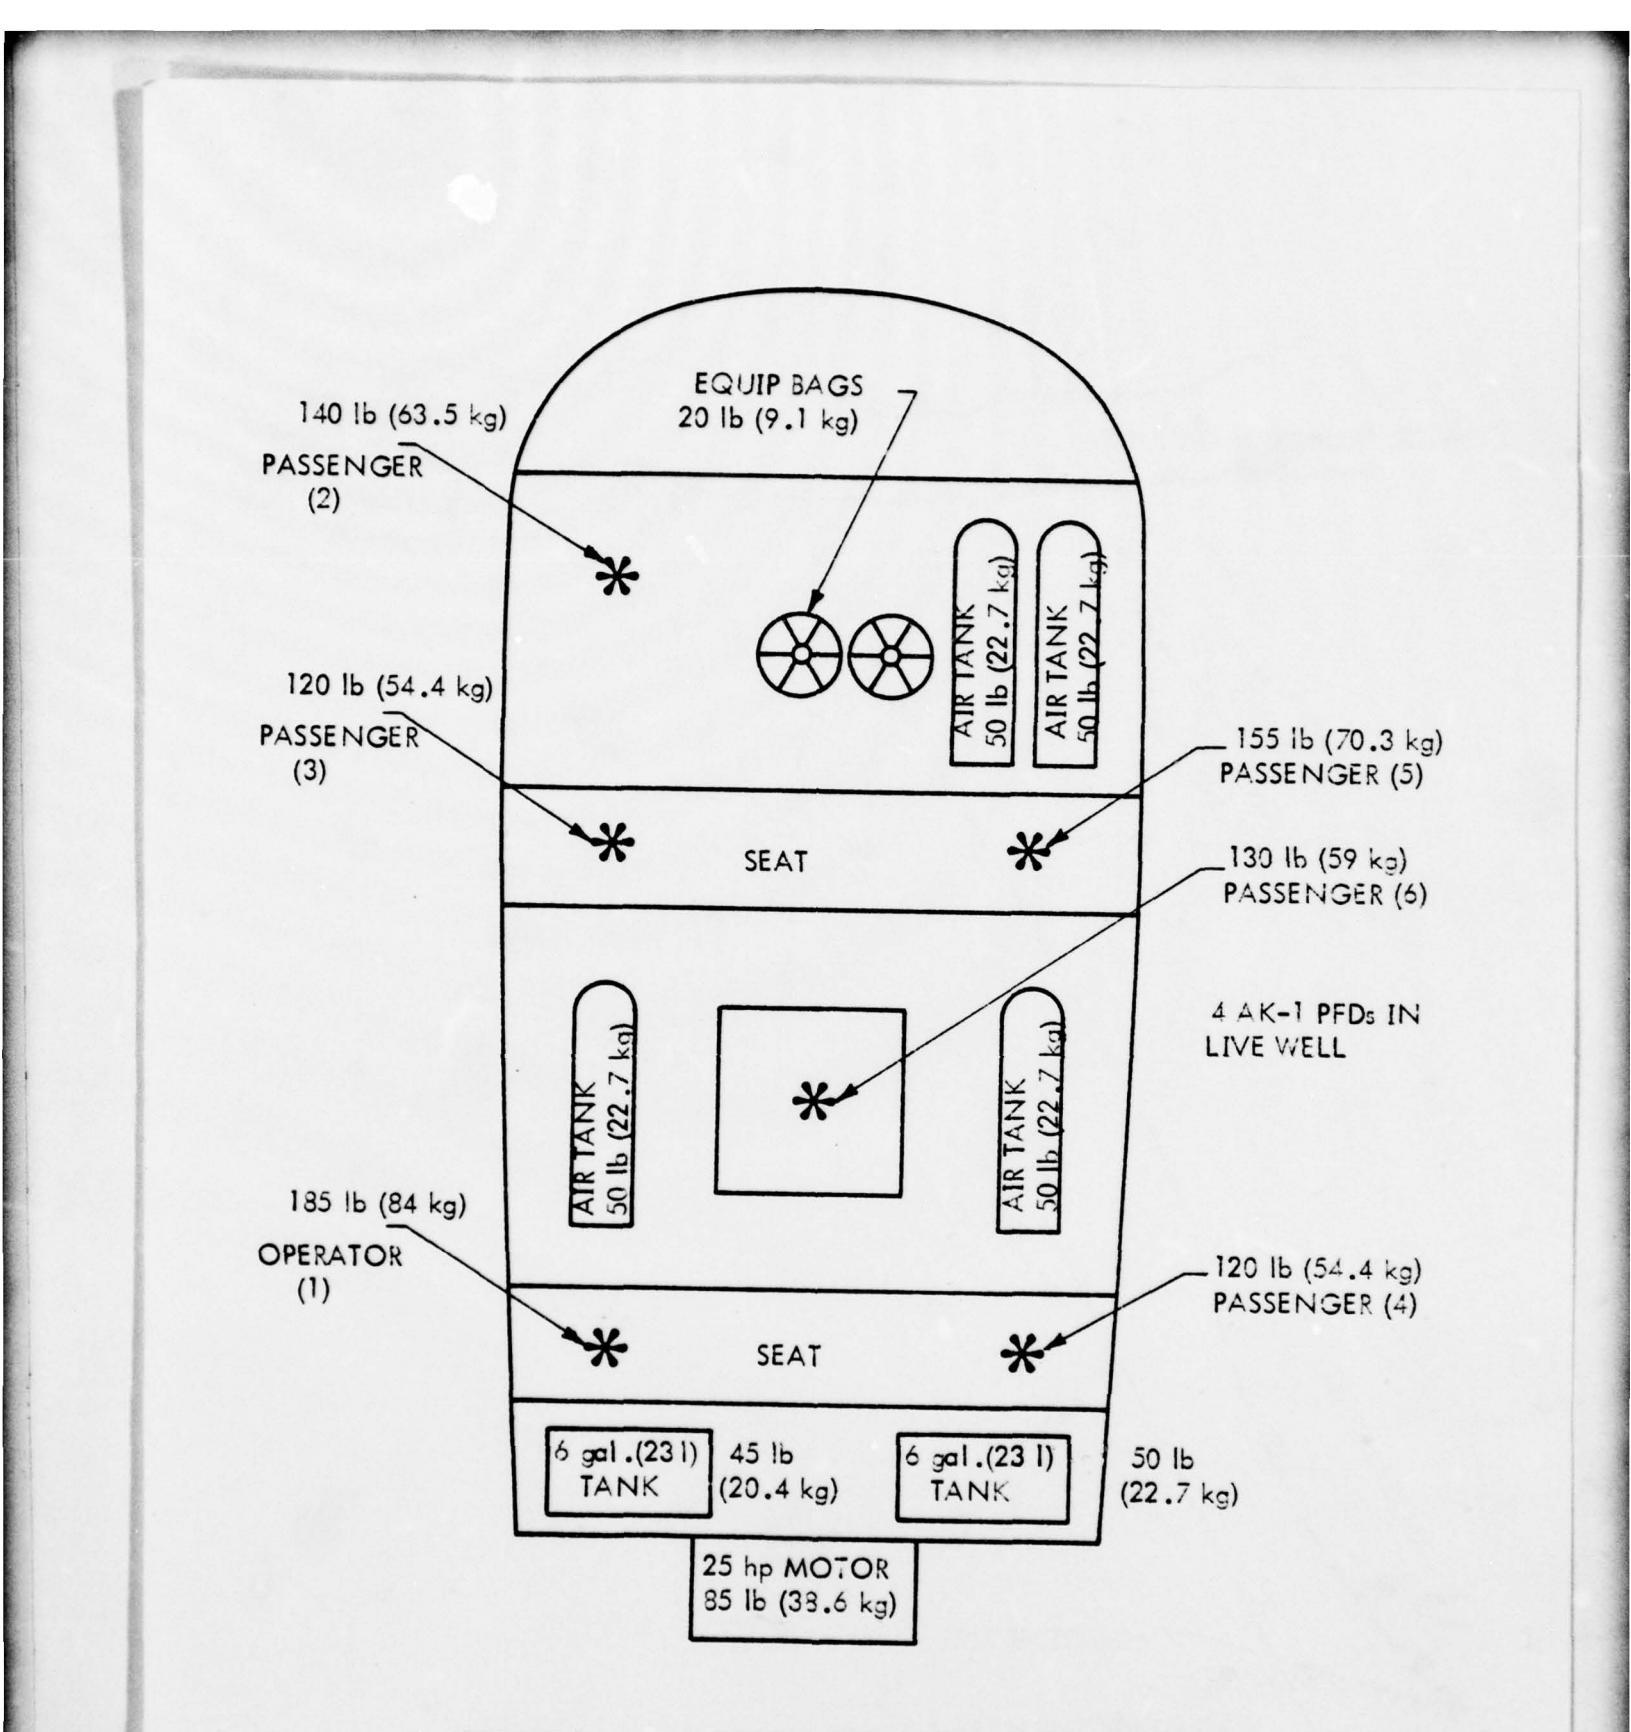
FIGURE 1. LOAD DISTRIBUTION AT TIME OF ACCIDENT

According to the estimated weight in the boat at the time of the accident, the loading exceeded the maximum weight capacity, and there was most likely a significant amount of free water in the inner hull. The load distribution was such that the boat was most likely running essentially in a level attitude at approximately five mph (eight kph). The boat went over the crest of the two to three ft (0.6 - 0.9 m) wave and headed bow first into the trough. As the boat headed down the wave, any water in the inner hull would flow forward, increasing the weight in the bow. When the bow reached the trough, people, gear, and water weight in the bow and forward momentum of the boat caused the bow to slice into the next wave. The bow freeboard was reduced to zero and allowed water to flow freely over the bow, flooding the boat. With the flotation material installed low in the boat and the center of gravity of the weight in the boat at a much higher level, the boat had a natural tendency to capsize when flooded. After the boat was upside-down, the flotation material provided sufficient buoyancy to keep the boat afloat and stable with the occupants holding to the sides.

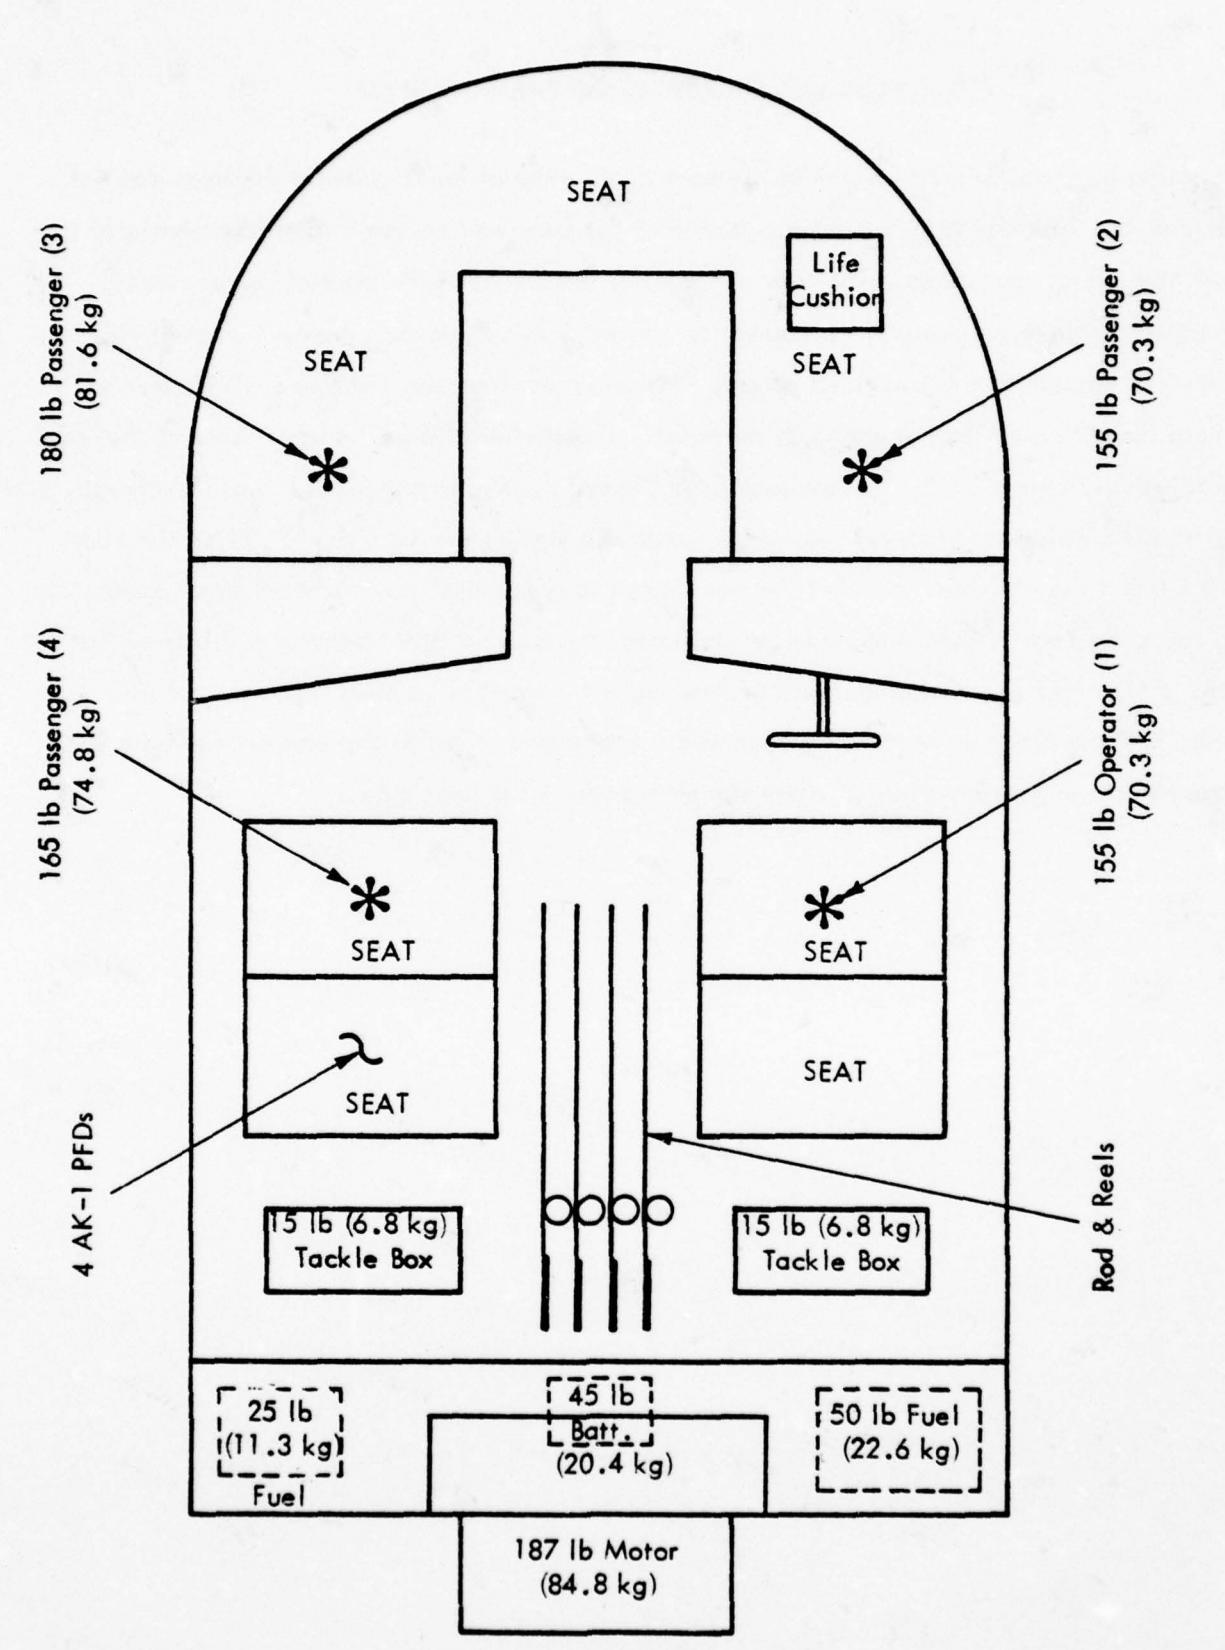
FIGURE 1. LOAD DISTRIBUTION AT TIME OF ACCIDENT

According to the estimated weight in the boat at the time of the accident, the boat was not overloaded. The load distribution was such that the boat was probably running essentially in a level attitude at idle speed. The tide was -0.3 ft (-0.09 m) at the time of the accident, consequently there was very little current or current induced waves. Rough waters in the inlet were caused by wind induced waves. The wind was from the southwest which created a sharp sheer line across the mouth of the inlet. The sheltered water on the inside of the inlet was relatively calm, while the exposed water beyond the mouth of the inlet was very rough. The transition distance from calm to rough water was most likely very short. When the boat went beyond the mouth of the inlet, waves started to break over the starboard stern completely swamping the boat. Wind and wave action causes the boat to drift to the ocean side of the north jetty. Apparently the boat had an insufficient amount or no flotation material installed because the boat eventually completely submerged. The boat probably floated due to entrapped air in the inner hull. When the air escaped, the boat sank.
