Special Report 78-17

September 1978

EFFECTS OF WINTER MILITARY OPERATIONS ON COLD REGIONS TERRAINS

COLD REGIONS RESEARCH AND ENGINEERING LABORATORY
U.S. ARMY CORPS OF ENGINEERS
HANOVER, NEW HAMPSHIRE

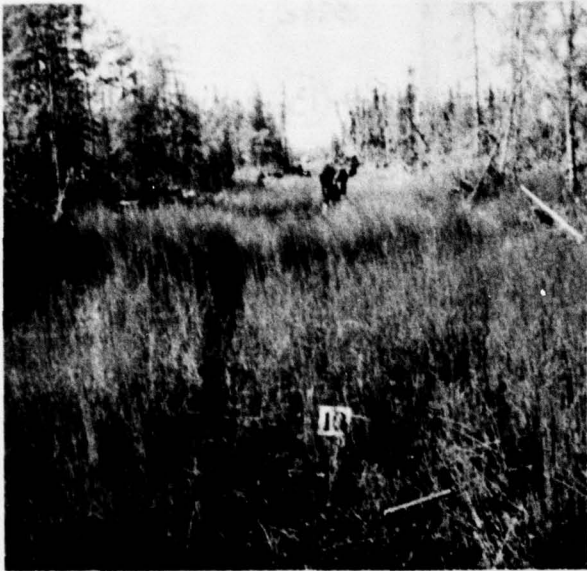
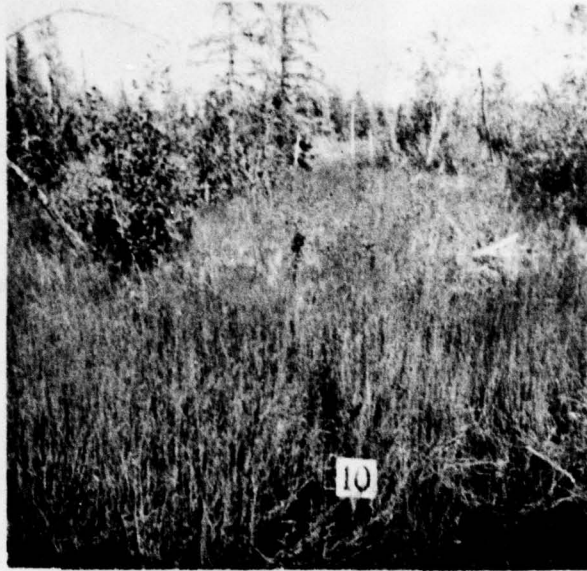
Site 10 (Figs. 6 and 7) A poorly drained, open black spruce and tamarack stand with a patchy shrub understory of willow and resin birch and a high percentage cover of sedges and grasses, primarily cottongrass, bluejoint reed-grass and common herbaceous horsetail.

Most of the surface vegetation had been removed by the bulldozer blade down to the surface of the organic soil. Since many roots and rhizomes were left in place, rapid sedge and grass regrowth has occurred within the trail. Thaw depth in the trail was approximately 1 m, and in the adjacent undisturbed area approximately 80 cm.

Figure 6. Site 10
(looking N).

Figure 7. Area adjacent to site 10
(looking E).

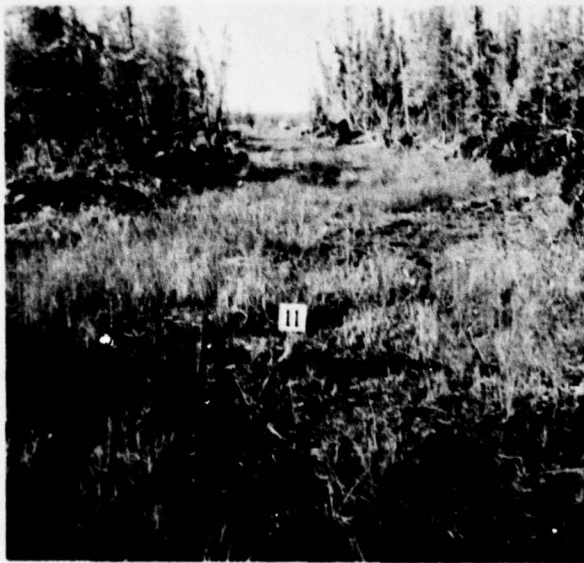
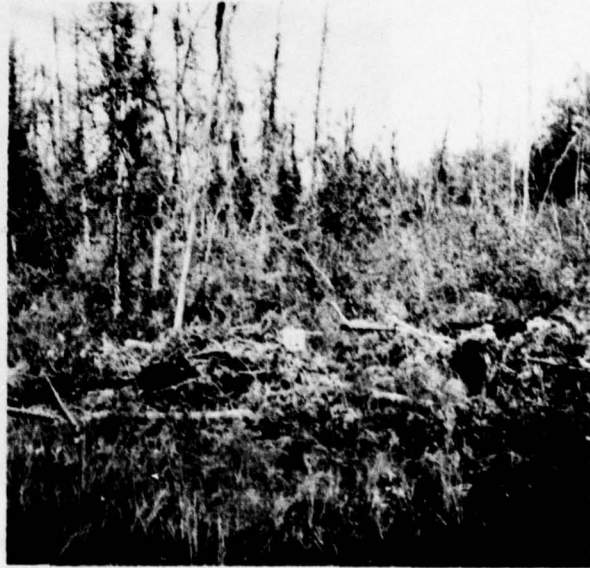
Site 11 (Figs. 8 and 9). Similar to site 10, except better drained with more continuous layer of black spruce and a few tamarack and almost complete cover by shrub understory of resin birch, buffaloberry and willow.

Trees and shrubs had been removed along with their roots, exposing large areas of organic soil. The revegetated grass cover on the trail varied from 1 to 80%, consisting mainly of cottongrass and a few tussock cottongrass with some bluejoint reedgrass and horsetail. Thaw depth in the trail was approximately 1 m, and in the adjacent area 90 to 95 cm.

Figure 8. Site 11
(looking N).

Figure 9. Area adjacent to site 11
(looking E).

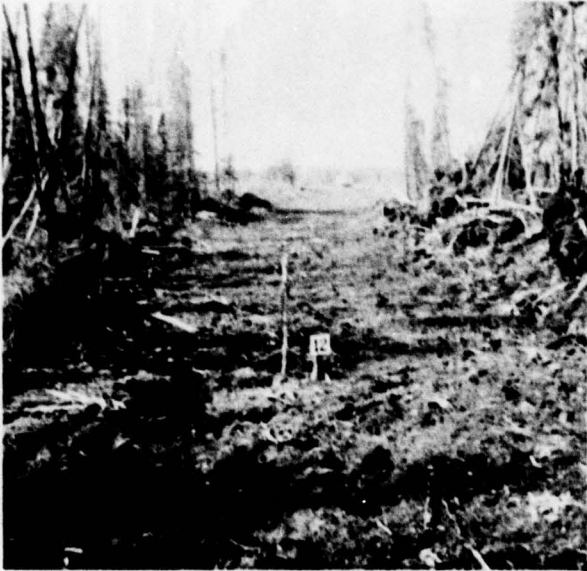
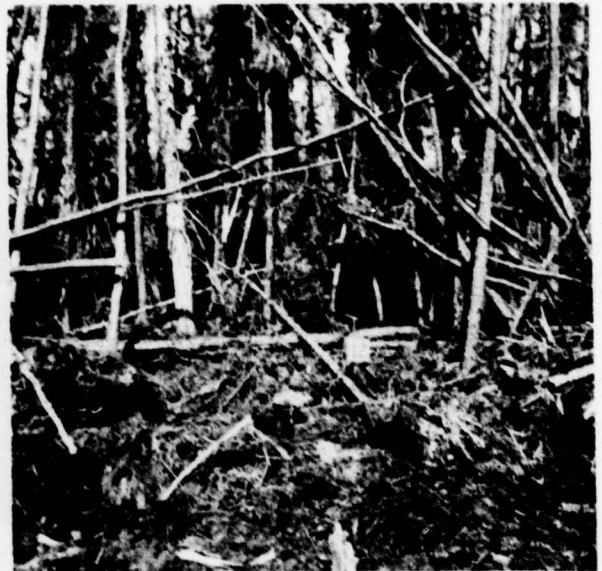
Site 12 (Figs. 10 and 11). Drier than the previous two sites with a 5 m (approx.) black spruce overstory, a few taller willows and an extensive low shrub understory of labrador tea, bearberry, low bush cranberry and prickly rose, and a moss ground cover.

Because of the overstory density, removal of the trees with their roots had resulted in nearly complete removal of the surface vegetation mat, exposing dry organic soil. Vegetation cover on the trail was less than 10%, consisting of scattered seedlings of cottongrass. Some scattered debris from the trees remained on the trail surface. The thaw depth probe penetrated only 70 cm to what appeared to be gravel, not the frost line.

Figure 10. Site 12
(looking N).

Figure 11. Area adjacent to site 12
(looking E).

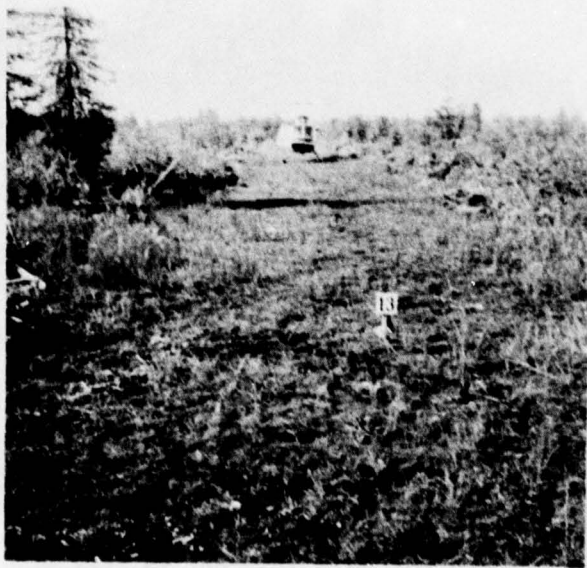
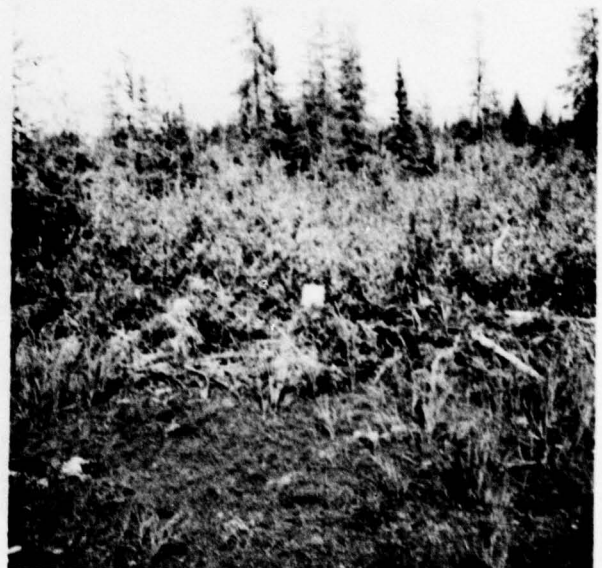
Site 13 (Figs. 12 and 13). A willow shrub thicket with scattered tamarack, resin birch, moss hummocks, bluejoint reedgrass and sedge.

The trail cut had been done with very little penetration of the bulldozer blade into the soil. Revegetation had produced a 20% vascular plant cover over the dried organic soil, the prominent species being tussock cottongrass, bluejoint reedgrass, horsetail, sedge and some willow. What appeared to be either the frost line or gravel was detected at a depth of 80 cm.

Figure 12. Site 13
(looking N).

Figure 13. Area adjacent to site 13
(looking E).

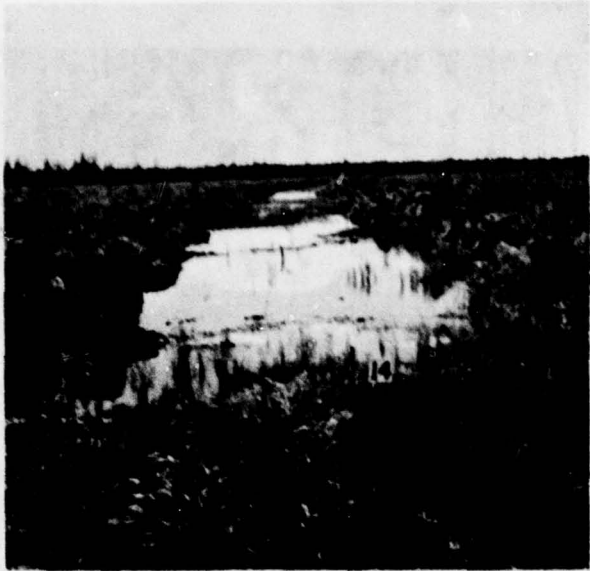
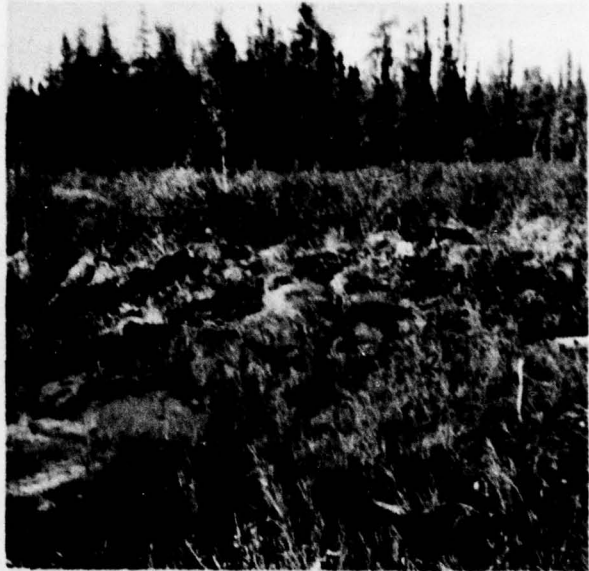
Site 14 (Figs. 14 and 15). A poorly drained, well developed shrub-tussock community with cottongrass tussocks up to 1 m in diameter, scattered paper birch with numerous resin birch and willow species; species frequently occurring on the tussocks include cloudberry, labrador tea, and blueberry, as well as mosses.

Blade penetration had been down to the bottom of tussocks, near the natural water level. The vegetation cover was less than 10%, primarily bluejoint reedgrass and horsetail, with exposed, wet organic soil and ponded water elsewhere. Thaw depth in the trail was 60 to 65 cm, and 35 to 40 cm in the adjacent area (measured from the bottom of tussocks).

Figure 14. Site 14
(looking N).

Figure 15. Area adjacent to site 14
(looking E).

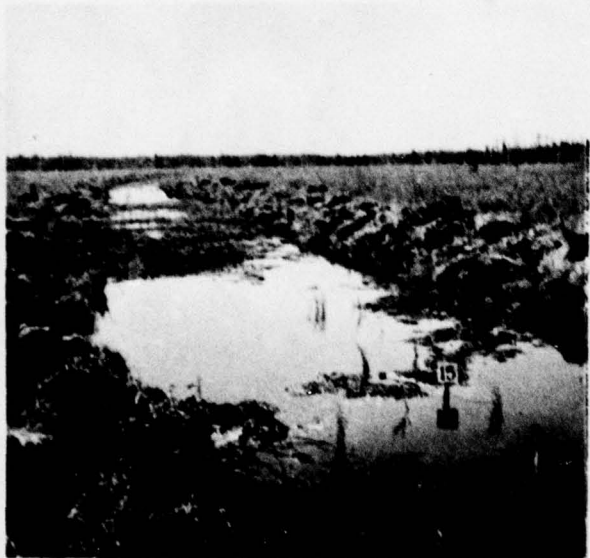
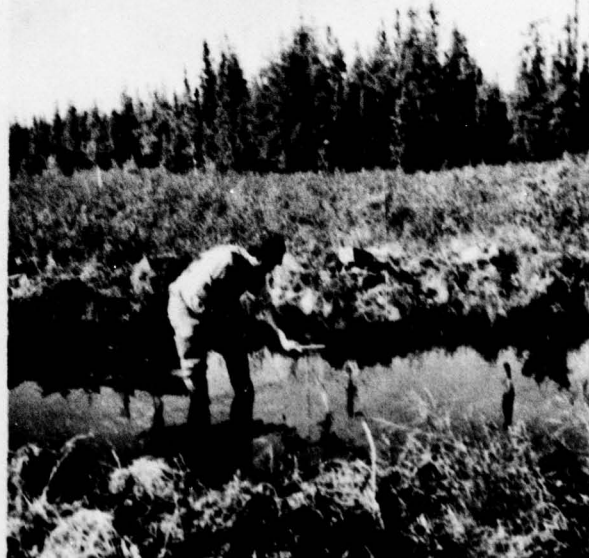
Site 15 (Figs. 16 and 17). Same original vegetation cover as at site 14.

At this location, blade penetration had been several cm below the bottom of tussocks, resulting in standing water, up to 10 cm deep, in the trail. Some bluejoint reedgrass and iris were observed in the water. Thaw depth was 70 cm below the water surface, and 31 to 36 cm in the adjacent area (measured from the bottom of tussocks). This site represents one of the deepest disturbances on the new trail, in terms of bulldozer blade penetration.

Figure 16. Site 15
(looking N).

Figure 17. Area adjacent to site 15
(looking E).

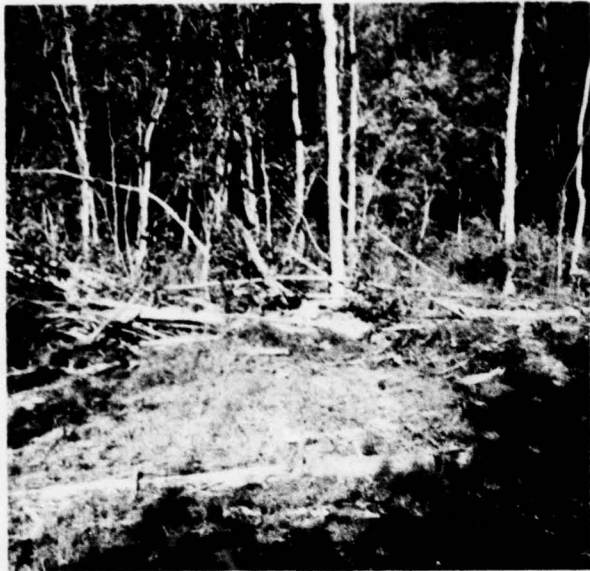
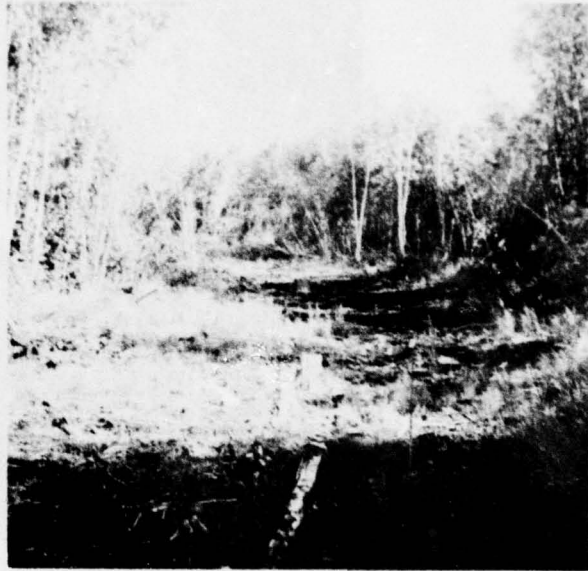
Site 16 (Figs. 20 and 21). A mixed paper birch (dominant) - white spruce stand with a tall understory of alder and willow (approx. 5 m.), indicating a relatively young stand.

Trees and other vegetation had been removed to a level even with the terrain surface. Some trees had been uprooted, exposing wet organic soil. Vegetation cover varied from 10 to 90% over the area, the dominant species being bluejoint reedgrass and horsetail with numerous willow seedlings. Thaw depth was greater than 1 m.

Figure 20. Area adjacent to site 16
(looking E).

Figure 21. Site 16
(looking S).

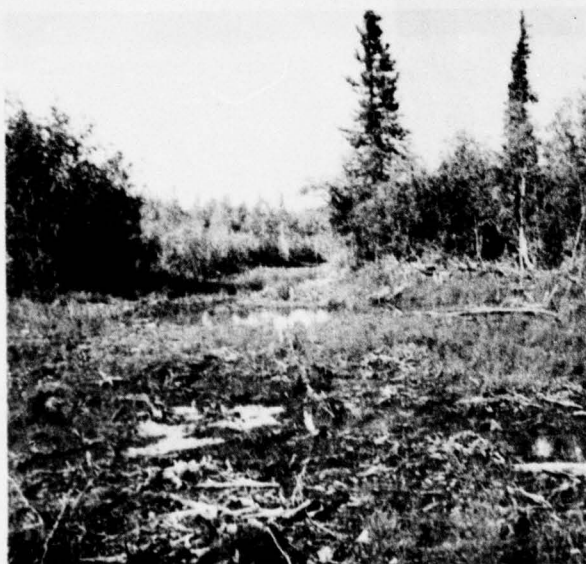
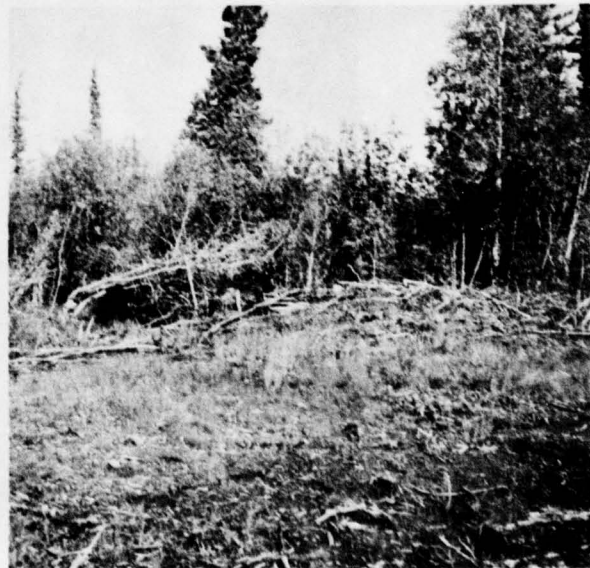
Site 17 (Figs. 22 and 23). A tall (5-m) alder-willow shrub community (similar to the understory at site 16), with a few paper birch and white spruce.

The surface disturbance was more severe than at the nearby site 16. Blade penetration and uprooting of some of the trees had resulted in several depressions deep enough to expose standing water. Vegetation cover varied from 0% in the exposed water areas to 80% in the drier, less disturbed locations, and included bluejoint reedgrass, horsetail, fireweed, prickly rose and bunchberry. Thaw depth was greater than 1 m.

Figure 22. Site 17
(looking N).

Figure 23. Area adjacent to site 17
(looking E).

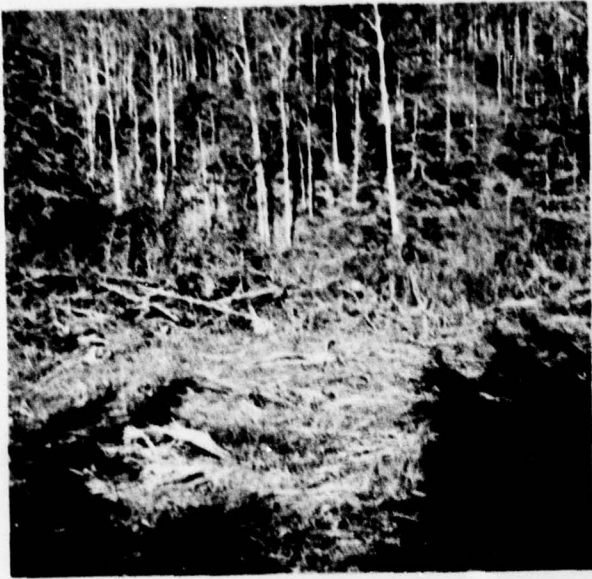
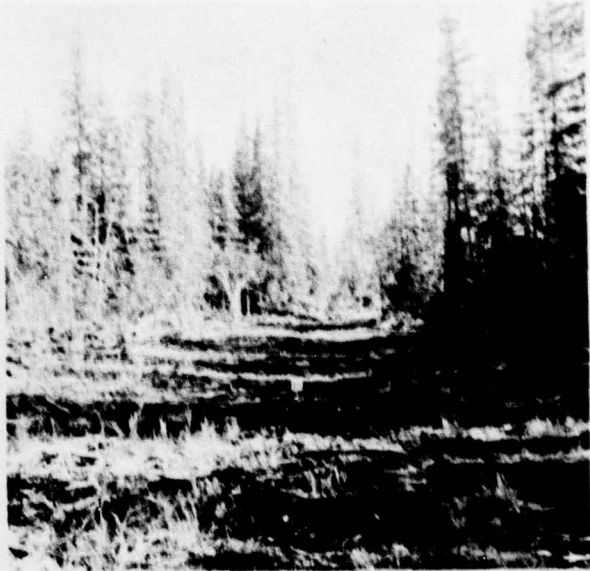
Site 18 (Figs. 26 and 27). A mixed spruce-birch stand, similar to site 16, but better drained, with a 10% vascular plant cover, consisting of fireweed, winter cress, horsetails, sedges and scattered willows.

Disturbance has been comparable to that at site 16, with vegetation removed even with the terrain surface, exposing organic soil at intermittent locations. This site had been used for vehicle repair and maintenance.

Figure 26. Area adjacent to site 18
(looking E).

Figure 27. Site 18
(looking S).

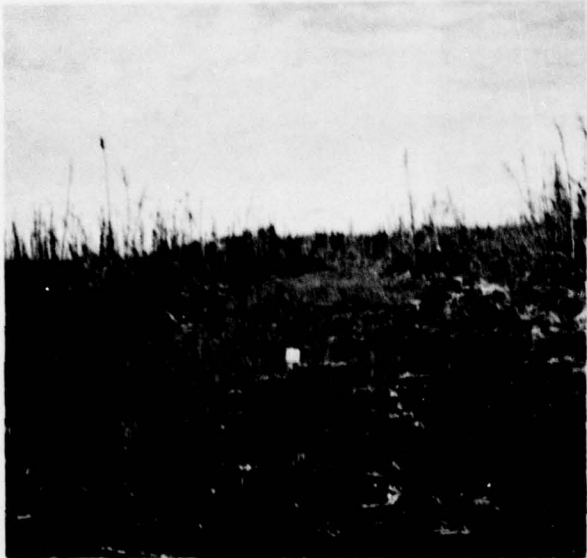
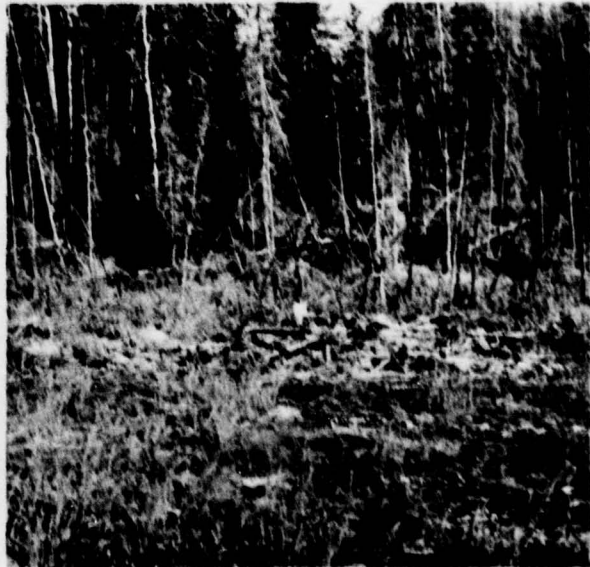
Site 19 (Figs. 28 and 29). A stand of dead spruce with a low shrub understory (primarily willow) in a well drained area.

Blade penetration had been even with or slightly below the soil surface, resulting in areas of exposed, dry organic soil. Revegetation by grasses and willow seedlings had produced a cover of less than 50% of the trail surface. This site was later burned out during a forest fire.

Figure 28. Site 19
(looking N).

Figure 29. Area adjacent to site 19
(looking E).

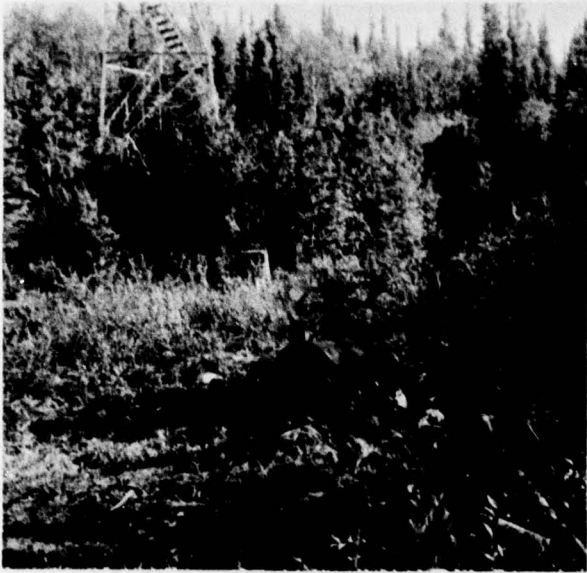
Some debris were found near the tower (Fig. 36), indicating troop activities, but generally the area had been cleaned up very well.

Figure 36. Troop concentration
(artillery) area.
