SUSQUEHANNA RIVER BASIN ROARING BROOK, LACKAWANNA COUNTY

NO. 7 DAM

PENNSYLVANIA GAS AND WATER COMPANY (NDS ID No. 363)

PHASE I INSPECTION REPORT

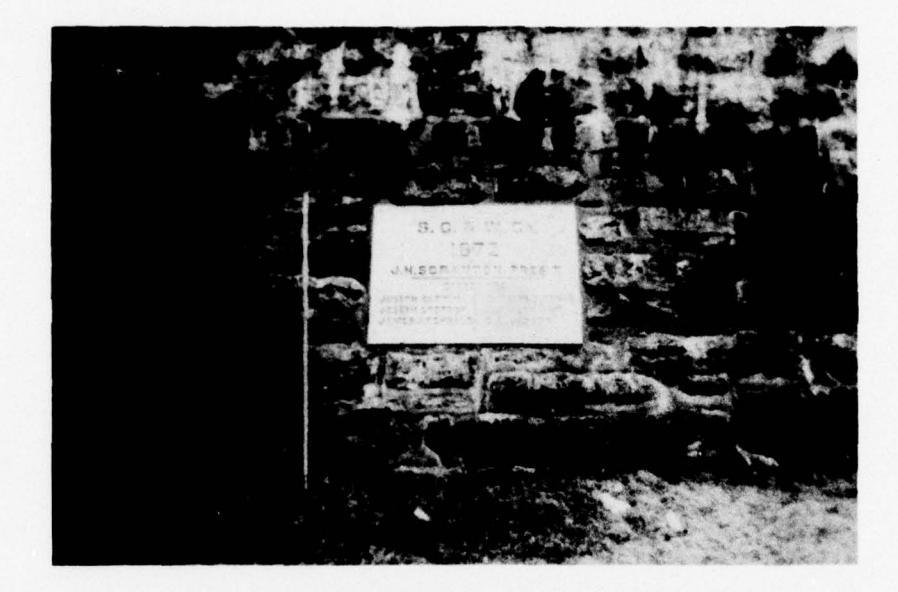
(2) <u>Gravity Dam.</u> Exposed masonry joints on the downstream face of the gravity dam were generally sound. However, over a 3-foot by 20-foot area between the gatehouse and the screen chamber building above the normal pool level, the masonry joints were cracked and weathered. A 1/16-inch wide vertical crack was on the downstream face behind the screen chamber building at the chlorine tank storage platform (Photograph G). The crack extended from just above the platform level to the top of dam, and a corresponding crack was nearby on the upstream face. The crack on the downstream face did not follow masonry joints, but went through two of the 12-inch thick facing stones. No differential movement was observed.

A. Downstream Face of Dam Left of Spillway

(2) Repair weathered masonry joints and vertical crack on the nonoverflow section located to the left of the spillway.

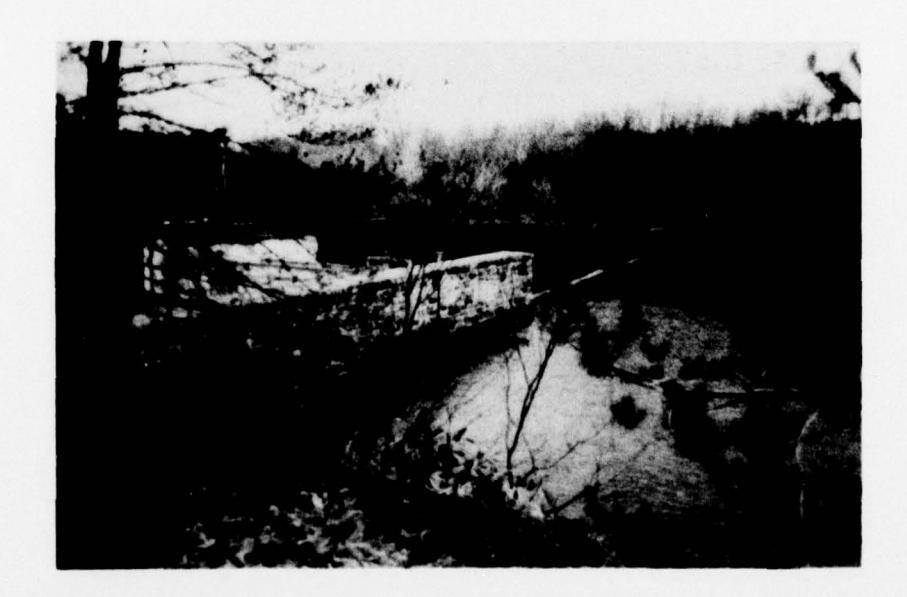
B. Dam and Spillway Approach Area Looking Downstream

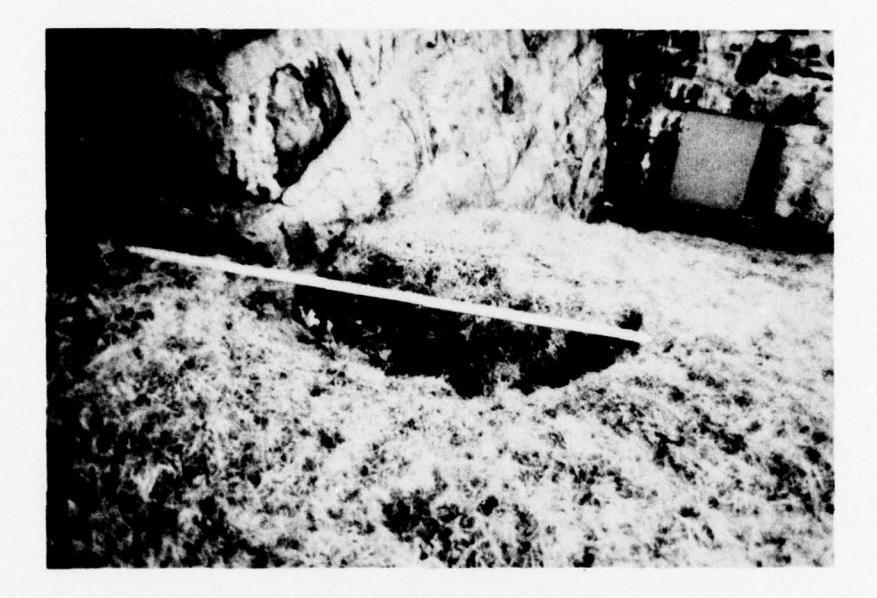
(1) Embankment Fill Area. The slope of the embankment fill area, which is located along the downstream face of the masonry gravity dam between the gatehouse and the screen chamber building, had a 12-foot by 25-foot area adjacent to the screen chamber building that was outlined by cracks. At the top of the affected area, which is at the top of the slope, some sloughing over a 5-foot by 2-foot area was observed (Photograph I). Maximum depth of depression at that area was 18 inches. At the lower end of the affected area, which is at the toe of the slope, the soil was more moist than the adjacent areas, but no actual water was visible. Along the toe of the slope at its right end, which is at the left corner of the gatehouse, clear standing water covered an area about 6 feet in diameter to a maximum depth of 4 inches (Photograph H). The source of the water could not be determined. Investigation of the lower level of the gatehouse showed several small weep holes in the wall near the same corner that were apparently installed to admit the water. The estimated flow into the gatehouse was 4 to 5 gallons per minute. The inflow was collected by a 6-inch diameter cast-iron pipe that discharged into the adjacent downstream channel. A 2-foot diameter depression in the backfill was at the junction of the outlet channel wall and the gatehouse, and several smaller depressions were located along the junction of the embankment slope and the left side of the gatehouse. The Owner said that the wet area and other conditions are seasonal.

(1) Embankment Fill Area. The various problems that were observed in the embankment fill area might be related. Apparently, all the problems are caused by one or more undetermined flows of water through the embankment fill. Examination of the surface area that drains to the problem areas indicated that probably not enough direct surface runoff would result to account for the observed deficiencies. Examination of previous inspection reports did not yield any information pertinent to the wet area. The actual damage caused by the water was slight, and it appears that the water is being removed in a manner that does not damage other features. The consequences of a slope failure of the embankment fill area are that the reserve resistance that it provides for the nonoverflow section of the dam against overturning and sliding would be reduced. Therefore, even though the Owner indicated that it is a seasonal condition, the problems are of some concern. (2) The condition of the weathered and cracked masonry joints on the small area on the downstream face of the nonoverflow section is undesirable, and the condition will probably worsen in time.

I. Slough in Embankment Adjacent to Gatehouse

(1) Install two or more observation wells, or other instrumentation, in the vicinity of the wet area in the embankment fill downstream from the dam. Monitor instruments and record data so that any change in condition is detected.

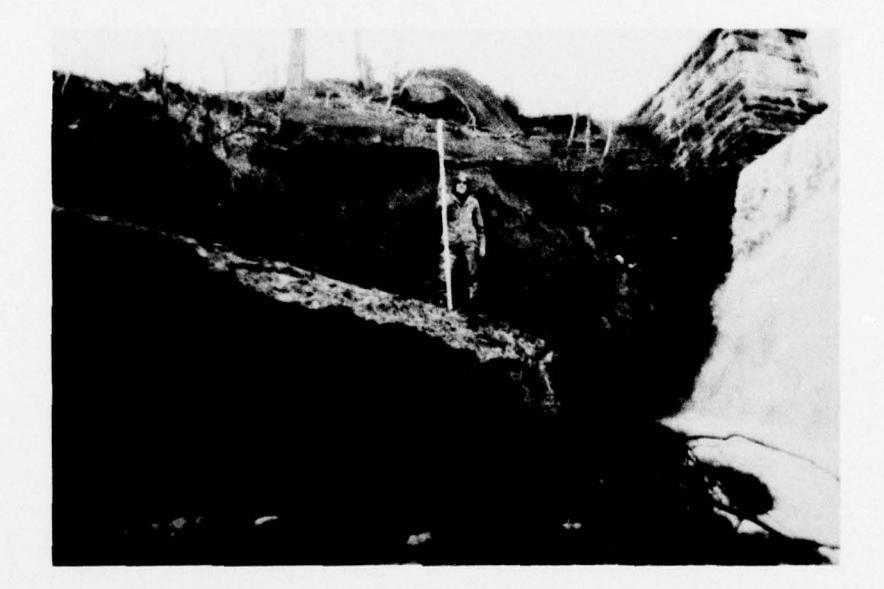
(2) The small concrete wall that acts as both a training wall and a support wall, and the adjacent concrete apron, have deteriorated to the extent that they are not considered fully functional. The longterm ability of the wall to support the rock mass is questionable, and the concrete apron has deteriorated to the extent of providing little protection to the underlying rock. The fractures that define the rock mass appear to be oriented in directions that would favor movement if support from the wall is lost. Failure of the rock mass could result in damage to the spillway.

J. Rock Mass and Wall Downstream from Spillway at Right Abutment

(7) Repair concrete wall and apron located at the toe of the spillway at the right abutment area.

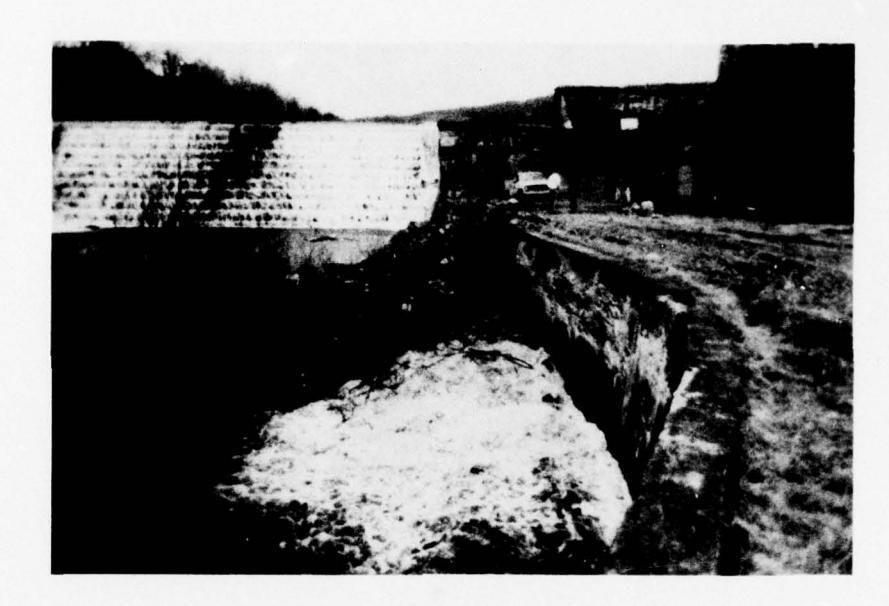
(4) <u>Outlet Channel Left Wall</u>. A concrete wall extends along the left side of the outlet channel from the gatehouse to the pipeline crossing (Photographs K and L). The following observations were made: (1) downstream from the outlet of the 48-inch diameter blowoff, about 20 linear feet of the foundation was undermined to an average depth of 1 foot; (2) seven drains had outlets on the face of the wall at various elevations, source of pipes unknown; (3) severe scaling and spalling were present along the base; and (4) many medium longitudinal cracks, one wide vertical crack, and one diagonal crack were on the exposed face.

(4) The undermining of the outlet channel wall is the most serious of its deficiencies. Although failure of this wall probably would not directly affect the dam, it might result in damage to the 48-inch emergency line.

K. Flow from 48-Inch Blowoff During Valve Operation

(9) Repair undermined portion of outlet channel left wall.
