FALLING SPRINGS DAM

NDS ID No. PA-00372 DER ID No. 35-39

PHASE I INSPECTION REPORT

NATIONAL DAM INSPECTION PROGRAM

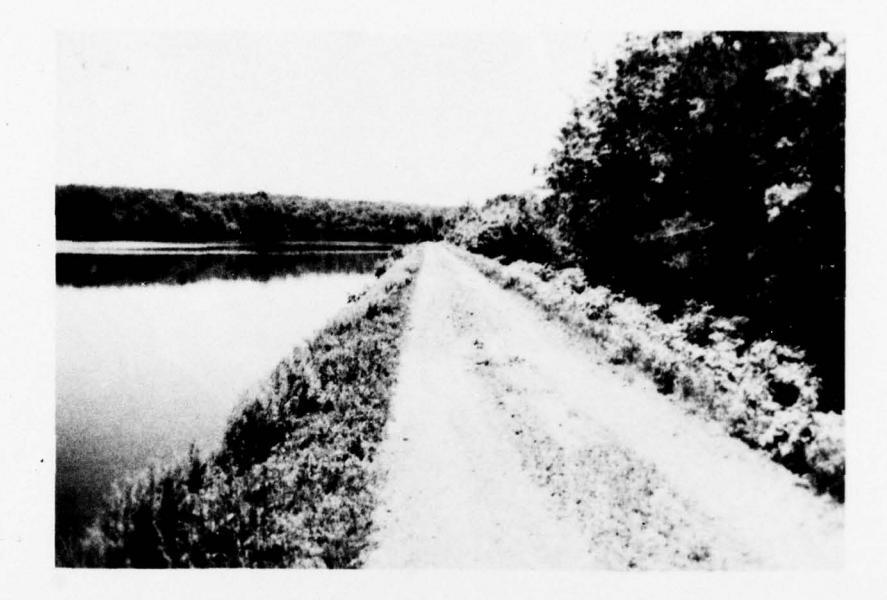
(1) Main Embankment. The main embankment was generally in good condition from what could be seen. However, brush and young trees with an average height of about 12 feet were growing on the downstream slope of the embankment and hindered the inspection. The growth was quite dense in places, with the diameter of the trees varying to up to 3 inches. Results of the survey of the downstream slope indicate that the slope varies slightly, but not significantly, from the design slope of 1V on 2H. A fallen 50foot tree was decaying on the slope. There was a row of mature evergreen trees that were spaced at about 12-foot intervals at the toe of the embankment. Several trees of about 12-foot height and 4-inch diameter were grouped near the junction of the main embankment with the left end of the spillway. The riprap on the upstream face of the main embankment is generally in place and is in good condition. There is a general cover of light brush about 18 inches in height on the upstream slope above the normal pool elevation.

A. Main Embankment View from Right Abutment

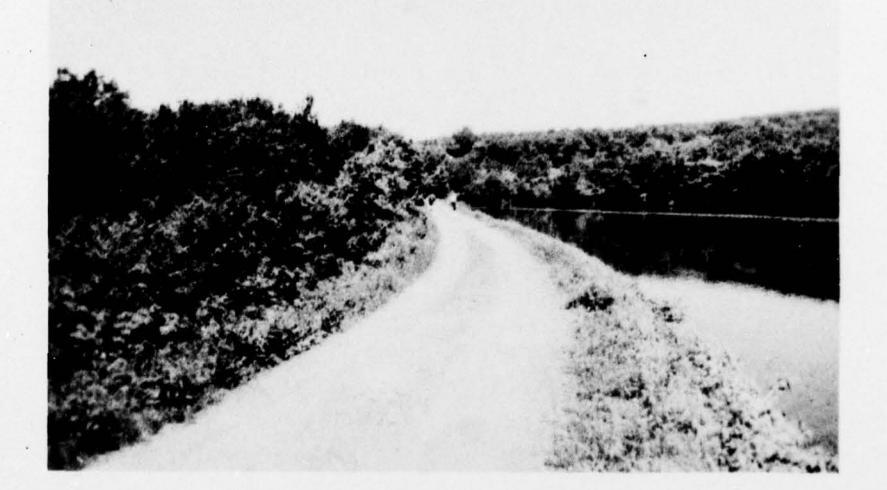
There were two wet areas at the downstream toe of the main embankment near the left abutment. The first wet area was the result of seepage through a 40foot by 100-foot portion of the vertical rock face immediately downstream of the left abutment. The seepage was collected by a rock-lined channel and joined the flow from the outlet channel about 180 feet downstream. The seepage was clear, and the flow in the rock-lined channel was about 5 to 10 gpm. The second wet area was observed about 20 feet to the right of the rock-lined channel and was approximately 3 feet wide and 15 feet long. The flow from the second wet area drained into the rock-lined channel and was estimated to be less than 0.5 gpm. The discharge from the second wet area was also clear.

B. Main Embankment View from Left Abutment

(5) Data collected from observation wells or other instrumentation should be utilized in evaluating the stability of the structures and assessing piping potential in the future. Continue to observe wet areas and measure and record seepage downstream of embankments. If conditions worsen, appropriate action should be taken to control apparent seepage with properly designed drains.

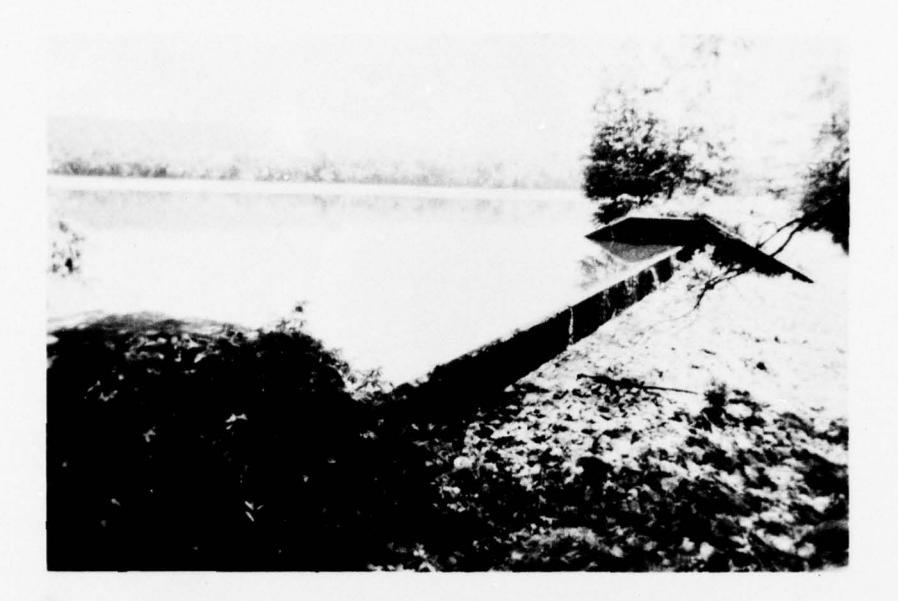
Spillway. In general, the concrete of the (1)spillway weir and spillway abutments was in satisfactory condition. Since water was flowing over the spillway crest, the downstream face of the spillway weir could not be closely inspected. It was observed, however, that moss was growing on the face and that coarse aggregate was exposed in several places across the face and crest. Concrete was spalled to an average distance into the reservoir of about 9 inches and to an average vertical depth of about 10 inches at three locations across the spillway Two of the spalled areas were at the monolith joints. crest. The joint filler was missing where the concrete was spalled at the joints. The third area of spalling was at a transverse or shrinkage crack 10 feet from the right abutment Two other transverse or shrinkage cracks were noted in the spillway weir. In general, the cracks were parallel with the flow and ran upstream for a distance of about 2 feet until observation was obstructed by the water in the res-ervoir. The cracks were about 1/4 inch wide and were probed to a depth of about 1/4 inch. No differential movement was noted at the cracks. Three small spalled areas and a small crack were observed on the spillway right abutment wall. The spalled areas were, on the average, about 5 inches wide, 6 inches long, and 3 inches deep. The vertical crack ran from the spillway crest to the top of the abutment wall. The crack was probed to a depth of about 1/4 inch. No differential movement was noted at the crack. There appeared to have been an attempt to patch the crack at one time.

(1) <u>Spillway</u>. The condition of the concrete of the spillway weir and spillway abutments is of slight concern at the present time. Additional spalling and surface cracking of the concrete could become more of a concern in the future. The spalling at the joints of the spillway weir could reduce the ability of the weir to act as a watertight structure. The conditions of the approach channel and the spillway apron are of little concern, although the debris, brush, and grass present are undesirable. There is general concern for the condition at the downstream end of the spillway apron, where the channel invert drops nearly vertical for a distance of about 6 feet. During larger discharges, considerable scouring could occur that might undermine the riprap apron and threaten the toe of the main embankment and the spillway.

C. Spillway

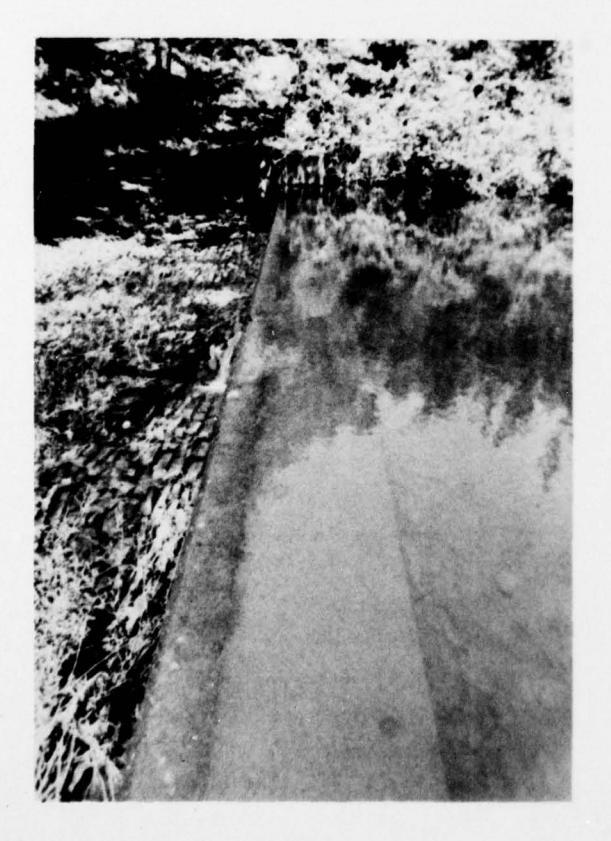
D. Spillway Crest

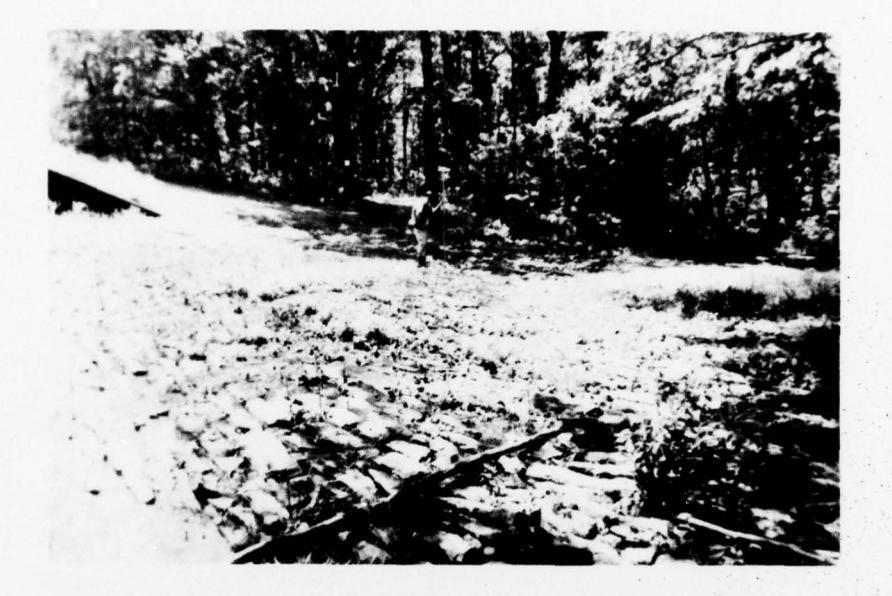
The spillway apron was generally in good condition. Grass was growing through the riprap cover over about 50 percent of the spillway apron. A 3-foot by 3-foot brush area was observed 2 feet downstream of the spillway weir. Minor debris had collected on the spillway apron. At the downstream end of the spillway apron, the channel invert drops 6 feet, nearly vertical, onto boulders, smaller rocks, and an earthen channel composed mostly of a hard clay. Construction methods for the channel were unknown, and the channel appeared to have been degrading for many years.

E. Spillway Apron

(9) Investigate scour damage that could occur during periods of high discharge at downstream end of spillway apron.

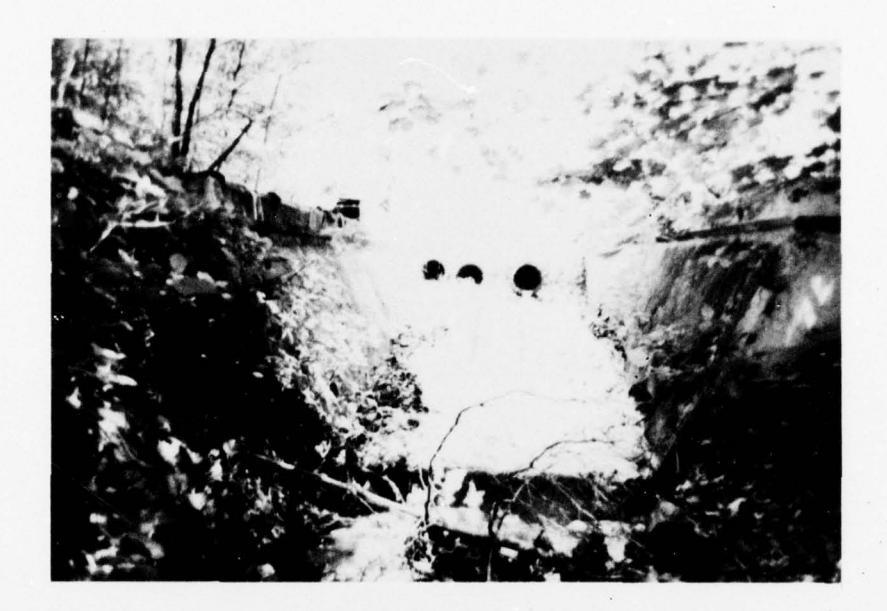
The two 20-inch diameter cast-iron outlet pipes discharged into the outlet channel. A third 20-inch diameter cast-iron pipe connected to the drainage gallery located in the core wall of the main embankment and discharged into the outlet channel. This drainage pipe was discharging water with a depth of flow of about 1/2 inch in the pipe. A deposit of orange clay was noted directly beneath the core wall drain outlet. The floor and the right outlet channel wall were in good condition. There was a vertical crack in the right outlet channel wall from the channel floor to and through the 9-inch coping on top of the wall. The crack was 1/2 inch wide, 4.3 feet high, and 10 feet downstream from the valve house. It appeared that there was an attempt to patch the crack at one time. The left outlet channel wall was severely deteriorated and undermined (Photograph H). The concrete was disintegrated for about 2 feet immediately below the valve house. The wall was undermined at the junction of the wall and the floor for the entire length of the wall. The maximum distance of undermining into the wall was 14 inches; the maximum vertical distance of the affected area was 27 inches. The concrete coping and the vertical face of the wall was deteriorated at several places to a depth of 3 inches. The 9-inch coping and the top 2 feet of the end of the left outlet channel wall was disintegrated to a depth of 3 inches. There was There was evidence that repairs had been attempted in the past.

G. Core Wall Drain and Outlet Works from Downstream End of Outlet Channel

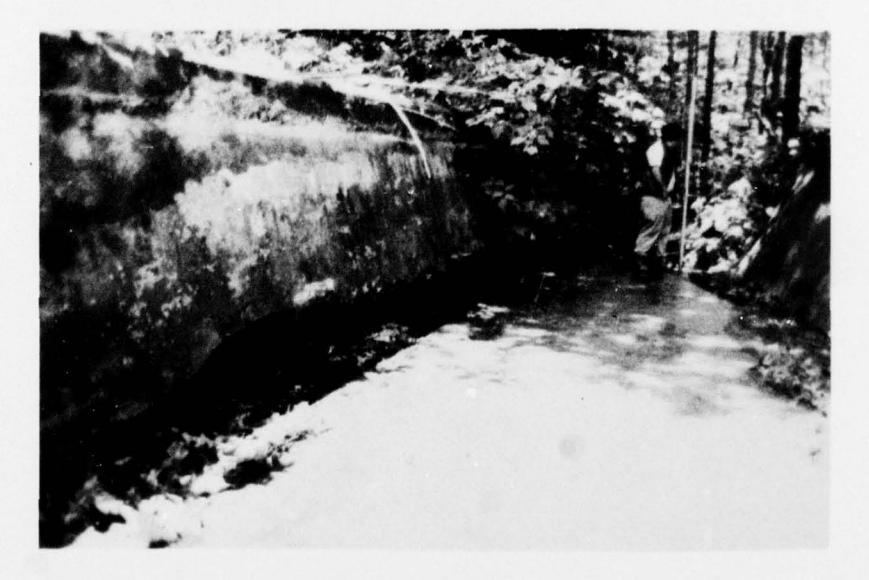
The left outlet channel wall was showing evidence of severe deterioration. Lack of maintenance may increase the deterioration and thereby threaten the stability of the wall. Continued deterioration and undermining of the wall could lead to a failure of the wall, which may threaten the toe of the main embankment.

H. Undermining and Disintegration of Left Outlet Channel Wall from Upstream End of Outlet Channel

(8) Repair the concrete of the left outlet channel wall.

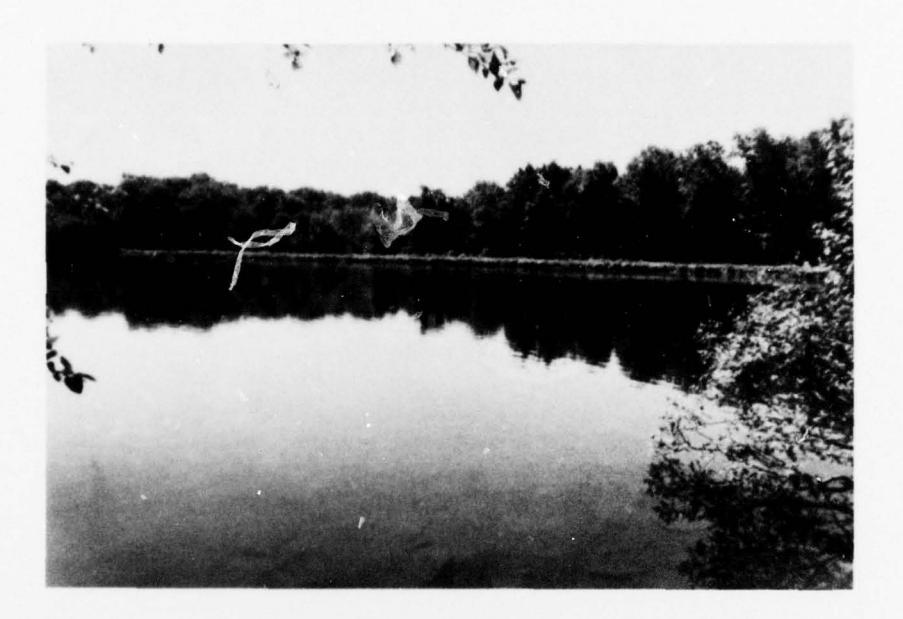
(2) Auxiliary Embankment. The auxiliary embankment was generally in good condition from what could be seen. However, 3.5-foot high brush, growing on the downstream slope of the embankment, hindered the inspection. Results of the survey of the downstream slope indicate that the slope was slightly flatter than the design slope of 1V on 2H. The area immediately downstream of the toe was covered with mature broadleafed trees with an average height of about 60 feet. The riprap on the upstream face of the main embankment is generally in place and is in good condition. There is a general cover of light brush about 18 inches in height on the upstream slope above the normal pool elevation.

I. Upstream Face of Auxiliary Embankment from High Natural Ground Between the Embankments

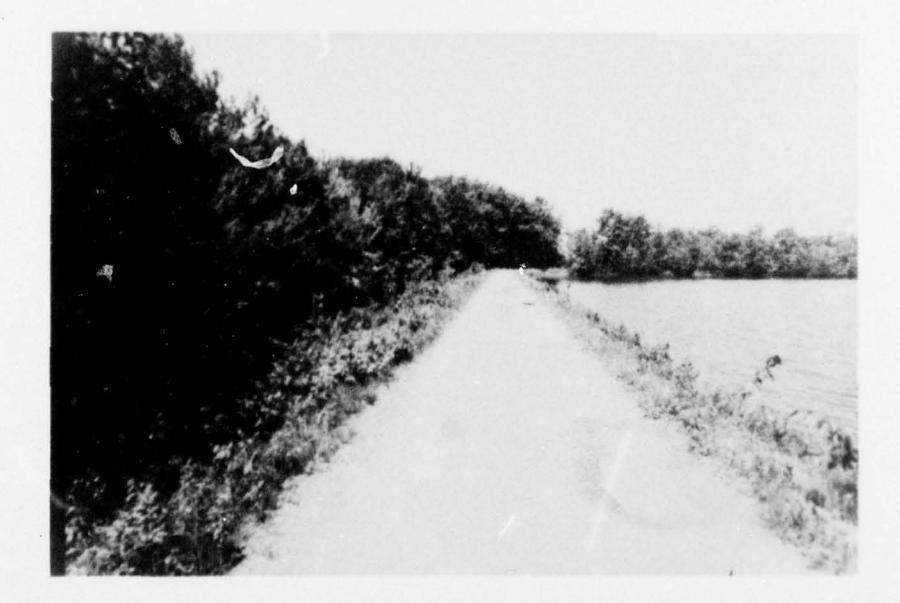
Two wet areas were observed near the auxiliary embankment. The first wet area was a general swampy area of triangular shape below the downstream toe near the middle of the auxiliary embankment. The length of the wet area along the toe was about 200 feet, and the standing water extended about 600 feet downstream of the toe. There was no outlet for the wet area, and there was no discernable flow. old cuttings of brush and small trees were lying in the swampy area near the toe. The second wet area was a small pool of standing water at the left abutment on the downstream side (Photograph L). The pool area was 6 feet long and 5 feet wide, and the pool was 0.5 foot deep. It appeared that the pool collected surface runoff that had drained along the access road to the dam. There was no discernable outflow from the pool.

J. Auxiliary Embankment View from Left Abutment

(6) Investigate surface runoff from left abutment. If it is determined that the wet area at the left abutment of the auxiliary embankment is caused by surface runoff from the left abutment, provide positive drainage for the runoff.

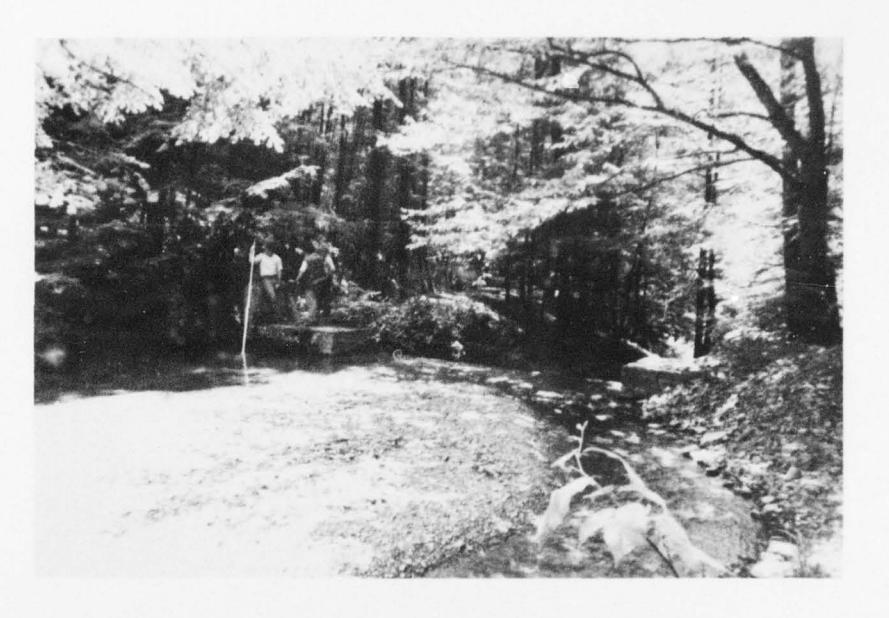
e. <u>Downstream Conditions</u>. A small diversion structure consisting of a 7-foot high masonry dam and headworks for a canal is located about 0.6 mile downstream of Falling Springs Dam (Photograph M). At that point, a portion of the flow from Falling Springs Creek is directed via an earthen canal for a distance of about 0.3 mile into Campbell Ledge Storage Dam. Campbell Ledge Storage Dam supplies water to Campbell Ledge Intake Dam, which distributes water to Pittston, Old Forge, and Taylor. The locations of the dams are shown on Plate 1.

M. Diversion Structure Below Falling Springs Dam for Supply to Campbell Ledge Storage Dam

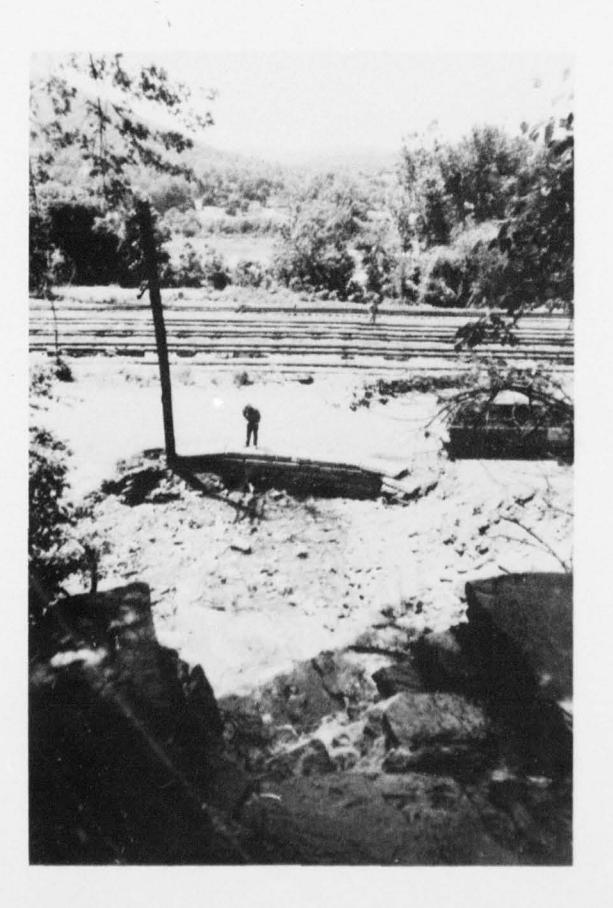
N. Outfall of Falling Springs Creek Under Road and Railroad Tracks into Susquehanna River
