National Dam Inspection Program. Howells Run Dam (ID Number PA 434), Ohio River Basin, Howells Run, Cambria County, Pennsylvania. Phase I Inspection Report . 11) Jun 78 TABLE OF CONTENTS PAGE SECTION 1 - PROJECT INFORMATION DACW31-78-C-\$\$49 1 1.1 General 1 1.2 Description of Project 1 1.3 Pertinent Data 3 SECTION 2 - ENGINEERING DATA 5 2.1 Design 5 2.2 Construction 6 2.3 Operation 7 2.4 Other Investigations 7 2.5 Evaluation 7 SECTION 3 - VISUAL INSPECTION 9 3.1 Findings 9 3.2 Evaluation 10 SECTION 4 - OPERATIONAL FEATURES 12 4.1 Procedures 12 4.2 Maintenance of the Dam 12 4.3 Maintenance of Operating Facilities 12 4.4 Warning System in Effect 12 4.5 Evaluation 12 SECTION 5 - HYDRAULICS AND HYDROLOGY 13 5.1 Evaluation of Features 13 SECTION 6 - STRUCTURAL STABILITY 14 6.1 Evaluation of Structural Stability 14 SECTION 7 - ASSESSMENT AND RECOMMENDATIONS/REMEDIAL MEASURES 15 7.1 Dam Assessment 15 7.2 Recommendations/Remedial Measures 15 ORIGINAL CONTAINS COLOR PLATES: ALL DOG REPRODUCTIONS WILL BE IN BLACK AND WHITE. DISTRIBUTION STATEMENT A 411001 LB Approved for public release; ibution Unlimited

NAME OF DAM: Howells Run Dam (New City Reservoir) STATE LOCATED: Pennsylvania COUNTY L

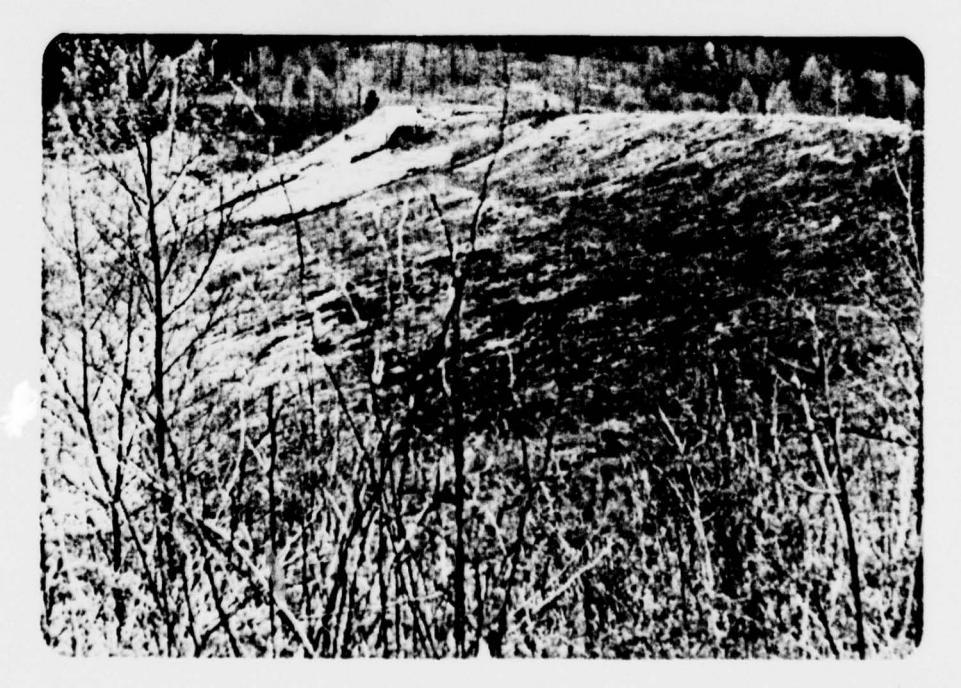
Downstream Face

4. High grass and patches of brush were found to impair the adequate inspection of the downstream face of the dam.

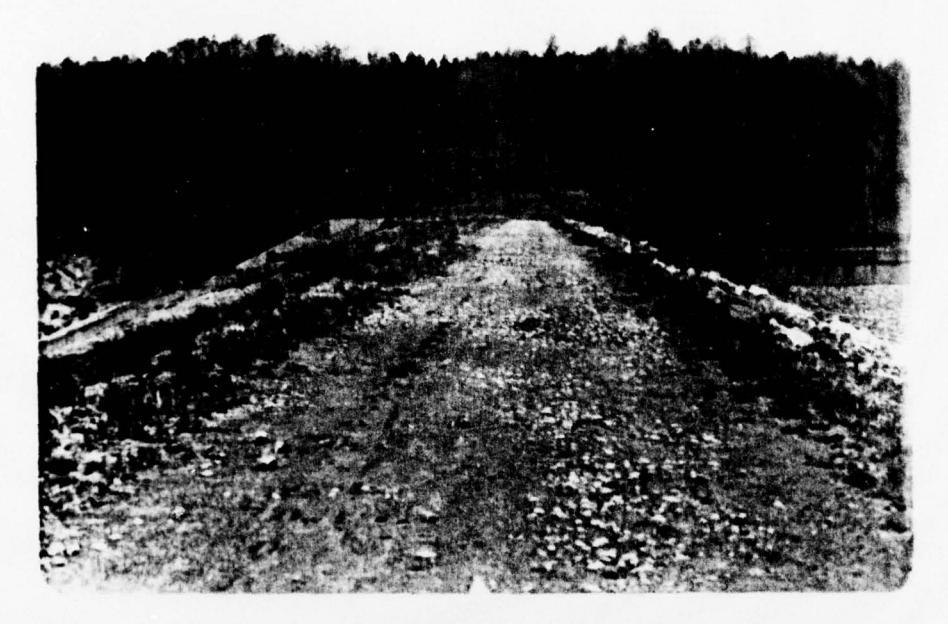
elevation. Review of the design drawings indicates that this condition was the result of camber built into the crest of the dam (Plate 1).

Photograph No. 1 Dam crest.

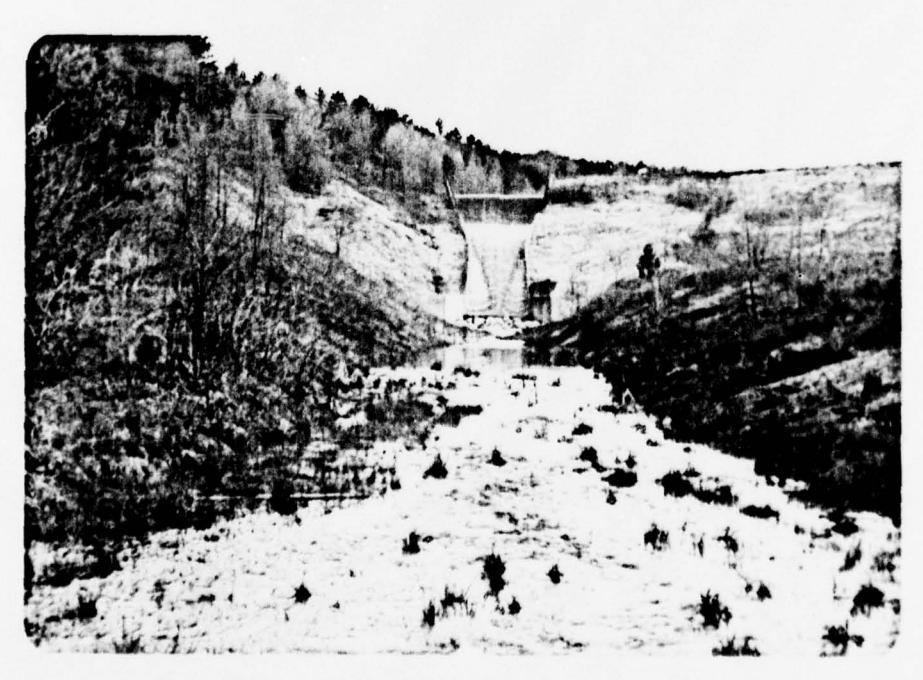
Photograph No. 2 Right abutment, spillway, and discharge channel.

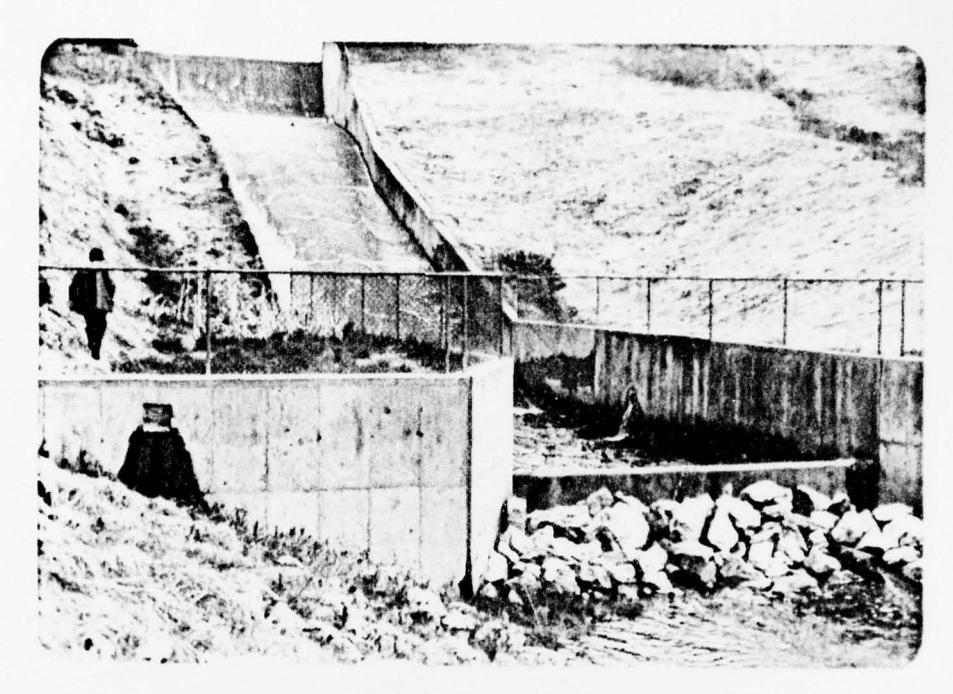
Photograph No. 3 Plunge pool.

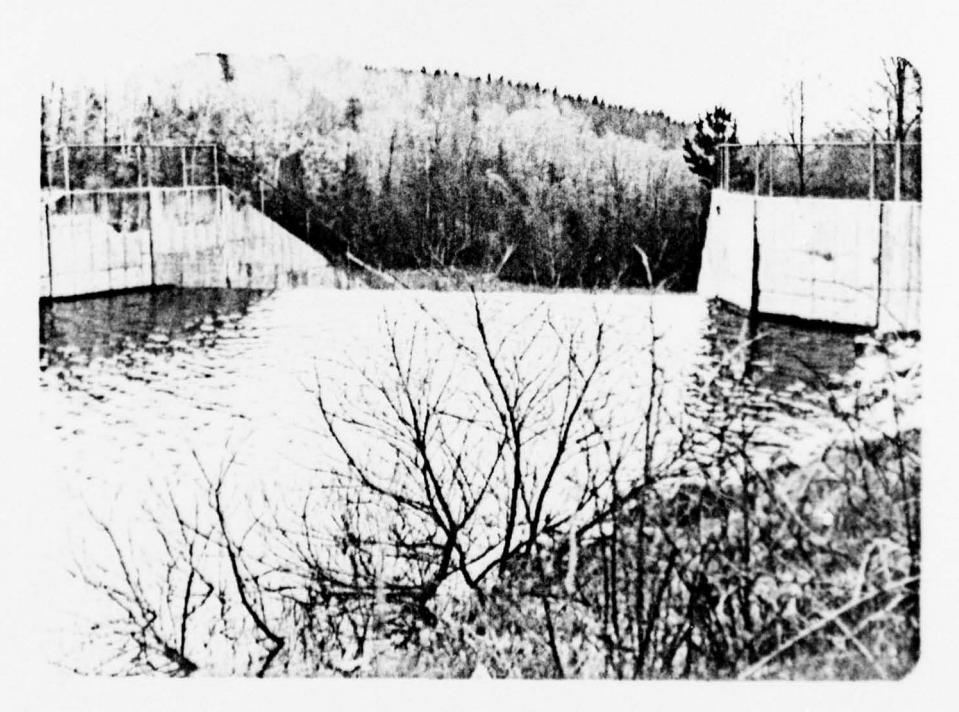
Photograph No. 4 Spillway approach channel.

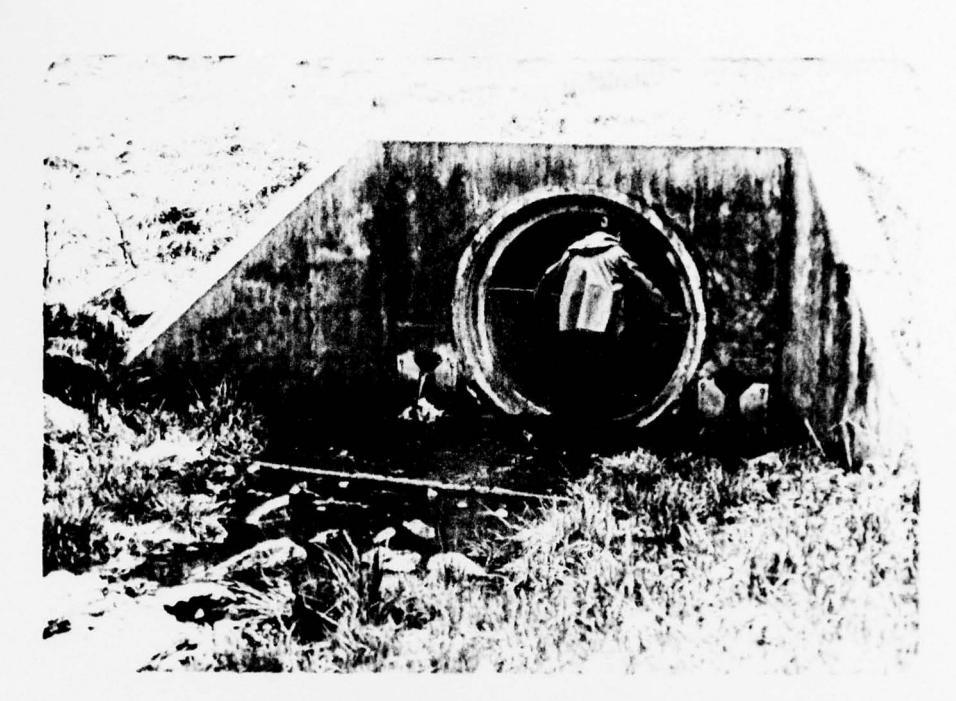
c. <u>Appurtenant Structures</u>. The spillway crests and plunge pools were examined for deterioration of the concrete or other signs of distress and obstructions that would limit flow. These structures were found to be in good condition and performing satisfactorily. As can be determined from the downstream end, the condition of the drainpipe is considered good.

Photograph No. 5 Outlet pipe and toe drainpipes.
